APPENDIX A

Site photographs

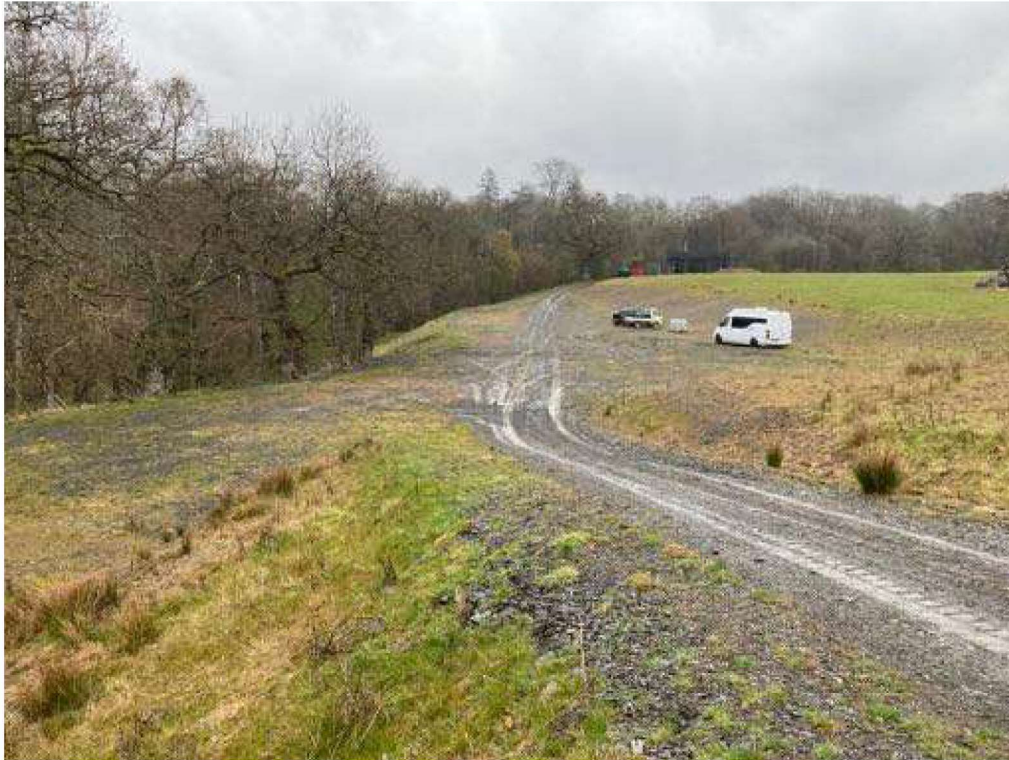
Photograph 1

Description: Site A: proposed motocross reception and parking area

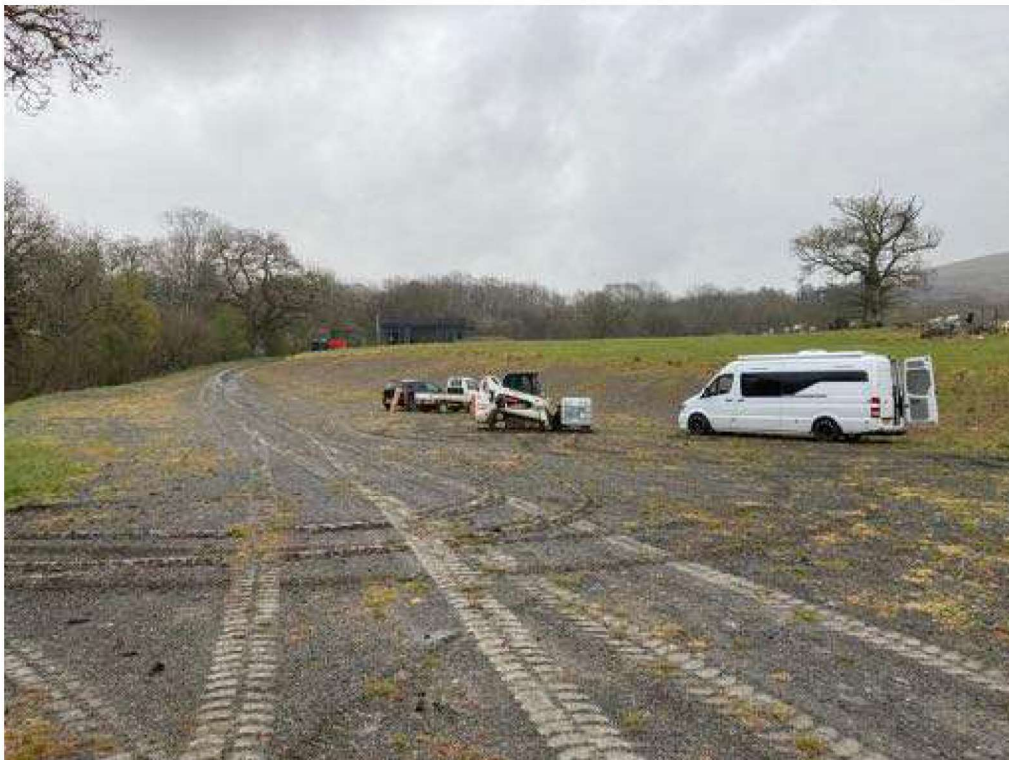
Photograph 2

Description: Site A: proposed motocross reception and parking area

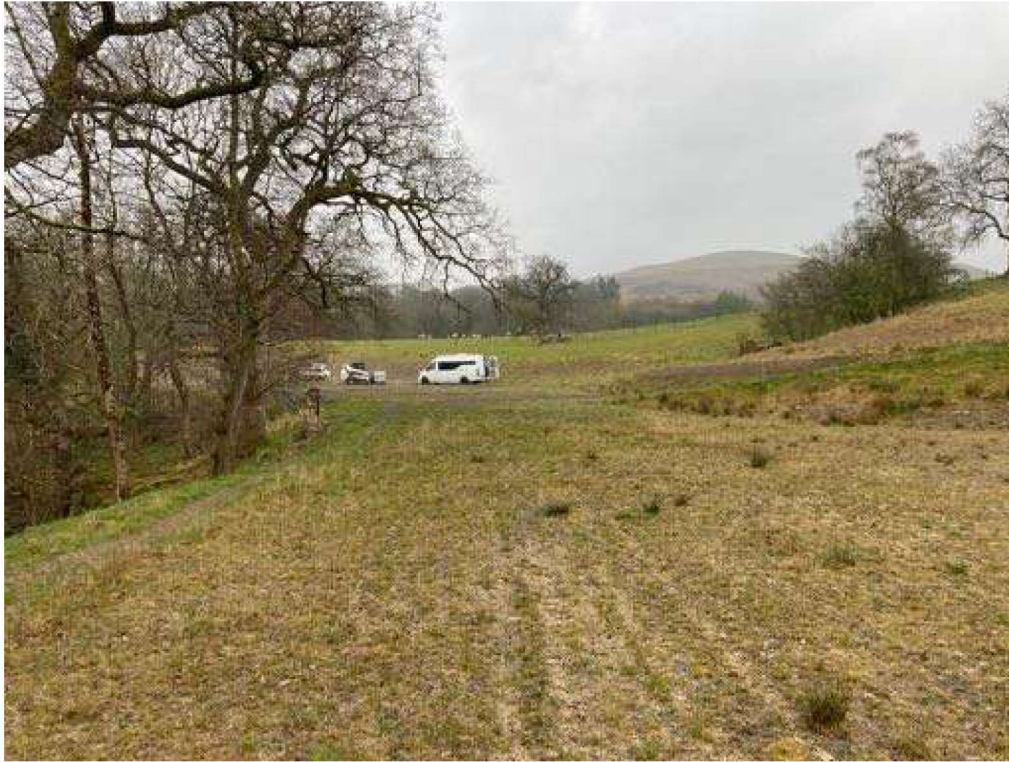
Photograph 3

Description: Site A: proposed motocross reception and parking area

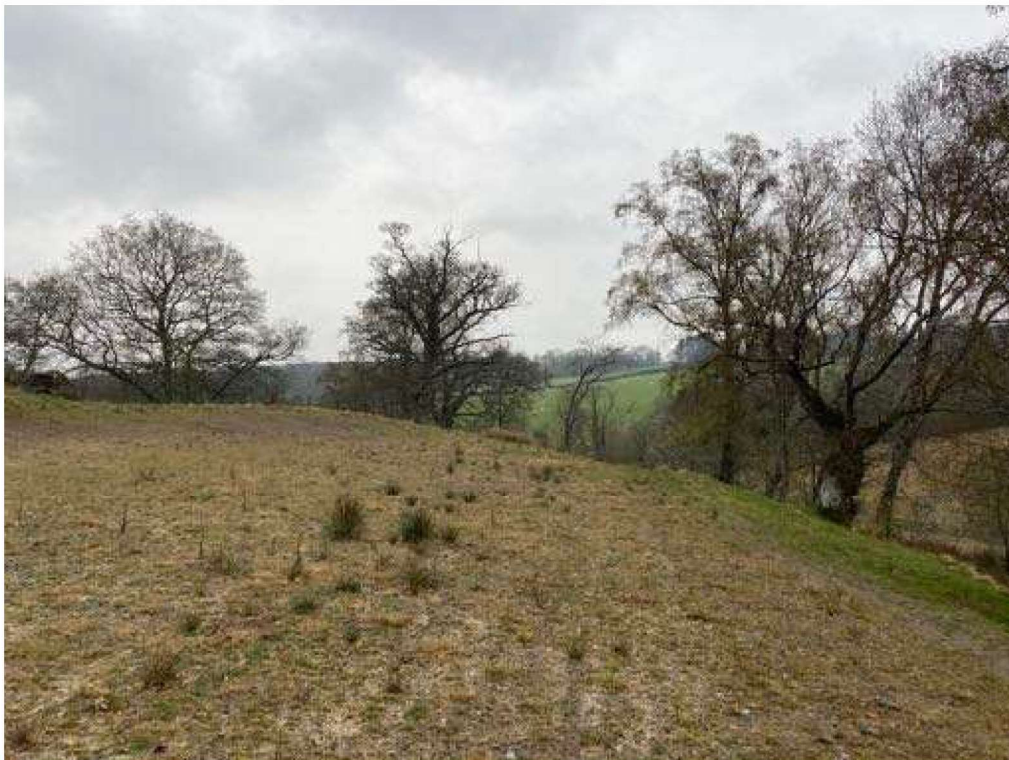
Photograph 4

Description: Site A: proposed motocross reception and parking area

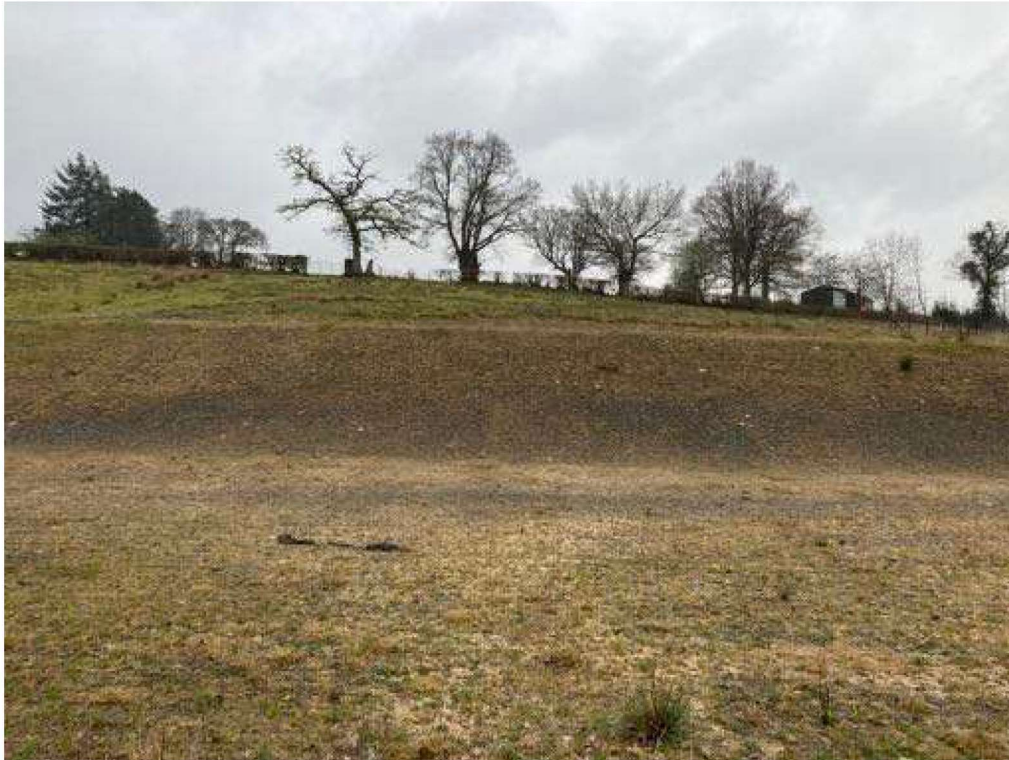
Photograph 5

Description: Site A: artificial bank resulting from previous groundworks

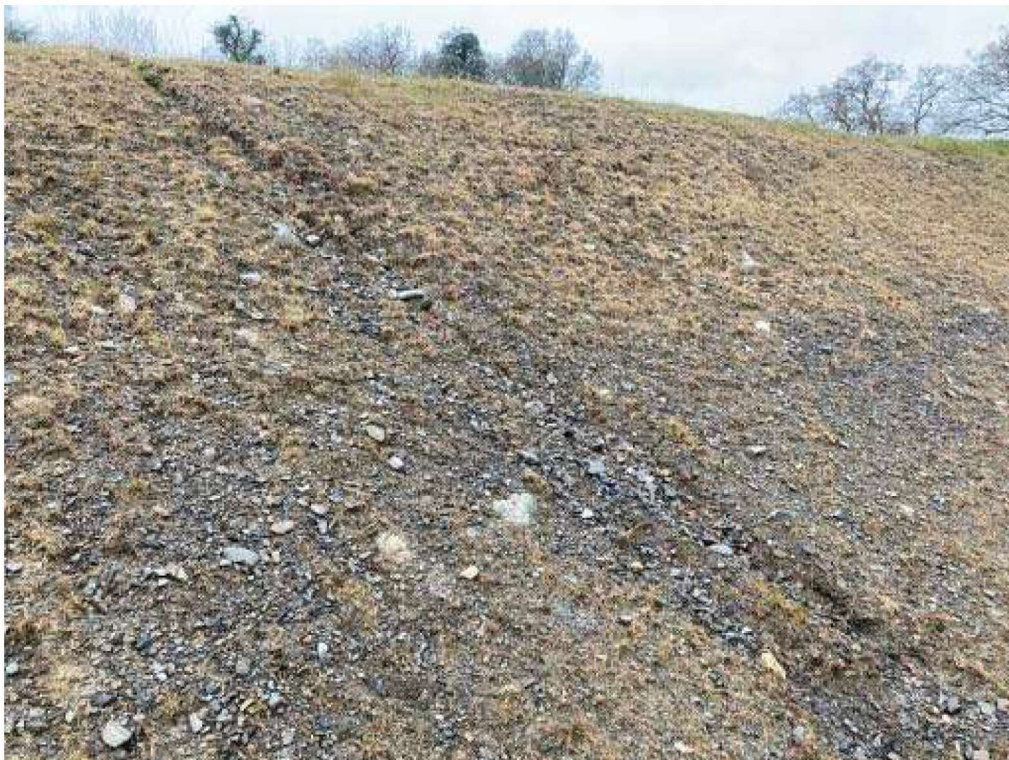
Photograph 6

Description: Site A: drainage rills within the artificial bank

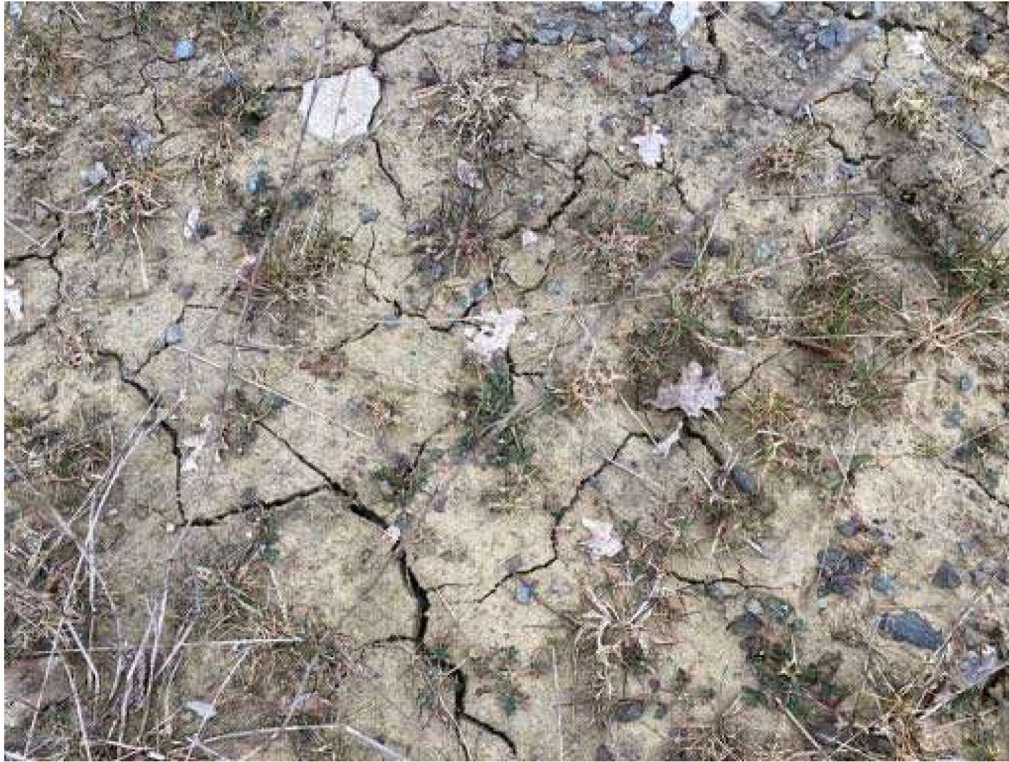
Photograph 7

Description: Site A: surface cracks within clayey soils

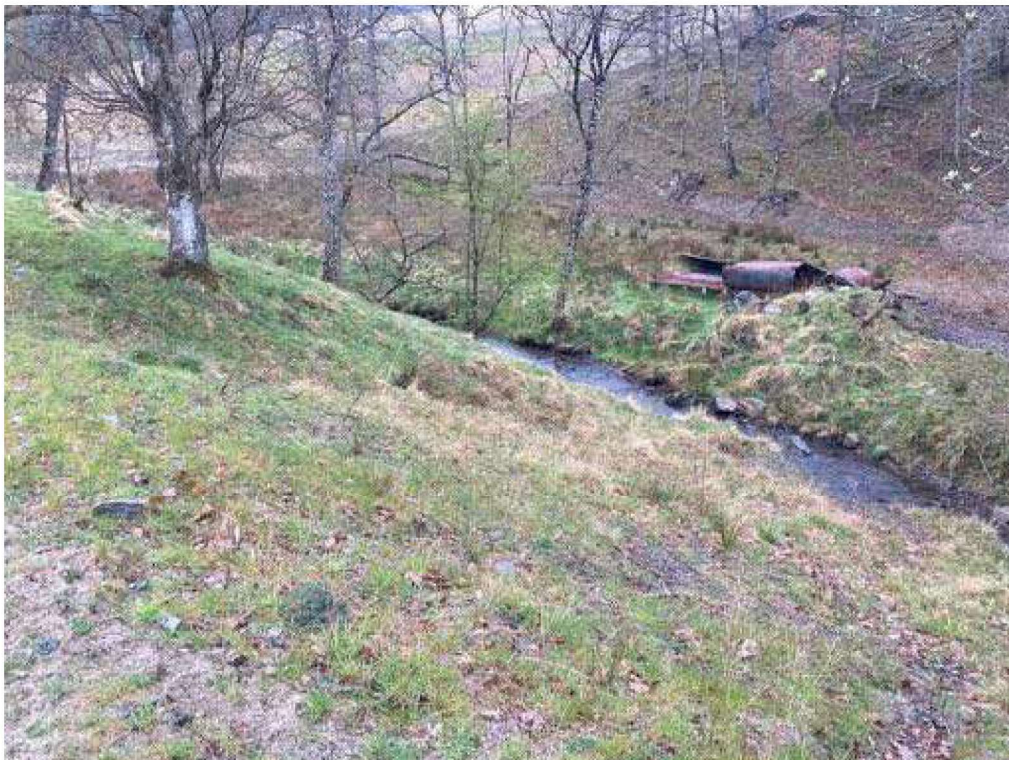
Photograph 8

Description: Site A: sloping ground leading down to Dulas Brook

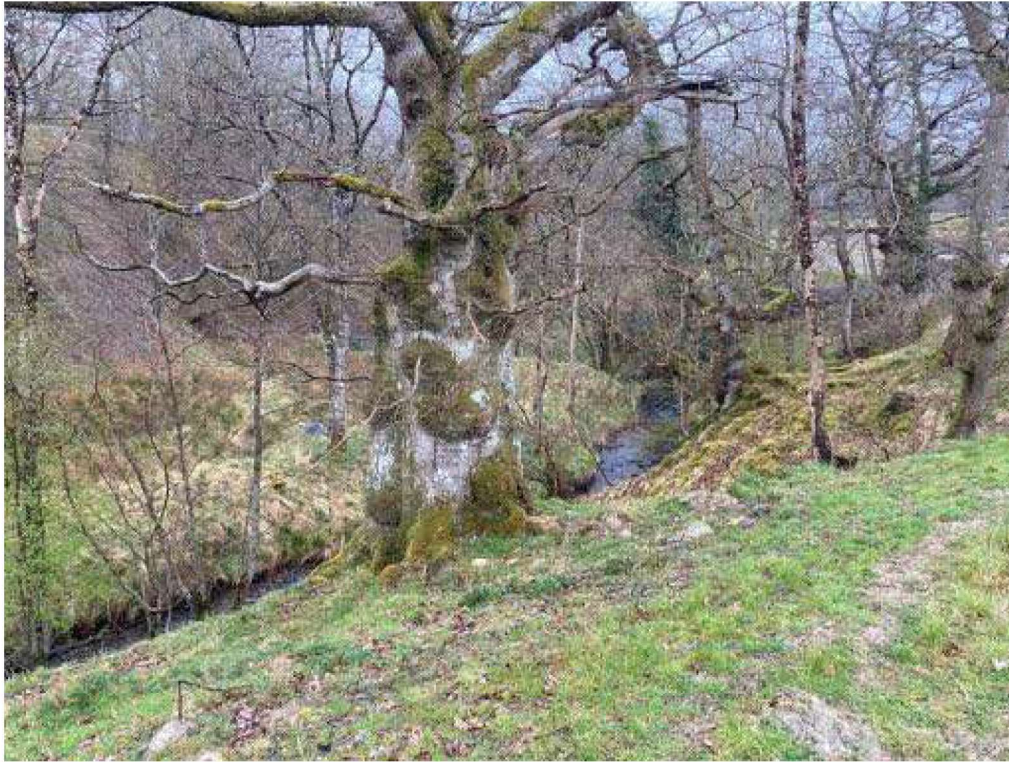
Photograph 9

Description: Site A: Dulas Brook river corridor

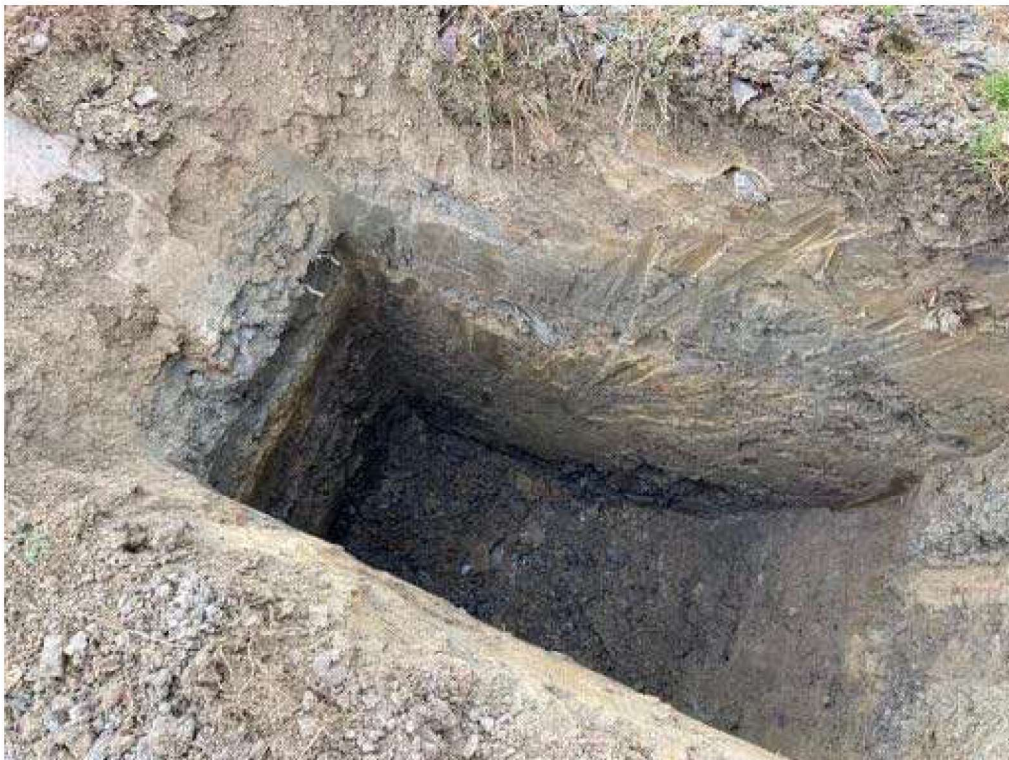
Photograph 10

Description: Trial pit TP01

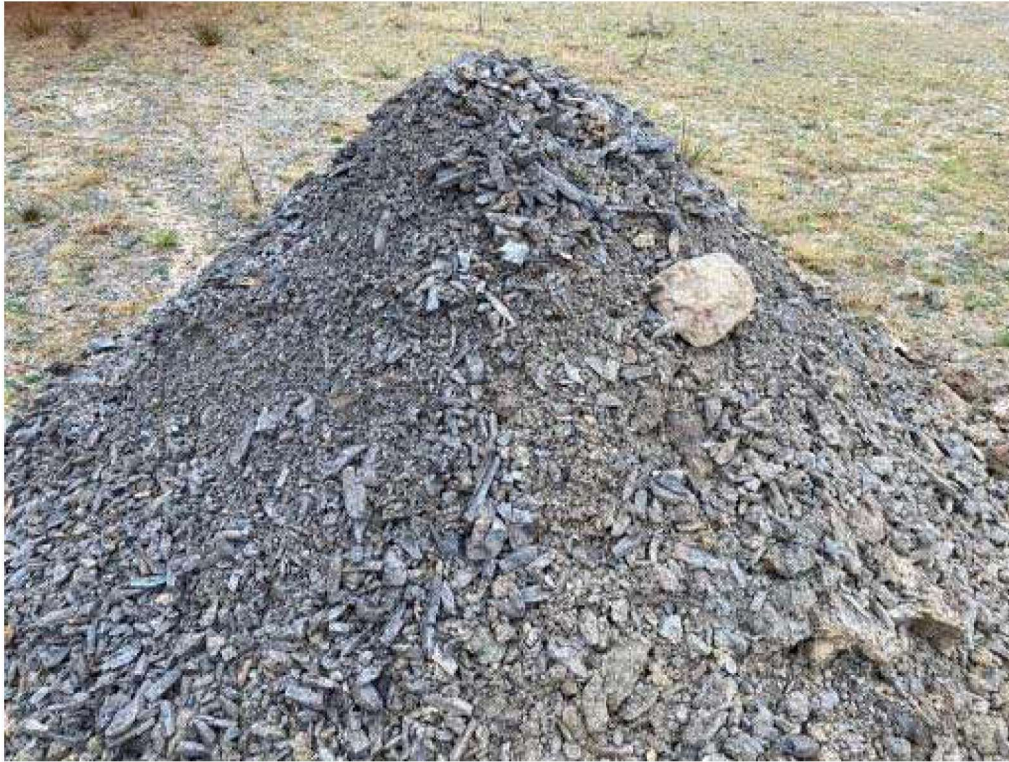
Photograph 11 **Description:** Spoil removed from trial pit TP01
 Date: 28/04/2021
 Location: North western part of Site A

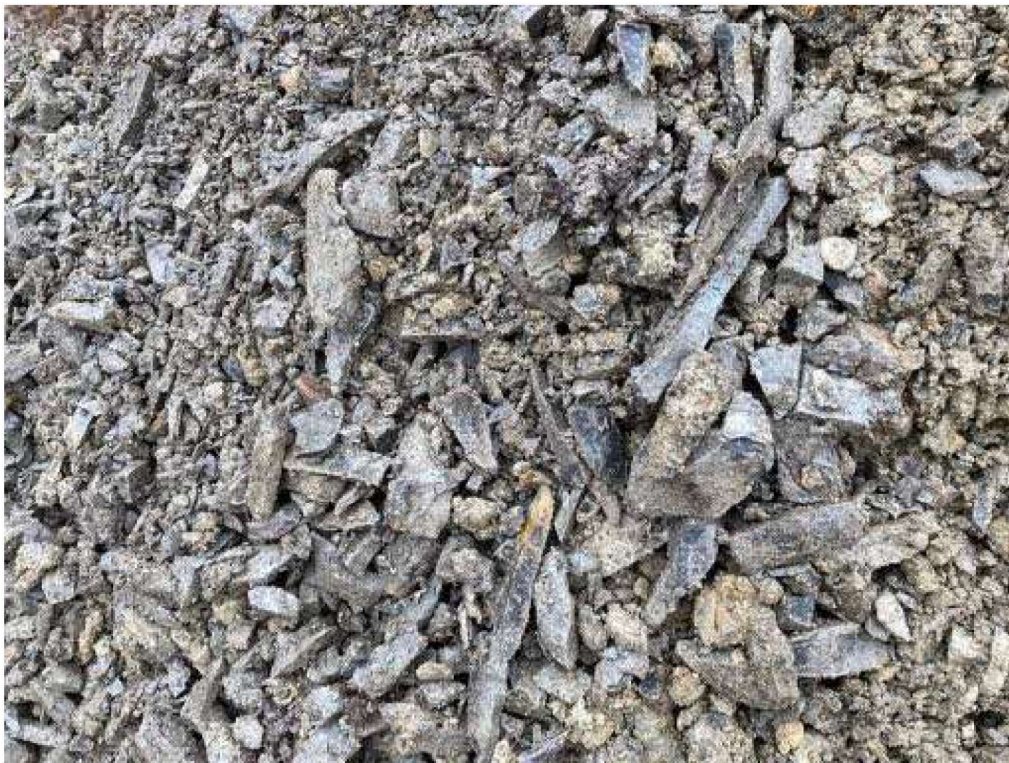
Photograph 12 **Description:** Spoil removed from trial pit TP01
 Date: 28/04/2021
 Location: North western part of Site A

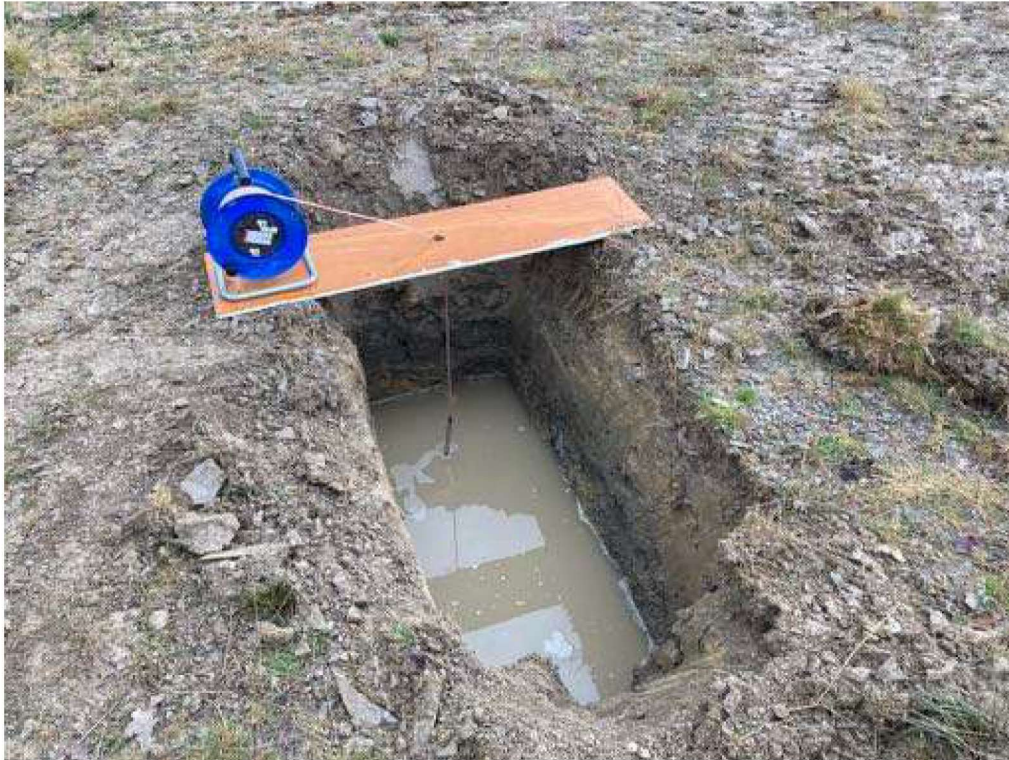
Photograph 13 **Description:** Water level monitoring at trial pit TP01 (start of test)
Date: 28/04/2021
Location: North western part of Site A

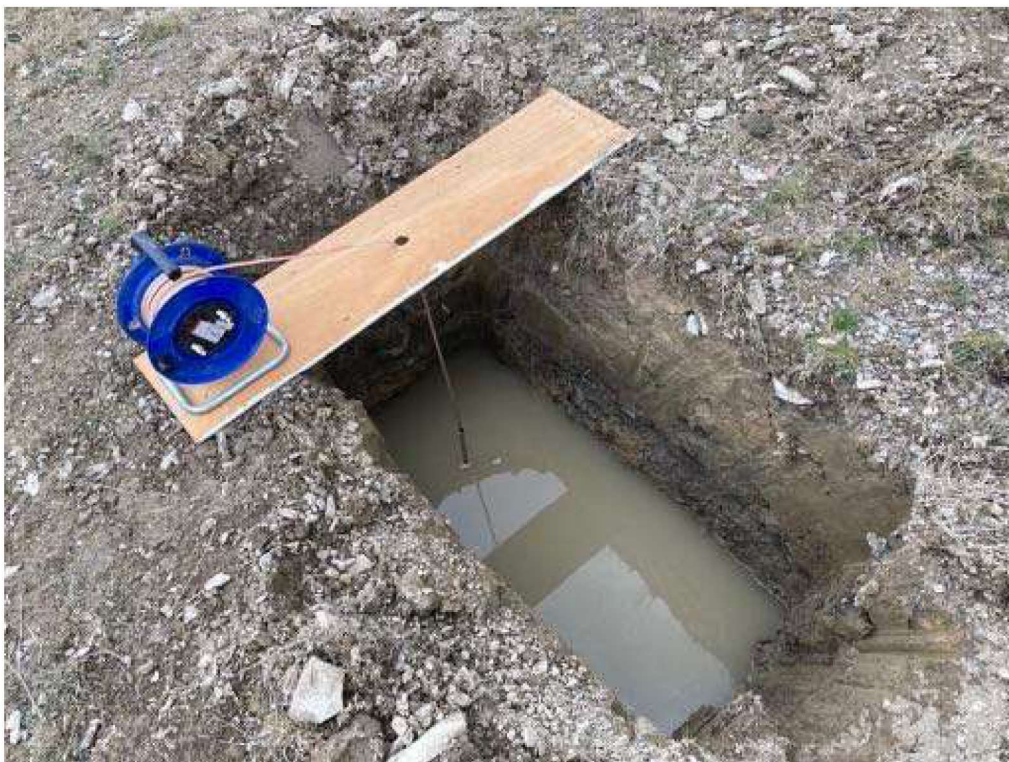
Photograph 14 **Description:** Water level monitoring at trial pit TP01 (end of test)
Date: 28/04/2021
Location: North western part of Site A

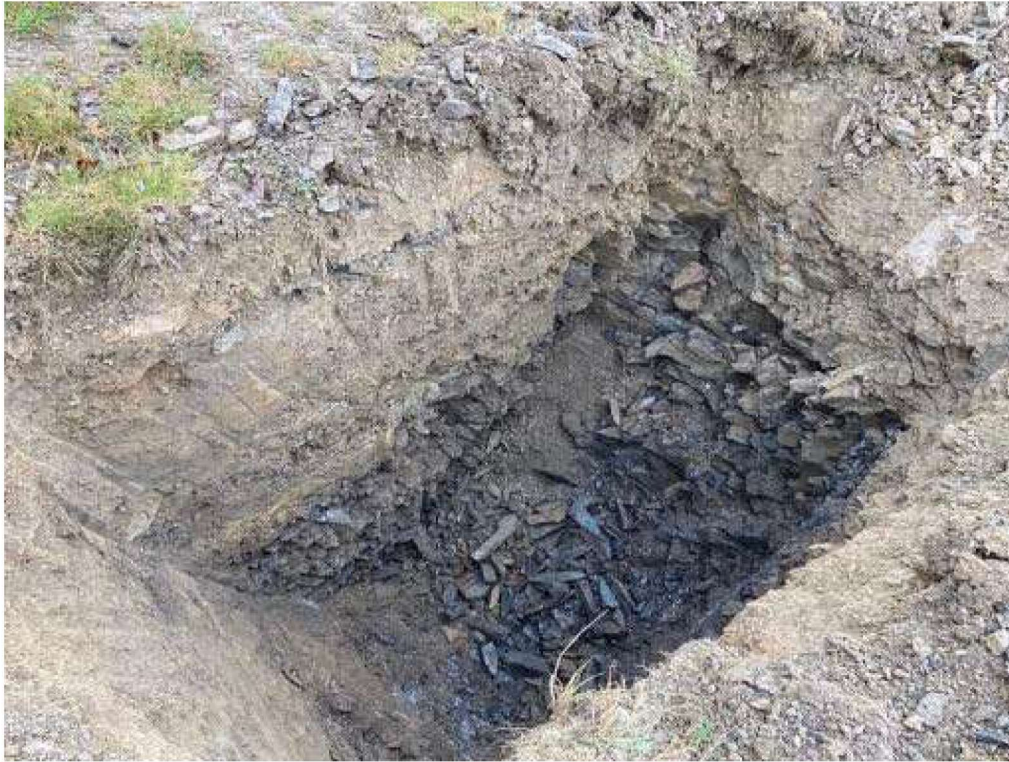
Photograph 15

Description: Trial pit TP02

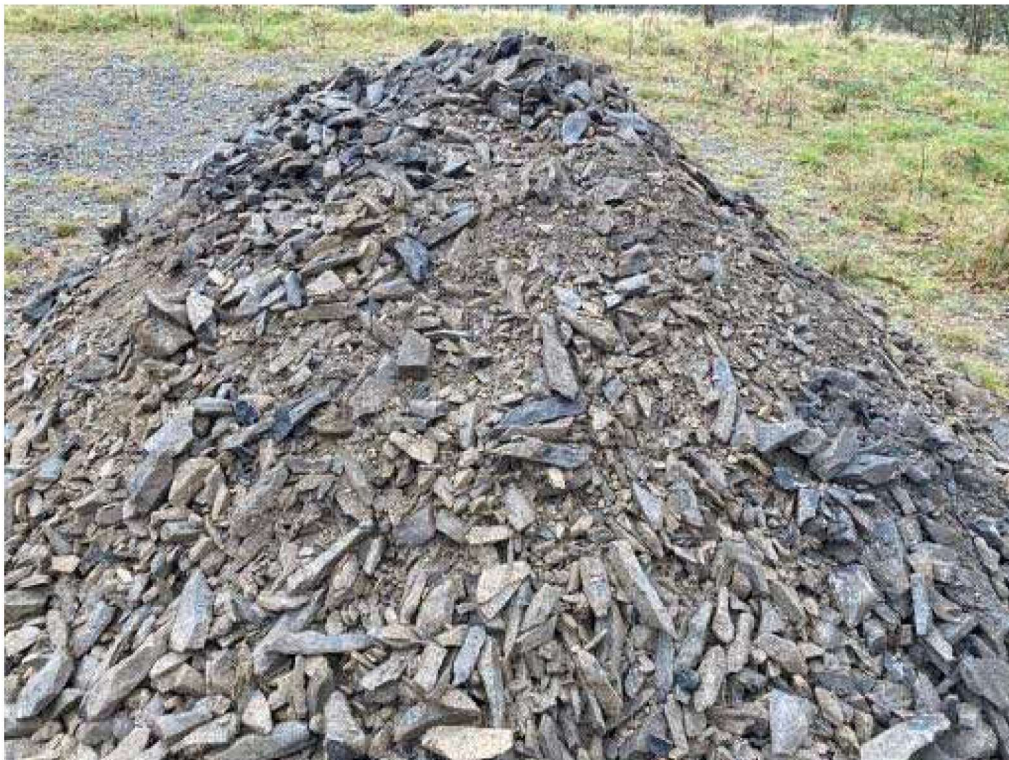
Photograph 16

Description: Spoil removed from trial pit TP02

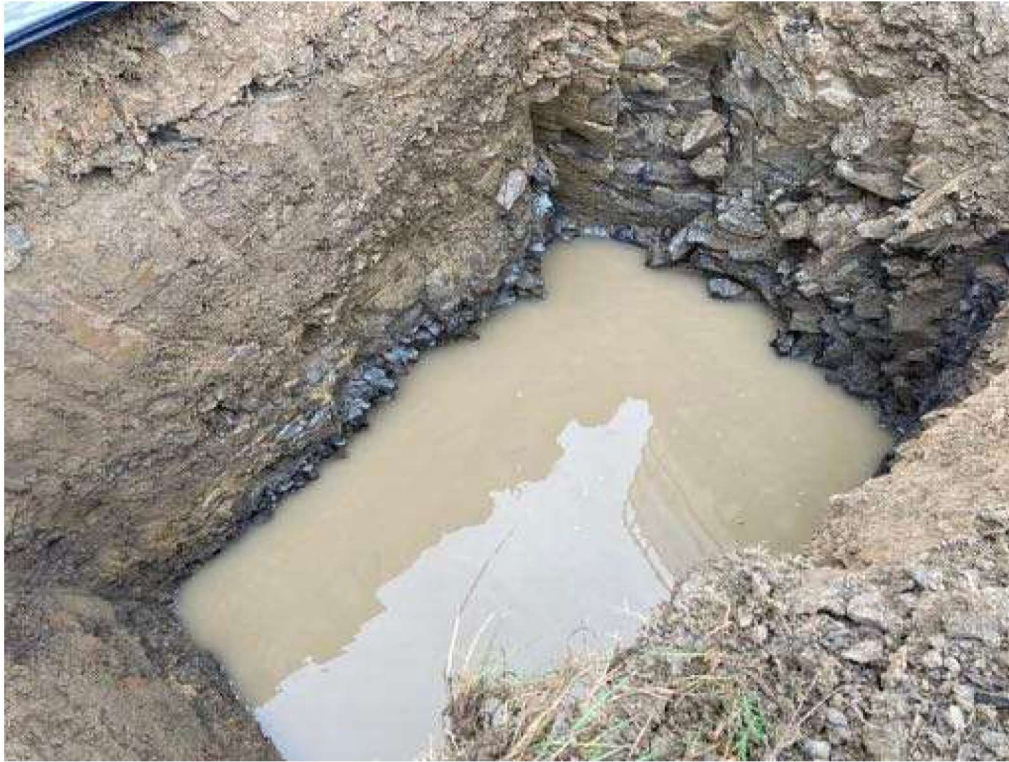
Photograph 17 **Description:** Inundation of trial pit TP02 (start of test)
 Date: 28/04/2021
 Location: North western part of Site A

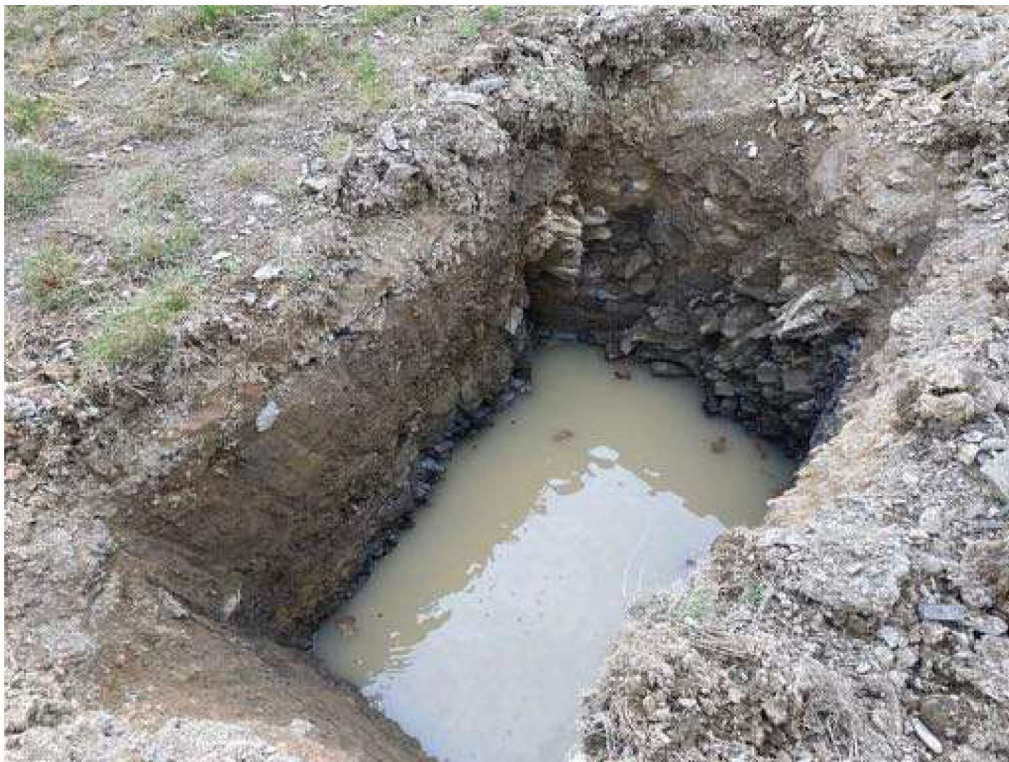
Photograph 18 **Description:** Trial pit TP02 (end of test)
 Date: 28/04/2021
 Location: North western part of Site A

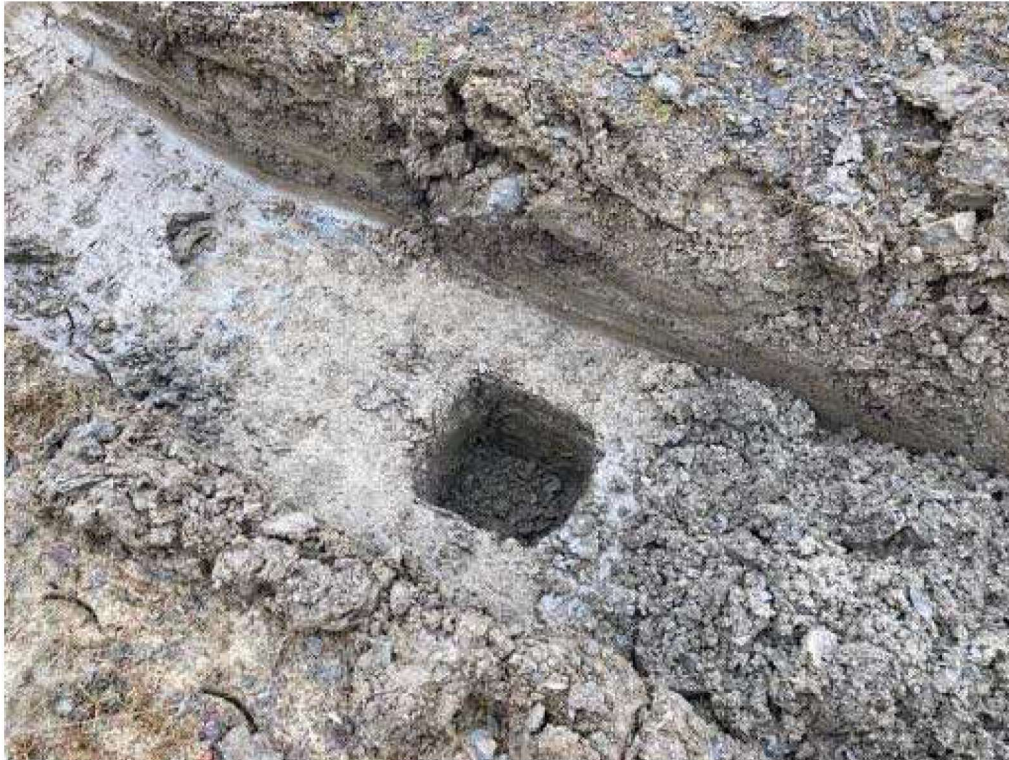
Photograph 19

Description: Hand pit HP01

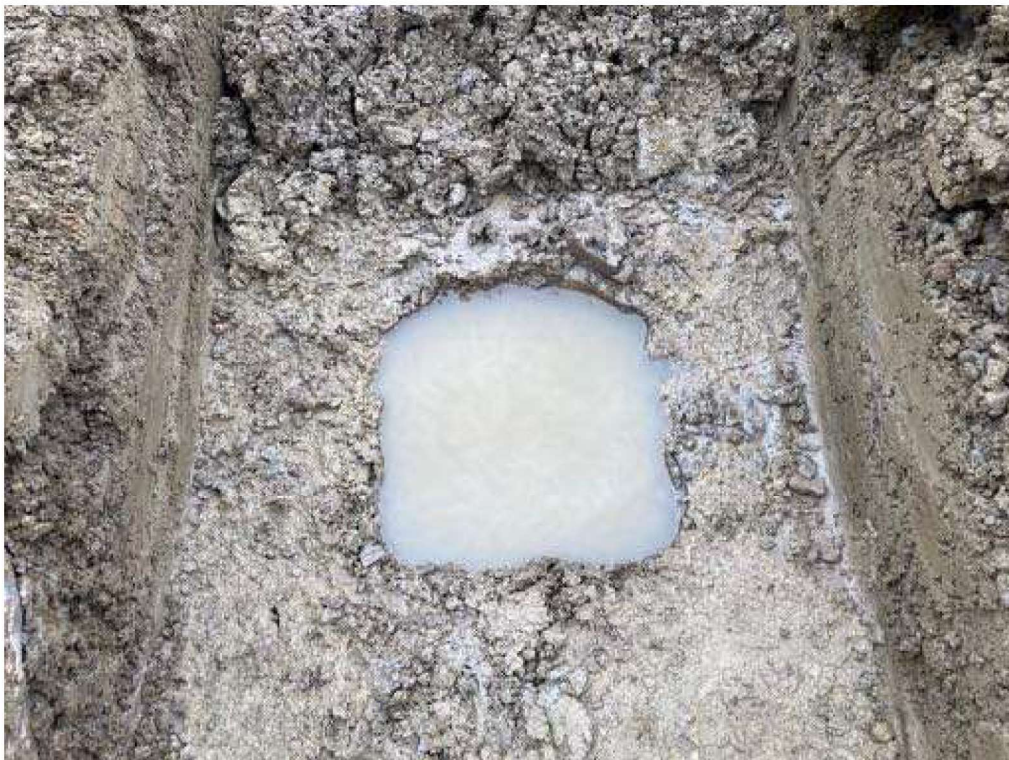
Photograph 20

Description: Hand pit HP01 (start of test)

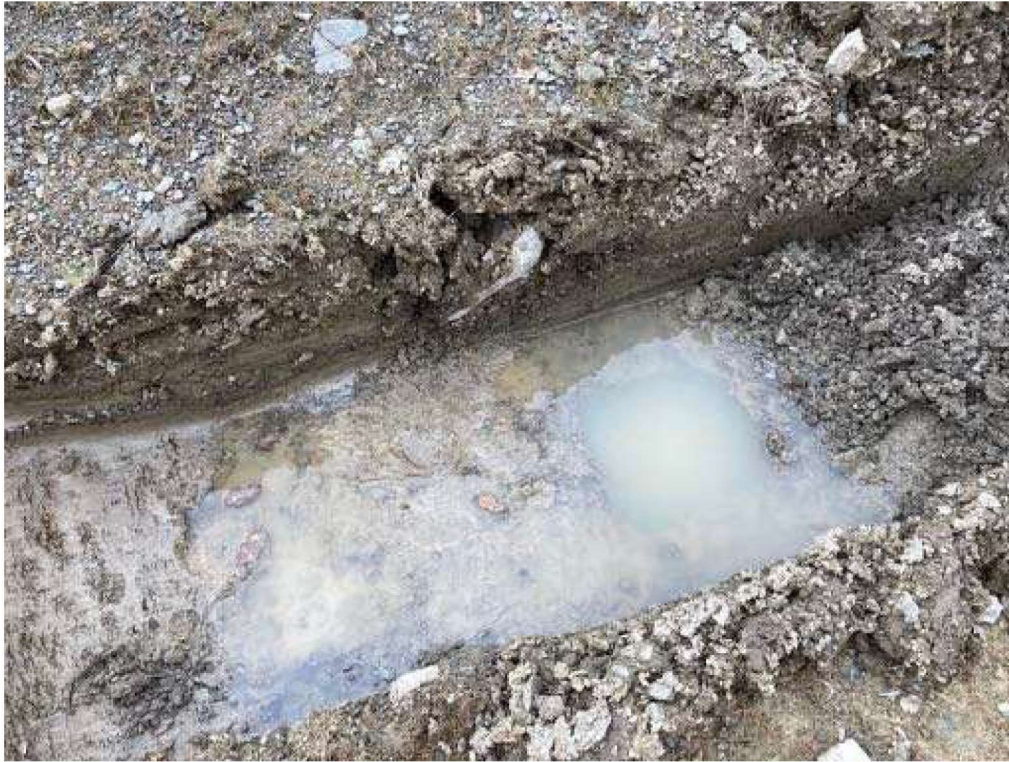
Photograph 21

Description: Hand pit HP01 – increase in water levels at end of test

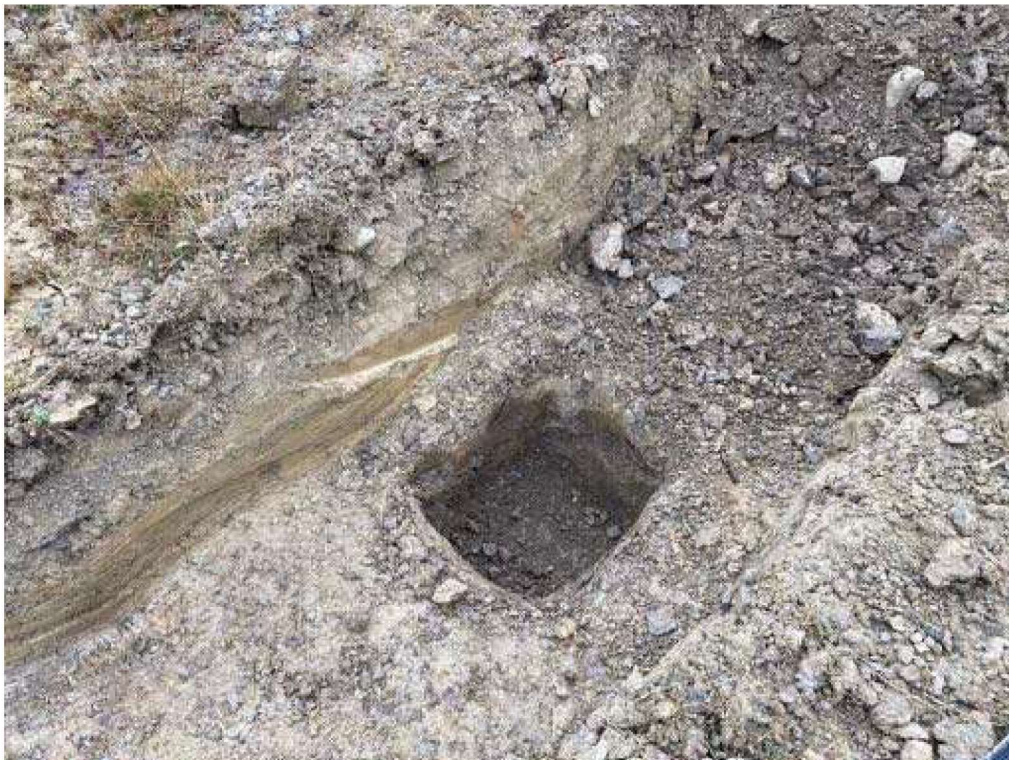
Photograph 22

Description: Hand pit HP02

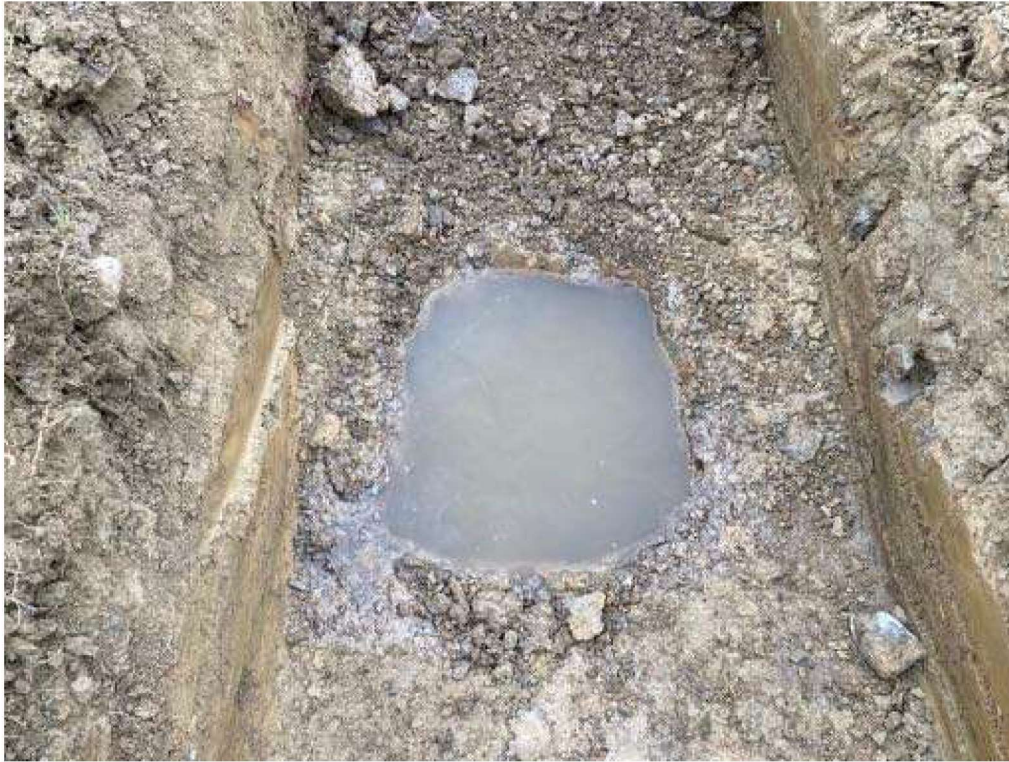
Photograph 23

Description: Hand pit HP02 (start of test)

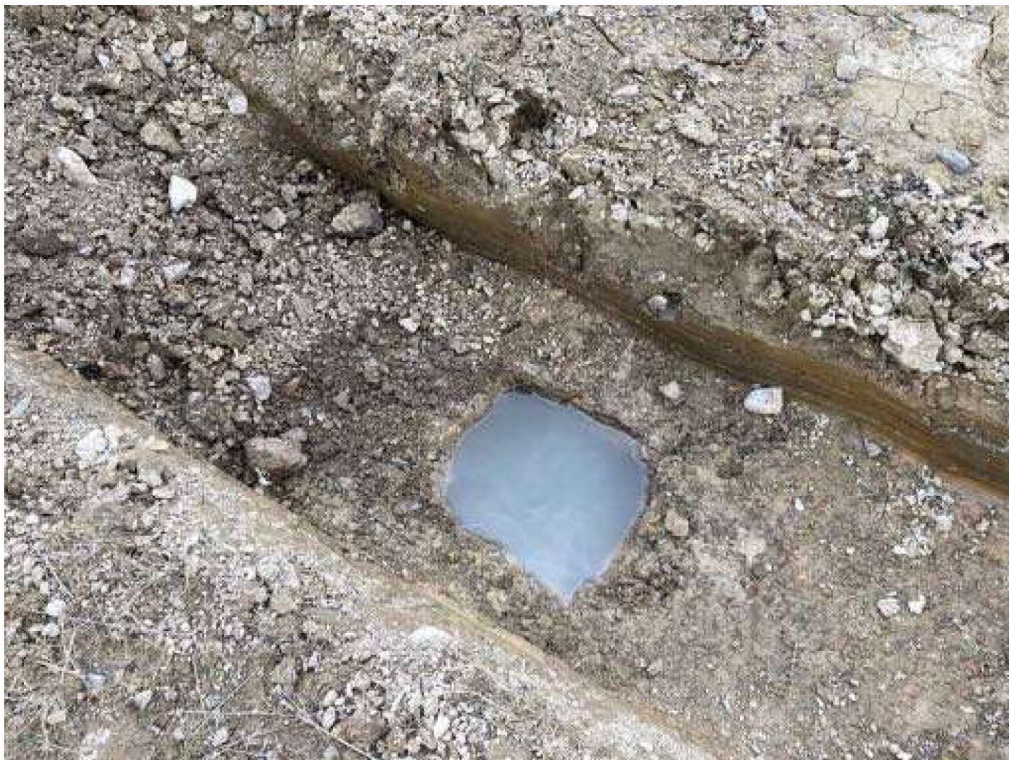
Photograph 24

Description: Hand pit HP02 (end of test)

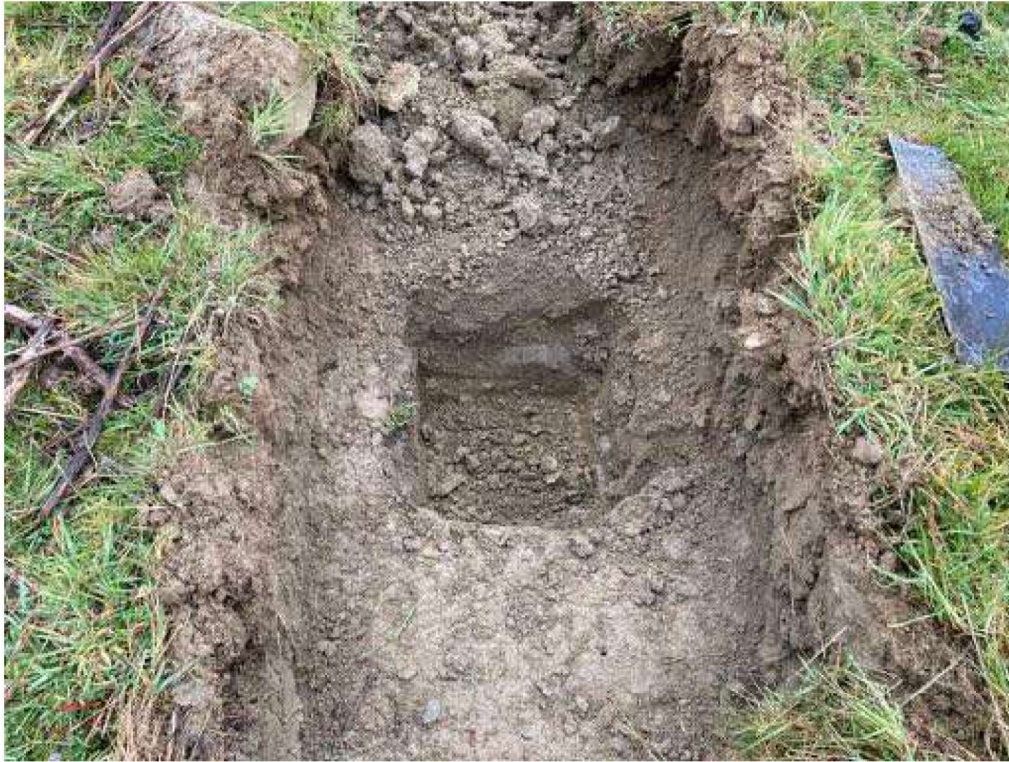
Photograph 25

Description: Hand pit HP03

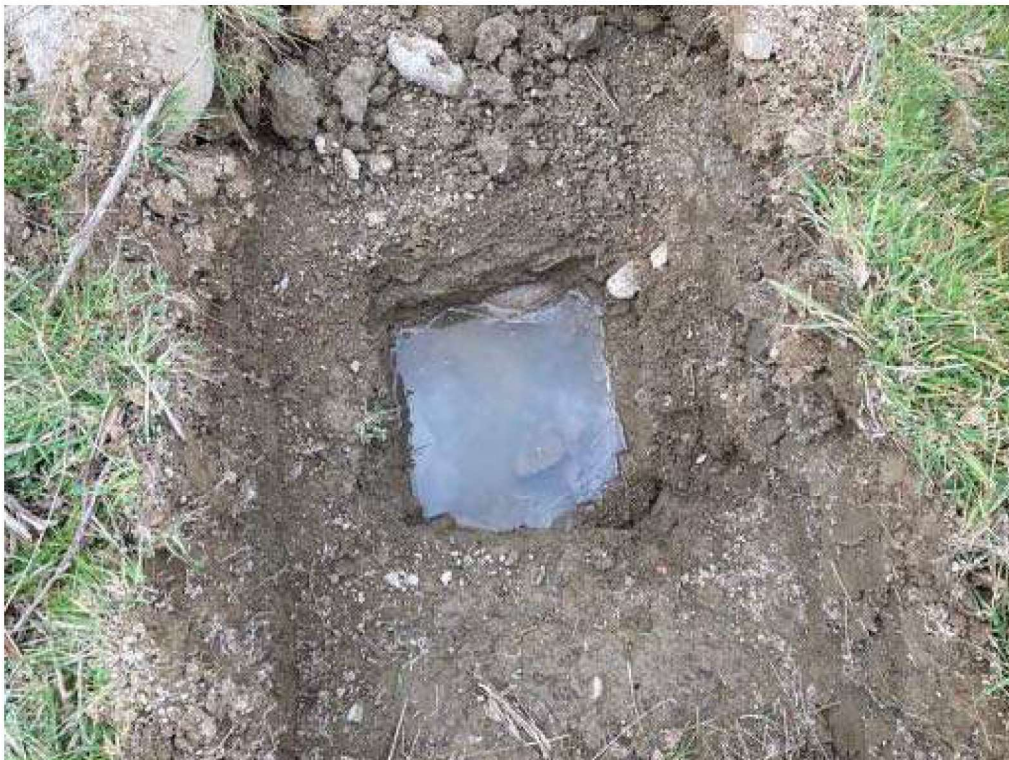
Photograph 26

Description: Hand pit HP03 (end of test)

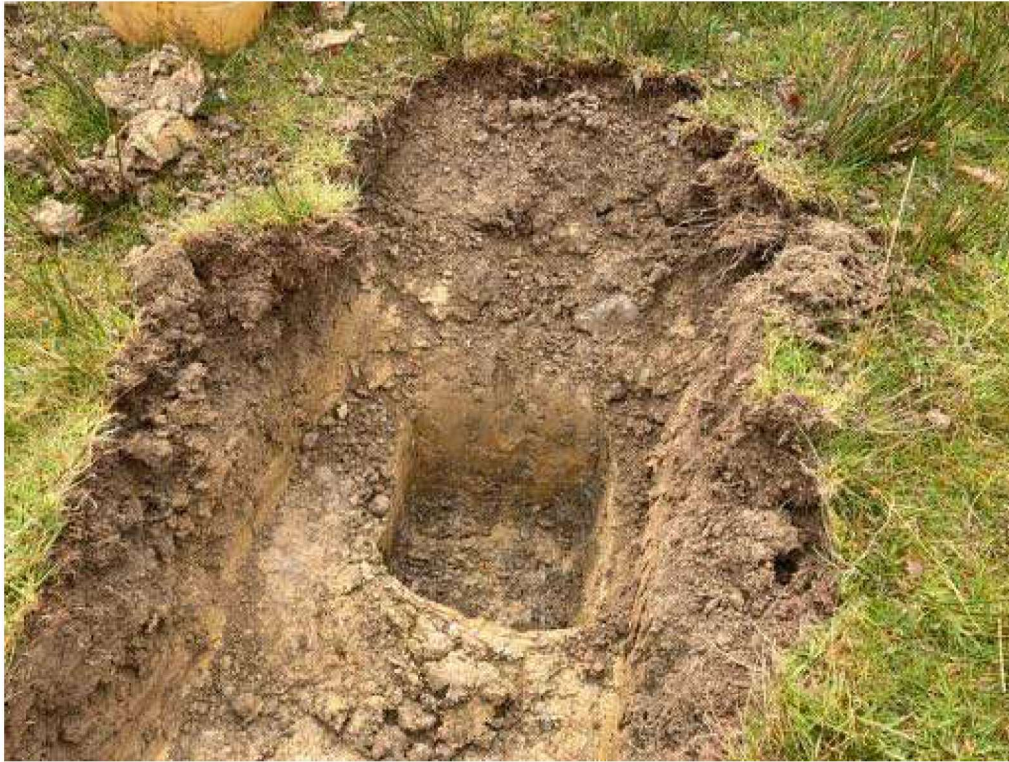
Photograph 27

Description: Hand pit HP04

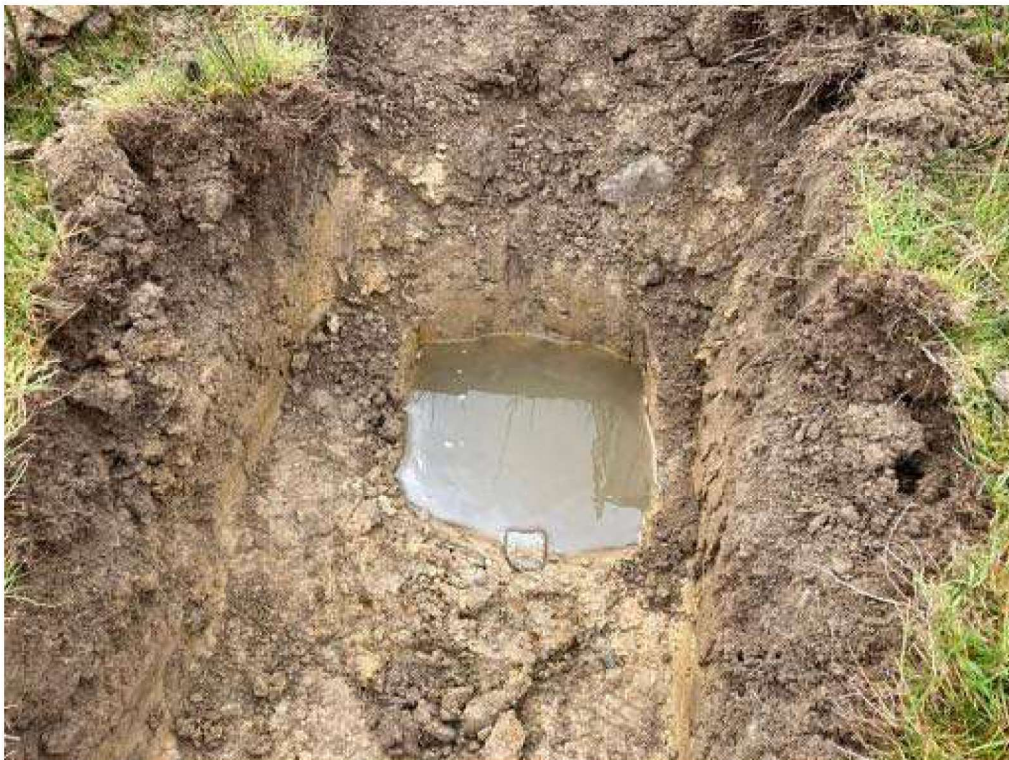
Photograph 28

Description: Hand pit HP04 (start of test)

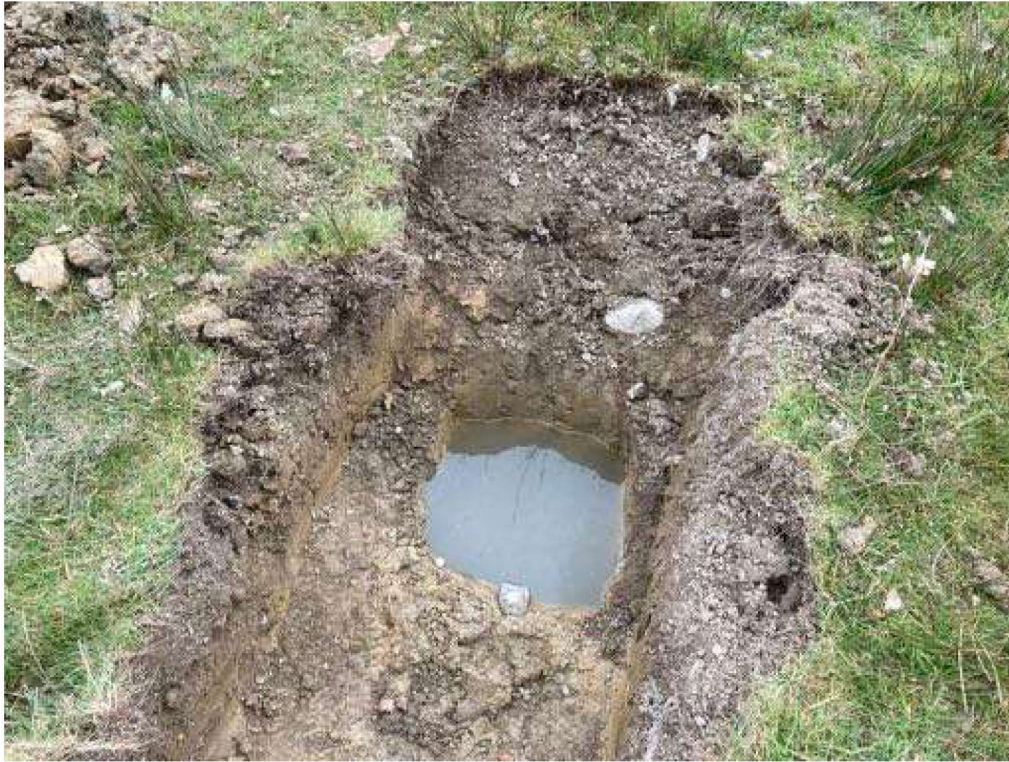
Photograph 29

Description: Hand pit HP04 (end of test)
