APPENDIX A

Site photographs

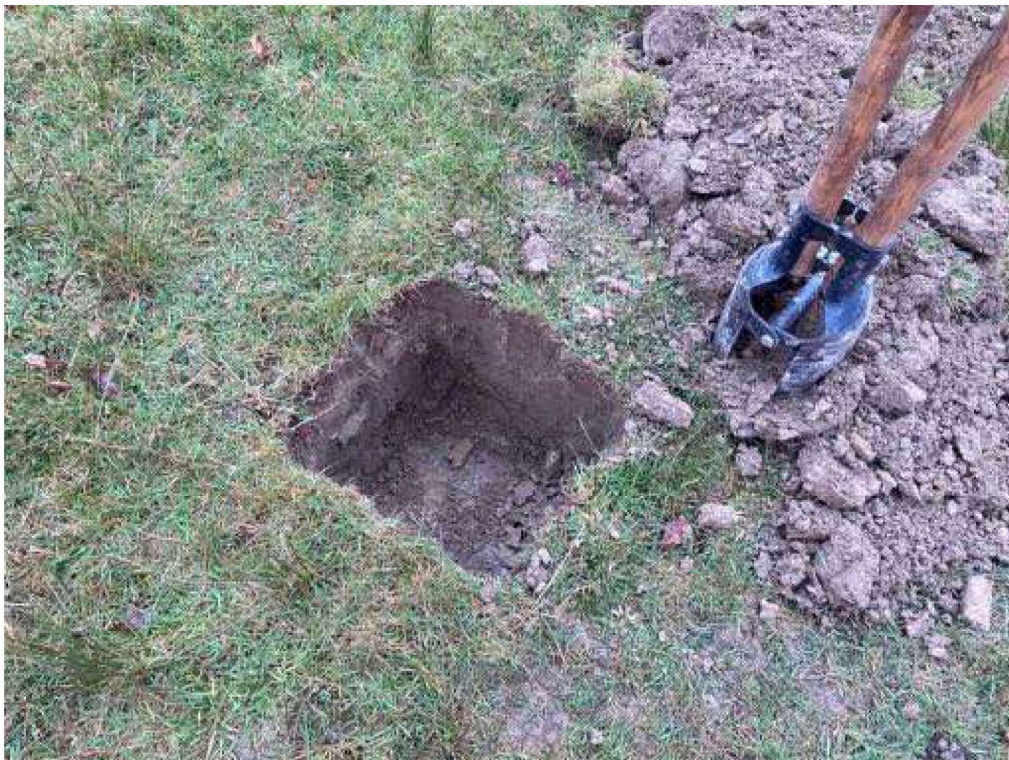
Photograph 30

Description: Hand pit HP05

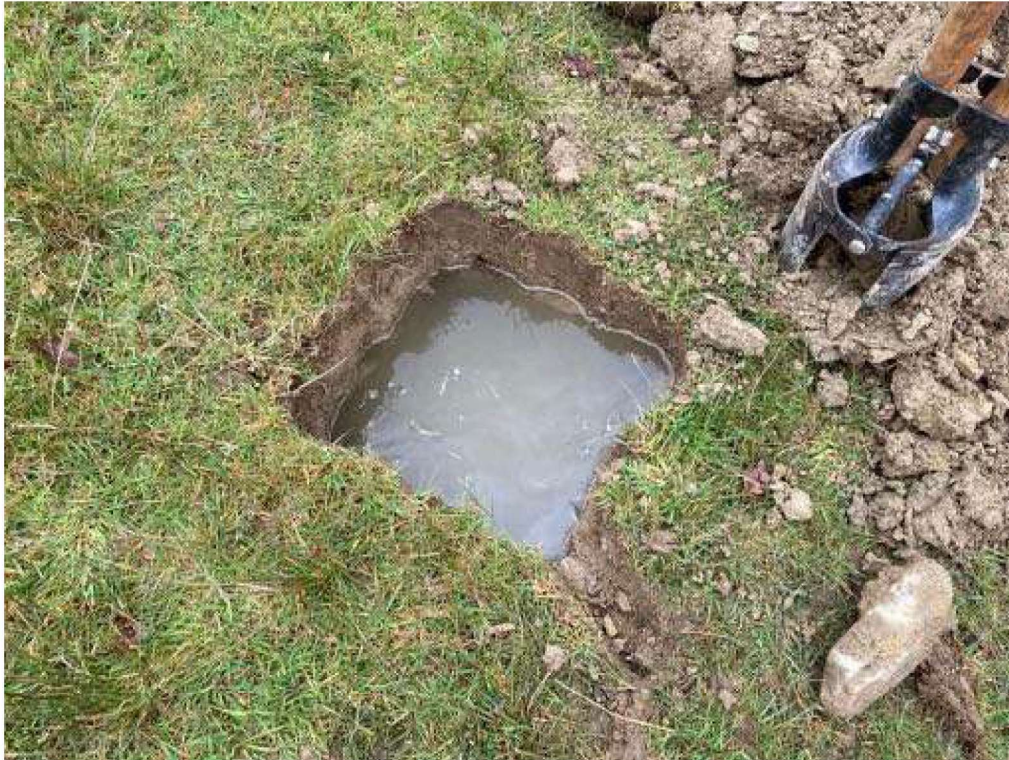
Photograph 31

Description: Hand pit HP05 (start of test)

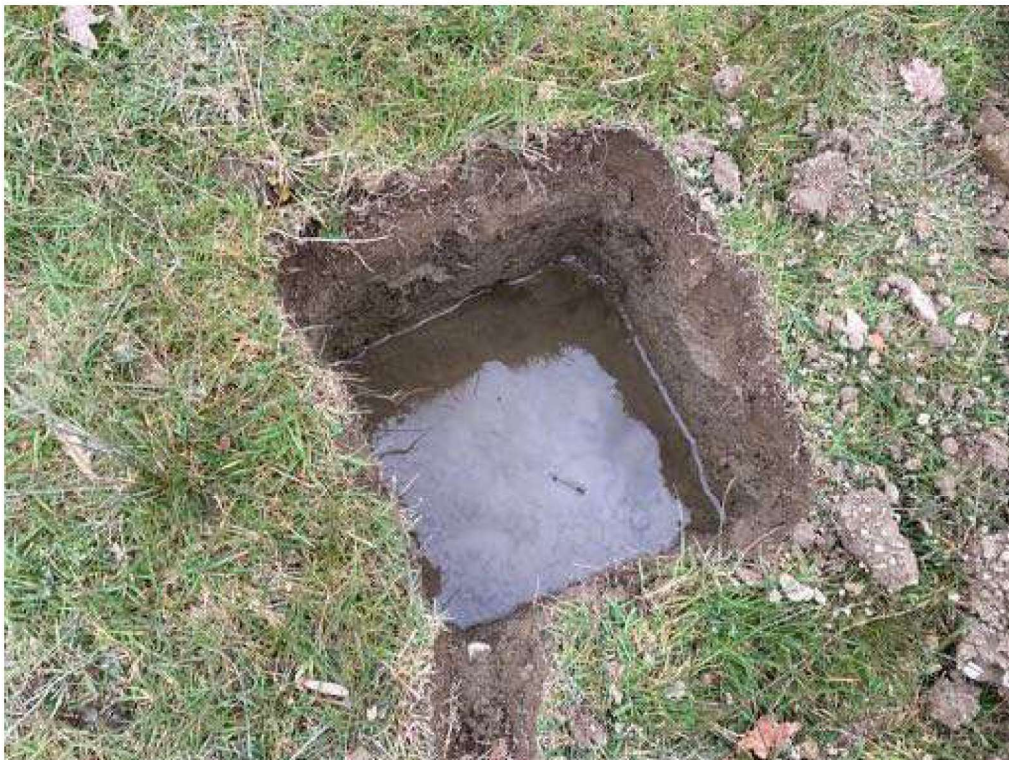
Photograph 32

Description: Hand pit HP05 (midway through test)

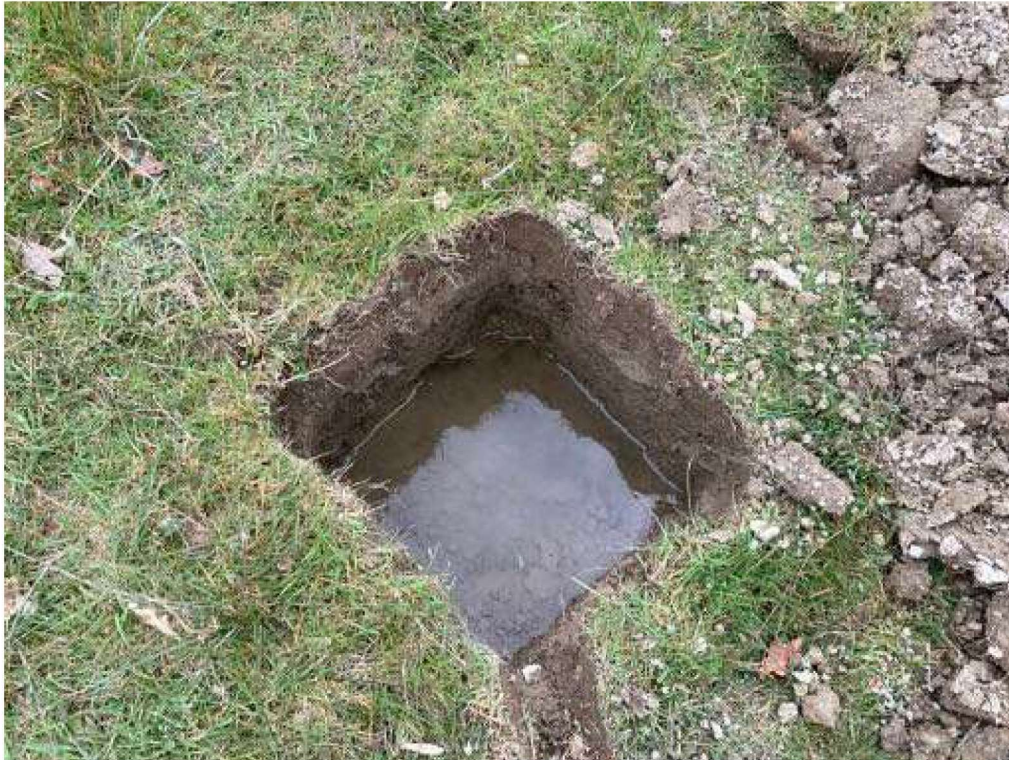
Photograph 33

Description: Hand pit HP05 (end of test)

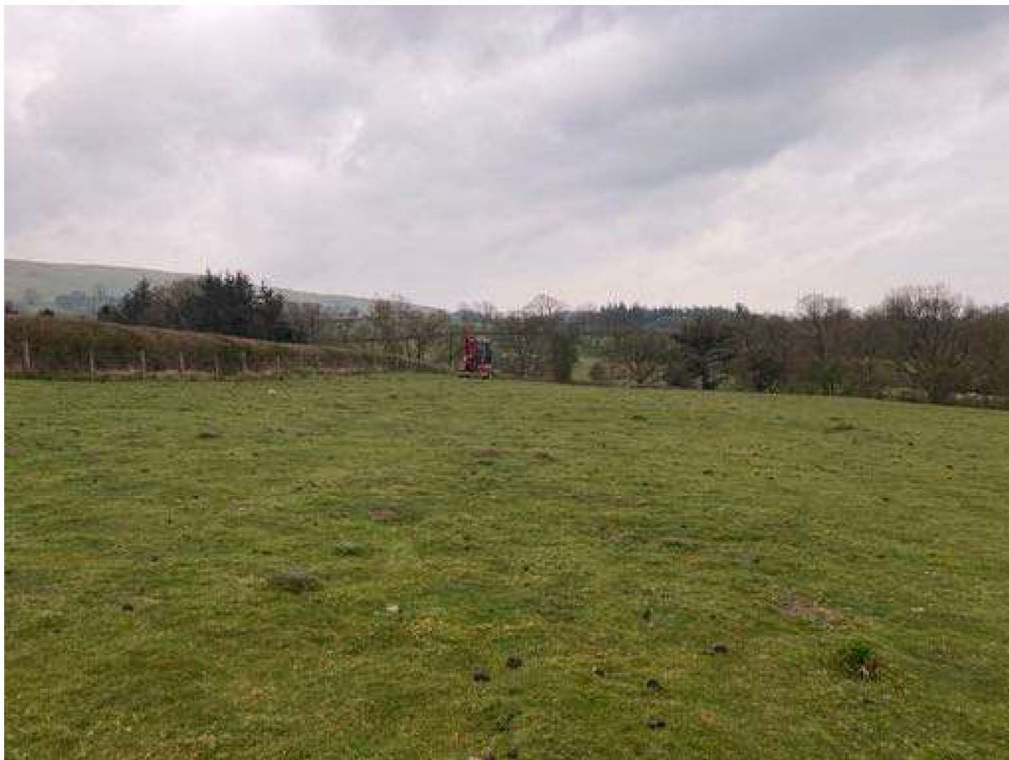
Photograph 34

Description: Site B: area of proposed log cabin development

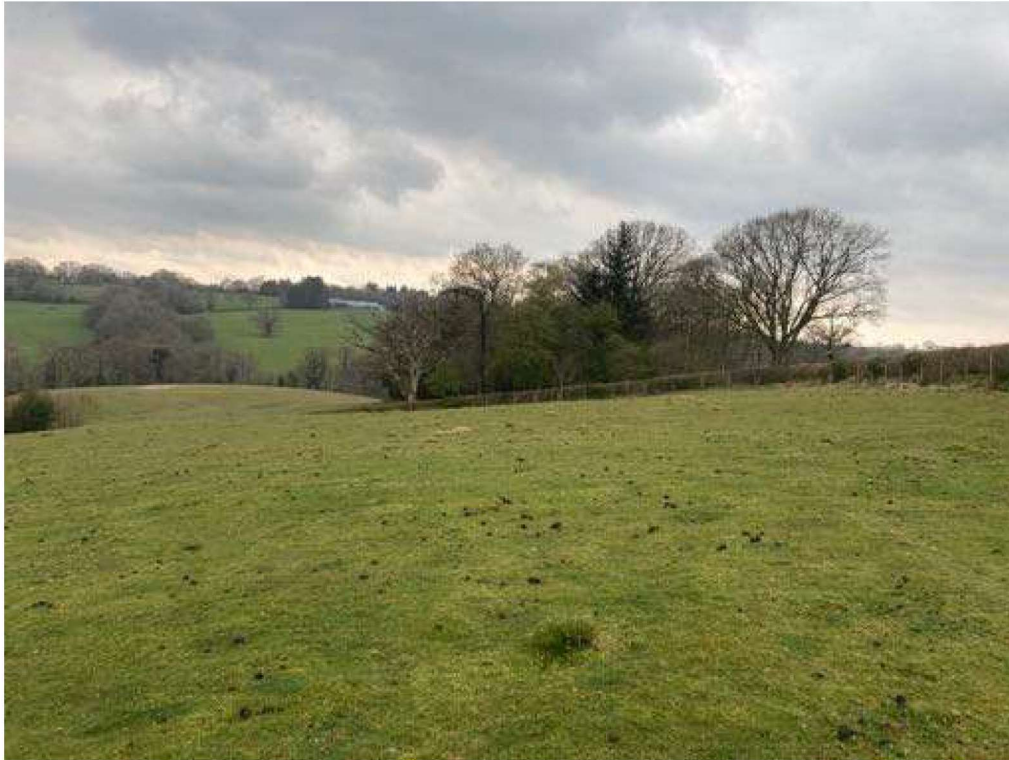
Photograph 35

Description: Site B: area of proposed log cabin development

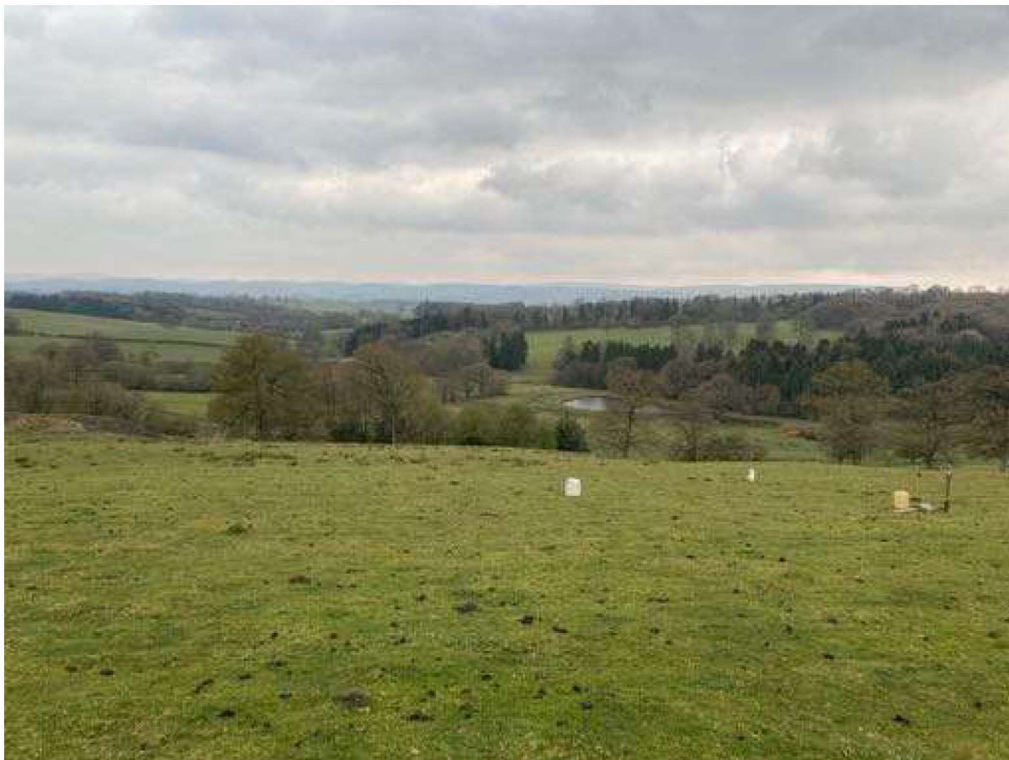
Photograph 36

Description: Site B: area of proposed log cabin development

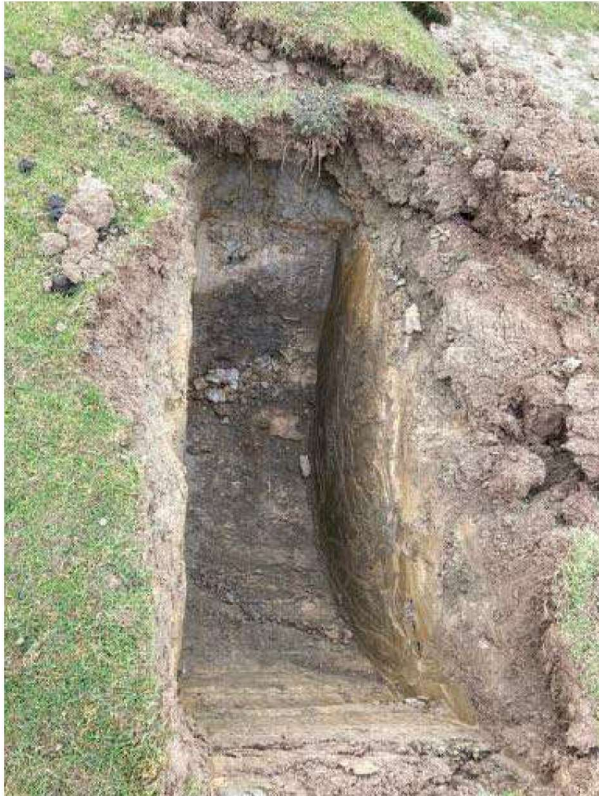
Photograph 37

Description: Trial pit TP03

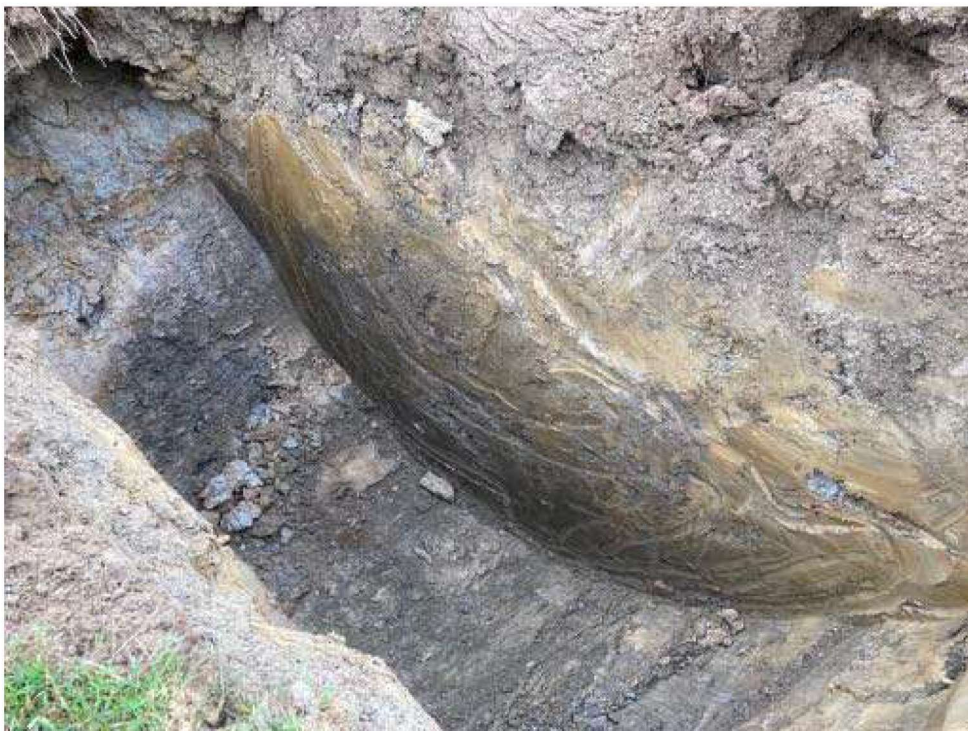
Photograph 38

Description: Trial pit TP03

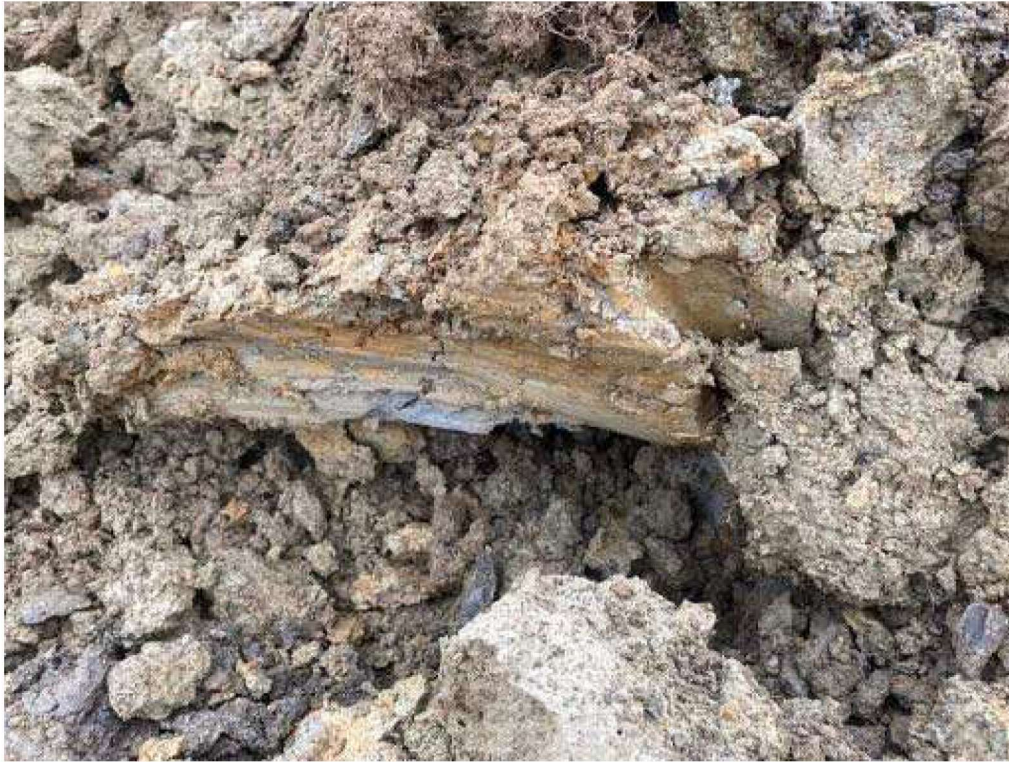
Photograph 39

Description: Clay deposits removed from trial pit TP03

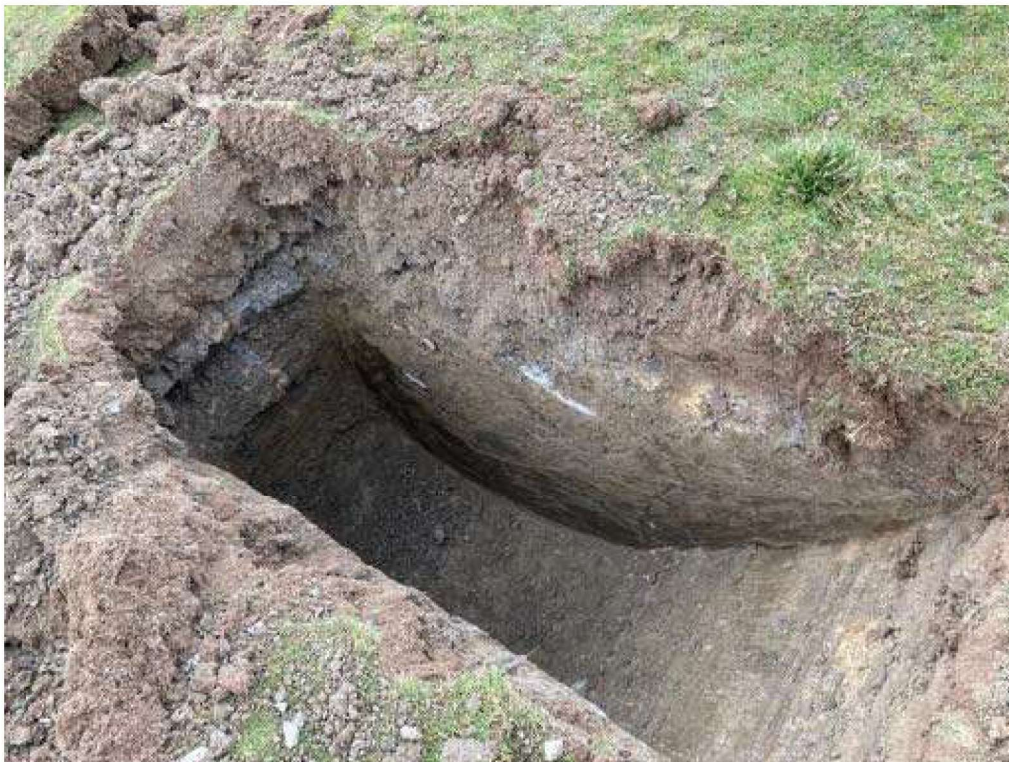
Photograph 40

Description: Trial pit TP04
