Our Ref: 21037/01

Application to Undertake Work to Trees in a Conservation Area

Flint Cottage 7 - 8, Southend Common RG9 6JP

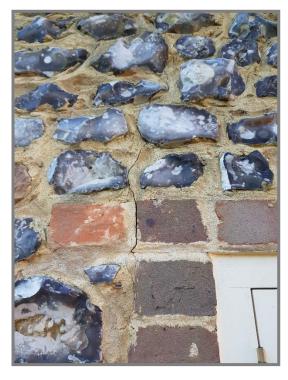
The crack to the left side of the window is illustrated below.

Close up photograph of the crack on the left hand side of a ground floor window

We understand that this section of the cottage was built in the 1980s and that the underlying ground conditions are clay. We do not know how this part of the cottage was constructed; however, the ground conditions and the proximity of the Cherry suggest the damage to the property is constant with foundation movement.

Given the above, this application askes that consent is granted to remove the Cherry.

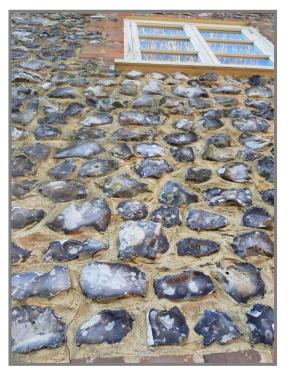
Photograph illustrating the crack extending up to the first-floor window.

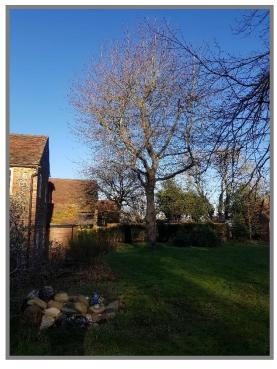
The recent removal of the adjacent Cedar due to the damage it was also causing to the retaining wall adds some weight to support this.

Context photograph: T932 Native Cherry proposed for removal.
