North Elevation (grid A)

CLIENT <b>Candida Baker</b>			<b>Cooper &amp; Withycombe</b> CONSULTING ENGINEERS <small>Norwich House 14-16 North Street Guildford Surrey, GU1 4AF</small> <small>tel 01483 457373 Fax 01483 566118</small>		
PROJECT <b>Dickhurst Farm</b> <b>Petworth Rd.Chiddingfold,Surrey,</b> <b>GU27 8BG</b>			ARCHITECT <b>Stedman Blower Architects</b>		
TITLE <b>Frame Defects to</b> <b>North Elevation , grid A</b>			DWG. STATUS PRELIMINARY <input checked="" type="radio"/> TENDER CONSTRUCTION RECORD		
DRAWN BY <b>BFS</b> DATE <b>jan 22</b>		CHECKED BY <b>BA</b> DATE <b>jan 22</b>		APPROVED BY DATE	
BASE DRAWING SCALE <b>1: 50 @ A3</b>			SCHEDULE SHEETS		
PROJECT No <b>21-2152</b>		DRAWING No. <b>05</b>		REV <b>-</b>

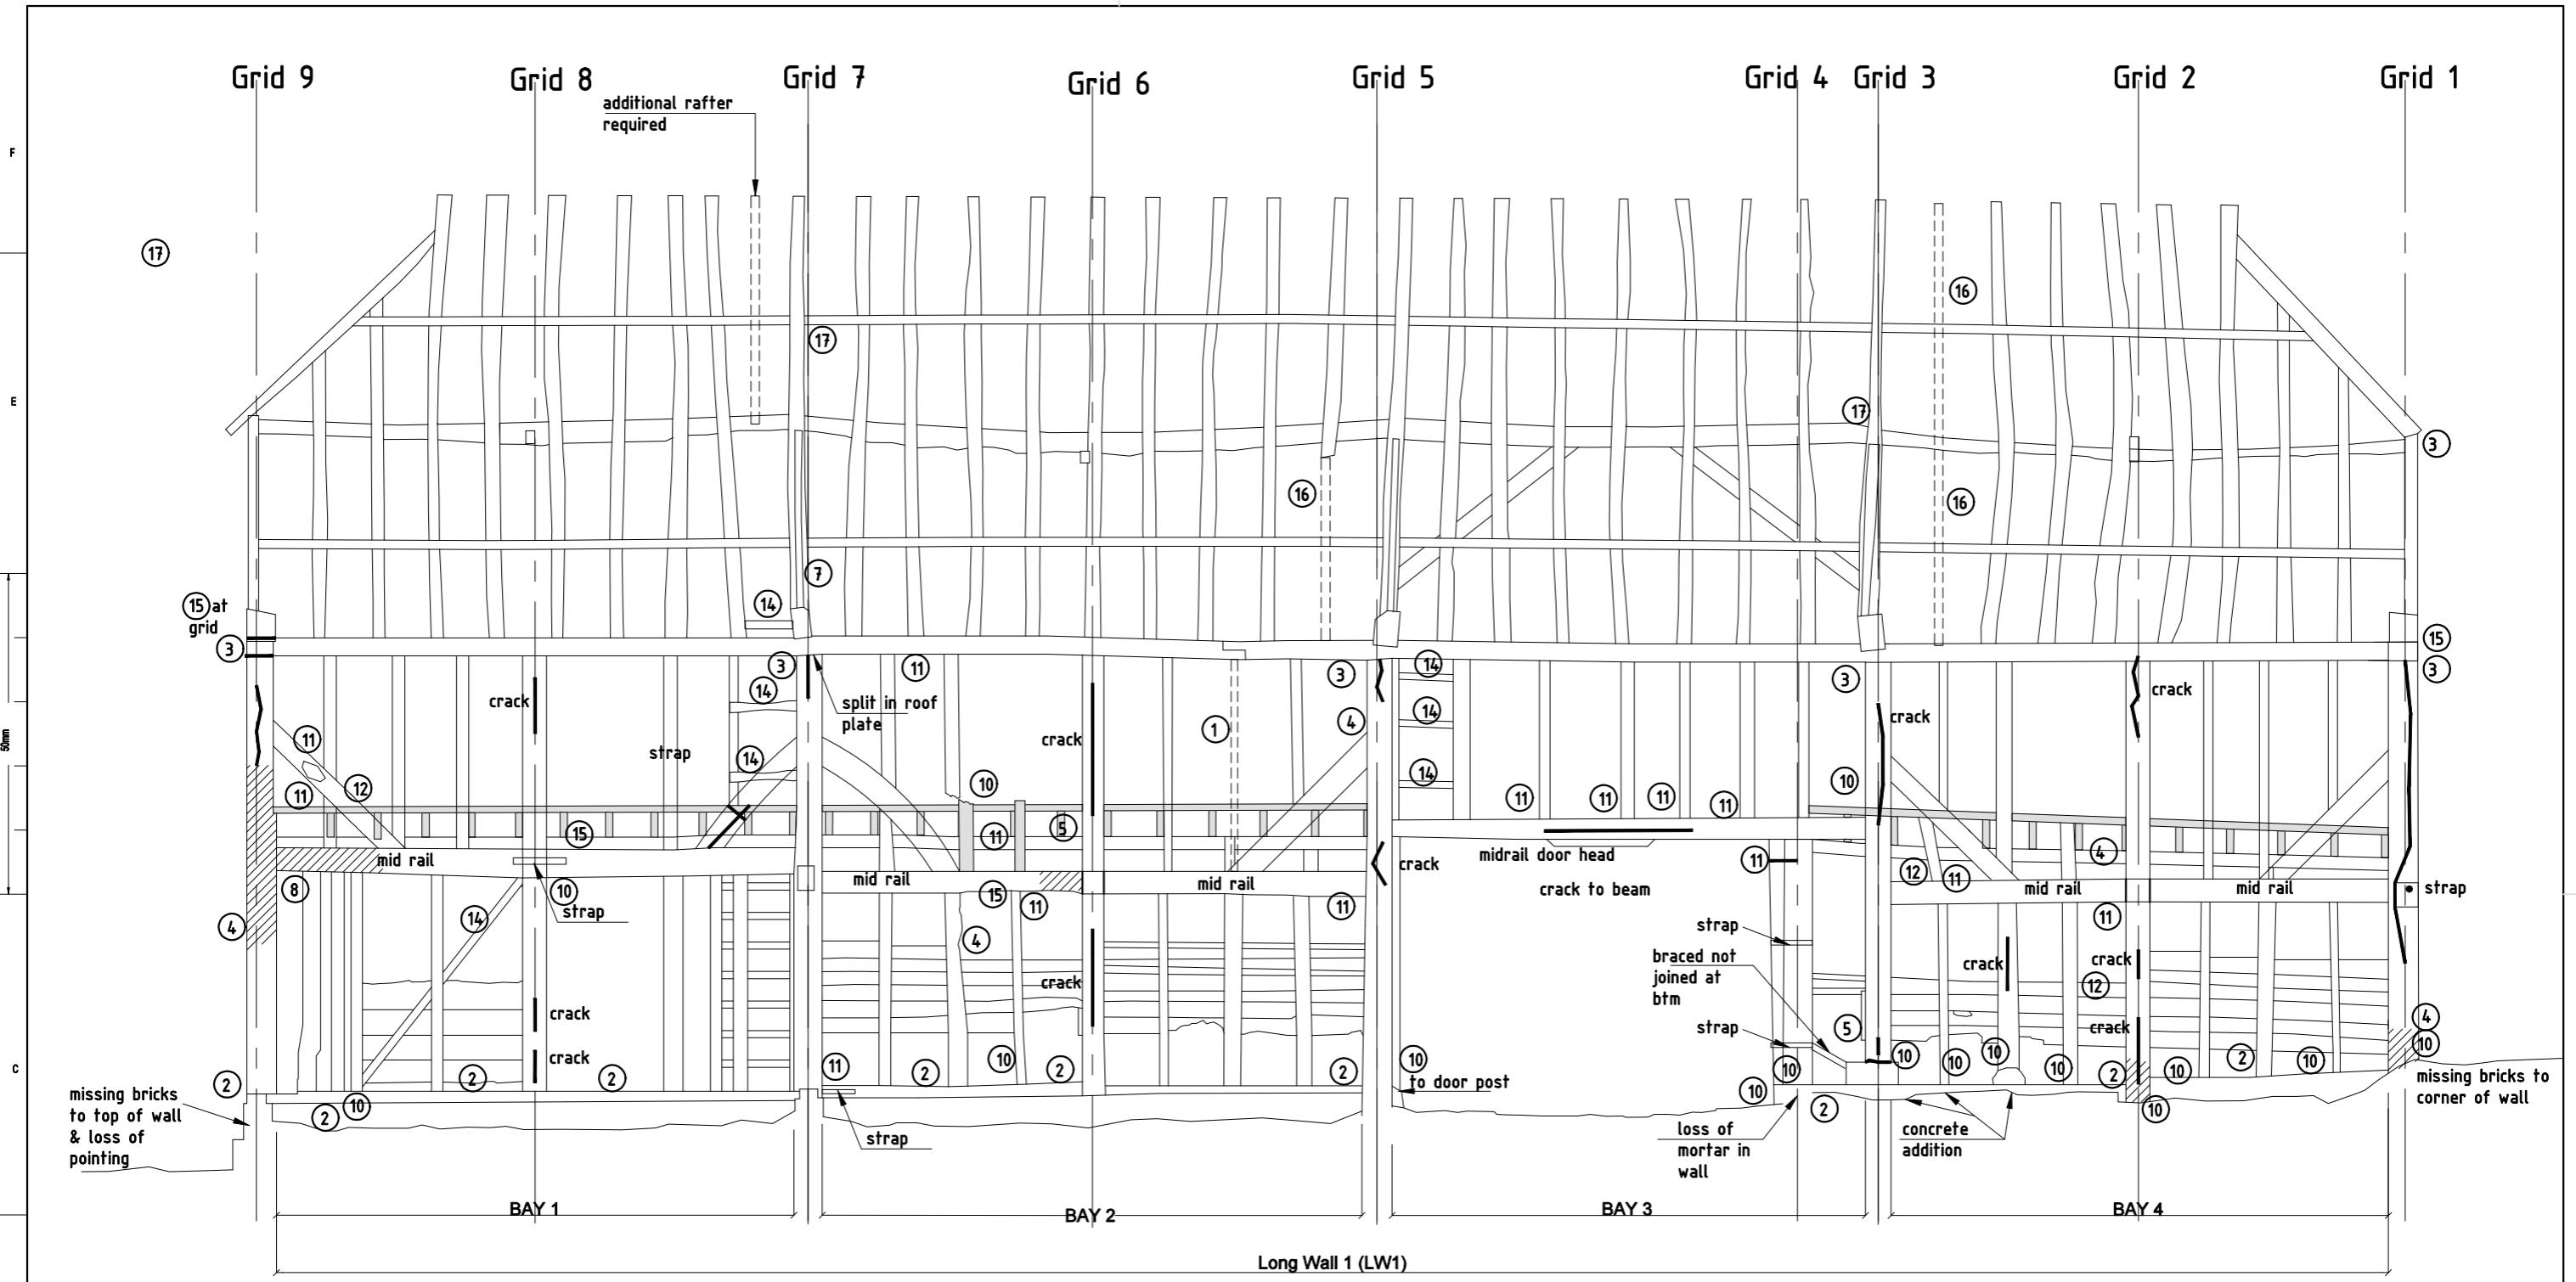
- 1 Missing stud
- 2 wall plate degraded (or missing)
- 3 Split at top of post
- 4 post severe decay
- 5 section of post severe decay
- 6 large hole to front
- 7 large hole to u/s beam
- 8 face severe decay
- 9 large hole to rear
- 10 loss of section and connection
- 11 loss of connection
- 12 loss of section
- 13 missing brace
- 14 added brace
- 15 beam severe decay
- 16 missing rafter
- 17 defective purlin connection
