CLIENT Candida Baker			Cooper & Withycombe CONSULTING ENGINEERS Norwich House tel 01483 457373 14-15 North Street Fax 01483 566118 Guildford Surrey, GU1 4AF	
PROJECT Dickhurst Farm Petworth Rd. Chiddingfold, Surrey, GU27 8BG			ARCHITECT Stedman Blower Architects	
TITLE Frame Defects to East Elevation grid 9 and West Elevation grid 1			DWG. STATUS PRELIMINARY ● TENDER CONSTRUCTION RECORD	
DRAWN BY BFS CHECKED BY BA APPROVED BY DATE jan 22 DATE jan 22 DATE		PROJECT No. 21-2152 DRAWING No. 07 REV -		
BASE DRAWING SCALE 1: 50 @ A3		SCHEDULE SHEETS

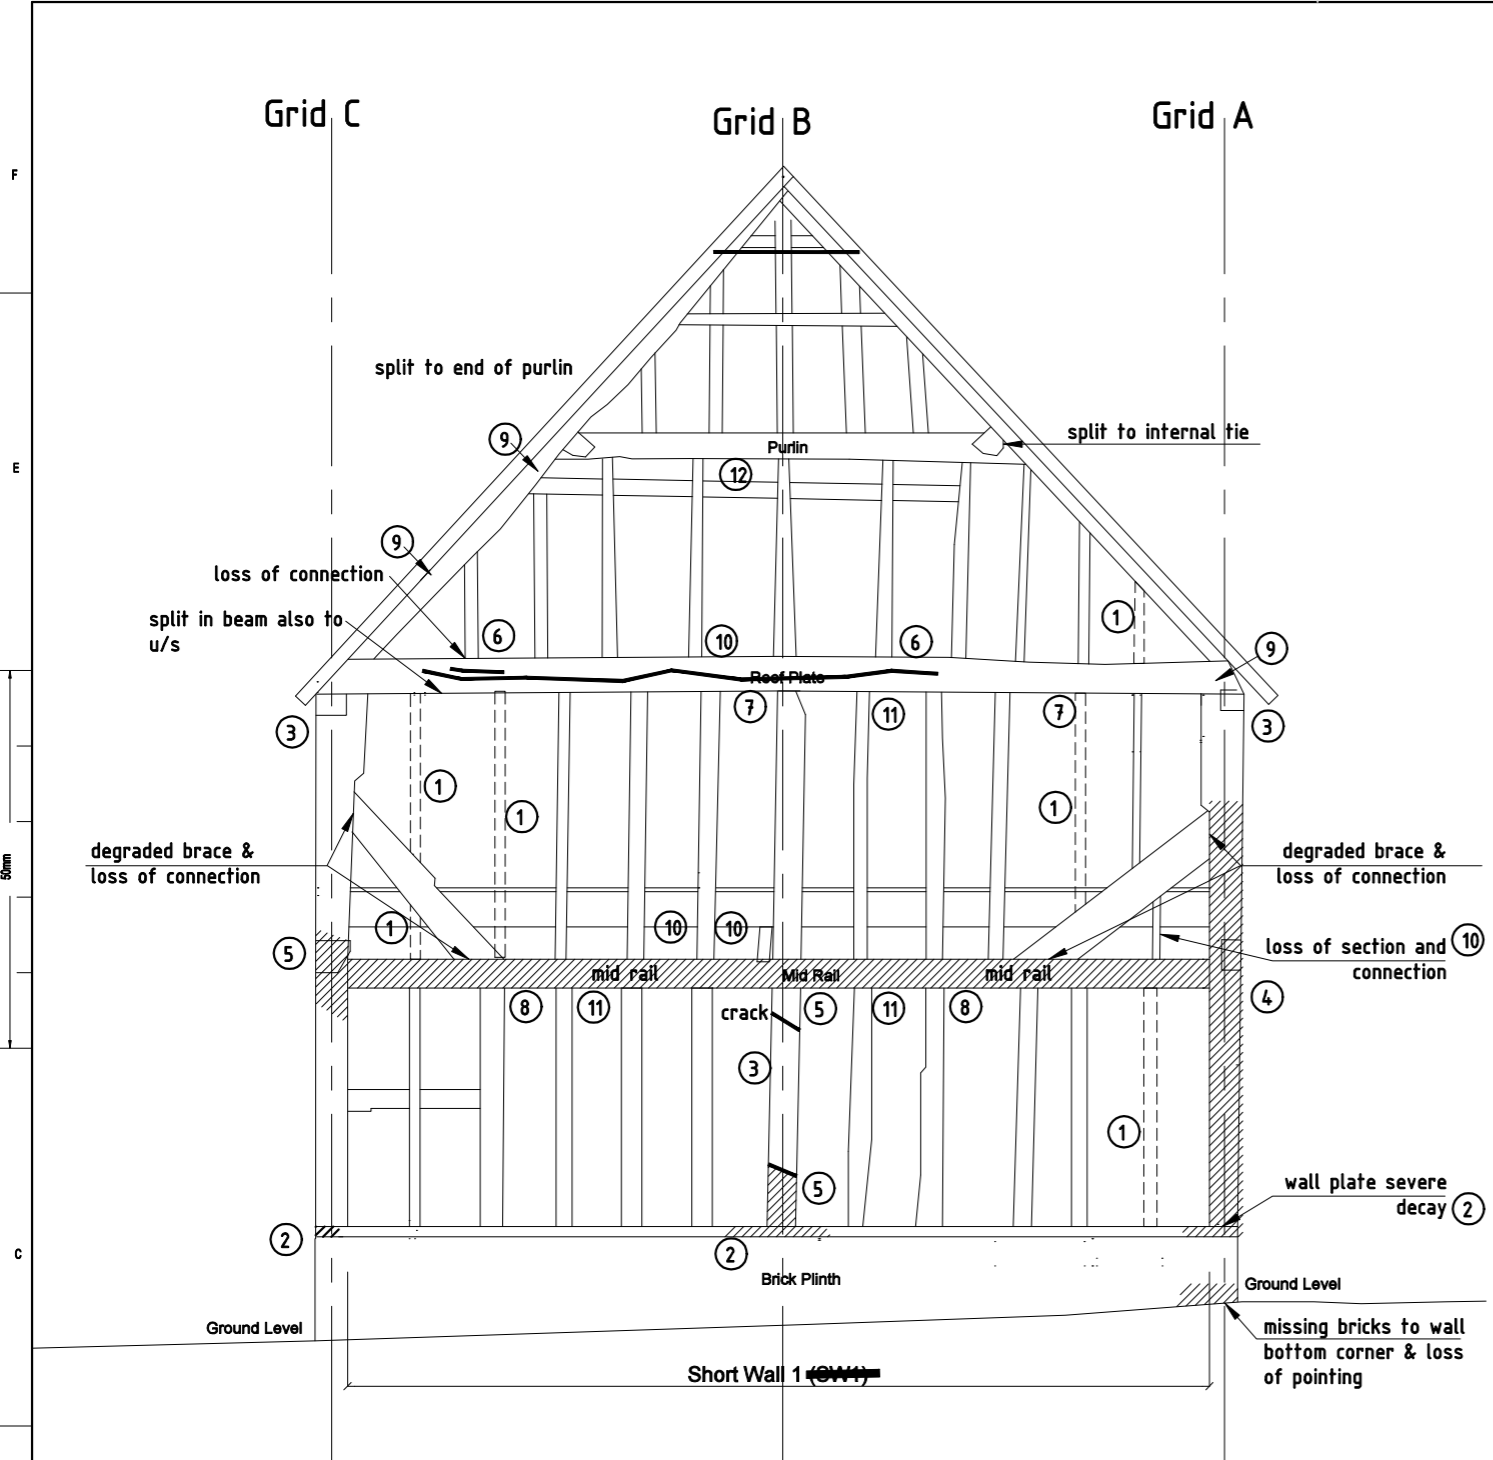
East Elevation Grid 9

- 1 Missing stud
- 2 wall plate degraded (or missing)
- 3 Split at top of post
- 4 post severe decay
- 5 section of post severe decay
- 6 large hole to front
- 7 large hole to u/s beam
- 8 face severe decay
- 9 large hole to rear
- 10 loss of section and connection
- 11 loss of connection
- 12 loss of section
- 13 missing brace
- 14 added brace
- 15 beam severe decay
- 16 missing rafter
- 17 defective purlin connection
