CLIENT Candida Baker		Cooper & Withycombe CONSULTING ENGINEERS <small>Norwich House 14-16 North Street Guildford Surrey, GU1 4AF</small> <small>tel 01483 457373 Fax 01483 566116</small>	
PROJECT Dickhurst Farm Petworth Rd.Chiddingfold,Surrey, GU27 8BG		ARCHITECT Stedman Blower Architects	
TITLE Frame Defects to South Elevation , grid C		DWG. STATUS PRELIMINARY <input checked="" type="radio"/>	
DRAWN BY BFS CHECKED BY BA APPROVED BY DATE jan 22 DATE jan 22 DATE BASE DRAWING SCALE 1: 50 @ A3 SCHEDULE SHEETS		PROJECT No 21-2152 DRAWING No. 06 REV -	
		TENDER CONSTRUCTION RECORD

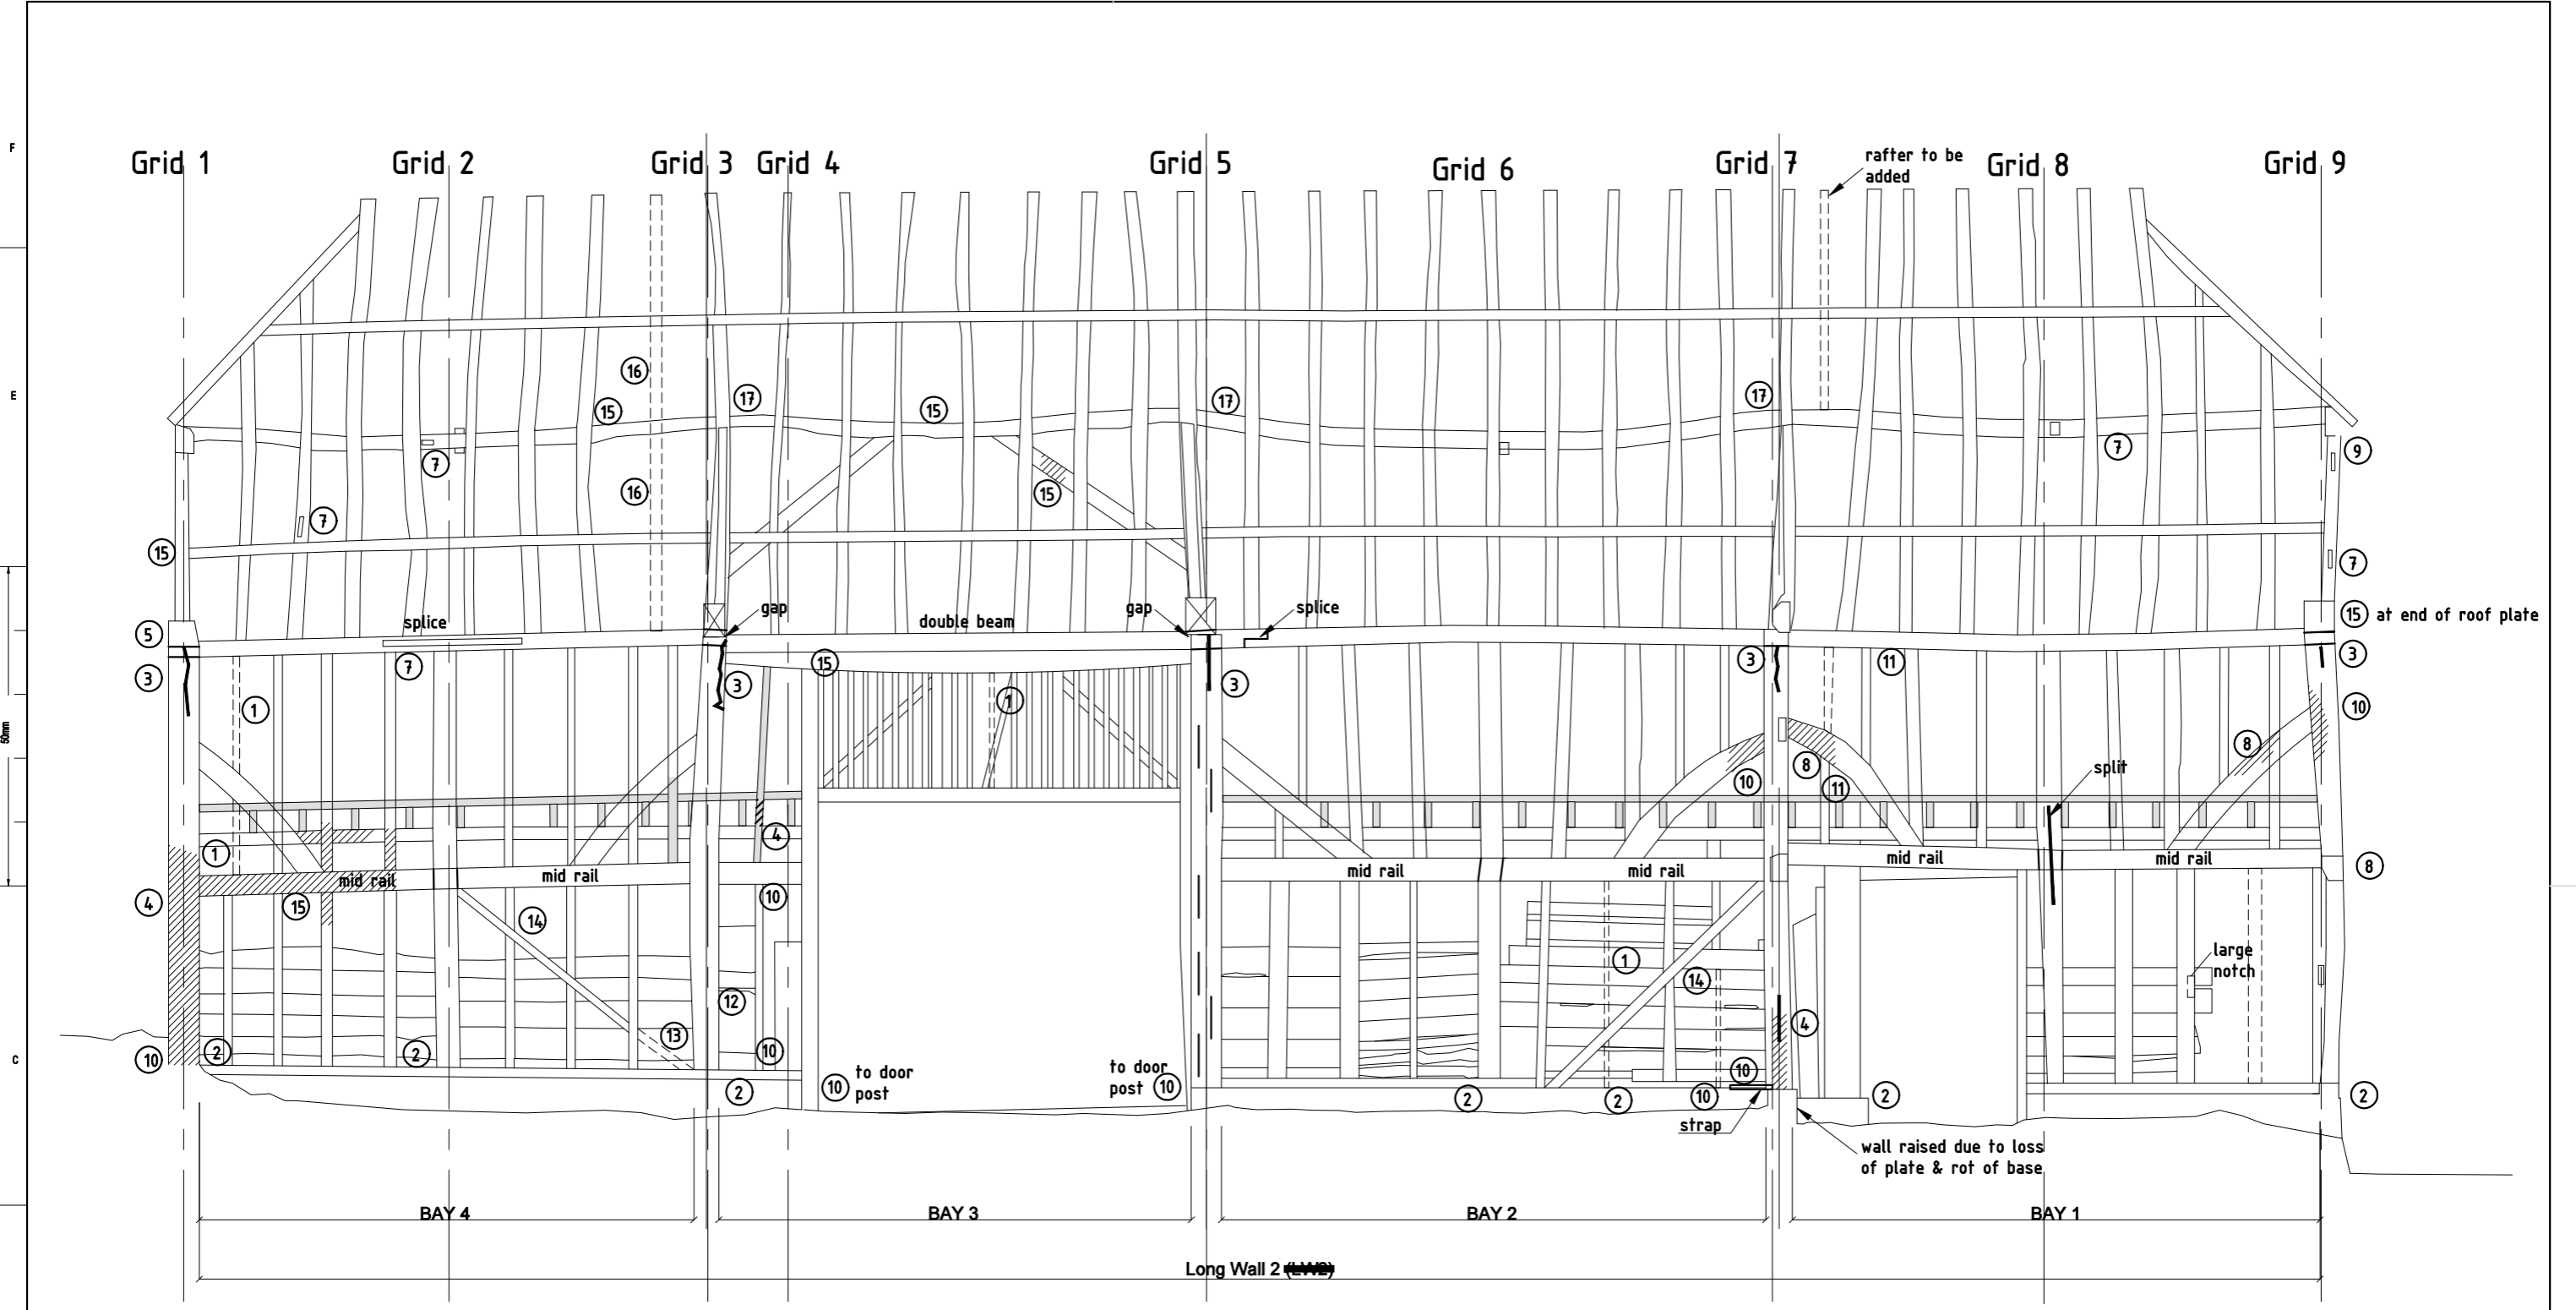
- 1 Missing stud
- 2 wall plate degraded (or missing)
- 3 Split at top of post
- 4 post severe decay
- 5 section of post severe decay
- 6 large hole to front
- 7 large hole to u/s beam
- 8 face severe decay
- 9 large hole to rear
- 10 loss of section and connection
- 11 loss of connection
- 12 loss of section
- 13 missing brace
- 14 added brace
- 15 beam severe decay
- 16 missing rafter
- 17 defective purlin connection
