# Arboricultural Impact Assessment

1 Park Villa, Thornham Parva

OAS 21-338-AR01  
January 2022

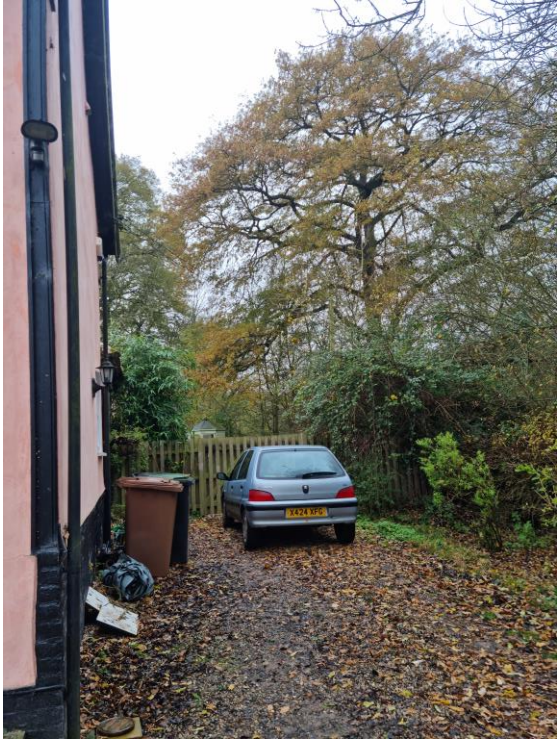
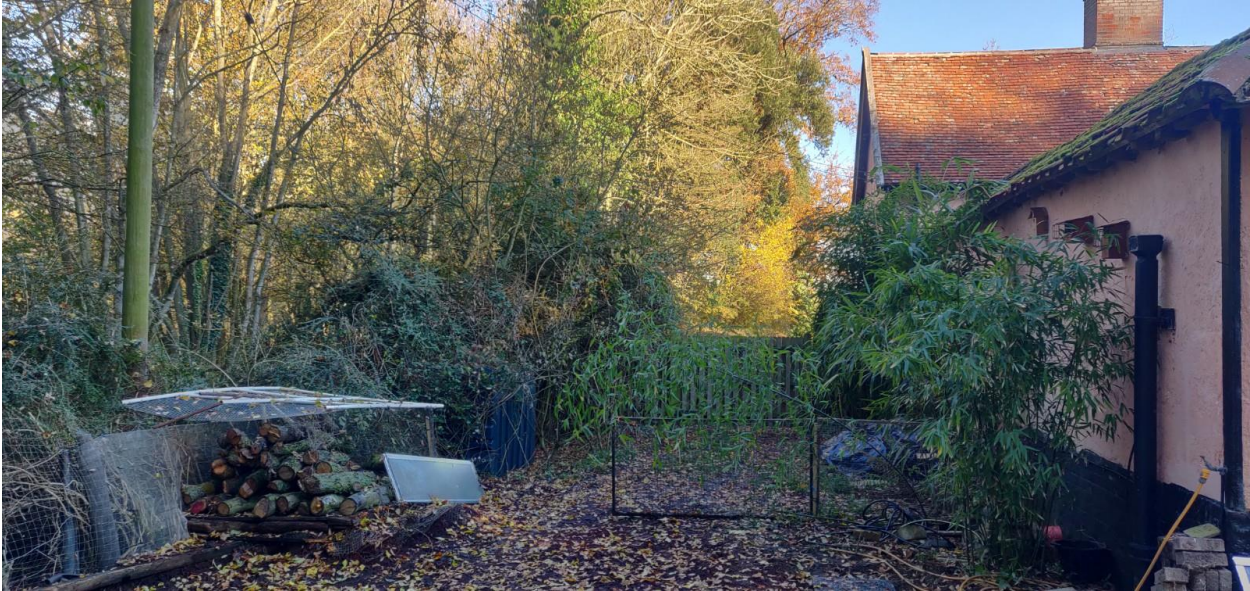
Showing views of proposed garage location

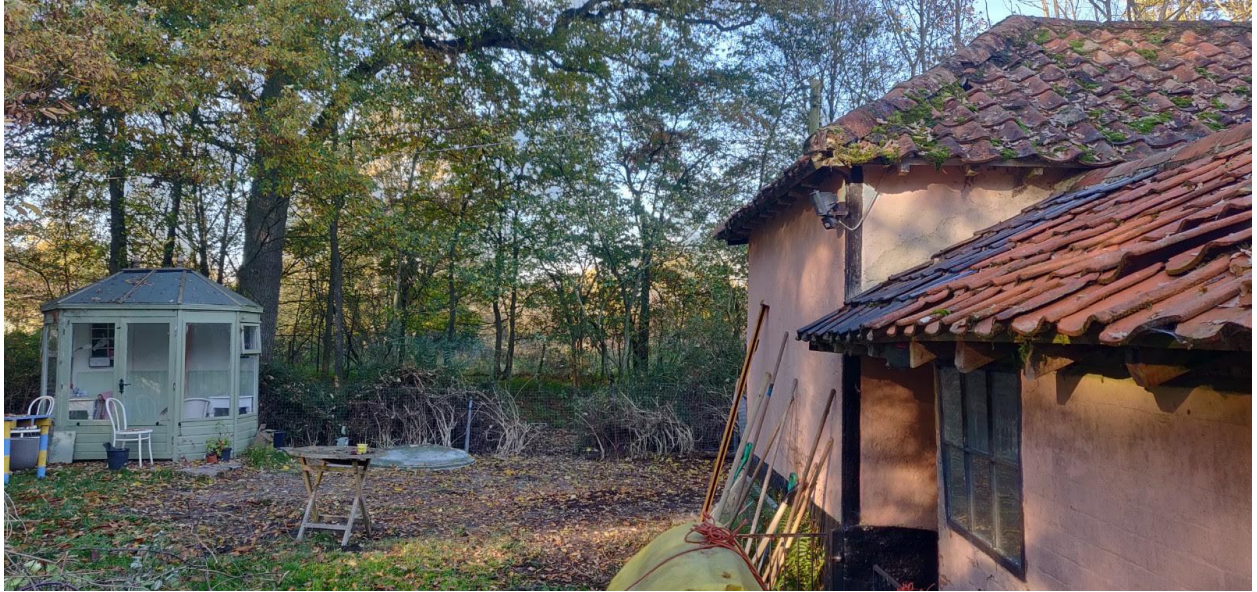
2.2.2 Both trees are located in a small unmanaged wooded area to the north boundary of the property. T1 Ash is of low value with Ash dieback evident in the crown. T2 is a large Turkey Oak with few faults with overall excellent value in both arboricultural and landscape terms.

Showing view from year with stem of T1 in background
