BUILDING SURVEY REPORT

Havencliffe House, Axmouth, Seaton EX12 4AB

10th December 2015

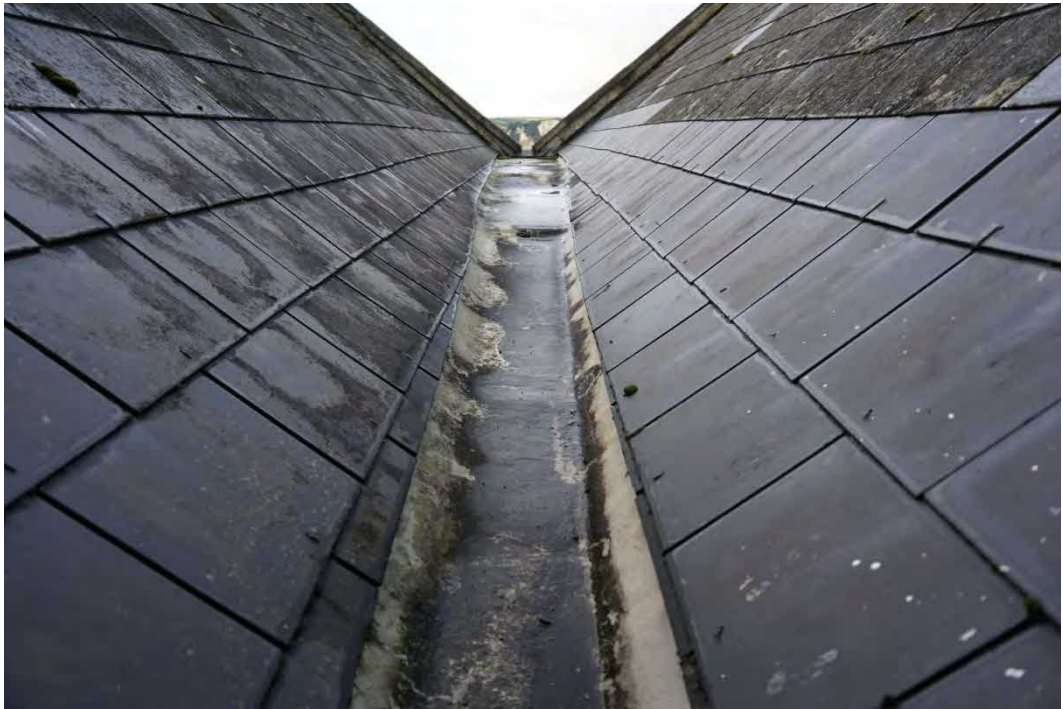
- 4.3 There is a valley gutter between two of the main pitched roofs which is visible from a window in bedroom six. The gutter has been lined with GRP (fibreglass) possibly covering older lead but this could not be confirmed. The work was carried out c. 15 years ago i.e. subsequent to the general re-roofing as is indicated by replaced slates to either side. This suggests that either the lead was not replaced when the building was re-roofed or that a fault subsequently developed. The gutter lining is not obviously defective but if in fact laid over lead differential thermal movement between the materials could cause in surface fracturing.

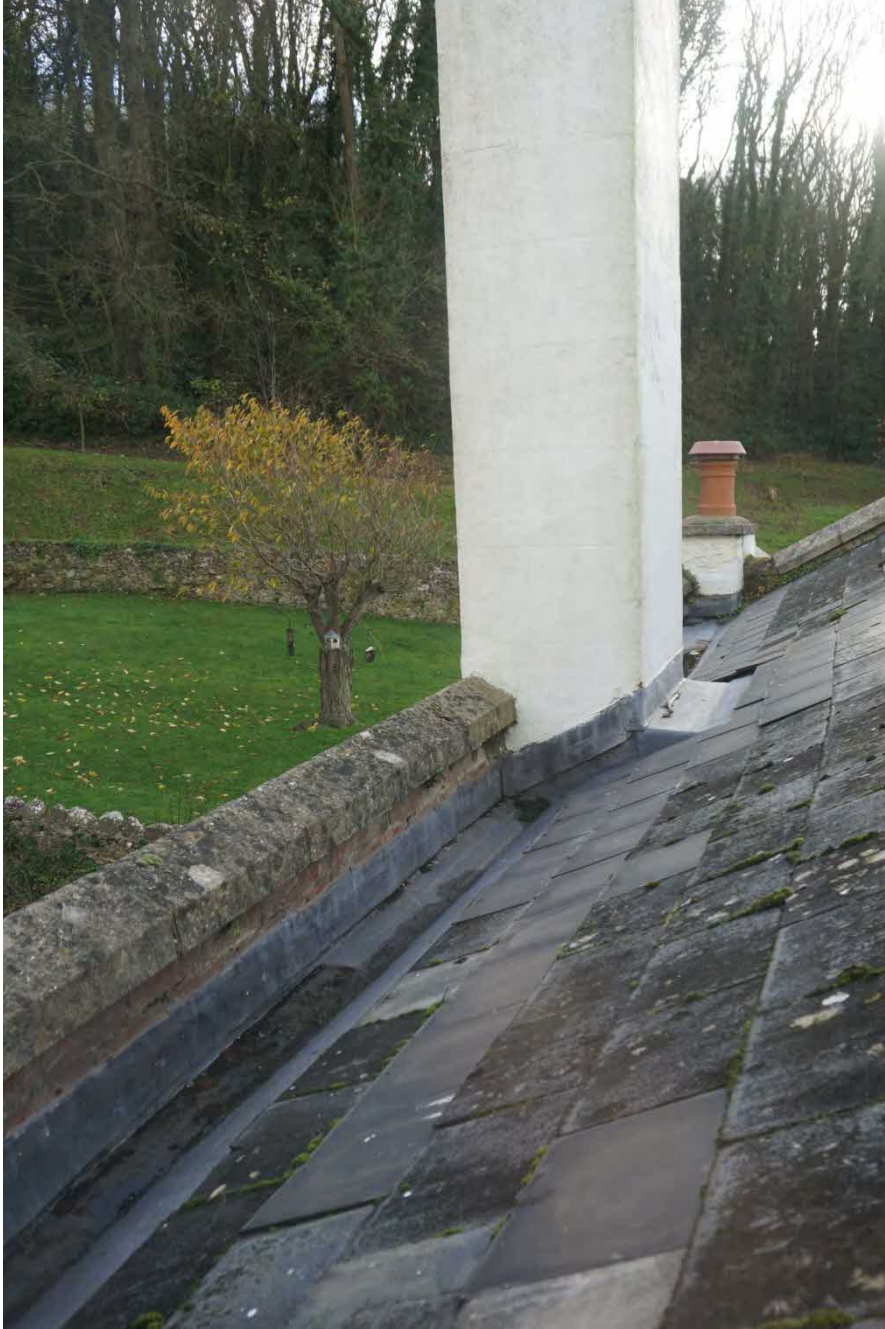
- 4.4 There are also gutters behind the parapet walls above the drawing room. It was only possible to see the east side (from window in bedroom two) photograph below. From the general appearance of the lead flashing the leadwork looks to be relatively modern but, again, the gutters have been lined with fibreglass subsequent to the main re-roofing.

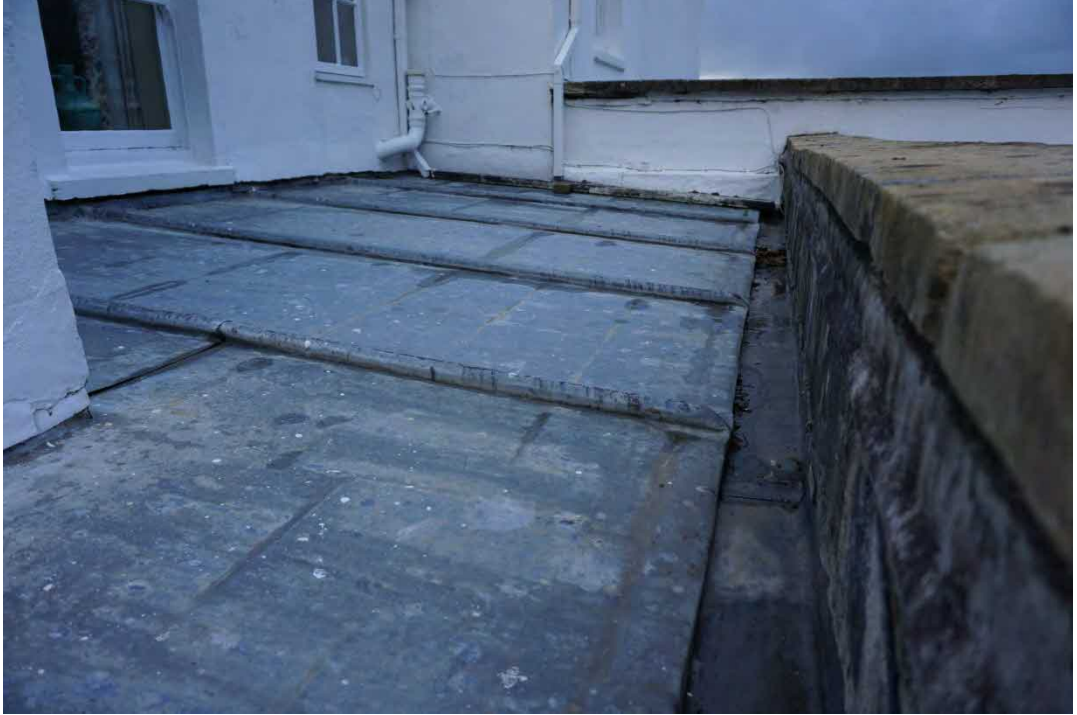
- 4.5 As well as the main pitched roofs there are flat/low pitch lead covered roofs above the entrance hall and snug/cloakroom area. The age of these coverings is uncertain but they are of a reasonable standard with lead cover flashings at parapet wall junctions and under parapet coping stones. Lines of depression/distortion in the lead indicate old possibly original timber boarding.

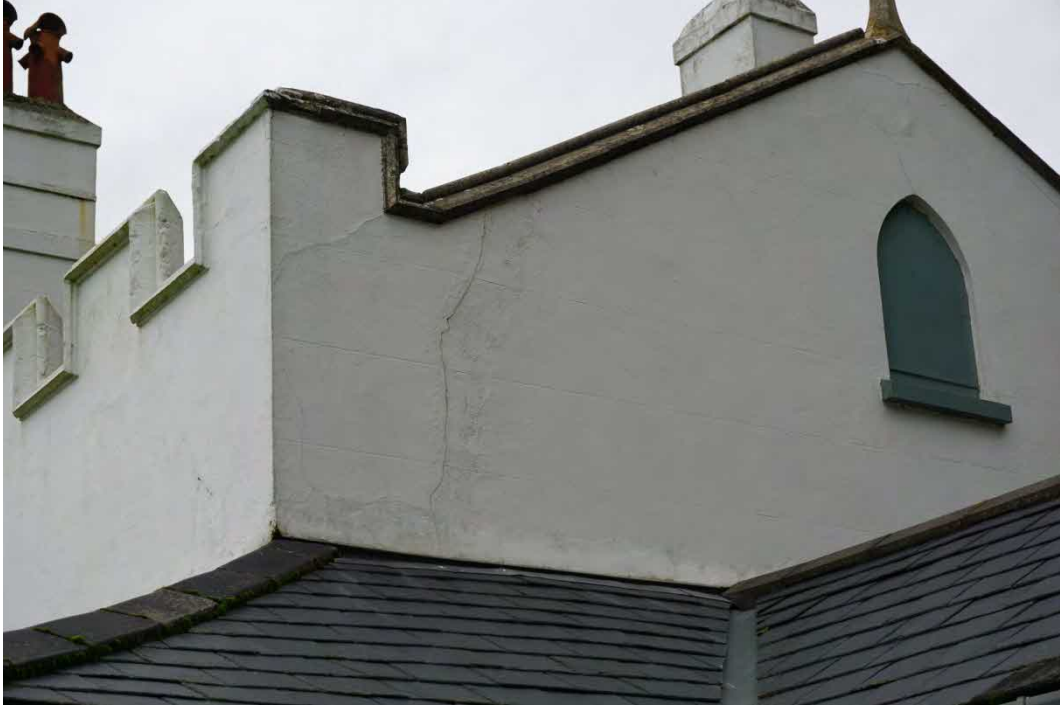
- 4.8 **Main Walls:** The main elevations are rendered with exception of rear kitchen wing (where rendering might have been removed on south side) and the walls are pointed to satisfactory standard of finish. Rendered finishes are in 'fair' order; sections have been re-rendered at various times with other ad-hoc repairs. There is some hairline cracking on parapet walls around the drawing room (and general weathering of castellated stone copings), and on south gable towards south west corner there is a previously repaired vertical crack possibly reflecting some slight settlement on this corner, or an old fracture/weakness in the wall. The present cracking is not obviously recent and there is no damage or disturbance to coping stones above.

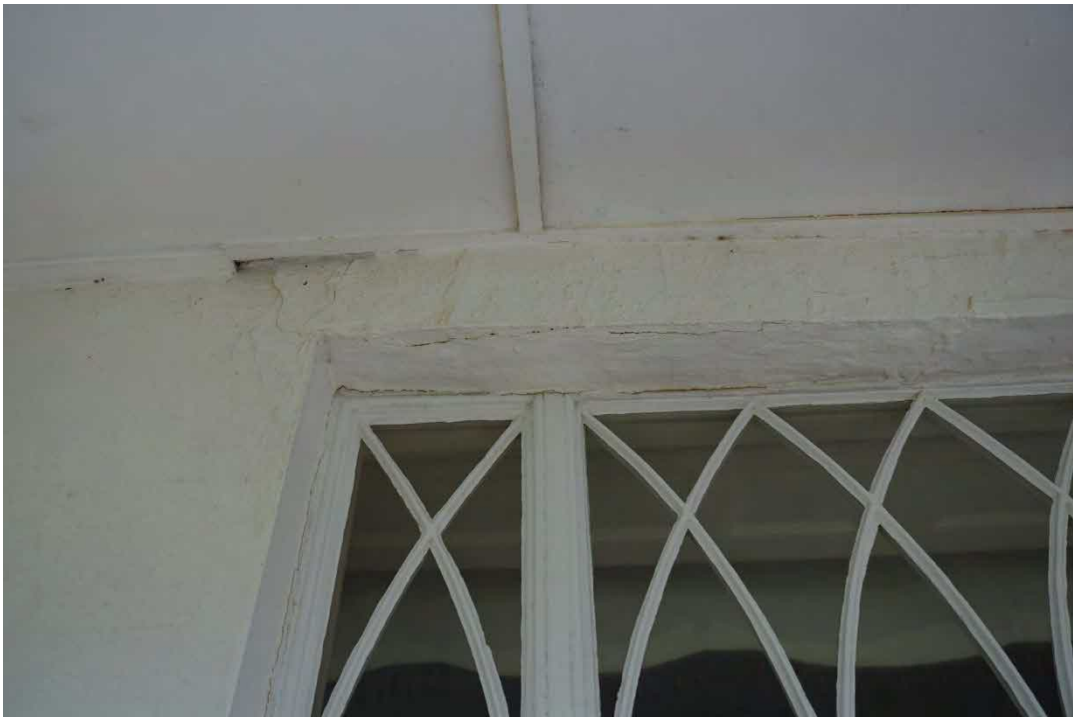
- 4.9 There is also some hairline cracking on the west wall the pattern of which combined with some cracking and distortion to the rendered finish above the head of the drawing room doors suggests possible deterioration/decay of a lintel. (There is a fractured stone step to the doors and there has been further movement subsequent to repair but it is not obviously related to any movement on the main wall.)

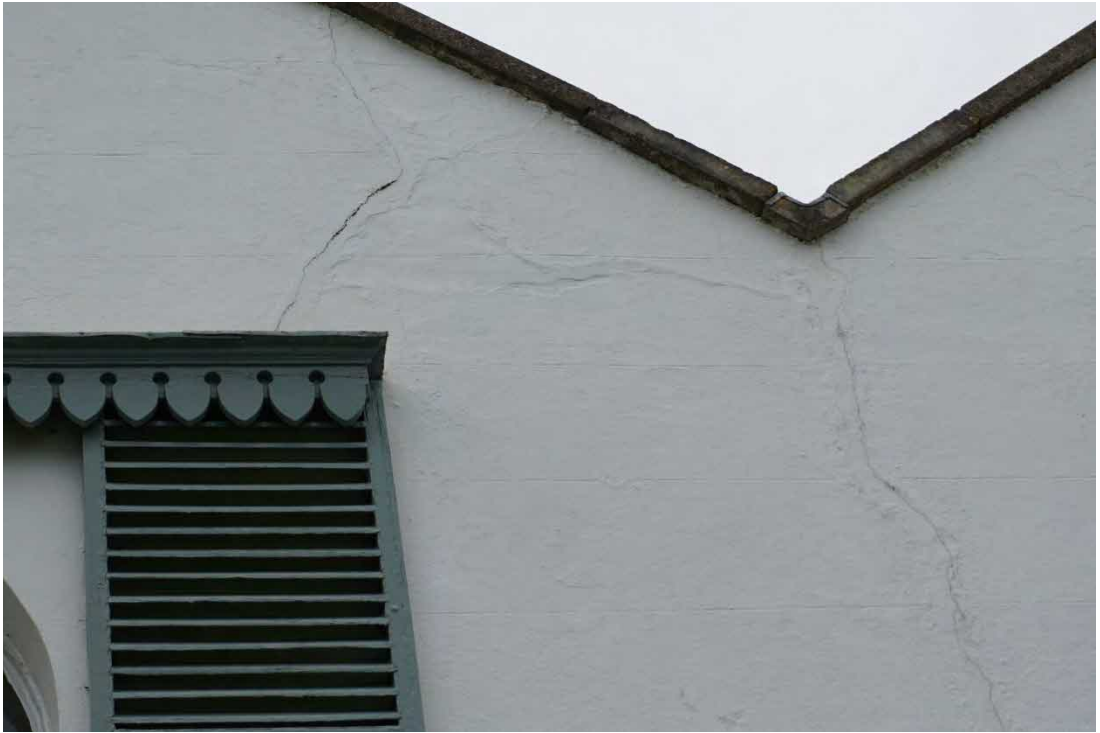
- 4.10 There is evidence of long-standing movement around the north west corner of the building in particular west facing gable to sitting room and bedroom above, i.e. evidence of crack repair with some subsequent opening up. This includes cracking over the height of the wall on the junction between the two gables (a structural divide in the building) and above and below master bedroom window. The sill to

sitting room is also out of alignment, dipping towards the corner (and the shutters do not close properly). The cracking is hairline only and although subsequent to past repair does not appear to be particularly recent.

- 10.2 There are indications of historic movement around the north west corner where there has probably been differential settlement over a long period of time in part as a consequence of the cellar which is only under part of the building. There is some fracturing in the masonry on both elevations but it does not appear to be recent and there is no obvious progression.

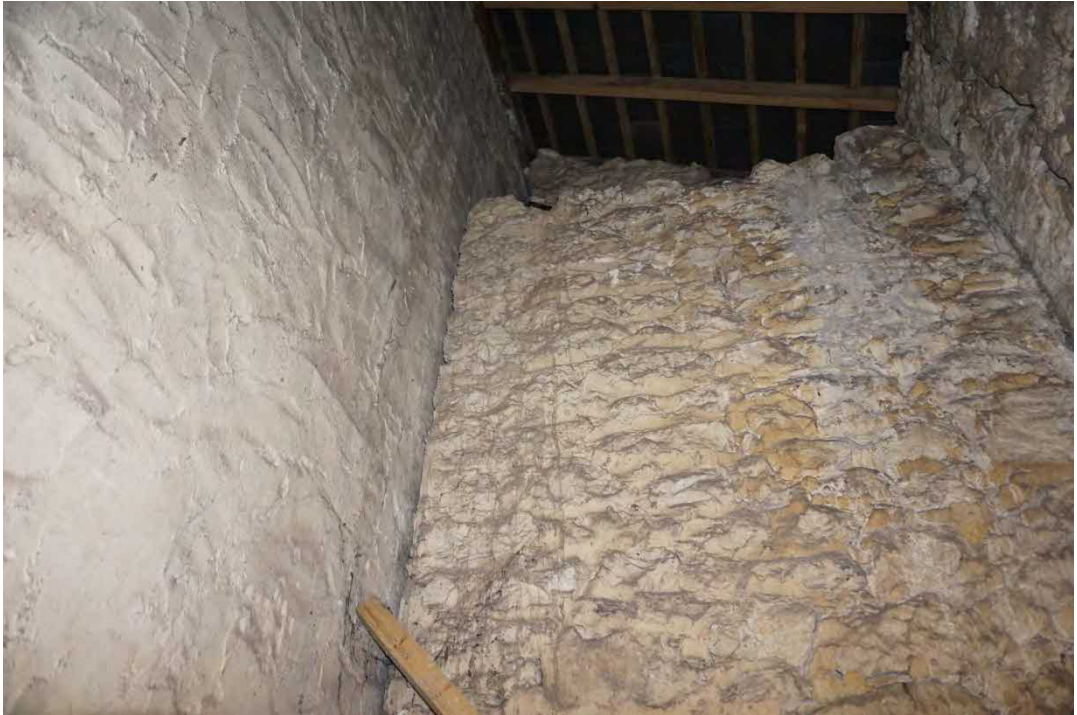
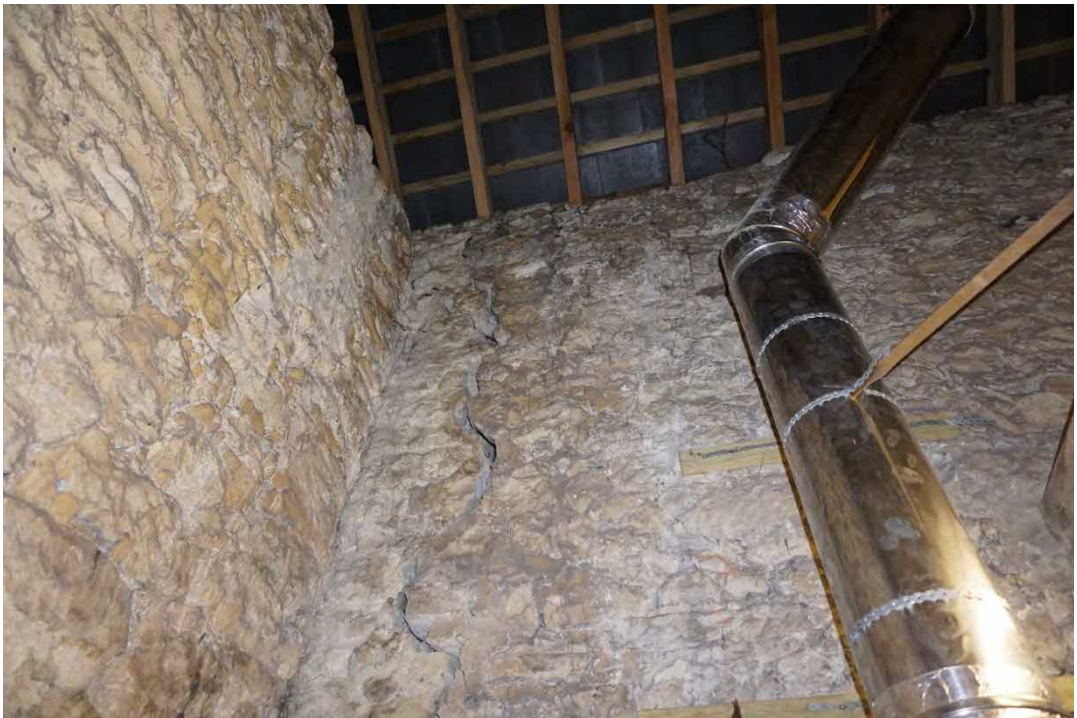
- 4.11 The return north facing wall (not the single storey lean-to) looks to have been relatively recently re-rendered. In the cellar area below there is some old fracturing evident to the right hand side of the chimney breast. The single storey part, which here covers the access to the cellar, is a later probably 19th century addition to the main building. The walls have rotated significantly out of upright, with a large joint gap between side wall and main building and there is also a large fracture on the north wall visible internally (photograph below) and with evidence of repair externally
- 4.12 The external render finish on this wall is not recent, in fair condition only. A rainwater downpipe on the corner simply discharges at the base of the wall not helping ground conditions. For general comment and advice see 10 below.

- 10.3 In addition, there does appear to have been some local subsidence affecting the adjacent single storey part. The walls enclosing the area leading down to the cellar have moved significantly out of upright. There are, again, no definite signs of continuing movement, but the wall has little lateral restraint and stability may have been compromised. Any further movement could cause damage and this will therefore need to be closely monitored. Inadequate drainage as noted (4.12) is likely to be adversely affecting ground conditions and requires attention.

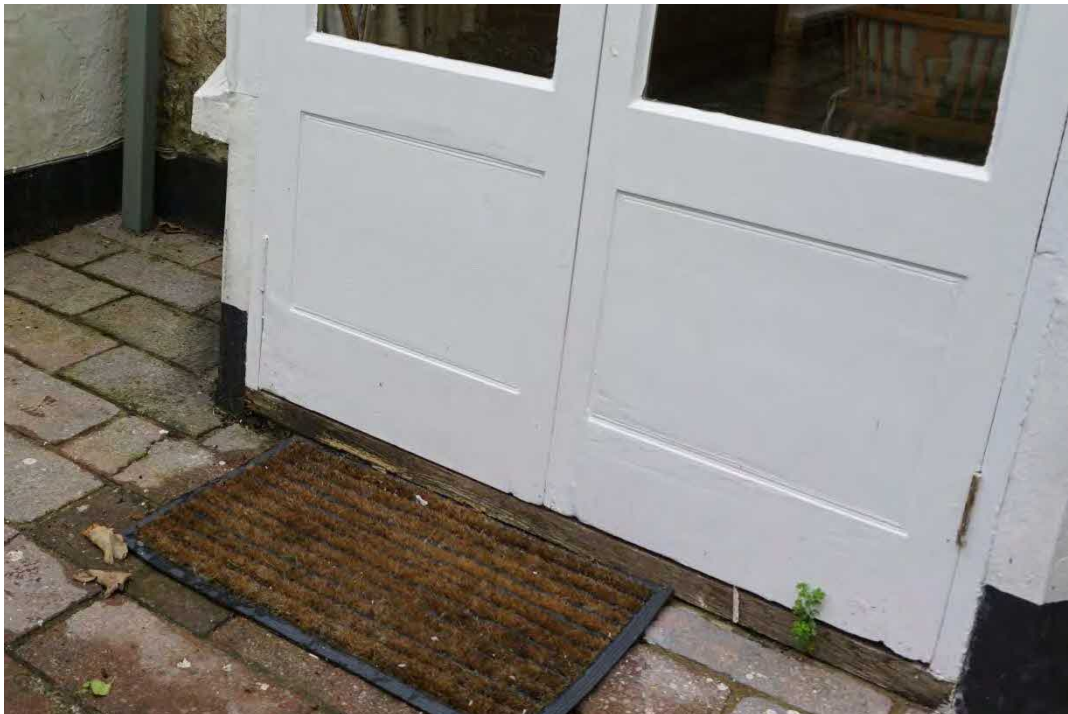
- 4.15 Windows around the first floor including later windows, e.g. bay windows to bedroom three and four are not particularly well fitting or draft proof. Many are not freely operating and have been 'painted shut', and there is some condensation damage to the joinery. In the master bedroom there is wet rot in the base of the frame, that should be repairable. The sill has been covered with lead. The window in the adjoining dressing room is not opening.
- 4.16 Windows do not have any lockable catches or security devices. There are a small number of cracked panes. Windows and doors around the ground floor have been maintained with some extensive use of filler repair e.g. around base of kitchen doors and window. There is rot in base of south utility door frame and the door threshold on north side to courtyard is loose.

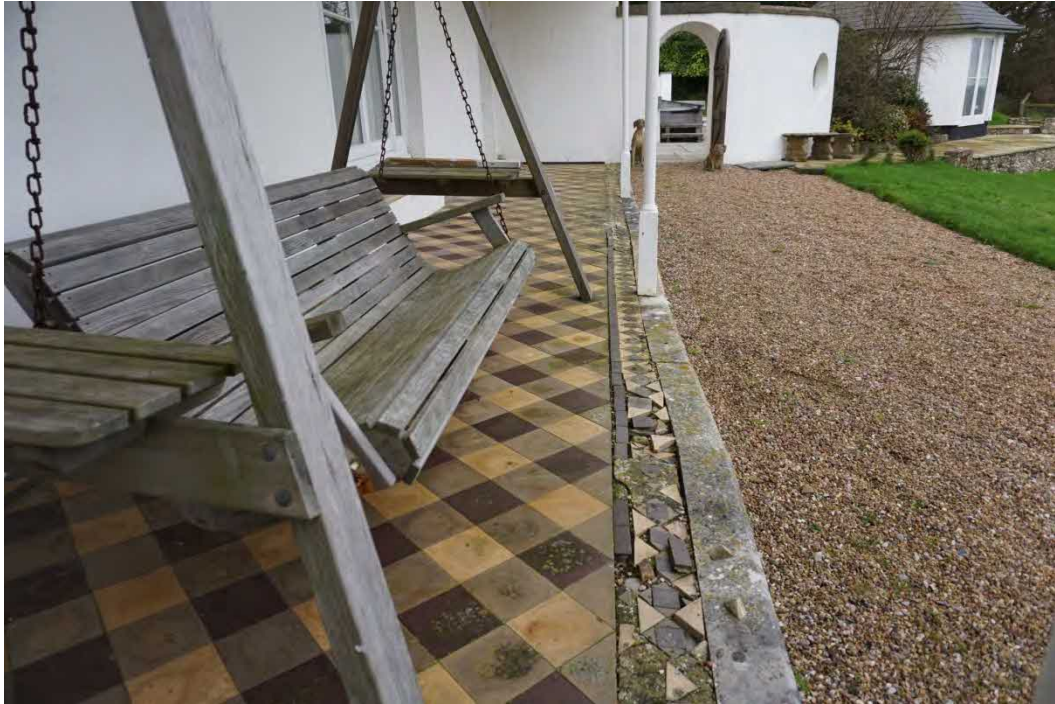
- 4.17 **Conservatories and Porches:** The garden room (built following consent in 2007) is on cavity block base with good quality timber framing above double glazed and with a slated roof (natural slate) with lead weather proofing at abutments, fibreglass lined valleys and concrete ridge and hip and tiles.
- 4.18 The veranda has a swept profile roof supported on iron columns probably a later 19th century addition as front porch section. The roof looks to be original although is board and enclosed under, whereas the lean-to roof over the cellar area was replaced when the building was re-roofed. The roof covering is as the rest of the house, but there is a basic adhesive flash band material weatherproofing at wall junction. Some settlement has affected stone edging and tiled flooring.

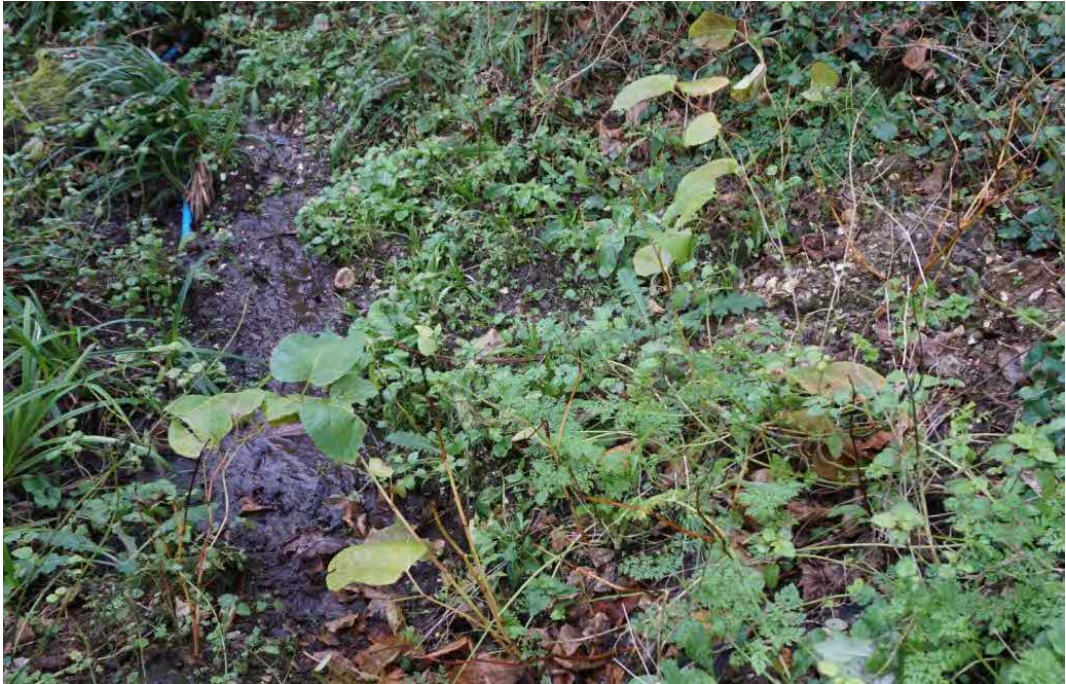
- 8.4 To the east side beyond the buildings is a wet overgrown area of land. Adjacent to where some recent work has been carried out for the water supply there are some plants that look to be Japanese Knotweed (ill. below). See comment at 10 below.

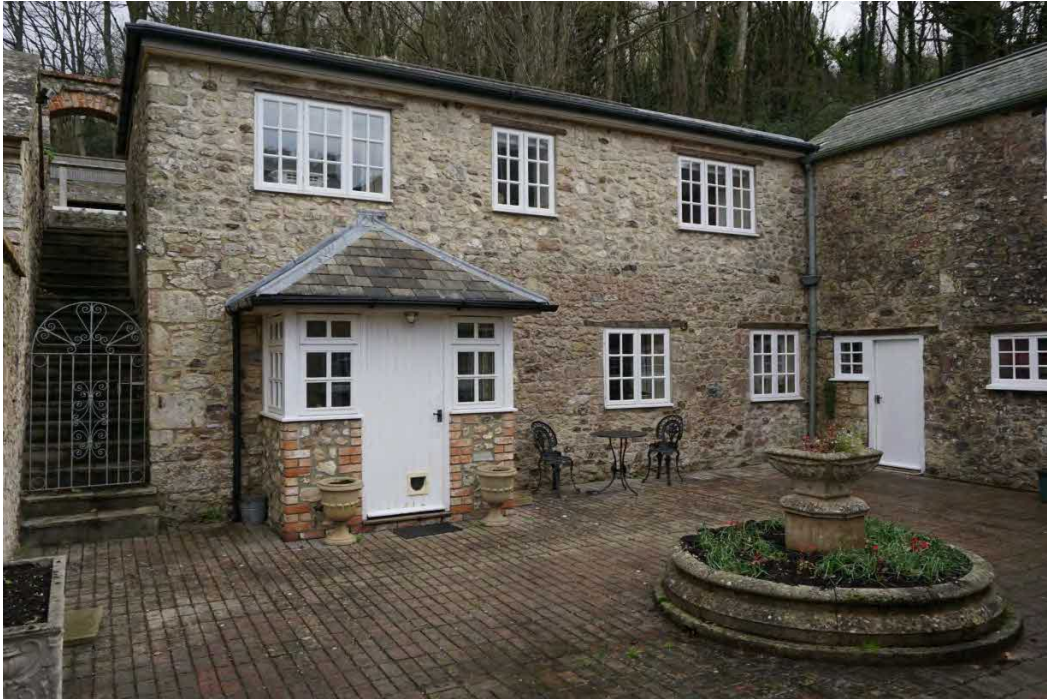
- 9.1 **The Cottage:** The cottage was completely renovated about 10 years ago. It is clearly an old building of substantial solid stone wall construction under a slate roof. The roof is of modern construction and it appears, from wall finish, as if the building may have been partially reconstructed and the front wall raised in height. The entrance porch is also a modern addition, walls with visible damp course.

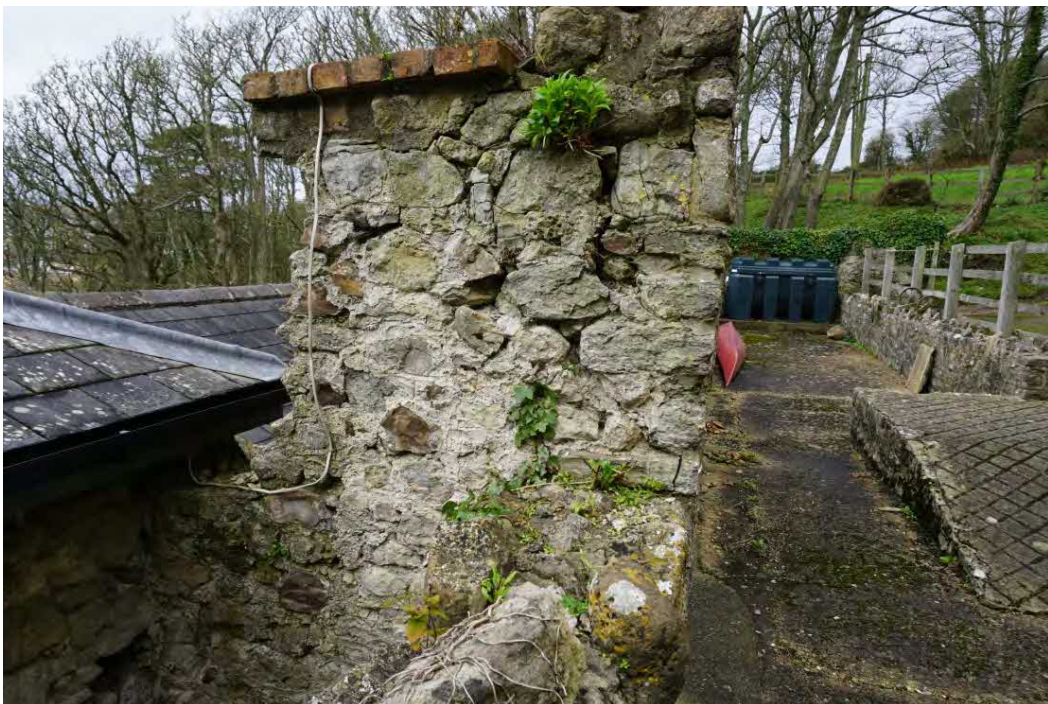
- 9.2 Externally the roof covering is natural slate with vapour permeable underfelt, concrete ridge tiles and lead covered hips. A brick and rendered chimney stack is in reasonable order. There are high ground levels to either end of the building but at the rear there is a space between the cottage and high retaining wall adjacent. There is no access to this enclosed area other than by ladder. Wall finishes are in reasonable order, mainly old lime pointing to rear, more recent cement mortar pointing to front. There is a small rendered section on north wall which has some loss of key. Immediately adjacent to the north east corner where an old boundary wall has been cut back leaving a stone pillar the masonry is in poor condition.

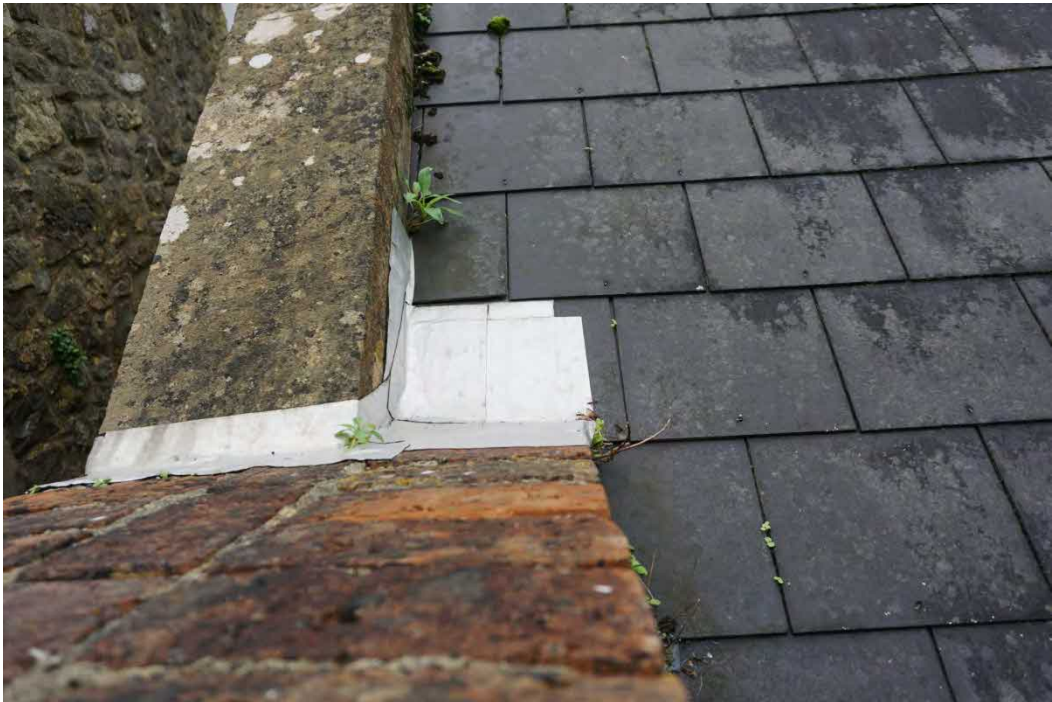
- 9.5 **Garage:** The garage block appears to have been altered from a former mono pitch roofed building, gables raised in blockwork and with a modern pitched roof construction of relatively lightweight framework, but adequate for the covering of man-made slate with conventional roofing underfelt. Timbers are affected by some active woodworm (common furniture beetle). There is rainwater penetration on the south east corner due to poor detailing at roof/gable parapet junction.

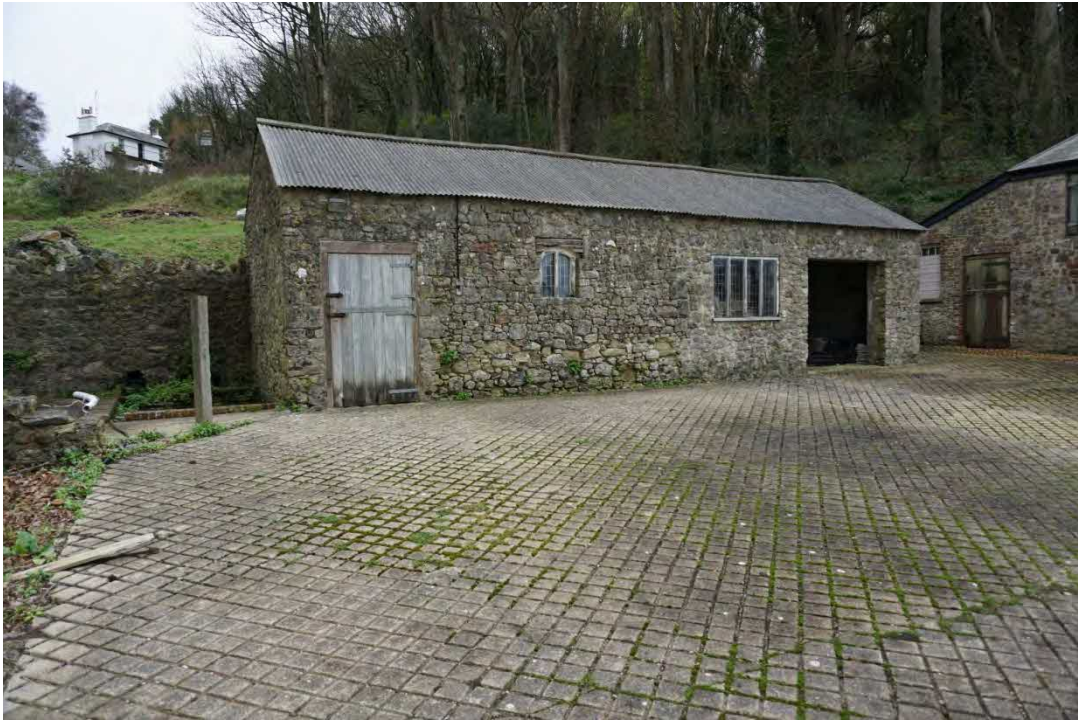
- 9.6 Large timber doors are of fair standard only with simple padlock locking. Internally there is a new block partition wall, floors are all flagstone and around the walls there are areas of old timber panelling in deteriorating condition and detached from wall being almost free standing. Damp penetration is affecting old plastered finish on front wall.
- 9.7 **Storage Barn:** This building, which is not secure, is mainly of solid stone construction but partially re-built in block with stone facing and has a pitched roof with corrugated asbestos cement covering. The roof construction is adequate for the

present covering but timbers are affected by woodworm. Timber windows and doors are in poor condition.

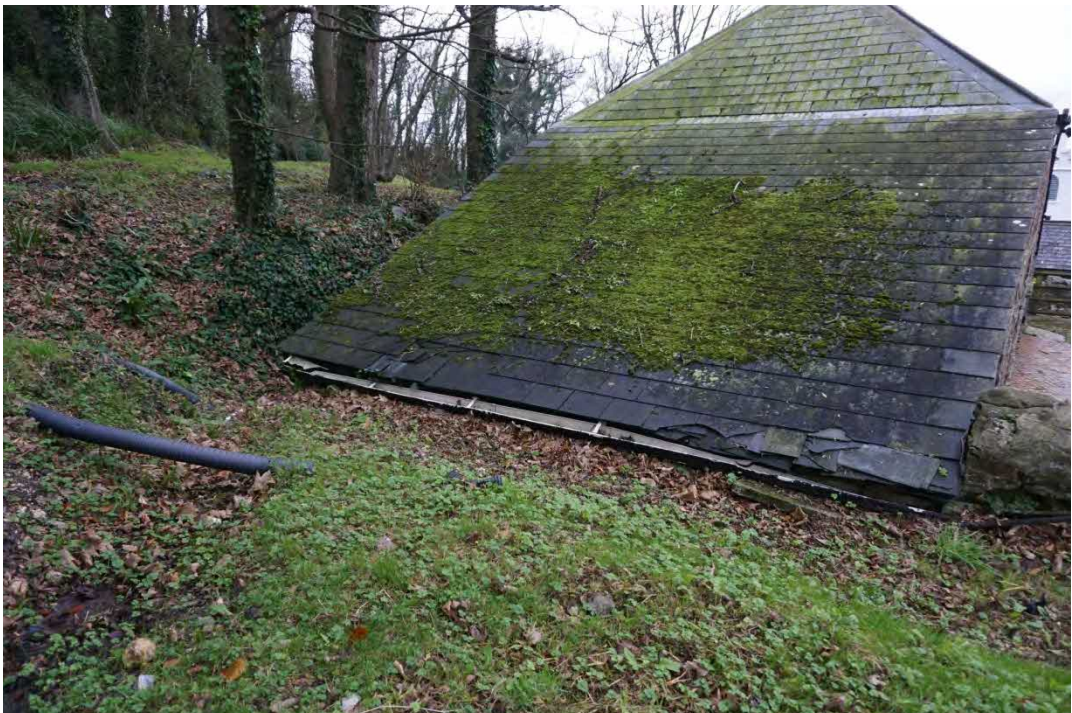
- 9.8 **Stable Block:** This is a traditional building of stone construction with a traditional king post truss roof construction of reasonable standard and re-slatted with natural slate on roofing felt. There are original timber panel stable divisions, profile brick flooring and a timber storage loft. The lean-to at the east end is of more recent renovation with a new roof structure of reasonable standard but again with beetle damage. The covering is of man-made slate with conventional underfelt. There is some slate damage and leakage occurring on eaves affecting underlying timbers.
