## Heritage Statement

Site Name: Yew Tree Farmhouse

### Schedule of Works:

Internal alterations to a Listed Building comprising the removal of one inserted staircase (GBRG 6/1996) and recombination of remaining sound parts, together with those of a second inserted staircase (treads and risers), to preserve overall historic fabric.

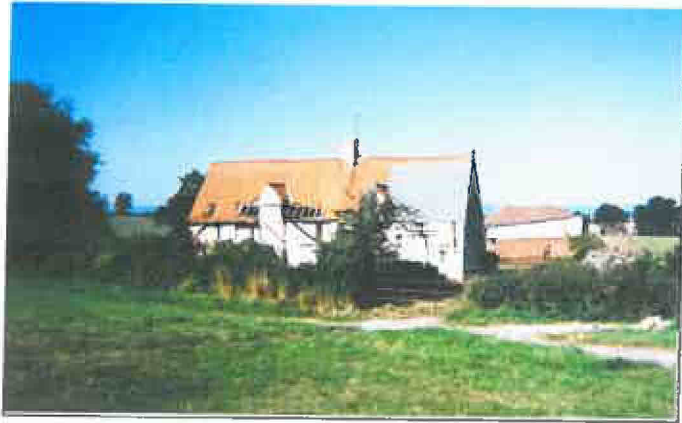
**Yew Tree Farmhouse**  
**From Whaddon Green,**  
**showing large areas of damaged roofing**  
**allowing catastrophic water ingress**

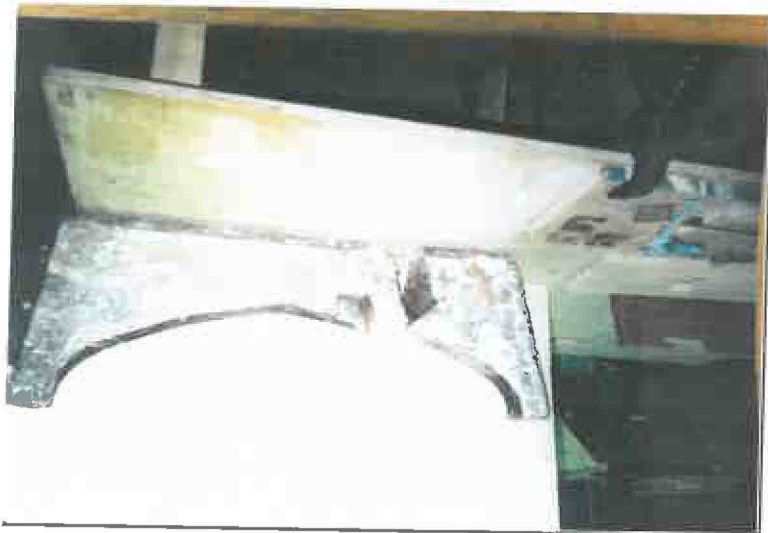
Door head assessed

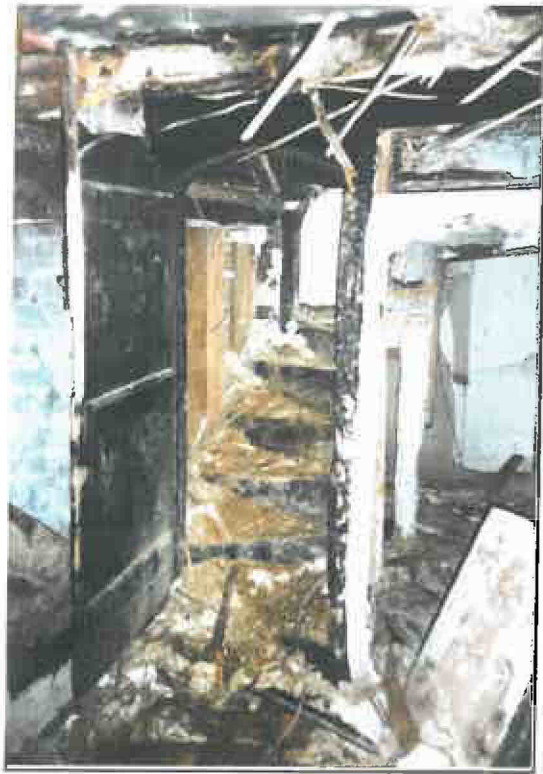
3. Significant quantities of moisture trapping detritus had accumulated in heaps on the treads: see Appendix III. This had led to ideal conditions for fungal decay (moist, warm and dark) and insect attack of the timber. Given that the material was the less durable elm, the components had deteriorated rapidly beyond repair or reuse.

Central Staircase : A considerable accumulation of moisture trapping detritus lay on each tread

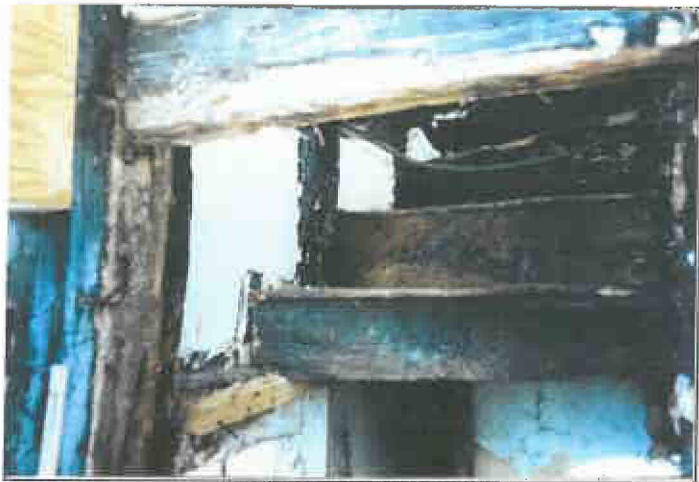
2. Some parts of both staircases were missing, presumed broken in use, and lost.

Numerous parts missing, decayed or broken

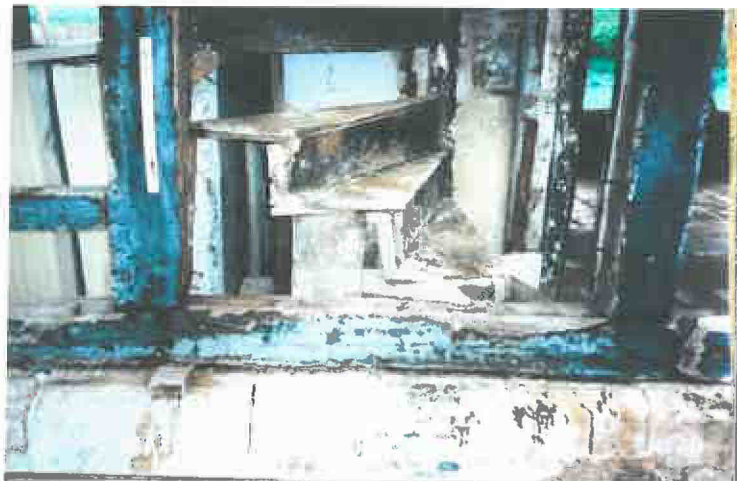
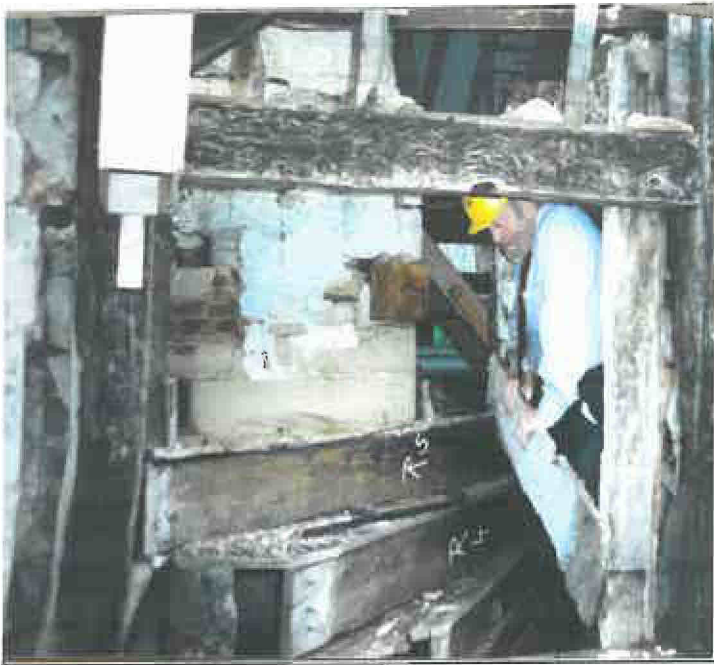
4. Staircase parts were numbered in situ then carefully removed for examination.

Carefully numbered for dismantling and assessment
