# **Phase 1 Land Contamination Risk Assessment**

## **Erection of 6 No. Dwellings Following Demolition of Existing Buildings**

**White Hall Farm, Church Street,  
Kilham,  
East Riding of Yorkshire  
YO25 3RQ**

Reference: 3190D P1 Arundel - Kilham

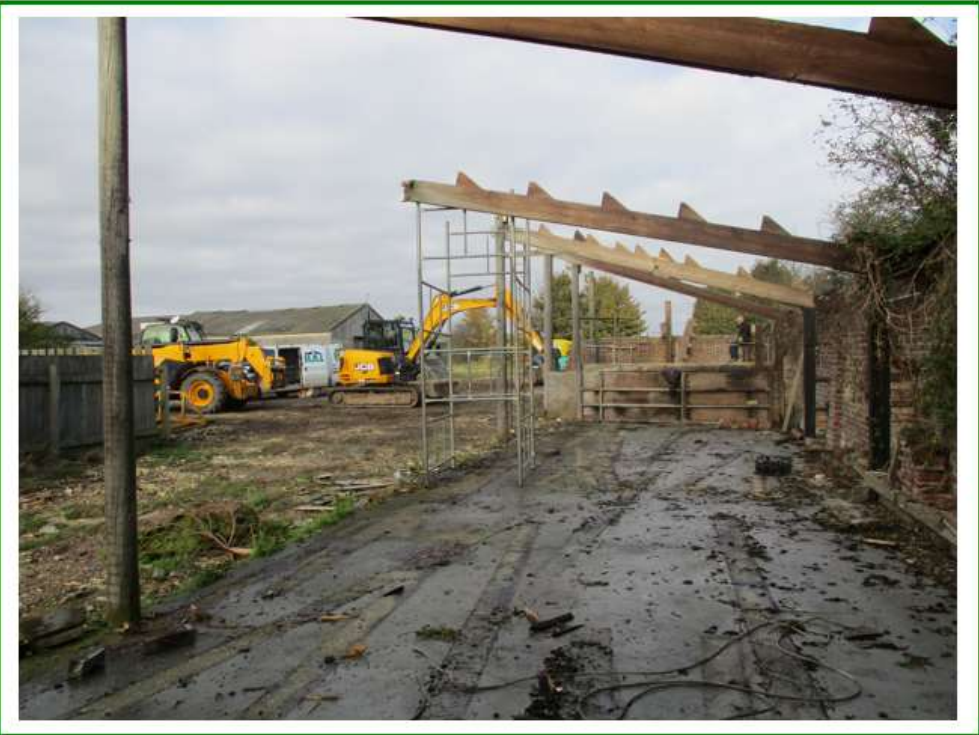
**Photo No.5: Facing north showing interior and concrete flooring of demolished barn**

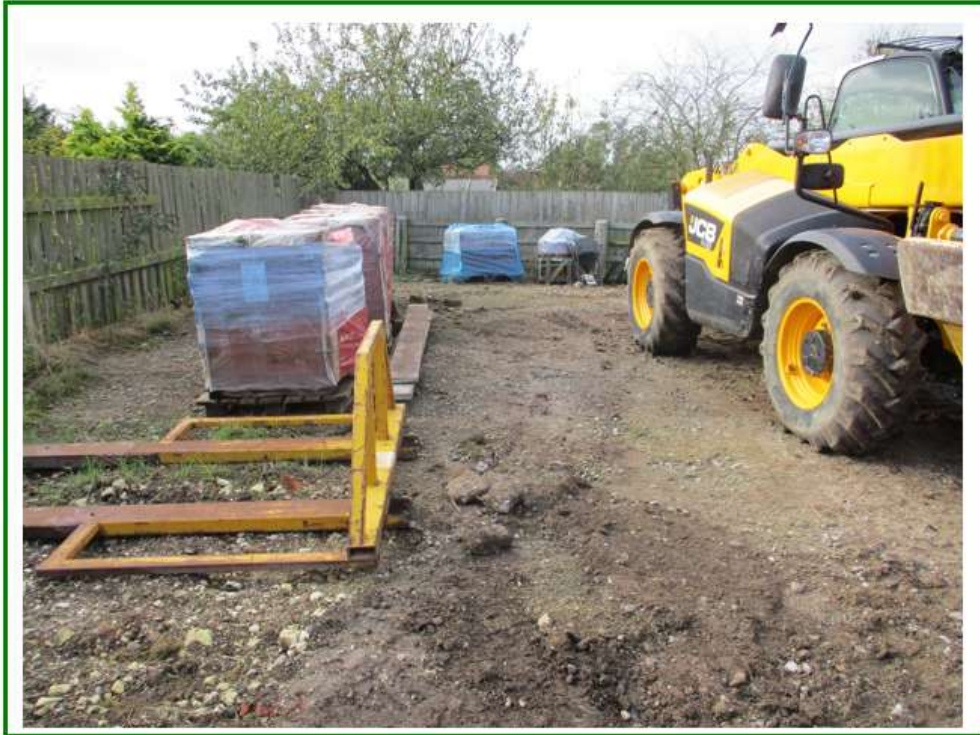
**Photo No.6: Facing west from access track adjacent to demolished barn showing materials storage in west of site**

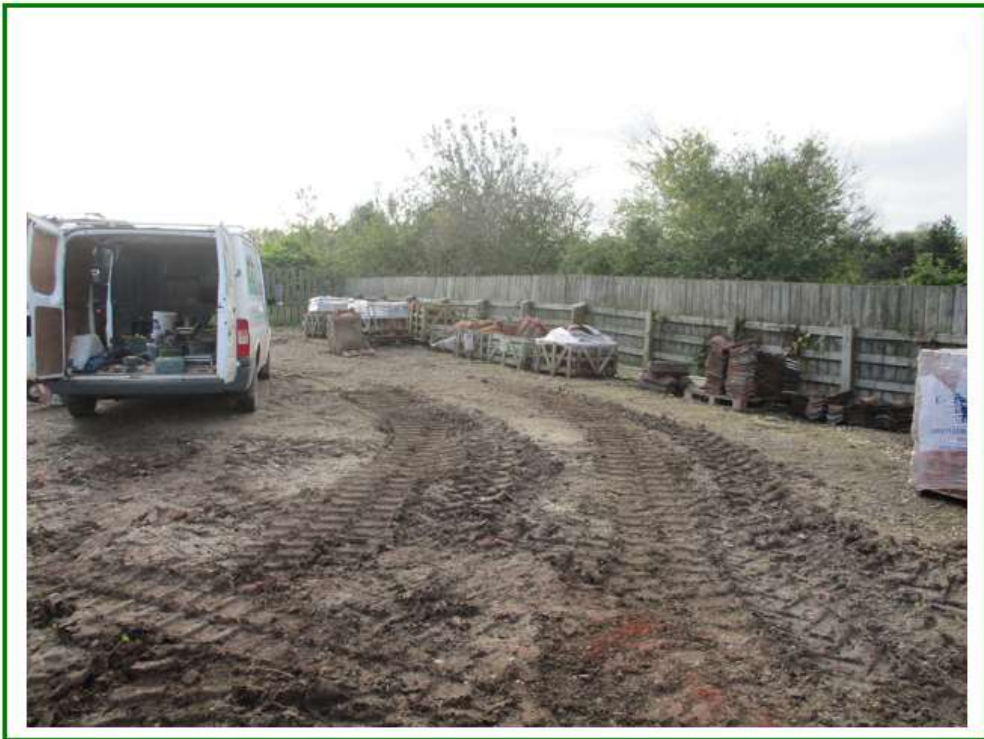
**Photo No.7: Facing south west from central area of site showing area of materials storage along western boundary**

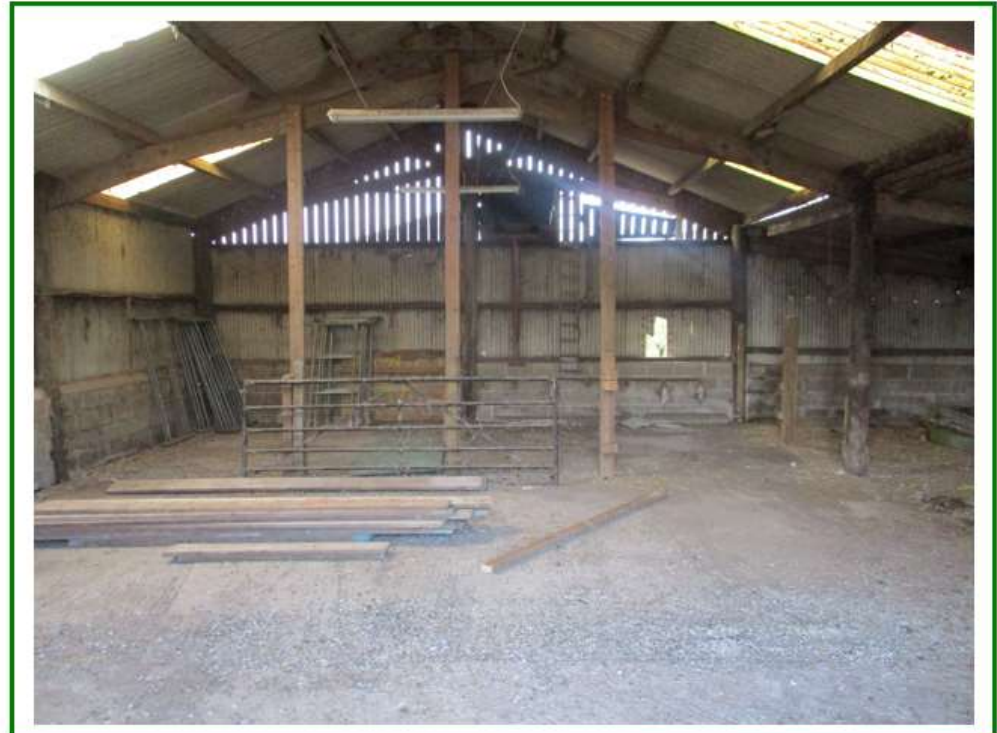
Photo No.10: Facing west showing interior of the barn and concrete flooring along with PACM composition of barn

It is recommended that a Phase 2 Intrusive Site Investigation is planned and carried out on site. This should involve the formation of trial pits targeted at areas noted to be potentially contaminated. This includes areas of soft-landscaping (in particular the northern extent of site), the area of historical sheep-dipping, the spoil heap and adjacent burnt patches of ground and areas where scattered PACM debris has been noted.

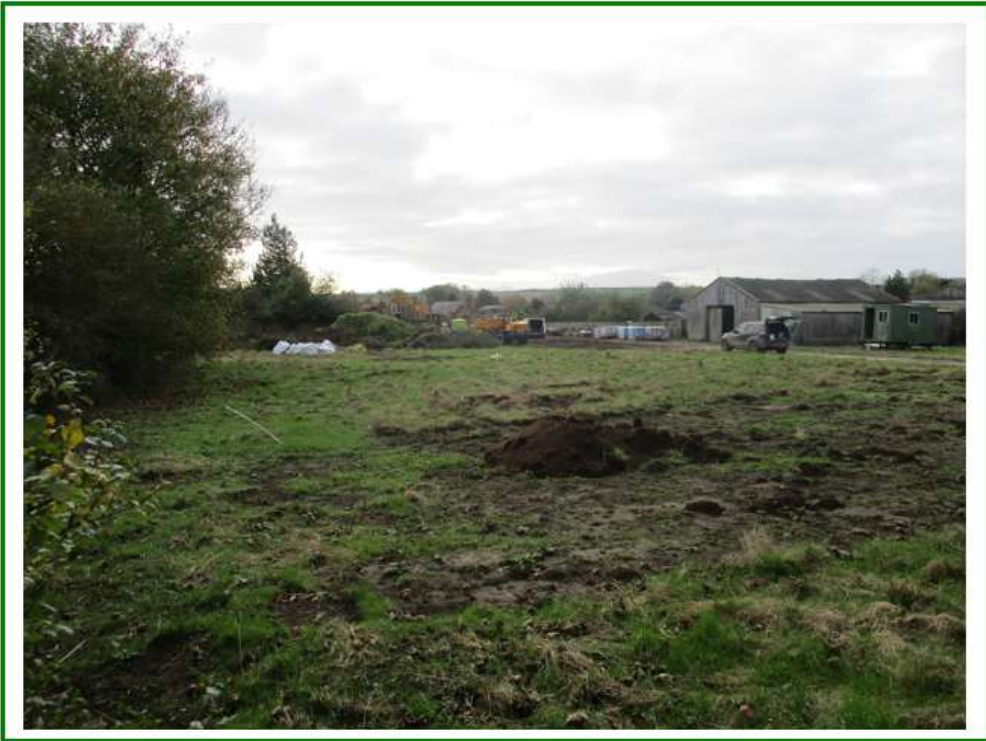
**Photo No.11: Facing SW from the NE corner of site showing main site area, small pit (foreground) and spoil heap (background)**

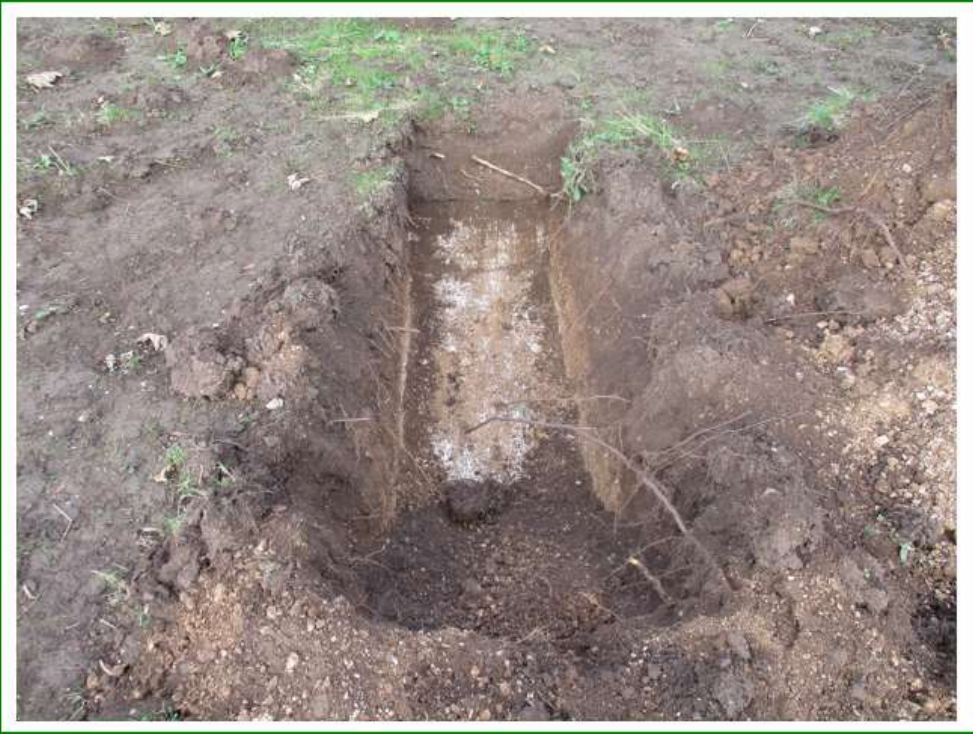
**Photo No.14: One of 2 No. small pits noted in the NE and NW corner of sites showing topsoil atop residual bedrock chalk**

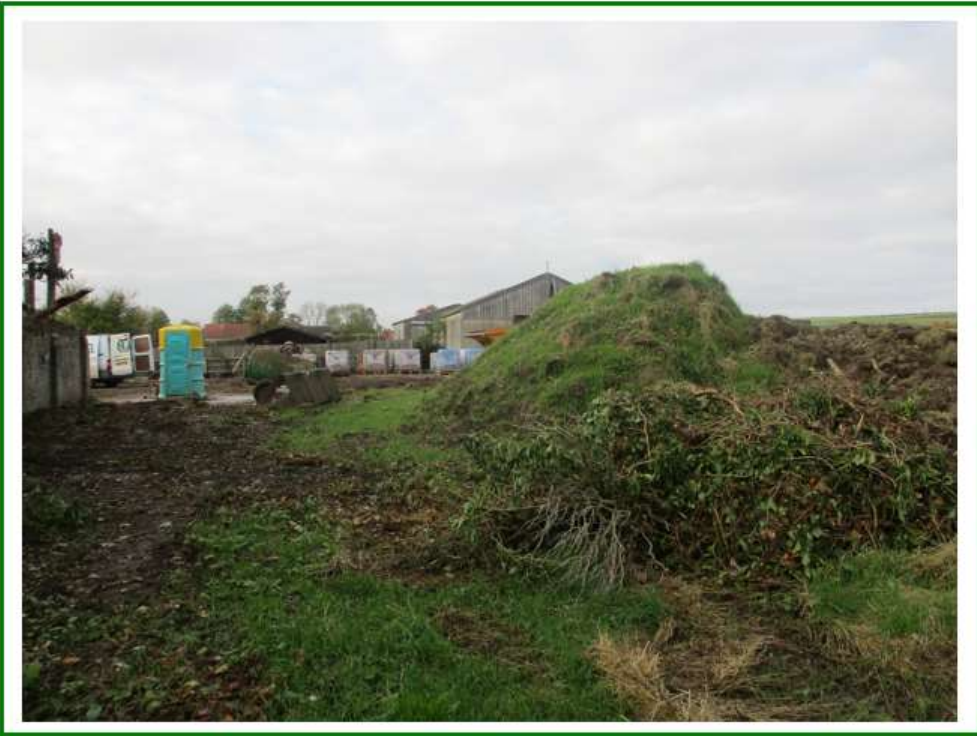
**Photo No.15: Spoil heap of topsoil noted in the SE corner of the main site area (northern extent of site)**

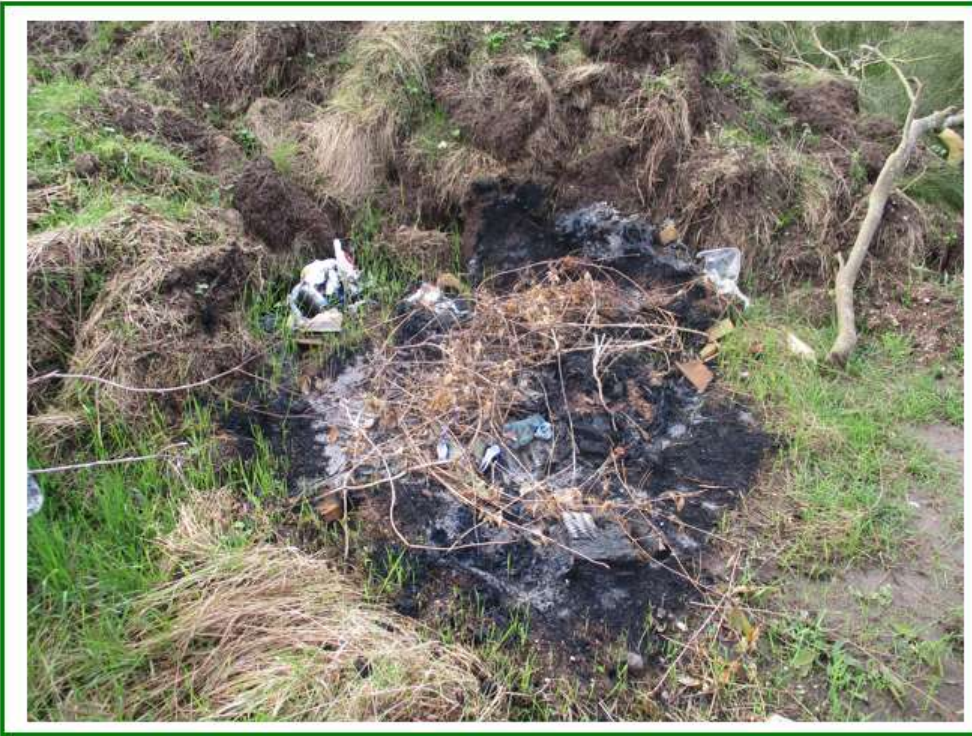
**Photo No.16: Evidence of localised fires noted adjacent to the spoil heap with melted plastics noted within**

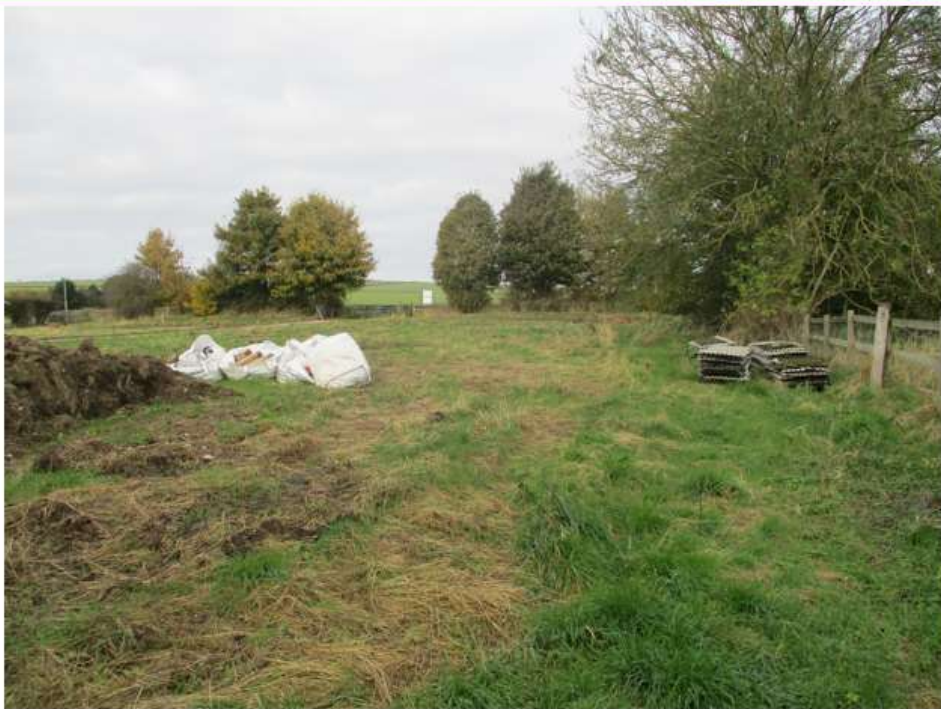
**Photo No.17: Facing north from the SE corner of the main site area showing spoil heap (left) and asbestos sheets (right)**

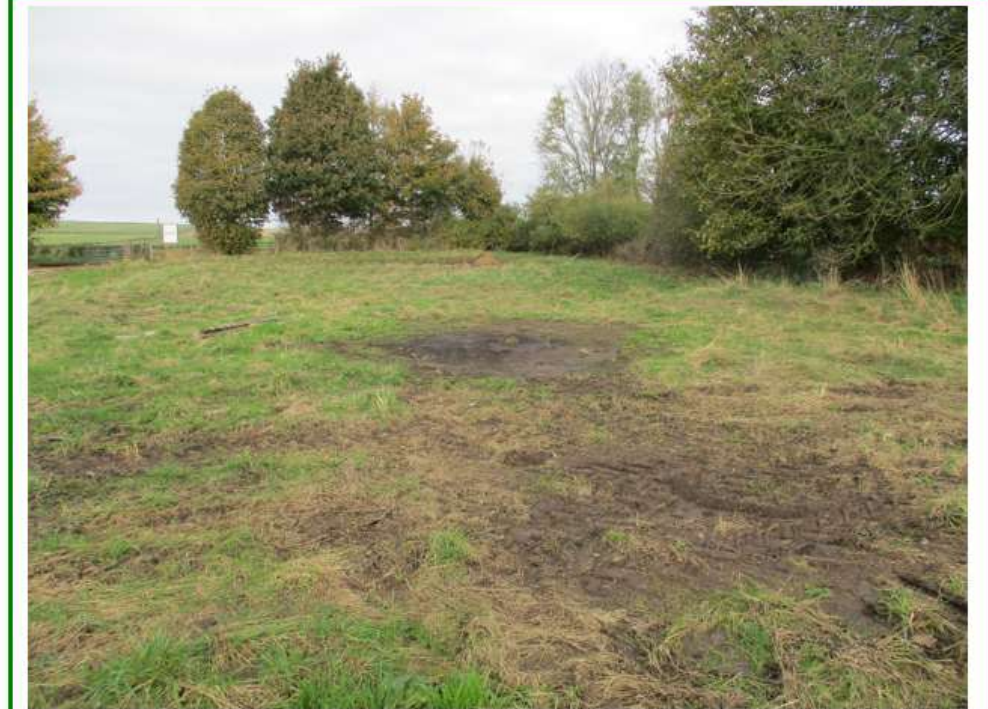
**Photo No.18: Facing north from the northern side of the spoil heap showing a second area of localised burning**
