21 Freeman Avenue
Henley
IPSWICH
IP6 0RZ

CONCERNING SUBSIDENCE DAMAGE

ENGINEERING APPRAISAL REPORT

Our Ref: 9255790

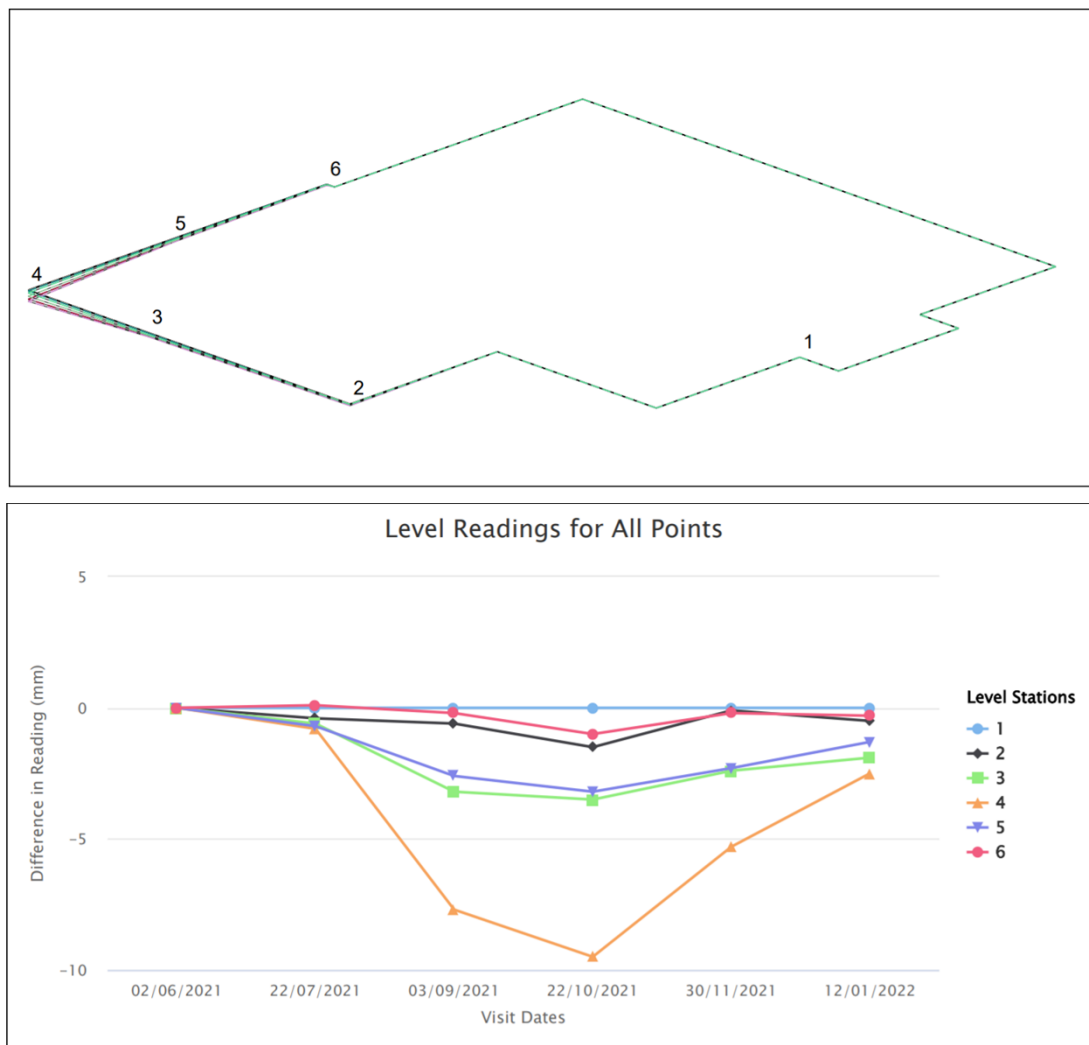
Level monitoring has been underway since June 2021. In summary, the results to date show downwards movement to the rear left-hand corner of the building over the dryer summer months, and recovery (upwards movement), over the wetter winter months. This pattern of movement is consistent with the operation of a clay shrinkage mechanism and confirms the dewatering effects of the Lime tree roots on the shrinkable clay sub-soil:
