### *Independent Arboricultural Consultancy*

## 1. REPORT SUMMARY

### 1.2 Scope and Purpose of the Report

It has been commissioned to fulfil conditions 7, 8 and 9 of the planning approval. These require a landscaping scheme, a Tree Protection Plan and a Hedgerow Translocation/Replacement plan.

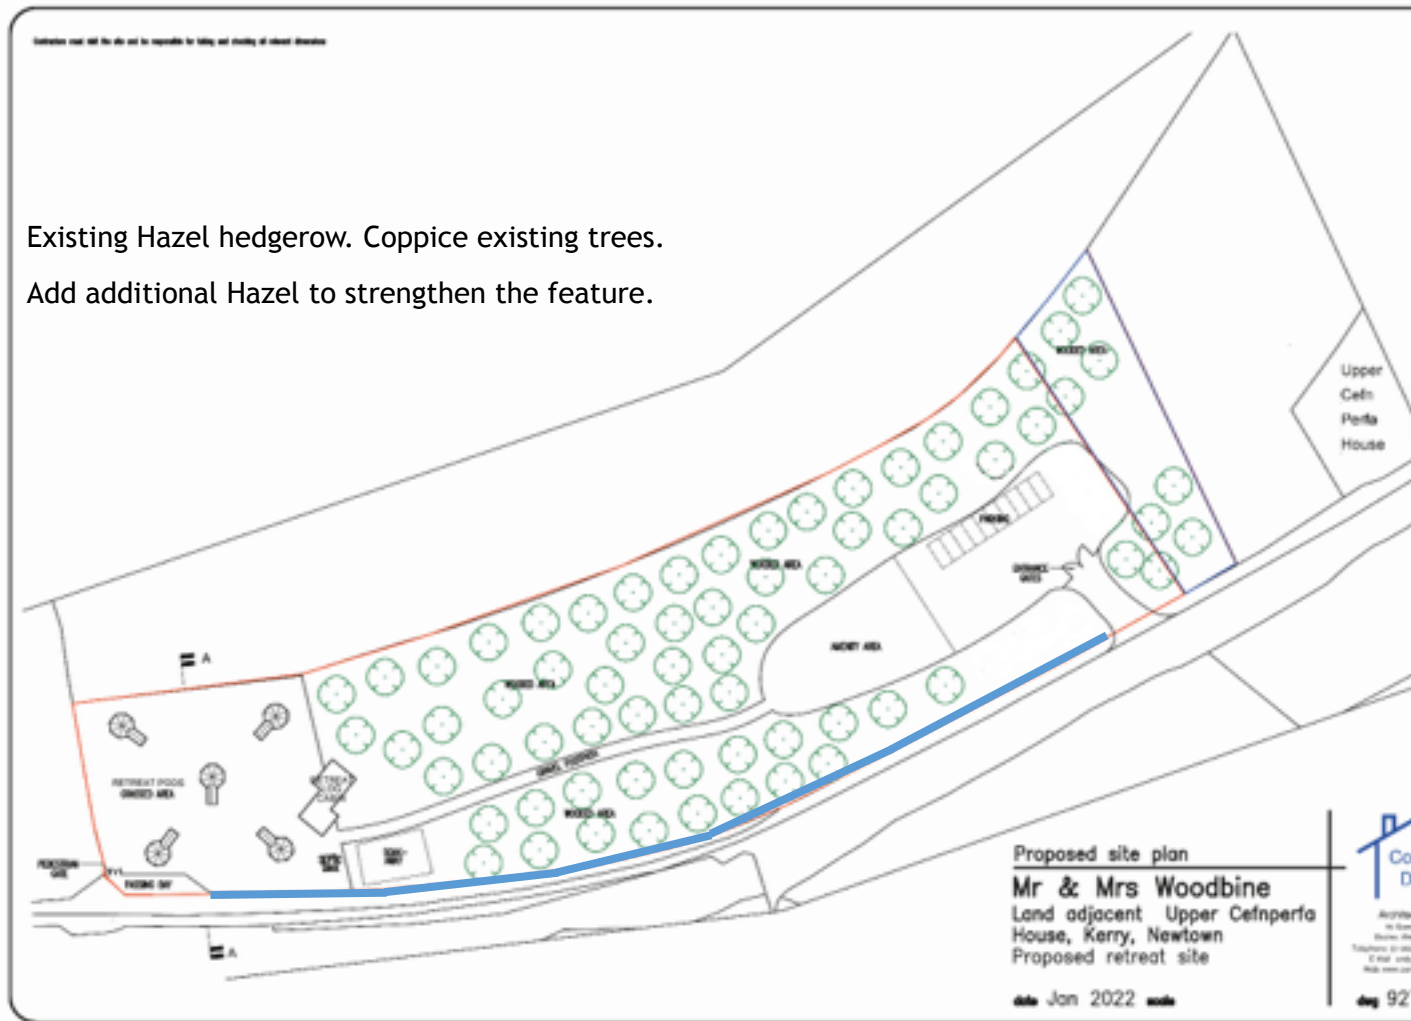
### Appendix VII: Hedgerow Replacement Plan

Existing Hazel hedgerow. Coppice existing trees.  
Add additional Hazel to strengthen the feature.

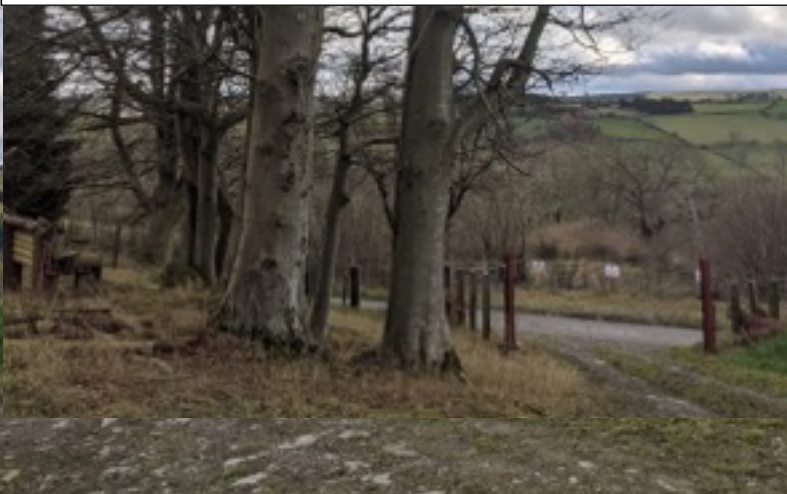
**Image 3:** Beech trees at the entrance to the car park. Picture taken from the proposed car parking bays.

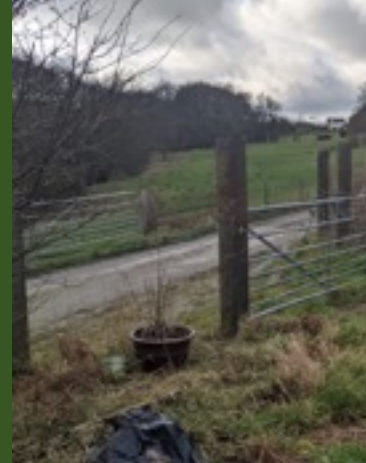
**Image 11:** Hazel hedge to the right of the proposed passing bay as it looks prior to works commencing.

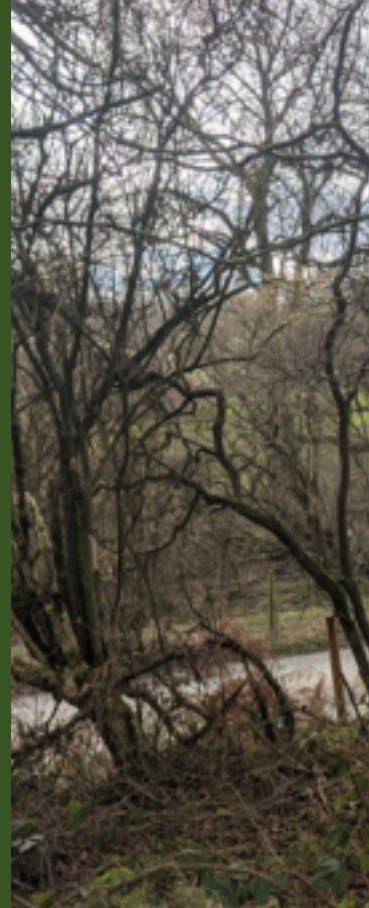
**Image 13:** Please refer to previous plans. This is hedge 2, located by the proposed glamping pods.
