**Heritage Assessment for Middle Ripley Farm, North  
Ripley Road, Ripley, Hampshire, BH23 8ES**

August 2021

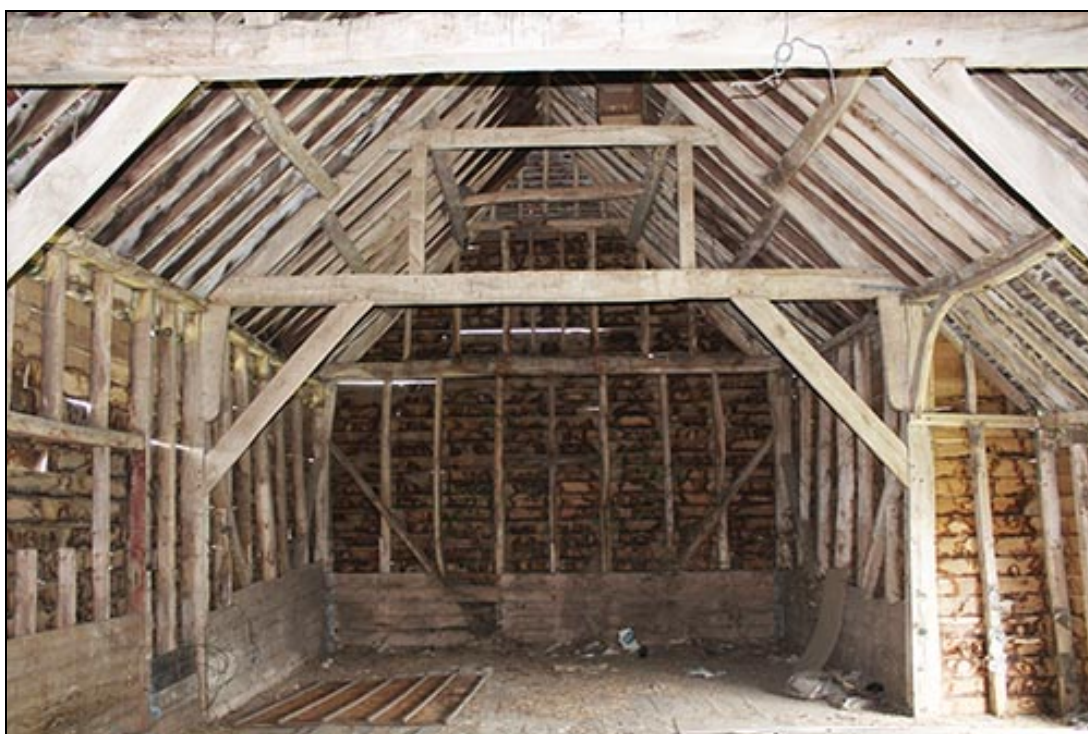
**Figure 13** Interior of the Threshing Barn looking west showing the frame construction and the original beech boarding on the lower walls as surviving in the western bay

2. The original structure is well constructed out of oak in a stud framing or “quartering” pattern with posts at the bay divisions with bowl-shaped jowls. The front doors, on the north side, project forward as a lean-to porch. Internally the walls were boarded up to a metre in height with beech feather-edge boards in order to retain the corn and deter any vermin. The roof cross-frames are collared with two queen struts that support tiers of staggered and tenoned purlins. At the apex is a ridge beam. There are four long wind braces, a pair in each outer bay. The roof itself was half-hipped and tiled.

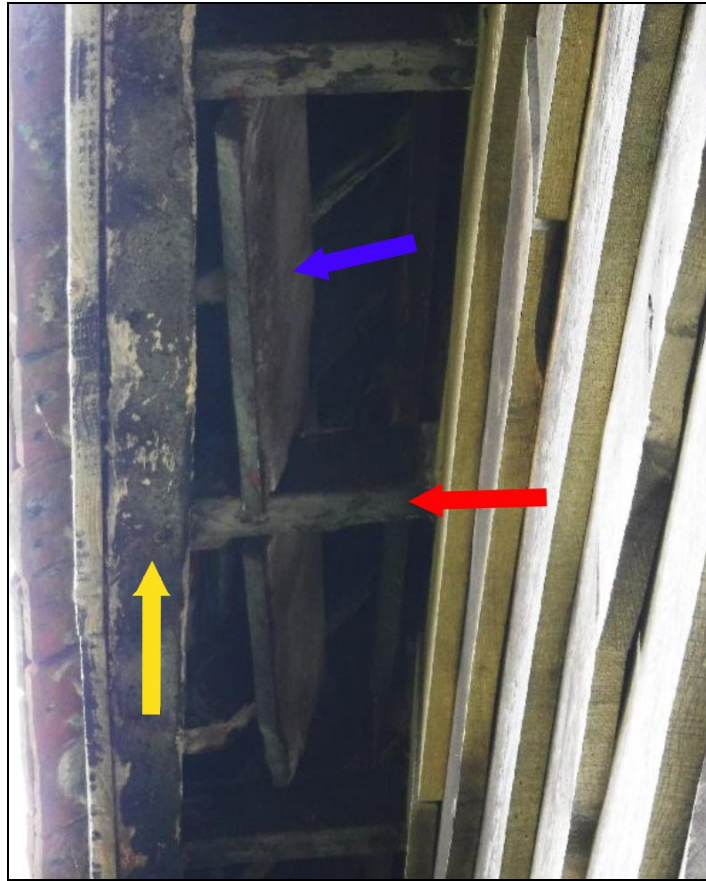
3. An unusual detail are the short horizontal timber struts nailed to the jowl posts and studs that supported a boarded soffit and external rail at the eaves, another anti-rodent feature to keep the corn safe. This may also have incorporated a ventilation slot to assist in drying out the stored produce. Externally the barn was weather-boarded, with some of the elm feather-edge boards surviving at eaves level above the horizontal struts.

**Figure 14** View up under the eaves showing the short horizontal timber struts (red arrow), the external rail (yellow arrow) and one of the near vertical boards that may be remnants of a ventilation scheme (blue arrow)

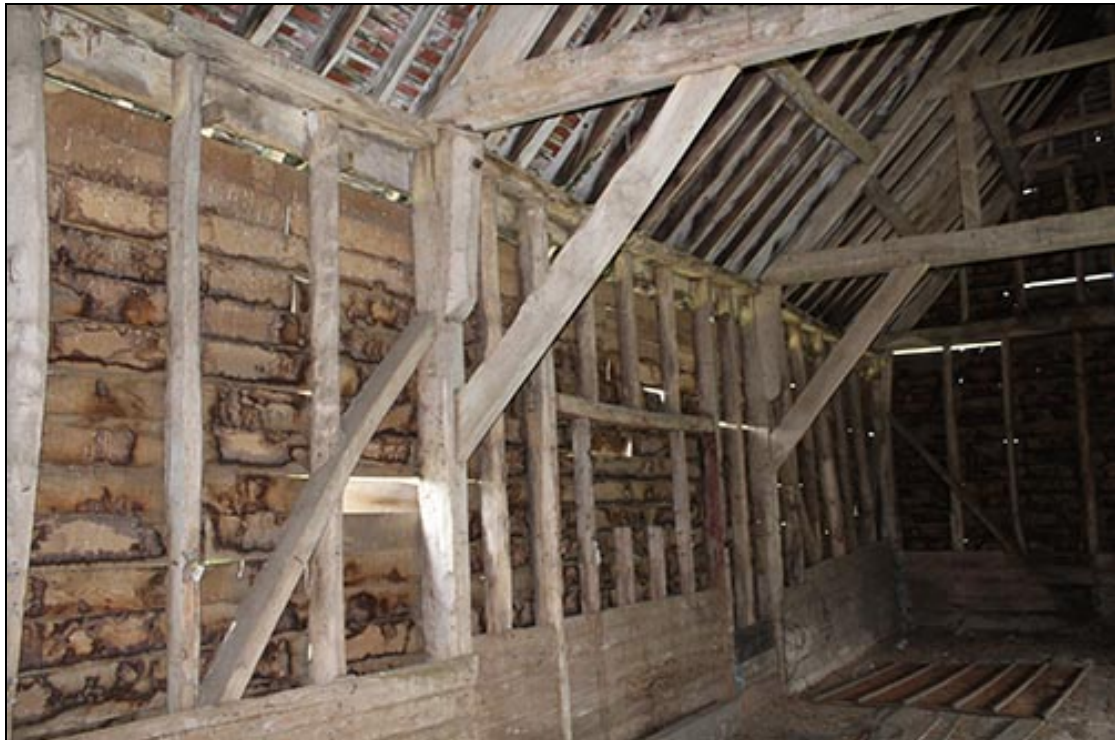
**Figure 15** The south wall of the Threshing Barn looking west and showing the surviving elm boards just below the wall-plate, together with the infilled south door in the central bay

5. A second phase of alterations occurred in the second half of the 20<sup>th</sup> century when the rear southern doorway was infilled with studwork and some softwood tongue and grooved boards fitted across it internally (see Figure 15). Finally in 2006/7 the external softwood weather-boarding was replaced with oak feather-edge boards.

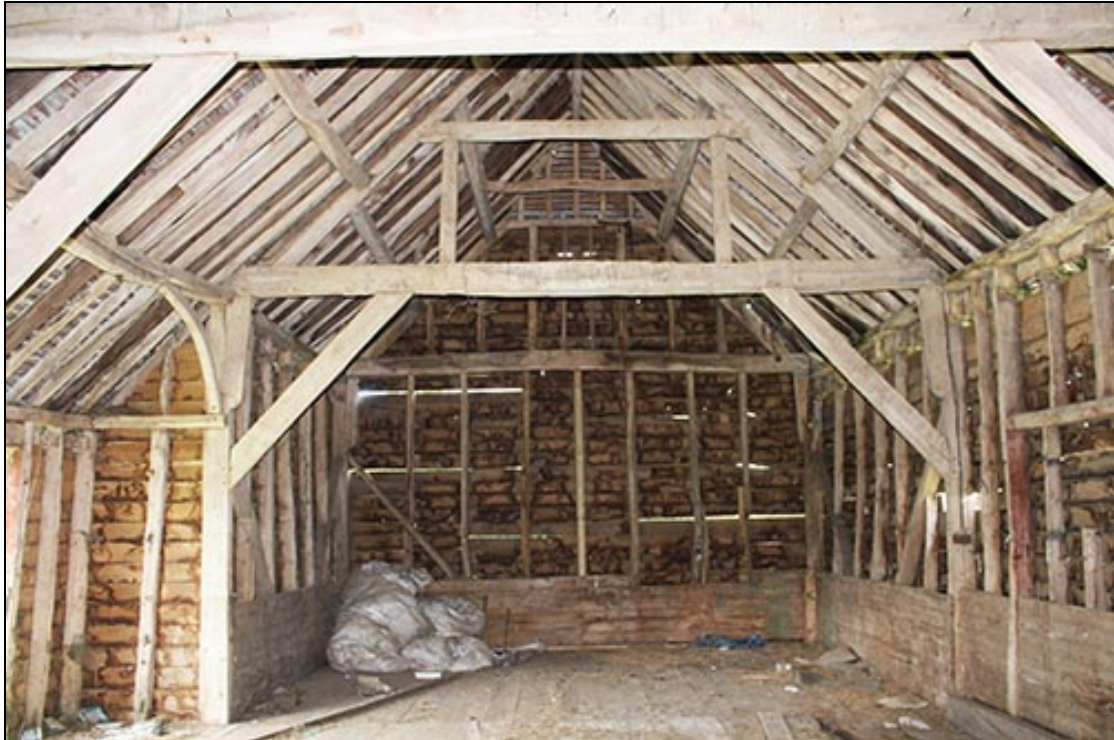
4. The first phase of alterations, probably in the late 19<sup>th</sup> or early 20<sup>th</sup> century, was for the insertion of softwood collars in the roof-space between the cross-frames to resist the bending of the purlins. Softwood rafters were also inserted alongside the existing oak rafters to further reinforce the roof. In addition the original beech internal boarding was replaced in the eastern bay using softwood tongue, groove and beaded boards and the external cladding likewise replaced with new softwood weather-boarding. The wall-plate in front of the porch, clearly bowing, was reinforced using two nailed on arch braces and a large timber fixed to the soffit.

**Figure 16** Interior of the Threshing Barn looking east showing the frame construction and the softwood boarding on the lower walls that replaced the earlier beech boards of the eastern bay in the late 19<sup>th</sup> or early 20<sup>th</sup> century. One of the additional collars between the purlins can be seen in the bay roof above, as well as the additional rafters. To the left can be seen one of the arch braces and the timber affixed to the soffit of the northern porch

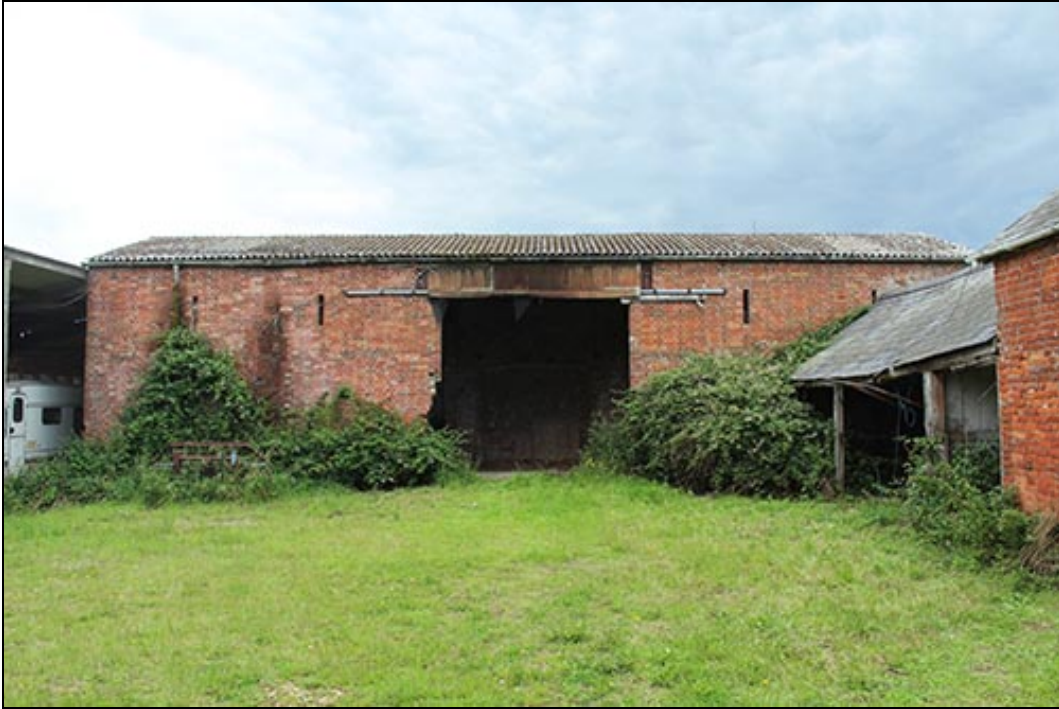
**Figure 17** The east elevation of the Brick Barn

2. This new brick barn is of five bays, totalling 17.4m in length and 6.1m in width, with opposing doorways in the central bay; the western of these being infilled with blockwork in the later 20<sup>th</sup> century. Both doors exhibit signs of vehicle damage, with their lower jambs broken away and only then repaired on the southern jamb of the western door. The external walls, which include four high-level ventilation slots in the east and west elevations, are largely of Flemish Garden wall bond, while the internal walls are in irregular bond.

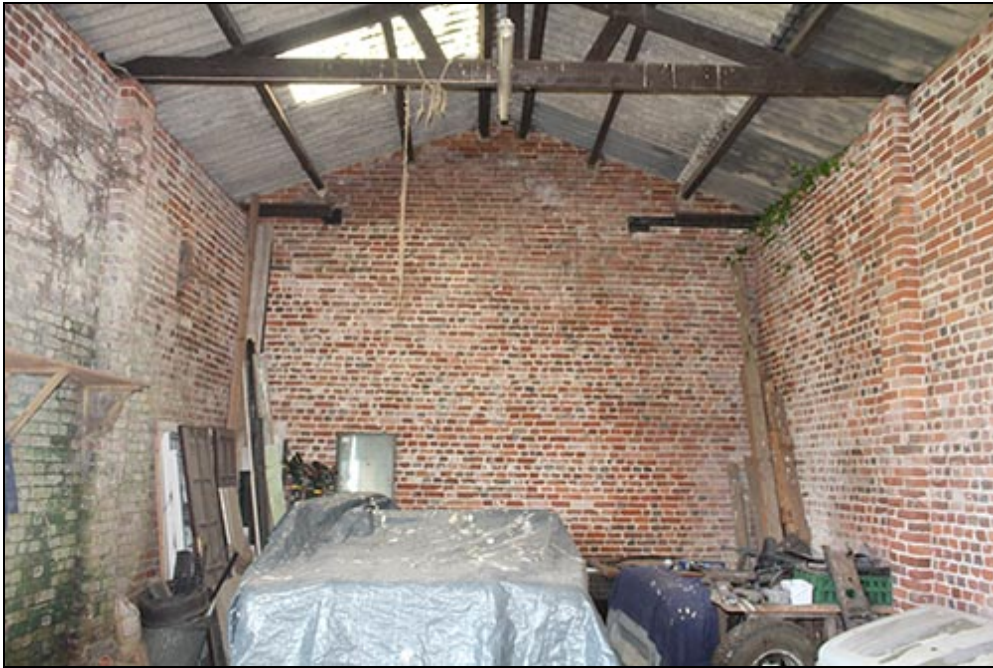
**Figure 19** The interior of the Brick Barn, looking south

3. The original roof of the Brick Barn is now lost, apparently as a result of a fire in the late 20<sup>th</sup> century, but it was reputedly thatched with a steeper pitch than its replacement, which is of corrugated sheets supported by softwood roof trusses and purlins. Modern anchor plates with tubular tie rods have also been inserted under the two central pairs of modern trusses to provide support to the walls. The earlier roof trusses were supported on brick pilasters projecting from the internal side walls. Charred timbers set high in the gable ends may also be related to this earlier roof structure, although it is not clear as to how.

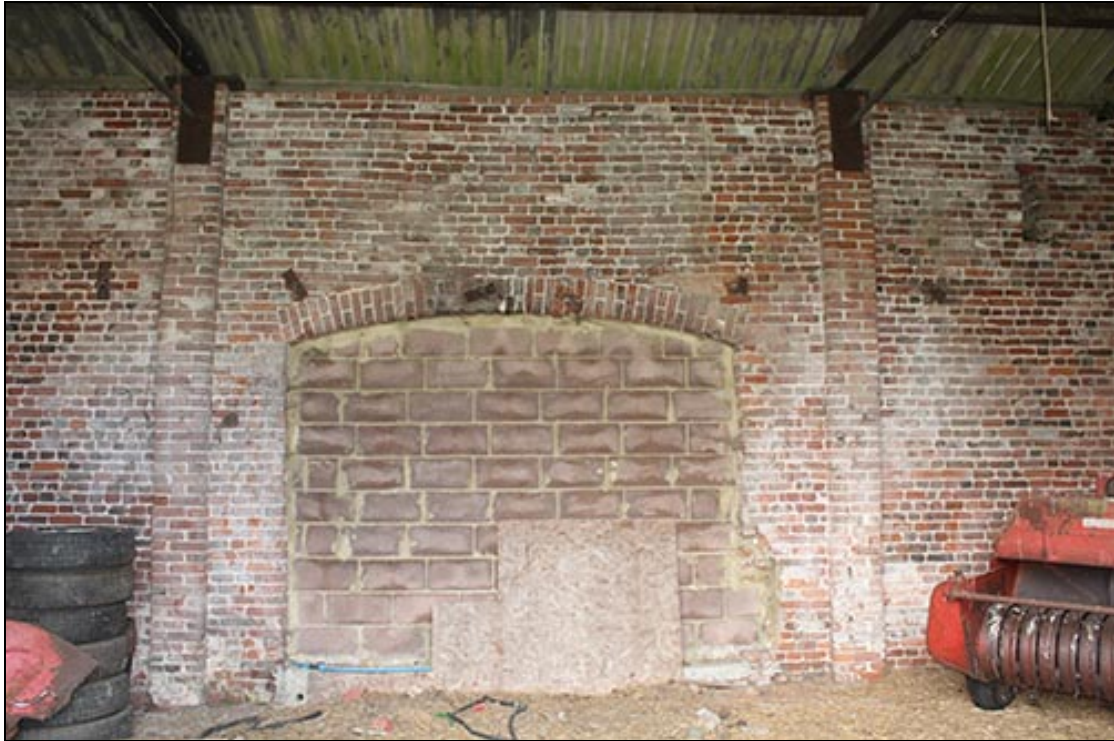
4. Five rectangular anchor plates with square nuts inserted through the west barn wall above and either side of the west barn door suggest that a lean-to was attached on this side, probably of only short duration, at some time between 1871 and 1897.

**Figure 21** The infilled west door of the brick barn showing the five anchor plates in a row above

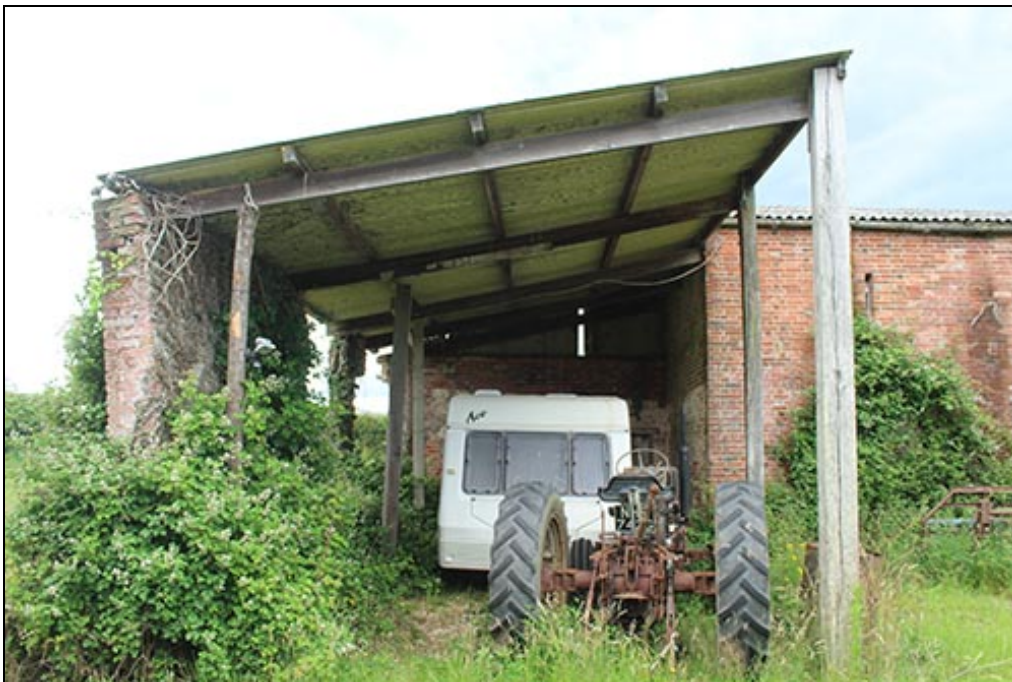
**Figure 22** The Lean-to looking west

1. Attached to the south end of the Brick Barn is a lean-to composed of two brick walls on the western and southern sides, the latter partially collapsed, and open to the east and part of the north. It is covered by a low-pitched corrugated sheet roof. The roof and timber supporting posts are modern, however the brick walls are clearly older.

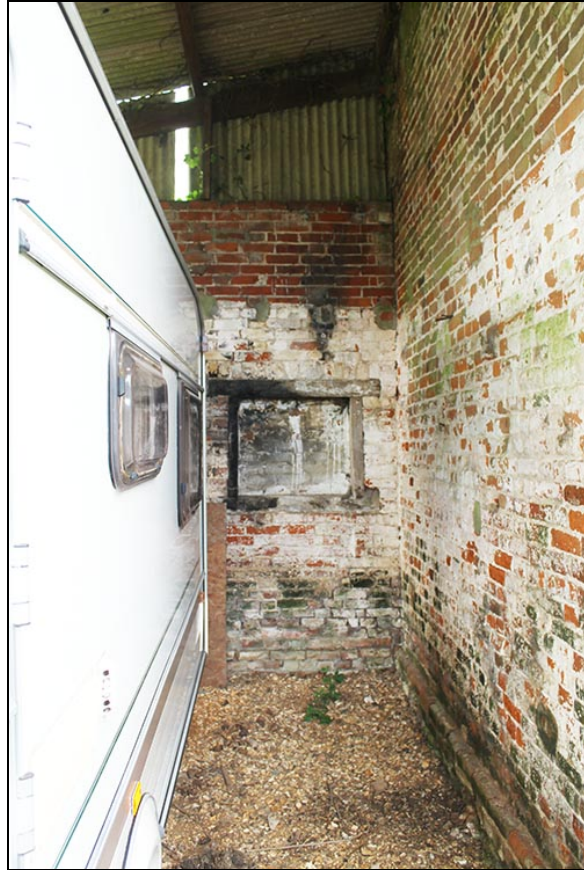
3. By 1839 this stable block had become attached to the brick barn to the north. The surviving brick wall that forms the western wall of the existing lean-to is clearly part of this link and is in irregular bond set in a lime mortar. Towards its northern end is a window with timber lintel, infilled with bricks again in lime mortar. Its southern end would appear to have butted up against the earlier stables to the south. A row of infilled slots in the brickwork internally would suggest that it was floored, with the walls of the lower space whitewashed, as is evidenced by traces still surviving.

**Figure 24** The interior of the Lean-to looking west towards the blocked window in its west wall; above can be seen the infilled sockets for the floor timbers.

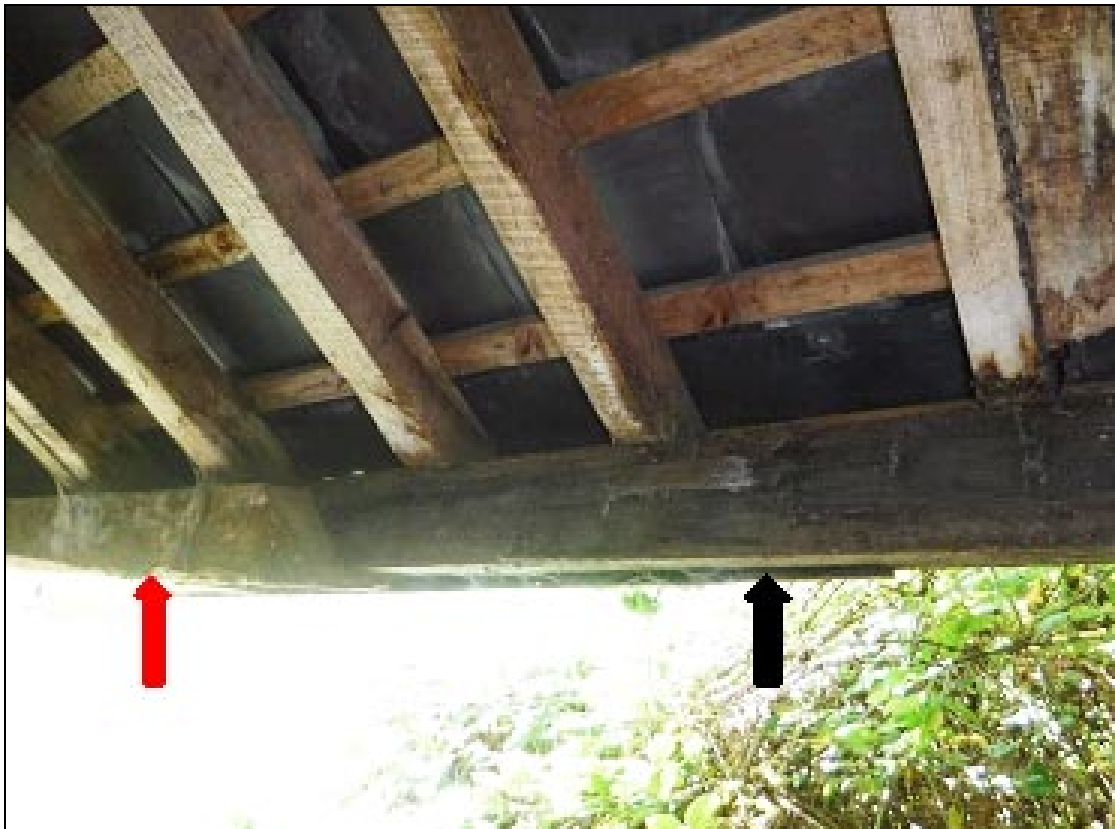
2. Sometime in the later 19<sup>th</sup> century its eastern bay was partially demolished, extended and re-built to form the Small Store, with the remainder of the eastern bay to the west partitioned off and floored with brick. In the mid-20<sup>th</sup> century the western part of the front wall-plate was repaired with a new section of timber, together with some of the rafters on the south elevation, with the overlying roof re-slatted. In the early 21<sup>st</sup> century further repairs were undertaken, again to the western part of the front wall-plate, although this time the adjoining stretch directly abutting the Brick Barn, and using a piece of former railway sleeper fixed to the earlier repair with a metal angle iron strap. A new western post was also added, again utilising a timber sleeper. The existing concrete floor may well have been added at this time.

**Figure 28** The west end of the front wall-plate of the Shelter Shed, showing the mid-20<sup>th</sup> century repair (red arrow) and subsequent early 21<sup>st</sup> century repair (black arrow)

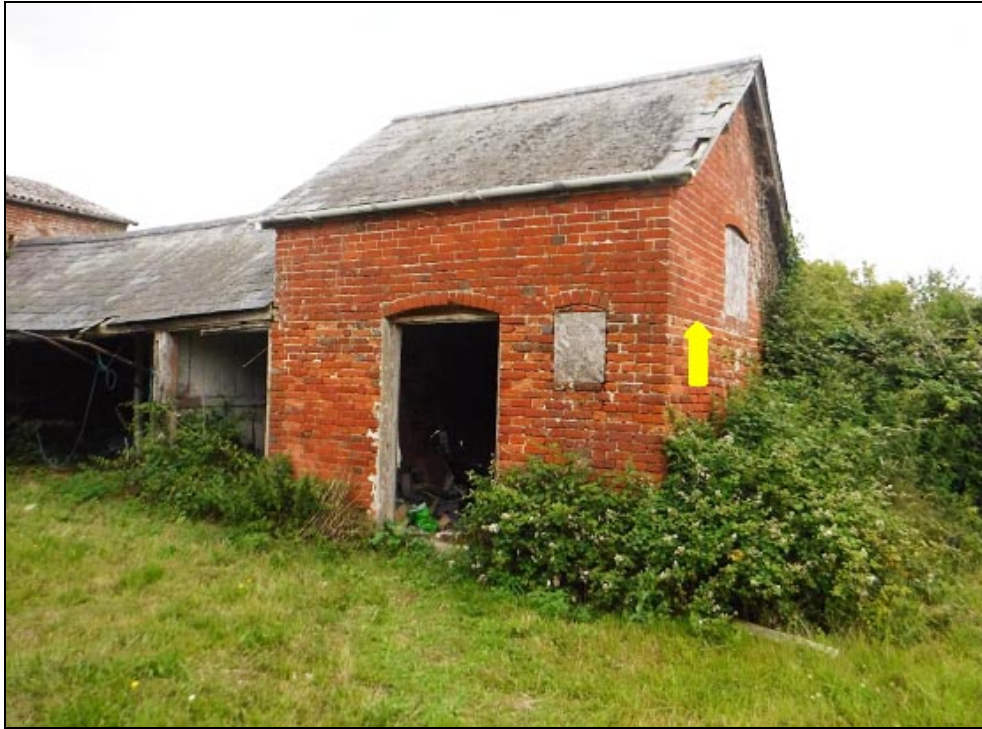
1. As state above, in the later 19<sup>th</sup> century part of the eastern bay of the Shelter Shed was re-built to form a small brick walled store. The location of its original windows and doorway are unknown, due to later re-modelling but are likely to have been in the south elevation. The roof was probably of slate to match the adjoining Shelter Shed.
2. In the early 20<sup>th</sup> century the walls of this store were raised, reputedly to house Shire horses. The existing south door and window date to this phase, as do a new window in the east elevation and a new door

**Figure 29** The Small Store looking north-west, with the height of its original brickwork indicated by the yellow arrow

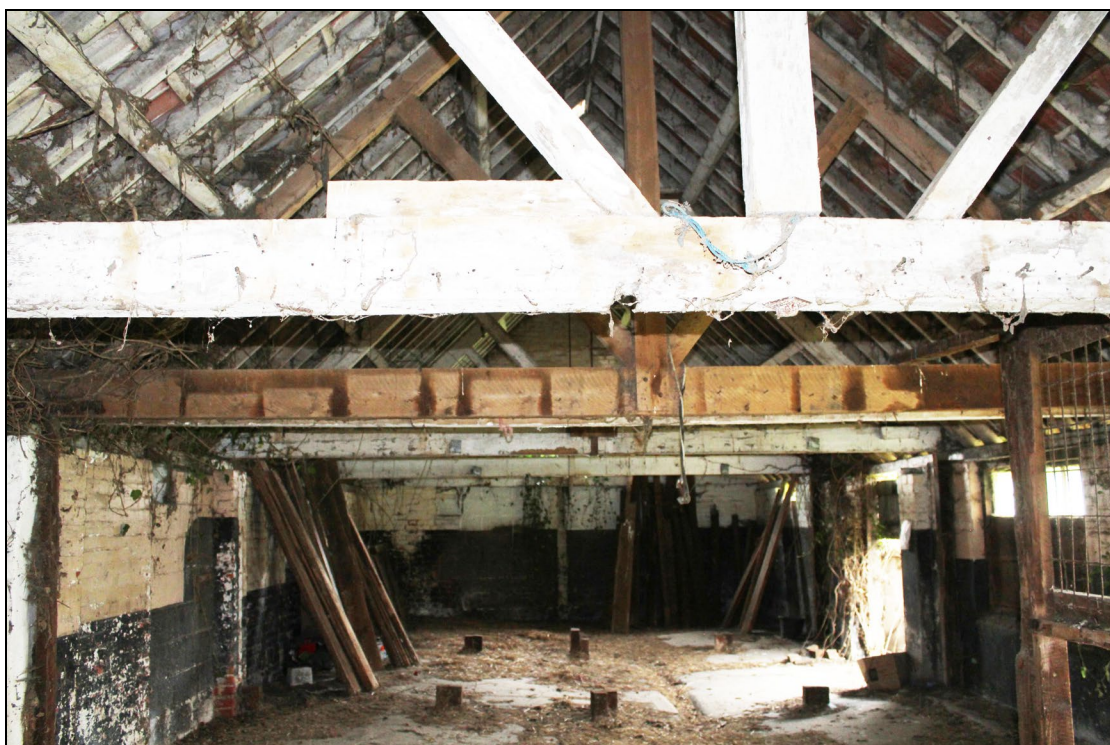
4. In the mid-20<sup>th</sup> century the eastern extension was demolished and replaced on the same footprint with a mass concrete-walled three-bay stable, with span of 5.25m and a corrugated sheet roof supported by softwood kingbolt trusses. At the other end, in the late 20<sup>th</sup> century, the roof truss at the junction between the original shelter shed and its western extension was replaced by a similar timber kingpost truss.

**Figure 33** The central (western part) and western blocks of the Stables, looking west. The division between the two is marked by the new truss (not painted white) that was inserted in the late 20<sup>th</sup> century.

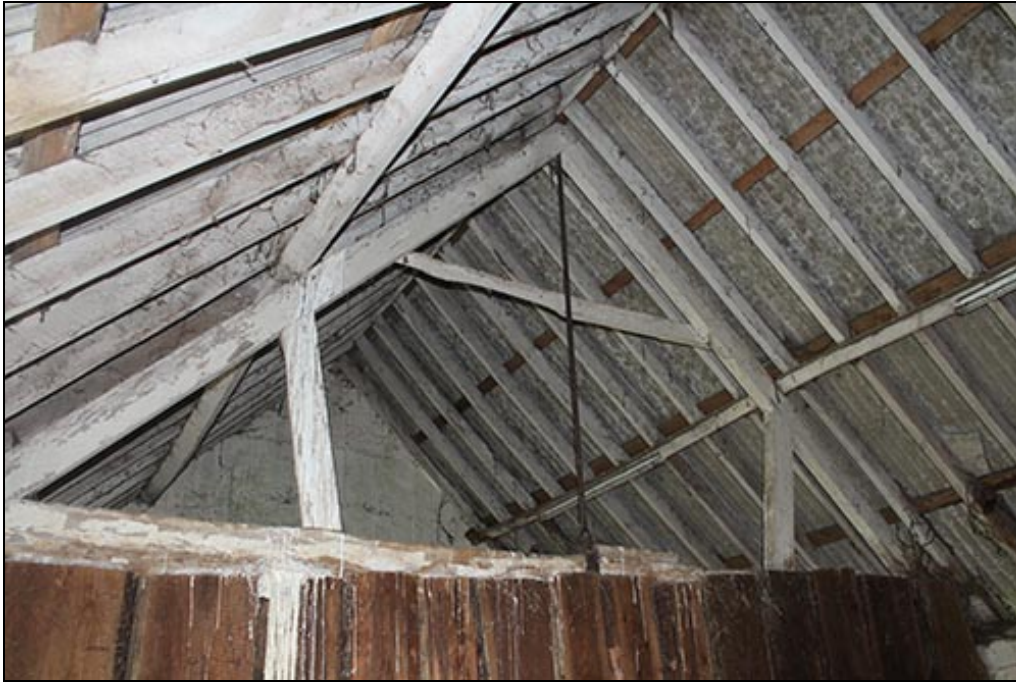
**Figure 34** A mid-20<sup>th</sup> century roof truss within the rebuilt eastern block of the Stables
