# Structural Condition Report

Middle Ripley Farm,  
Ripley

Project no.	12073
Project title	Middle Ripley Farm, Ripley
Client	Avon Tyrell Farms Ltd
Document title	Structural Condition Report

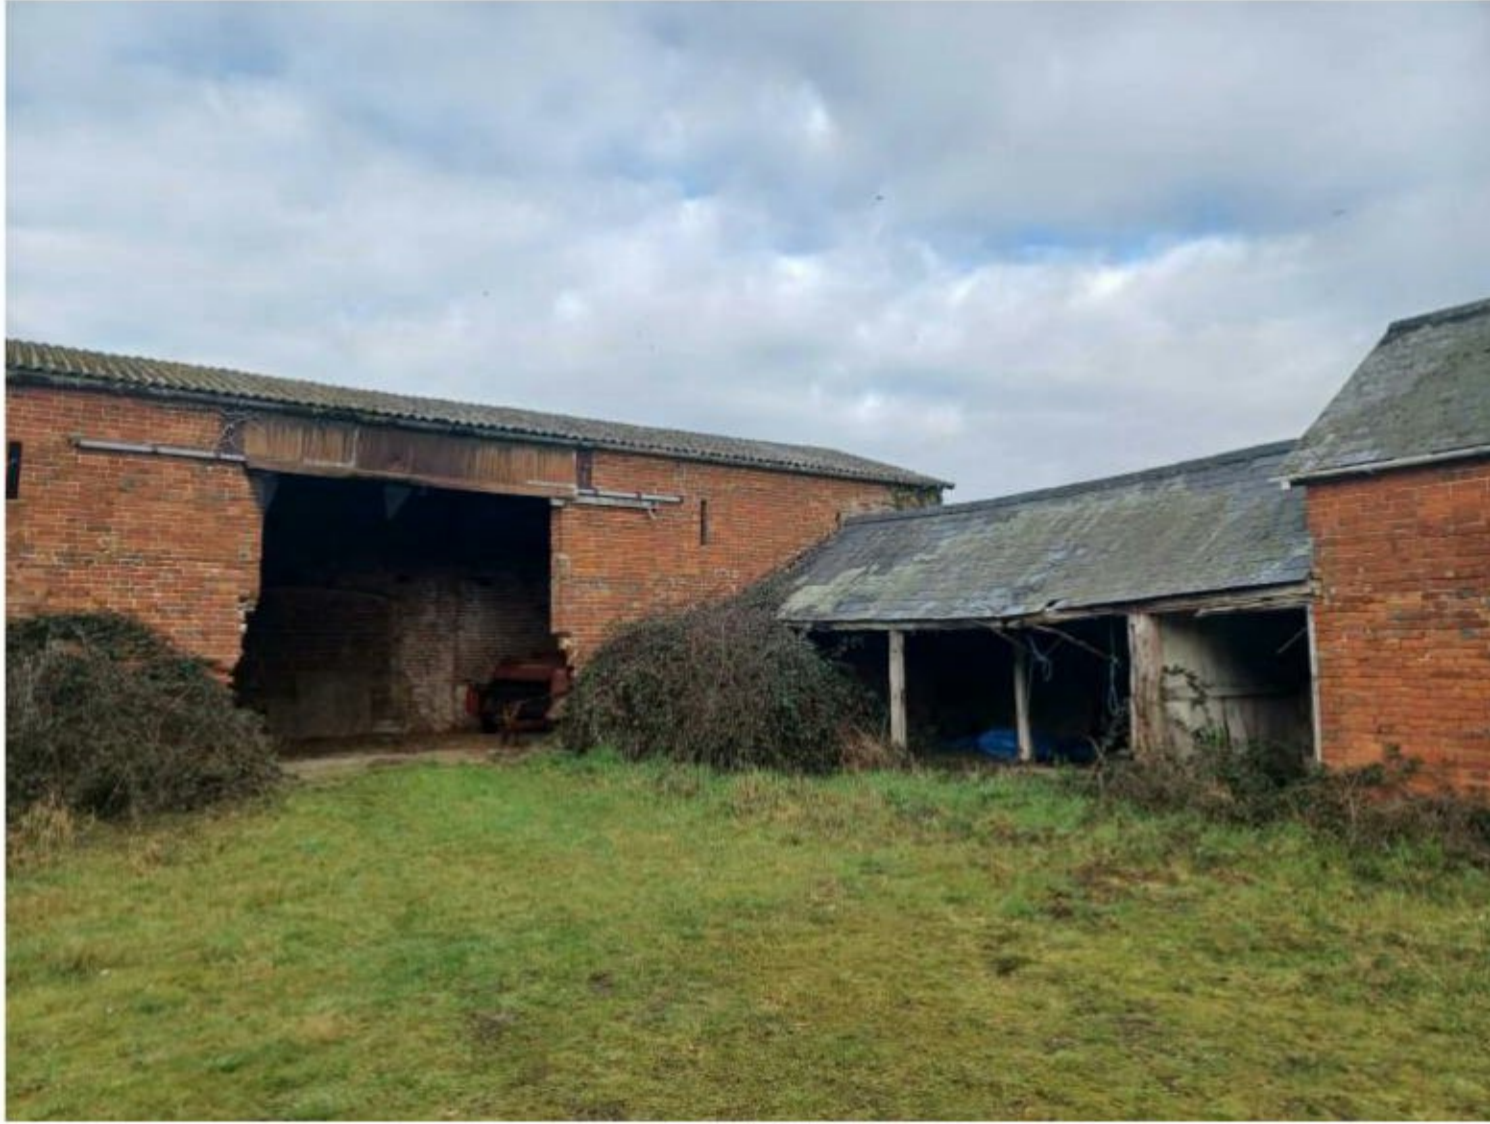
Figure 1 - Main Building

There is one large opening on the eastern wall, which was the main entrance to the barn, and appears to have suffered vehicle impact.

There is some algae and plant growth on the walls.

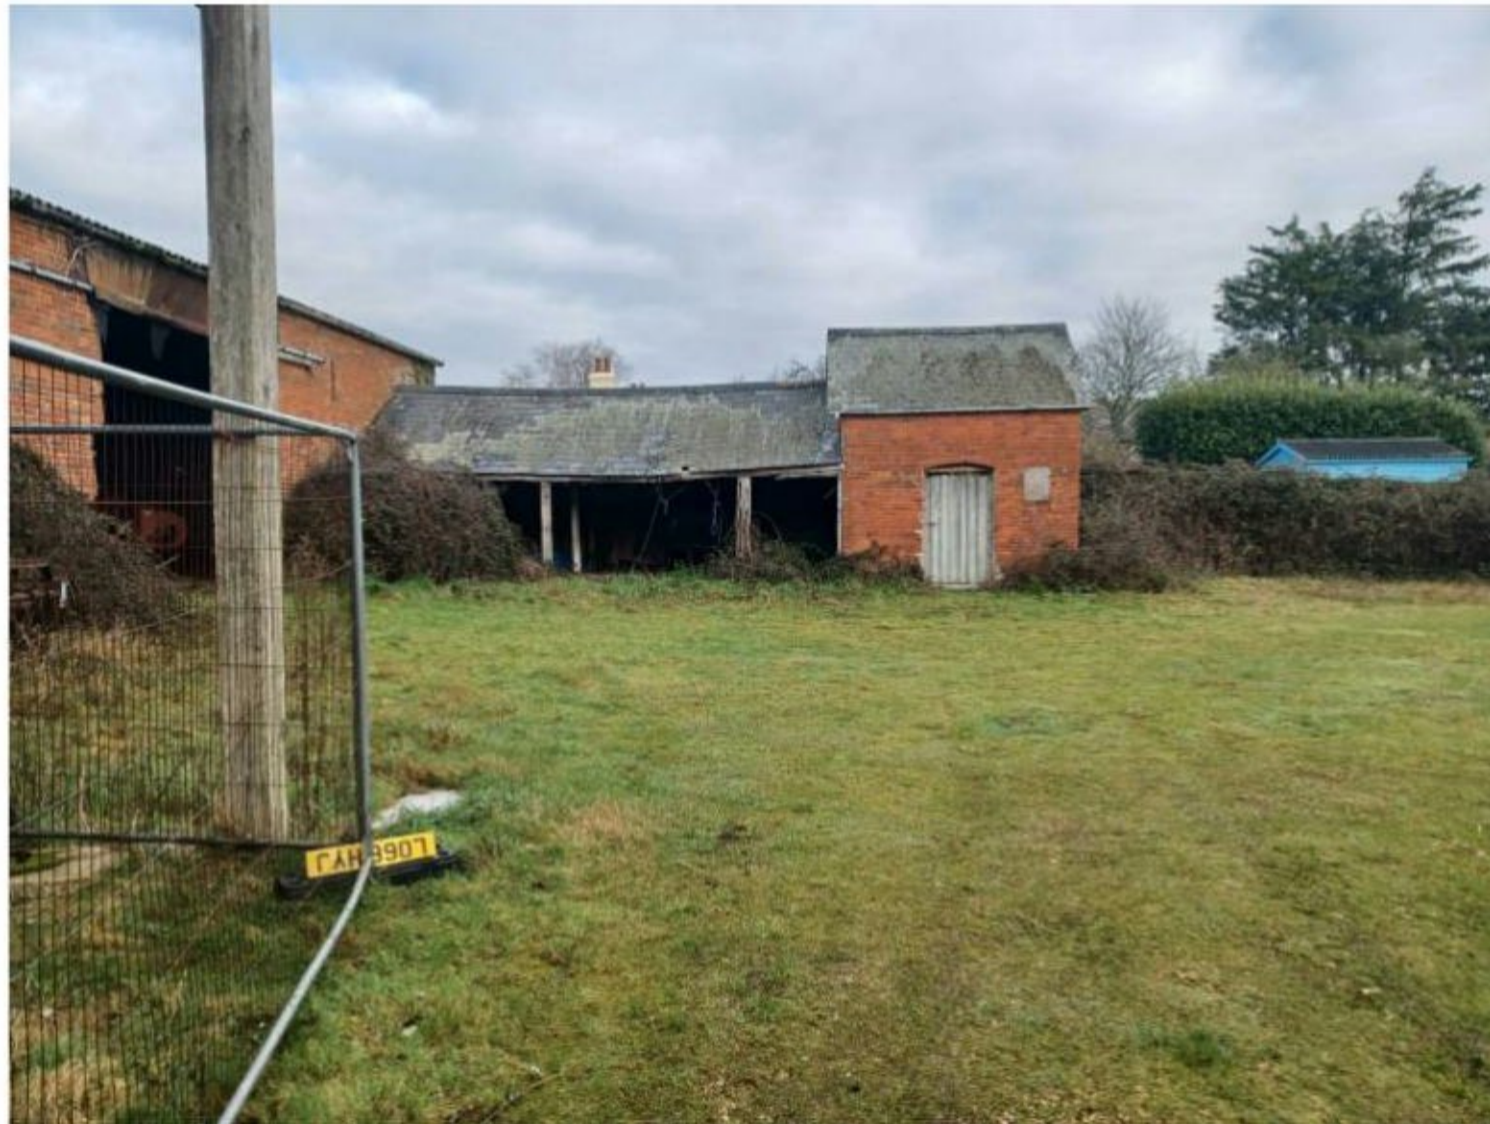
Figure 2 - Out Building

The roof to Barn A (Out Building) has suffered damage including damage and missing tiles plus rotting to rafter ends which will need replacing.

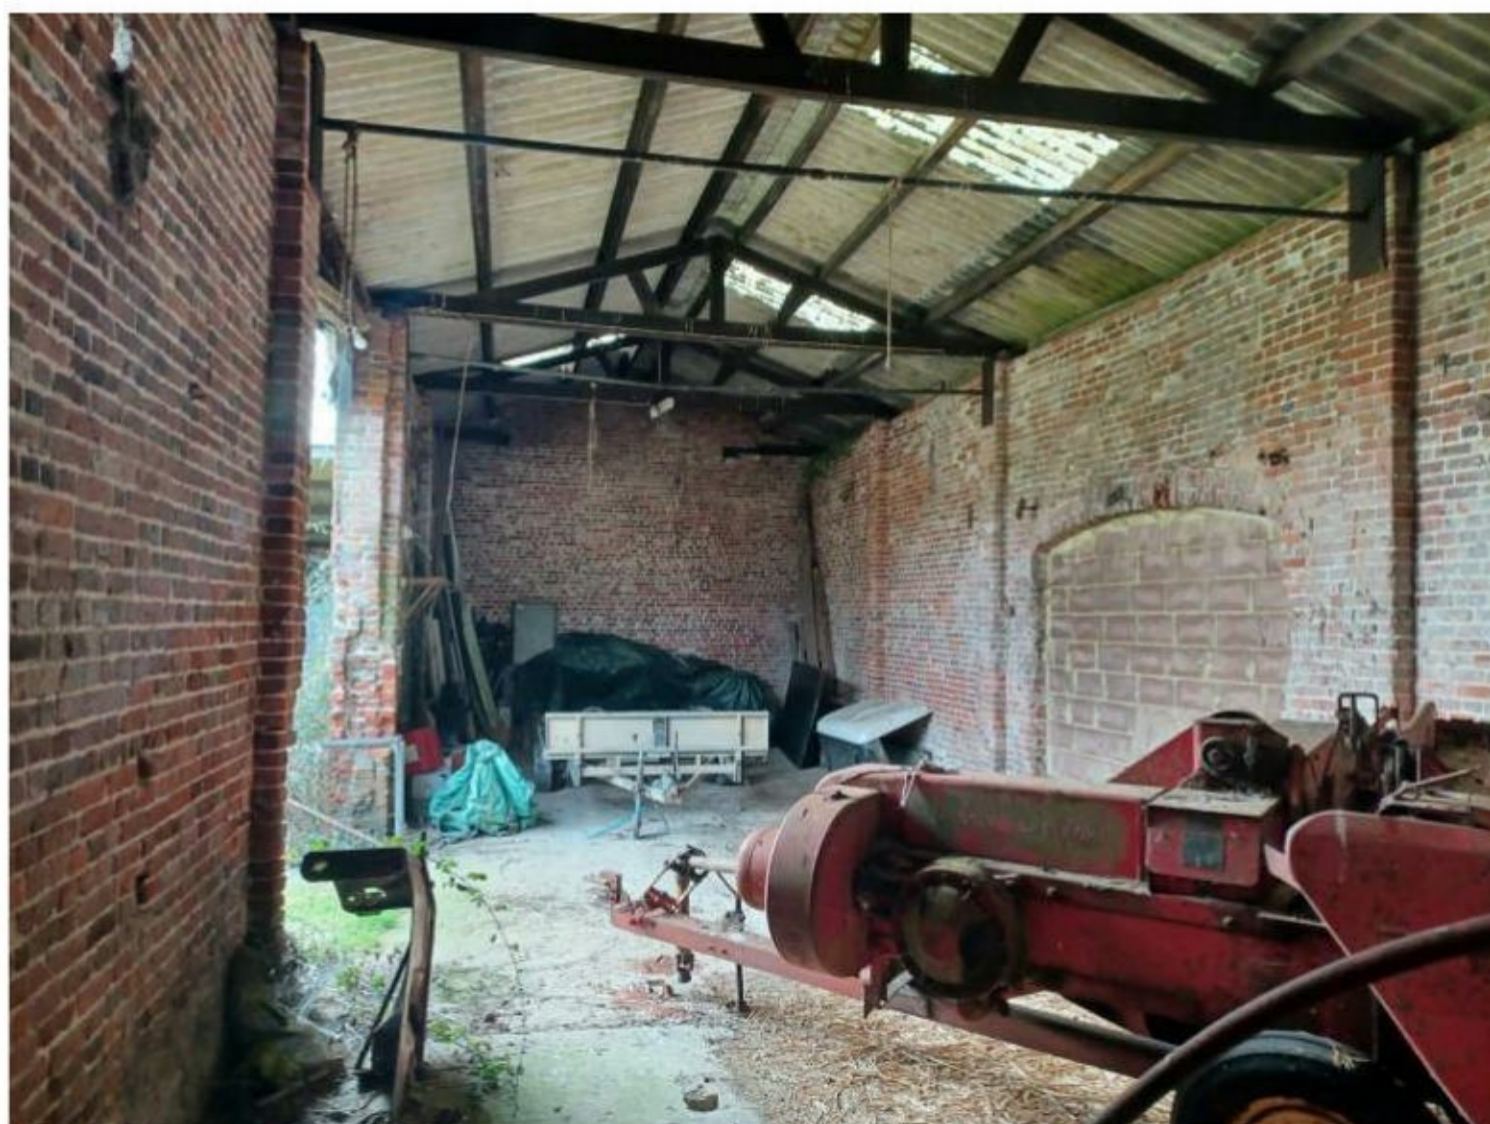
Figure 3 - Main Building  
(Internal)

The roof construction is a roof sheeting, potentially asbestos, which spans between timber purlins spaced at approximately 1.00m centres. The purlins in turn span between timber trusses. The trusses are at approximately 3.20m centres.

The gable walls are tied into the main side walls with an embedded timber restraint. Additionally there are two steel ties/restraints, at eaves, either side of the main door opening.

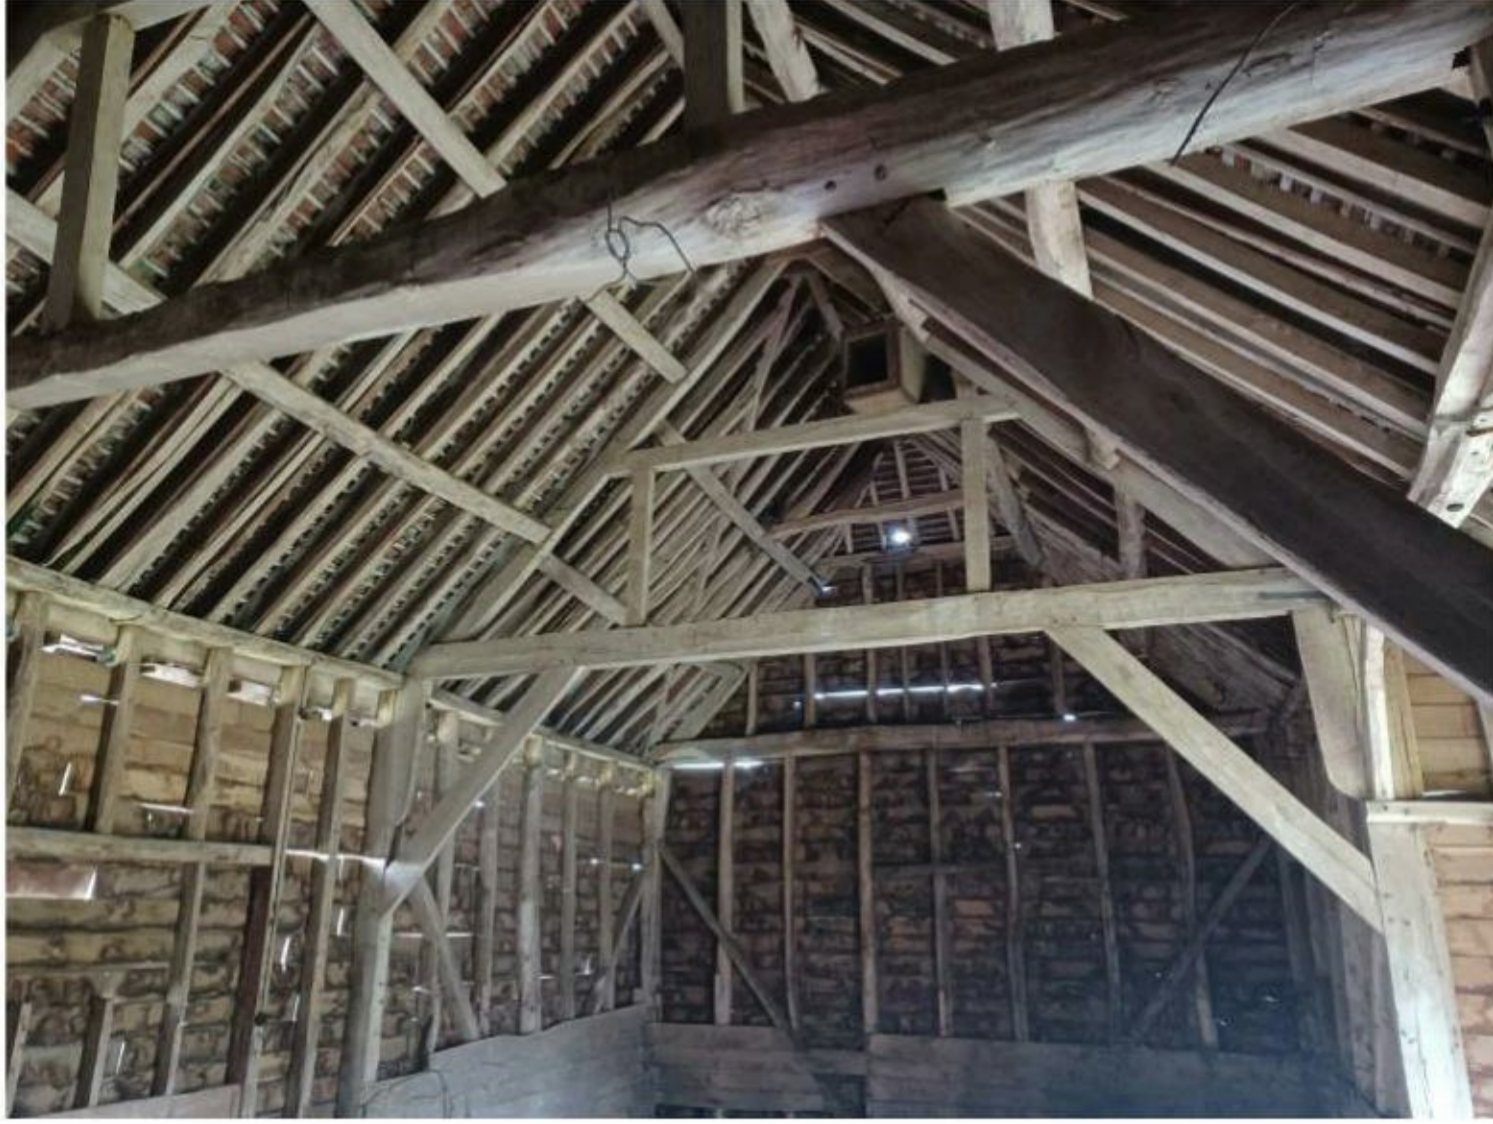
Figure 7 - Queen Post Frame

The roof construction is a clay tiled finish, timbers battens and timber rafters. The rafters are supported by timber purlins which span between timber 'Queen Post' trusses at nominally 4.00m centres.

There appears to have been some strengthening of the roof by the installation of additional/new rafters.

The 'Queen Post' trusses are supported by timber columns which are diagonally braced at eaves.

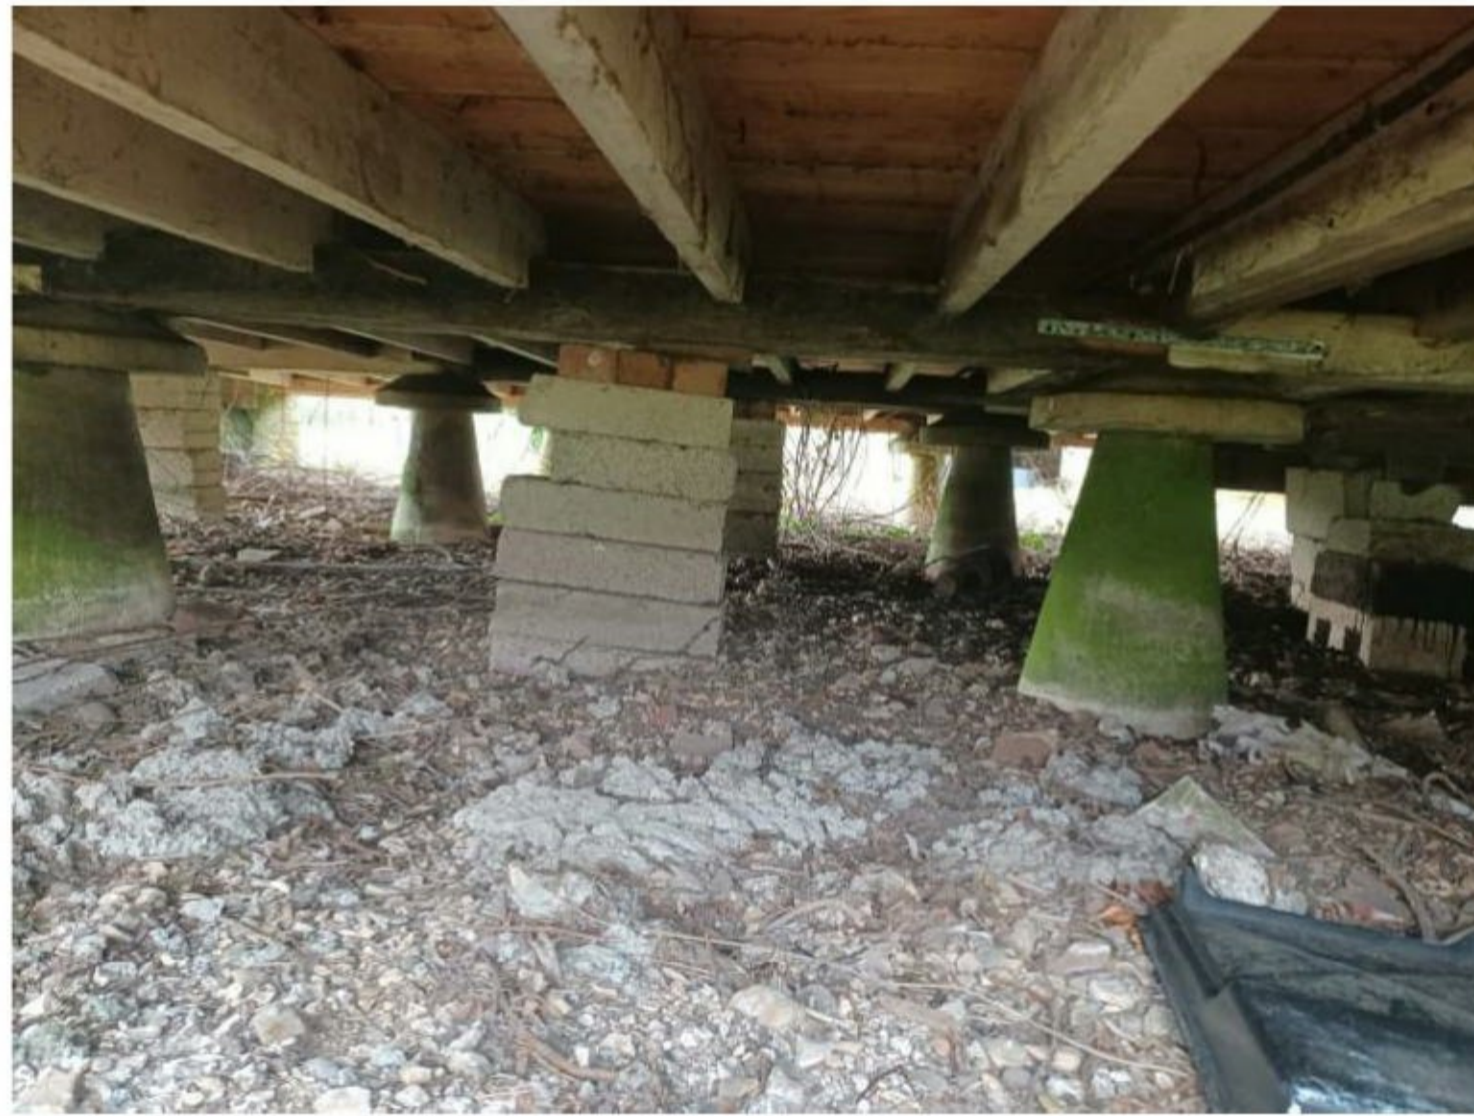
Figure 8 - Ground Floor Construction

The ground floor is a timber floor comprising heavy duty timber floor boards supported by timber joists.

The ground floor is raised off and the floor is supported by a regular grid of 'staddle stones'

The ground floor construction, generally will need to be reviewed in order to bring it up to modern standards of insulation and dampproofing.
