# Tree Work Application - Ellsall House, Ellerker, East Riding of Yorkshire

Date – 21st March 2021 Report by Mark S Feather BSc M Arb (RFS) Tech Arbor A MICFor

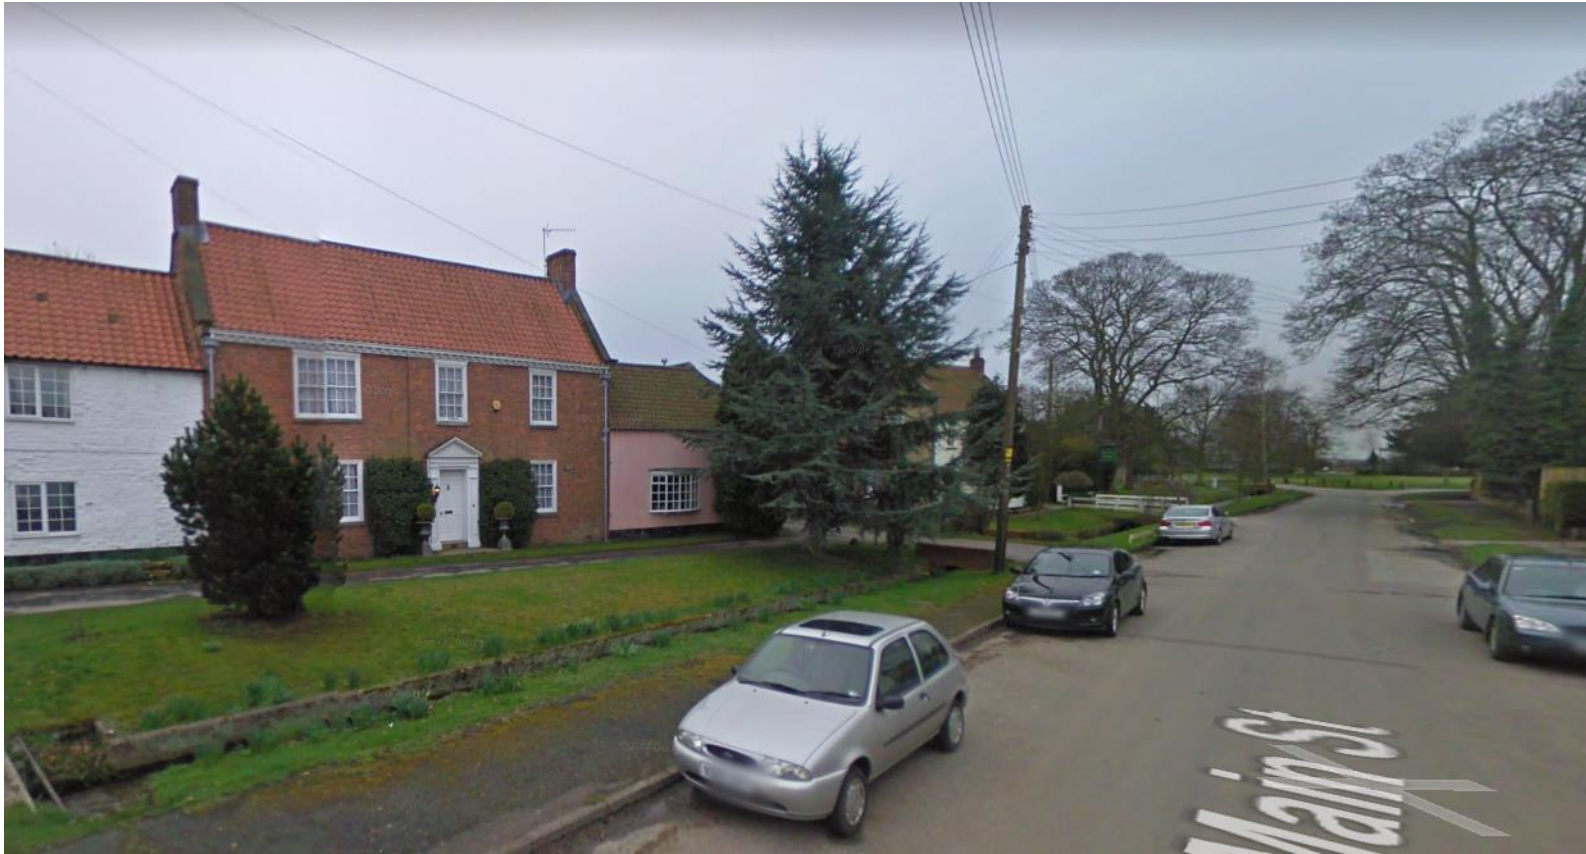
**Photograph 1 – View from Main Street**

The Cedar tree is located close to the front of the property and the reason for wishing to remove the tree are:

- Location of the tree tight to the front of the property and its ultimate size
- Problem with the branches in the crown of the tree interfering with overhead wires
- Concerns over the roots of the tree causing problems with the banks of the stream

Tree no	Species	Height	Stem Dia RPA	Branch Spread	Age class	Condition	Management Recommendations
T1	Cedar	14m	400mm	6m	M	Good	Remove
