# **Tree Safety Assessment and Report**

**3 Midgley Close Stamford Bridge East Yorkshire  
for Mr P Hyndman**

**June 2021**

**RICHARD LANCASTER: TREES & LANDSCAPE  
ENVIRONMENTAL CONSULTANCY**

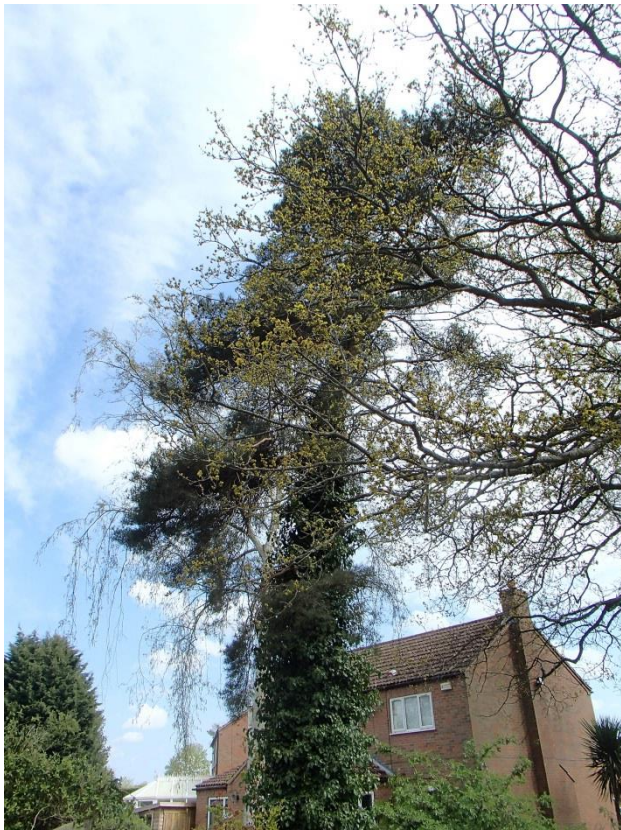
**Photo 1:** T1 Ivy-clad Scots Pine

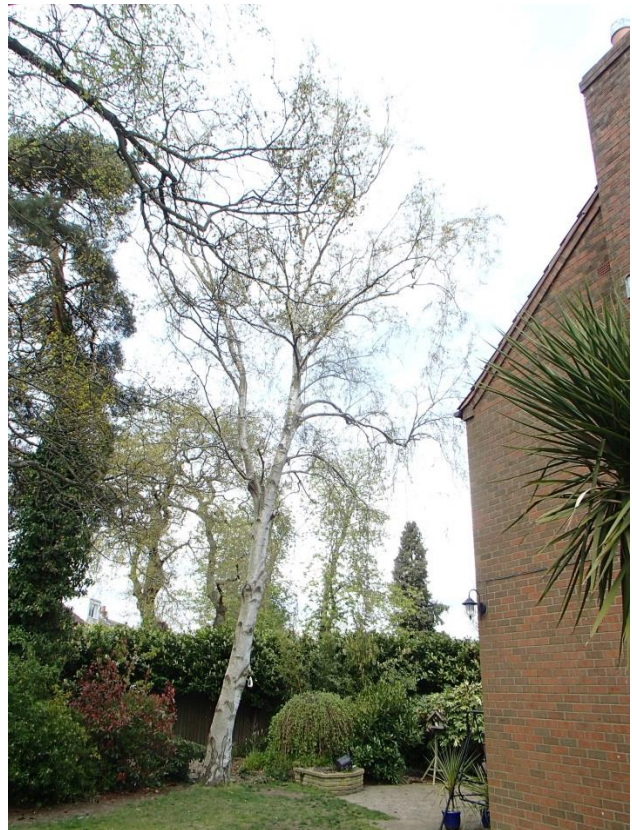
<b>Tree Schedule DRAFT</b>									
Tree No.	Species	Approx. Ht (m)	Approx. Diam (mm)	Crown Spread (average)	Life Stage	Physiological and Structural Condition. <i>Preliminary Management Recommendations</i>	Risk Assessment	Photo Ref.	
T1	Scots Pine <i>Pinus sylvestris</i>	15	450? (Ivy)	4 to 6m	M	Good foliage condition above Ivy clad stem, restricting a full inspection. Stem slightly twisted, and high level form is fair but compromised as typical of the species.  <i>No obvious safety issues; suggest Ivy is cut and removed/allowed to fall away, before another inspection check. Crown lift to 6m if desired, to open up space beneath canopy. (TPO approval for live wood)</i>	Very Low	1, 2	
T2	Silver Birch <i>Betula pendula</i>	18	425	8m	M	Weakest crown of the 3 Birch in the garden, with minor deadwood present. Small hanging branch above patio. Small hole at ground level into base of stem, north side, not extensive at present.  <i>No immediate safety work absolutely recommended though hanging branch and deadwood could be removed, if accessible.  Suggest this tree is chosen as first to be 'managed out' after new tree planting in northern corner of garden. (if so; TPO approval required)</i>	Low	2, 3

**Photo 2:** T2 Silver Birch, T1 to left, rear

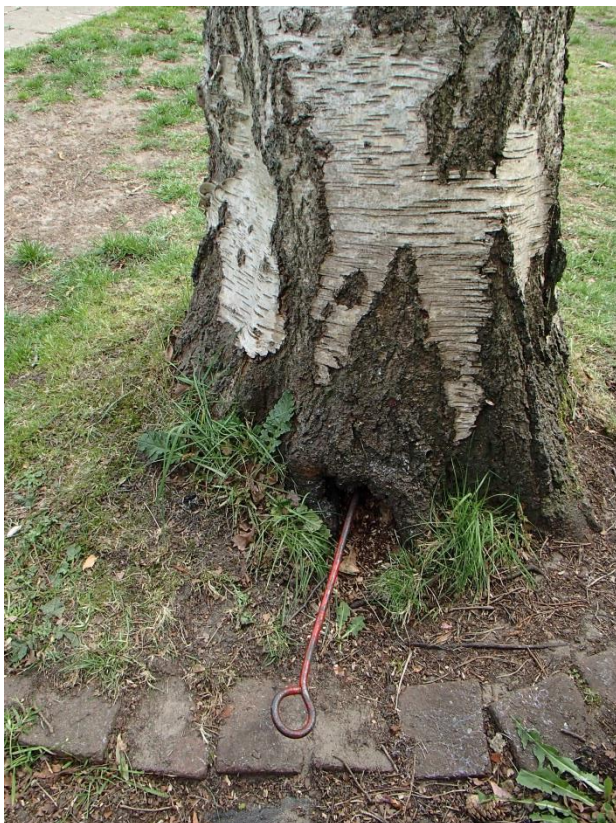
**Photo 3:** T2 Silver Birch, small cavity in stem base

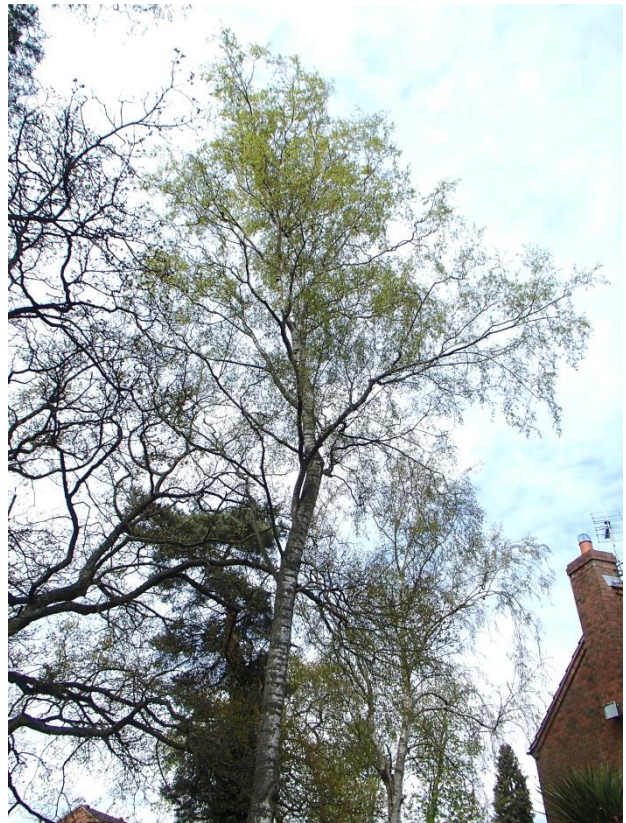
**Photo 4:** T3 Silver birch, upper canopy, T1 behind

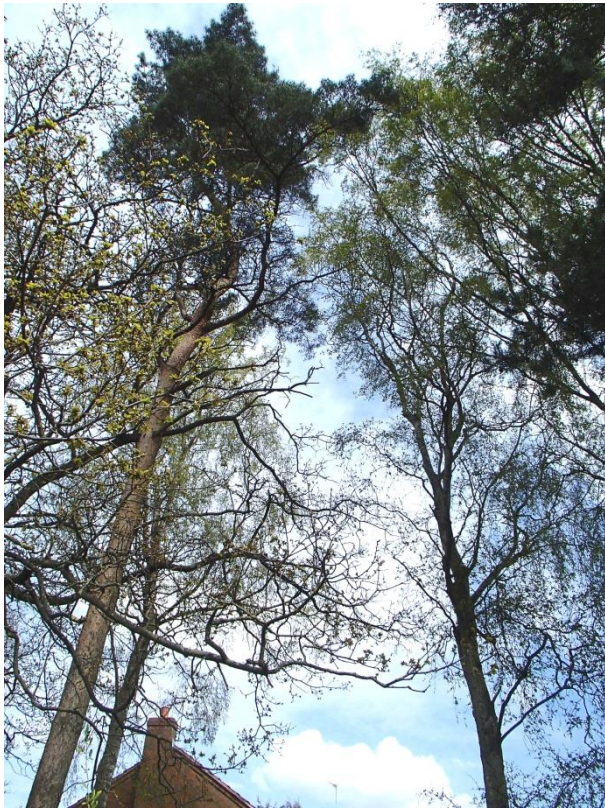
T3	Silver Birch <i>Betula pendula</i>	20	375	6 to 8m	M	Fair form and condition, reasonable canopy health. Strongest of the 3 Birch in the garden, but some minor deterioration is evident, probably as a result of the proximity of the house and other trees.  <i>No immediate work suggested (remove a rope causing constriction).</i>	Very Low	4	
T4	Scots Pine <i>Pinus sylvestris</i>	18	350	4 to 5m	M	Very small and high canopy, apparently sound and healthy. Slight stem twist at approx 12m. Typical, low, dead branches and stems.  <i>No immediate work suggested. Crown lift, removing dead branches, if desired. (TPO approval not required for deadwood)</i>	Very Low	5, 8

**Photo 5:** T4 Scots Pine to left, T5 Silver Birch to right.

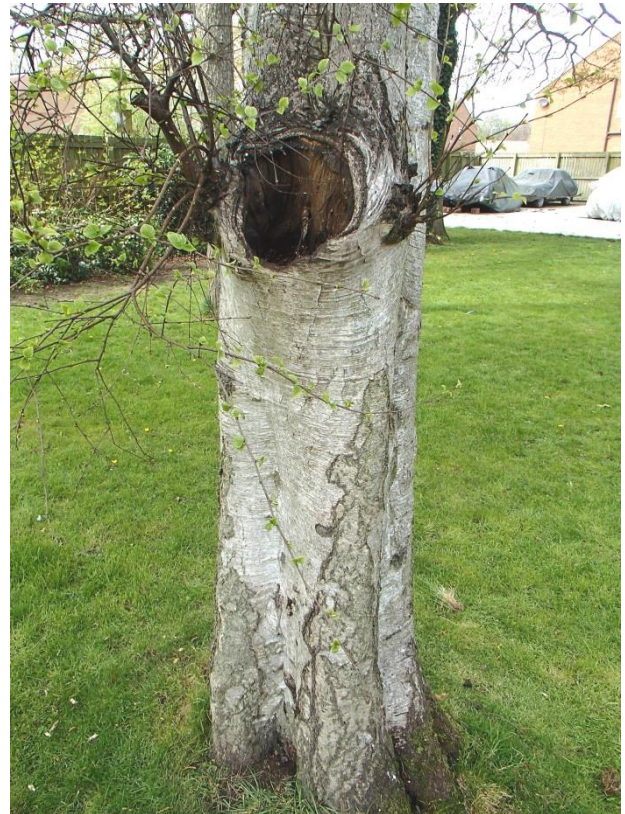
**Photo 6:** T5 Silver birch, cavity in centre of stem.

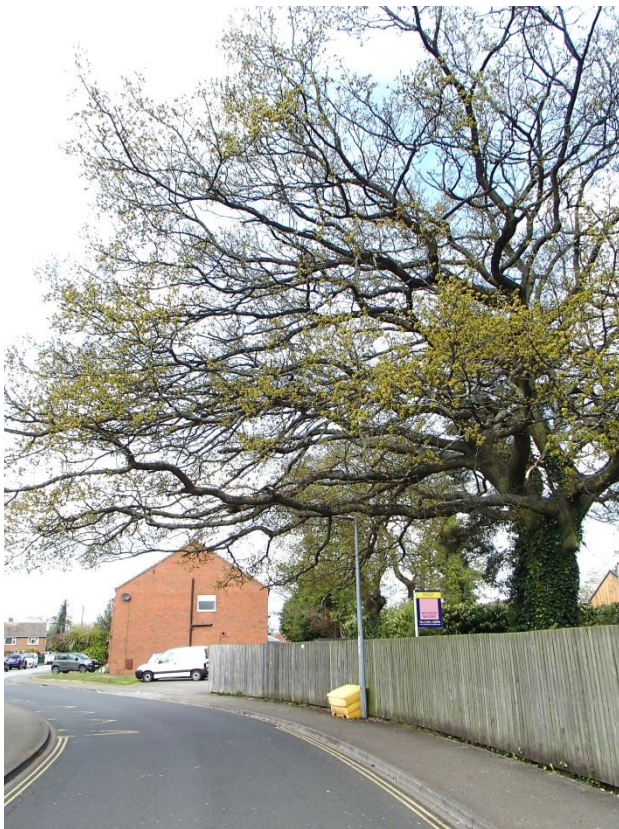
Of most concern is the Oak T6 which carries a fair amount of deadwood and which is obviously located close to where children will pass on the pavement. Even some of the live growth is relatively low over this pavement and evidence of ‘pruning’ by passing vehicle can be seen. A simple crown clean removing just deadwood is the easiest operation and does not require TPO approval, but a more extensive programme of crown lifting and some thinning/reduction would be more practical; and more efficient in the longer term (but requiring TPO approval).

<b>Tree Schedule DRAFT</b>								
Tree No.	Species	Approx. Ht (m)	Approx. Diam (mm)	Crown Spread (average)	Life Stage	Physiological and Structural Condition. <i>Preliminary Management Recommendations</i>	Risk Assessment	Photo Ref.
T5	Silver Birch <i>Betula pendula</i>	18	425	4 to 6m	M	Fair canopy, with minor deadwood. Large hole in stem at 1.5m AGL from previous branch removal. Cavity and wood decline extends down the stem approx. 300mm, with some associated bark decline. Of concern, but not presently considered a major hazard. <i>No immediate safety work suggested. Consider as an alternative first option to remove and replace, or even include T1 and T5 for removal and replacement in one TPO application.</i>	Low	5, 6
T6	English Oak <i>Quercus robur</i>	16	950	20 to 24m	M	Very wide spreading canopy, low in places. Dominant and character tree. Canopy health appears to be fair only, based on this April inspection (i.e. the tree was not yet fully into leaf). Fairly extensive deadwood, up to medium size or even larger in places, including some present over the pavement and road, opposite the school. Overall health and vigour has probably been compromised by construction of the concrete surface which covers a good proportion of the Oak's root-plate. (Technically contravening the TPO) <i>Recommend a crown cleaning exercise to remove deadwood, crossing branches etc., allowing for up to a 10% crown reduction all around. Also recommend crown lifting to 4m clear above the pavement, including full removal of large limb to south west at 4m AGL and including appropriate rebalancing above the garden.</i> <b>(TPO approval required)</b>	Low/ Medium	7, 8, 9, 10

**Photo 7:** T6 Oak, from adjacent pavement and road (Godwinsway)

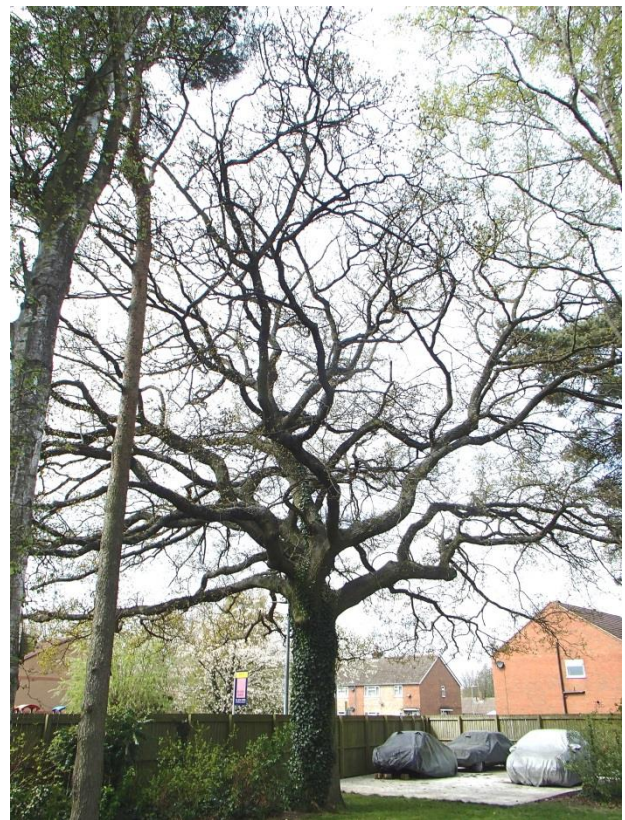
**Photo 8:** T6 Oak, from garden, T4 & T5 to left.

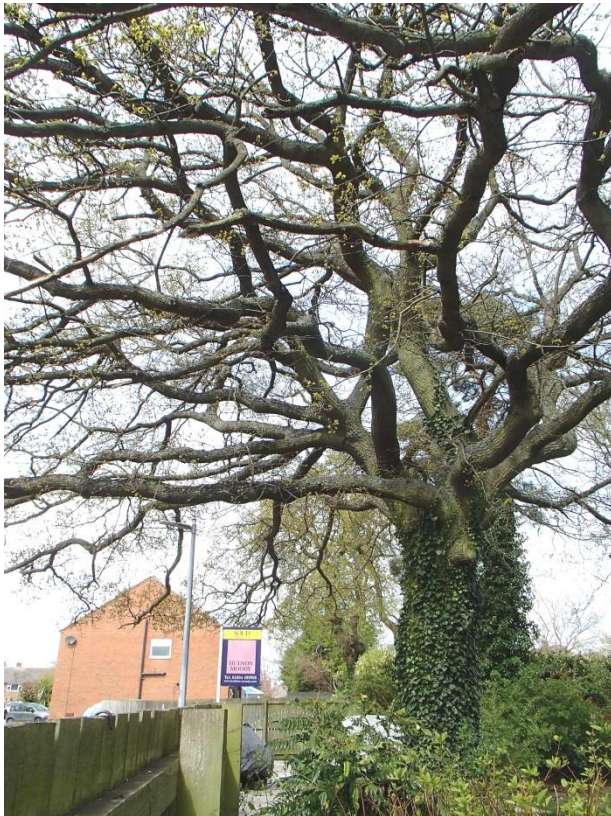
**Photo 9:** T6 Oak, against boundary..

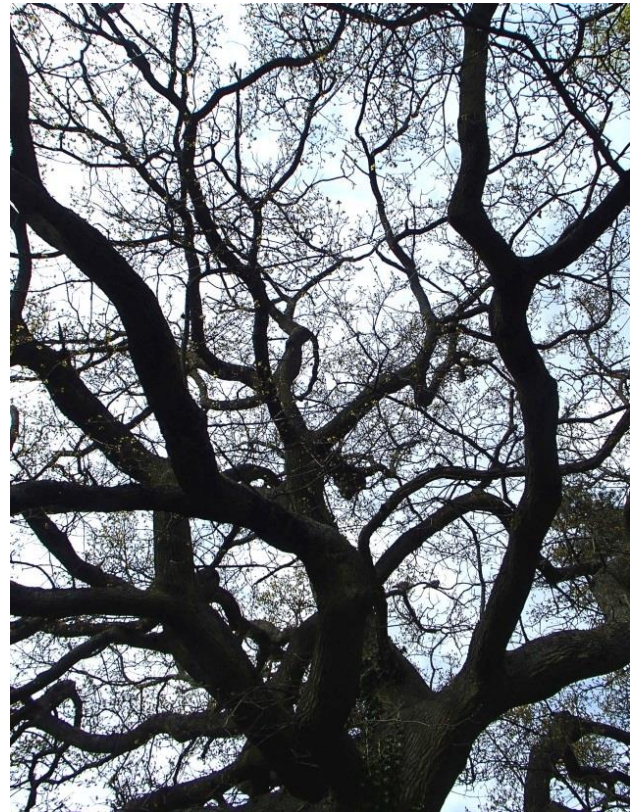
**Photo 10:** T6 Oak, canopy detail.
