Purpose of issue	
Project :	Church House, Wood Street ENS
Drawing Title:	Photographic Survey
Drawing No:	2964/ H /P4
Revision:	
Scale:	Date: June 2021
UPCHURCH ASSOCIATES	C/O 58 The Drive, High Barnet, Herts ENS 4JQ. www.upchurch-architects.com

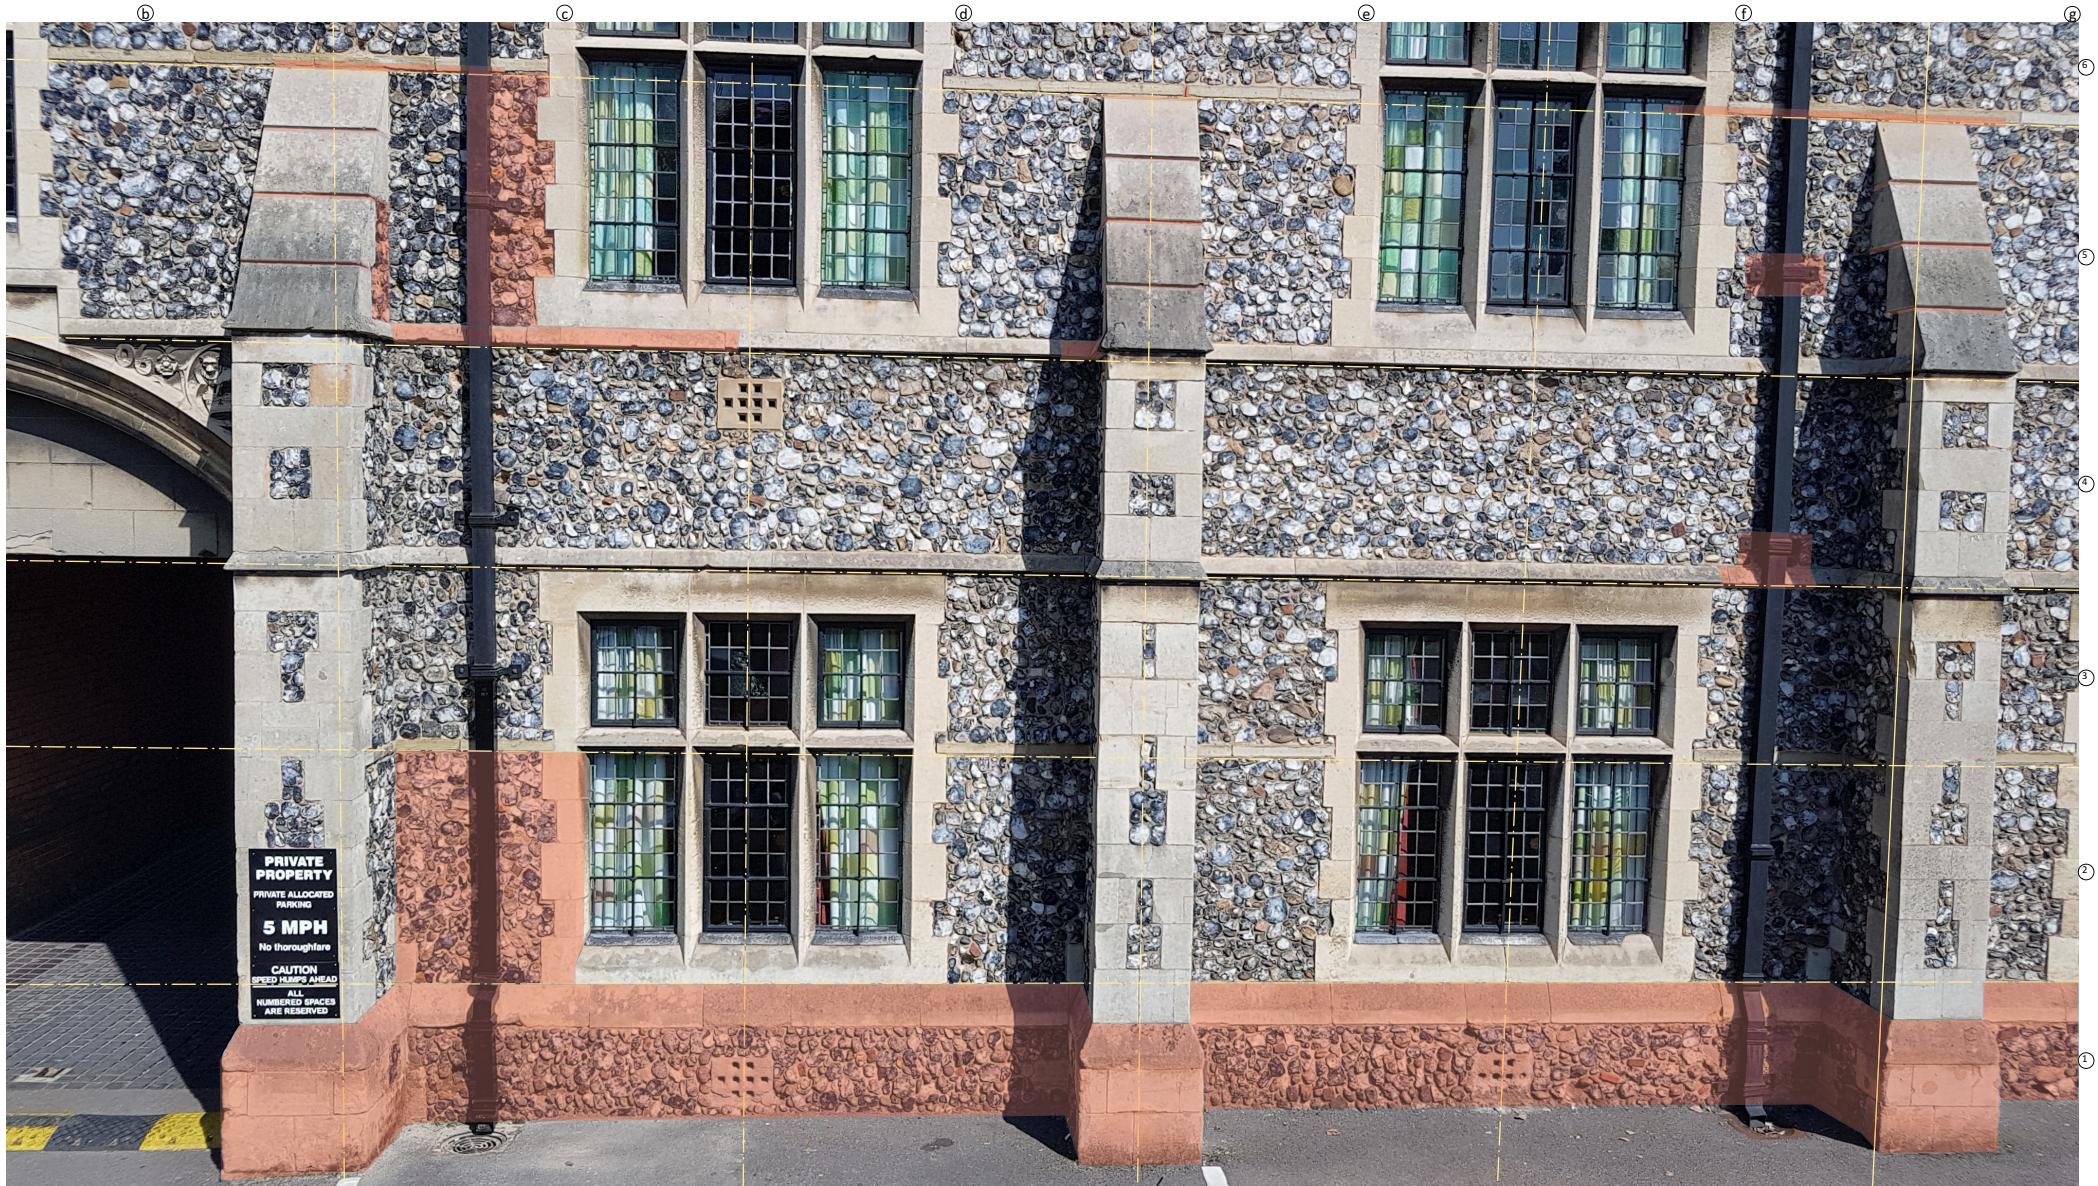
Plinth strip, Sector c1, d1, e1, f1, g1, h1

All Sectors: Investigate for loose sections of face-work

Pointing is worn back and existing aggregate to mortar too fine. Cut back pointing to firm substrate and re-point taking special care around pebbles used in this layer.

Re-bed some 7+ missing flints plus those disturbed by work in this area.

Point around fixings to downpipes.

point joints to chamfered plinth course.

Tamp back final pointing finish to expose flint edges.

Apply shelter-coat to 3 badly weathered ventilation stones.

Sector e3 new bath-stone indent to quoin block
full height of block on side face
