ARBORICULTURAL REPORT

**Park House Hotel
Bepton
Midhurst
GU29 0JB**

Arborsense Ref: Park House Hotel

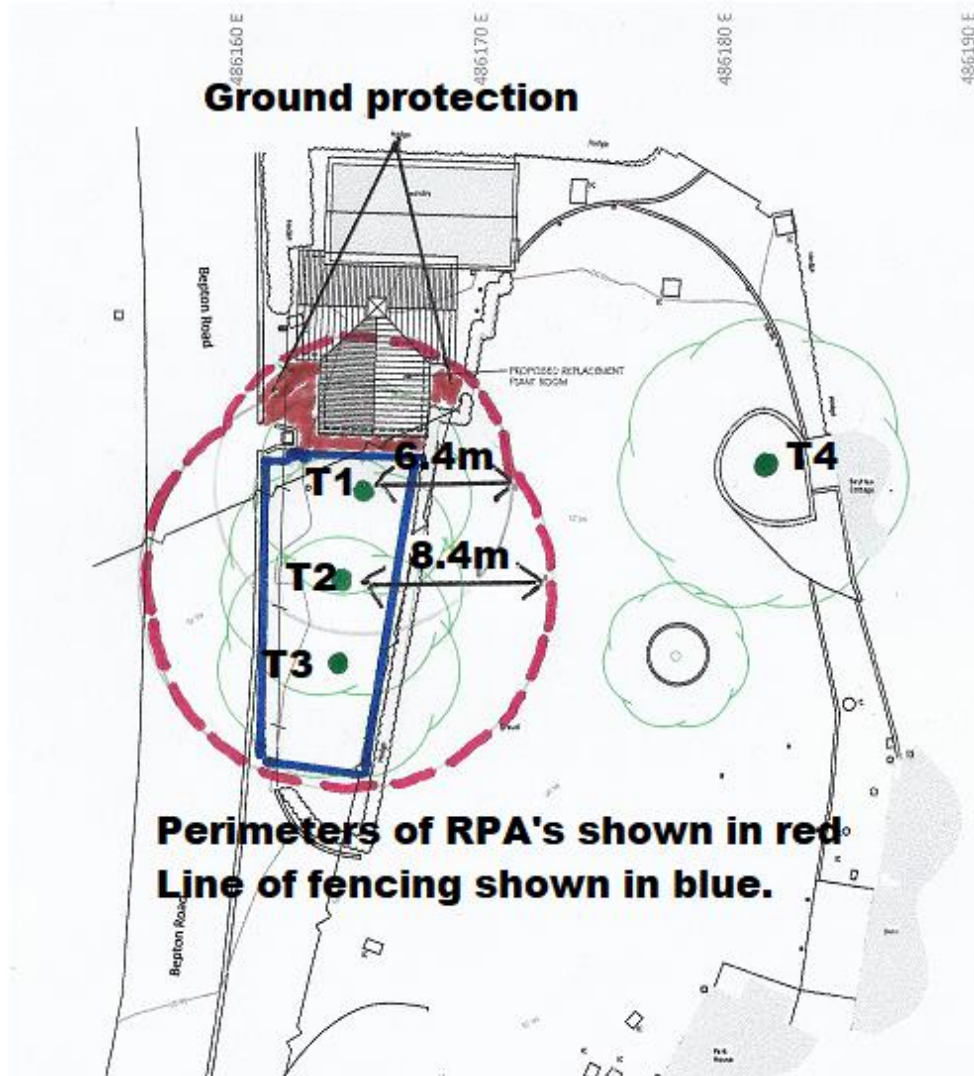
APPENDIX 3. TREE PROTECTION PLAN

4.1. There are 3 mature Holly Oaks on the verge by Bepton Road (T1, T2 & T3) the trees appears healthy with good vigour. I recommend that the lower northerly crown of T1 is lifted to 6m above ground level.

4.2. T4 is an over-mature Holly Oak, unfortunately the tree appears to be in decline, there is sparse foliage, dieback in the crown and fungal fruiting bodies on the main stem. Due to its proximity to buildings and car-parking I recommend that it is felled.

8.1. Fencing will be installed to protect the root protection areas (RPA's) of T1, T2 & T3 before any works commence; the fencing will be constructed in accordance with BS 5837: 2012 (*Appendix 1.*) The area enclosed by the fencing will be considered a complete exclusion zone; there will be no vehicles, equipment or machinery within the fenced off area. Under no circumstances will any materials be stored within the fenced off area, and no cement, diesel or oil stored near to it.

8.2. A Geo-textile three dimensional confinement system (*Appendix 2.*) will be laid before any works commence (shown as Ground Protection on the Tree Protection Plan). The system will minimize the potential for soil compaction. The confinement system should be filled with no-fines gravel, washed aggregate or cobbles. Materials with a high-fines content should not be used due to their almost impermeable texture when consolidated.
