Our Ref: BS/10194
Your Ref: N/A

Re: Proposed conversion of existing barn, Trucketts Hall, Boxted.

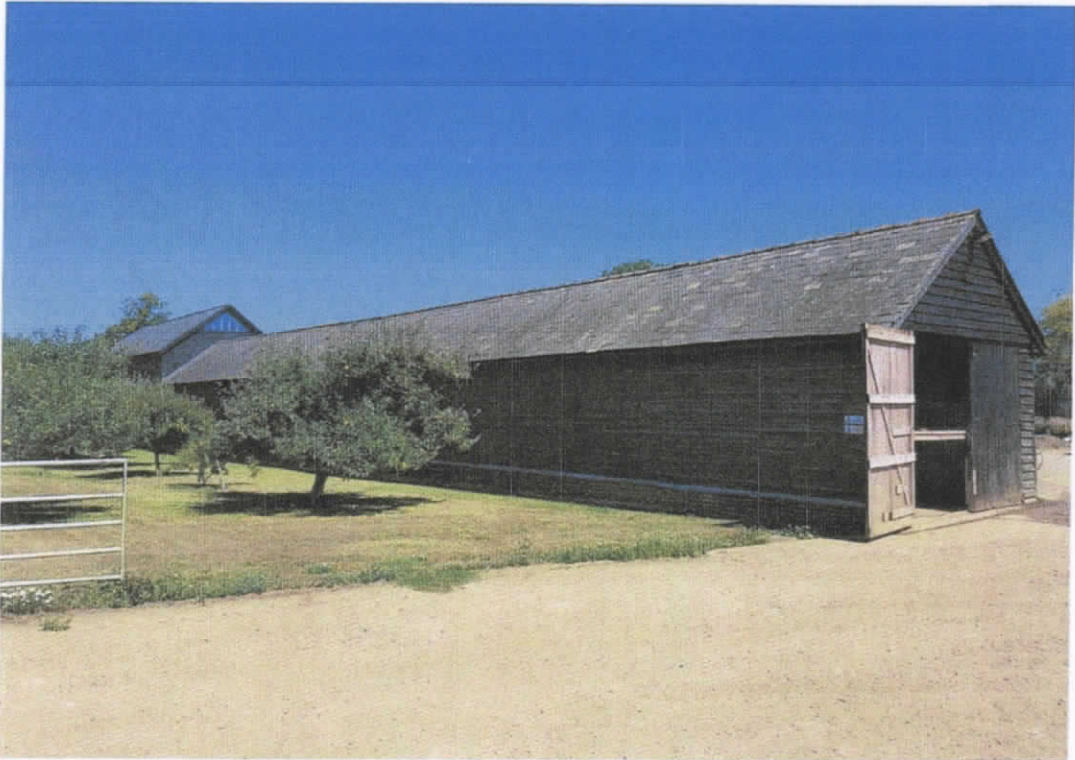
Photograph 1.

No significant sagging or dishing of rafters was observed, and the ridge line appears reasonably level throughout. (Refer photograph 1). To the east elevation, adjacent the southern gable, some slight localised sagging of the rafters is evident. All roof tiles are generally intact and complete.

External walls throughout are clad in black weatherboarding. The weatherboarding is complete and in good condition. Occasional horizontal movement is evident to both eaves. This movement is perhaps more generally a lean away from the road, in the direction of the prevailing wind.

In our considered opinion, the horizontal movement observed to both eaves is the result of the absence of sufficient intermediate buttressing or bracing along the length of the building, together with occasional failure of the connection between tie beams and eaves timbers. We would recommend the connections are inspected and repaired/strengthened as required, the details of which should be designed and detailed by a structural engineer. The provision of internal non-loadbearing stud partitions as part of any conversion, will provide the intermediate buttressing and overall stability required to restrain the roof structure and external walls in place. Again, these buttressing walls would require to be designed by a structural engineer.

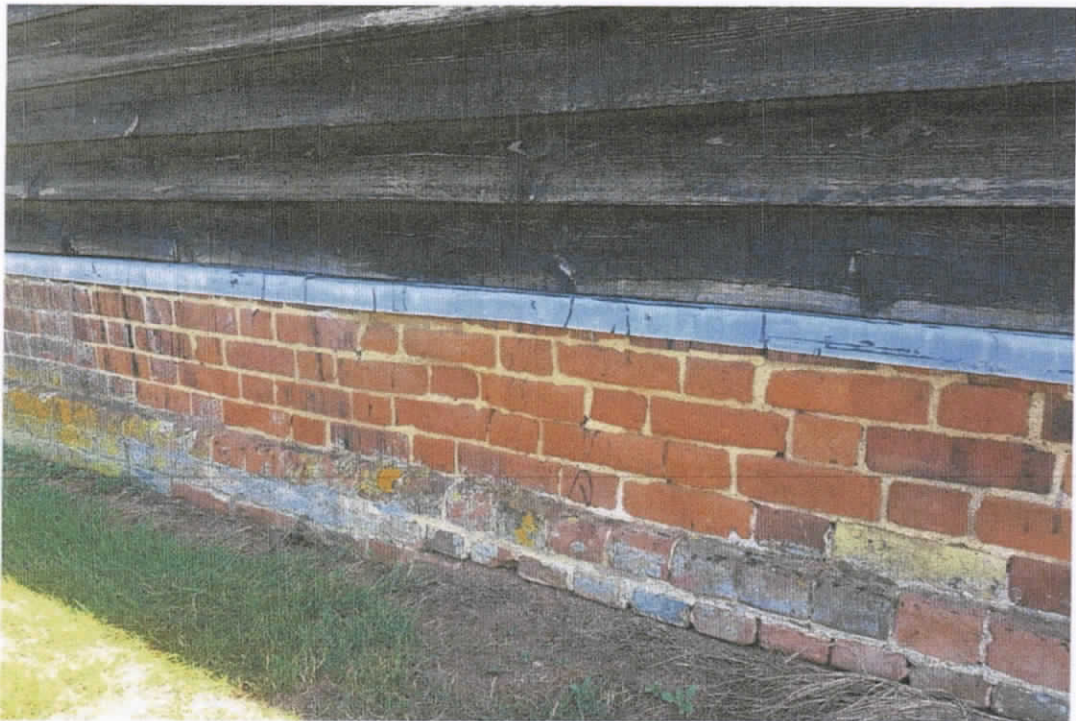
Photograph 2.

The brick plinth comprises 215mm solid soft red brickwork laid in a lime mortar. (Refer photograph 2). The height of the brick plinth varies from 400mm to 950mm above ground level. No significant cracking is evident. Lead flashing is dressed over the top of the wall. Generally, the brickwork is in good condition, however occasional localised loss of the face of the brickwork and mortar is evident.

Where there is a loss of mortar to the brick plinth, this should be repaired using a suitable lime mortar to ensure water tightness.

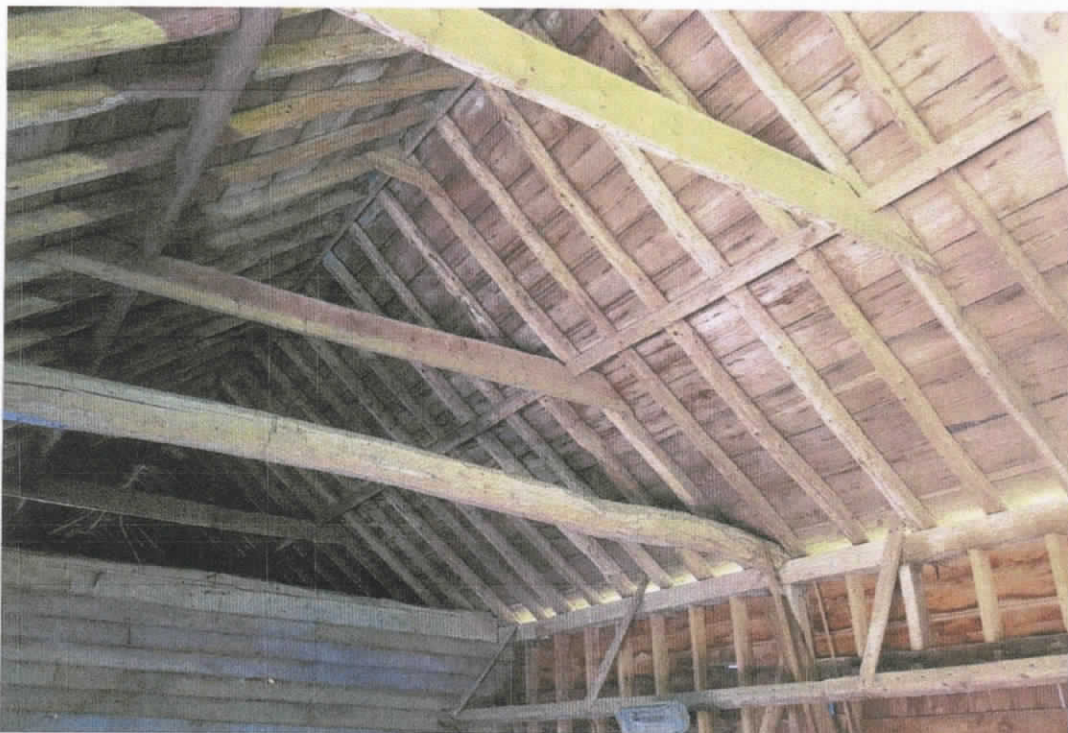
Photograph 3.

The roof structure to the main barn comprises a traditional cut roof with rafters at typically 400mm centres, supported by a mid-height purlin, which is in turn supported by timber collars at approximately 2m centres. The top of rafters is boarded throughout. A number of what may be the original rafters have been replaced with regularised sawn timbers. From the limits of our visual inspection, timbers forming the roof appear in good condition. Connections between rafters, purlins and collars appear sound. (Refer photograph 3).

There is no evidence of significant racking of the rafters.

We understand it is proposed to provide a vaulted ceiling throughout the existing barn as part of any conversion. As is perhaps typical, a structural analysis should be undertaken of the roof structure to consider its suitability for the additional loading, however at this time we would consider it likely that should any works be required, this is likely to be limited to providing additional timber collars between purlins.

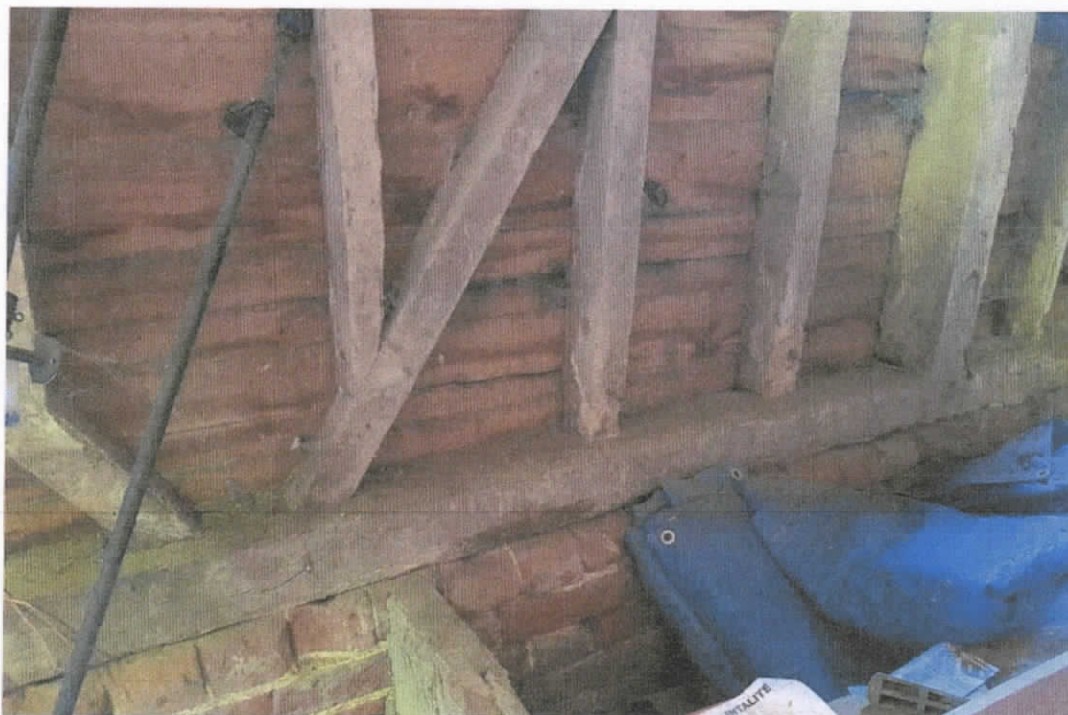
Photograph 4.

External walls comprise studwork at typically 400mm centres, with principal posts at tie beam locations. There are no diagonal braces or timber haunches at the junction of the tie beams and principal posts. A number of what may be the original studs have been replaced with regularised sawn timbers. Generally, the timber studs appear in good condition. Where visible, the existing timber sole plate is also in good condition. Diagonal timber bracings have been provided to both the east and west external walls. (Refer photograph 4).
