Tree Survey and Report BS5837

Proposed Development
Gunby Hall Stables, Bubwith

APRIL 2020

RICHARD LANCASTER: TREES & LANDSCAPE
ENVIRONMENTAL CONSULTANCY

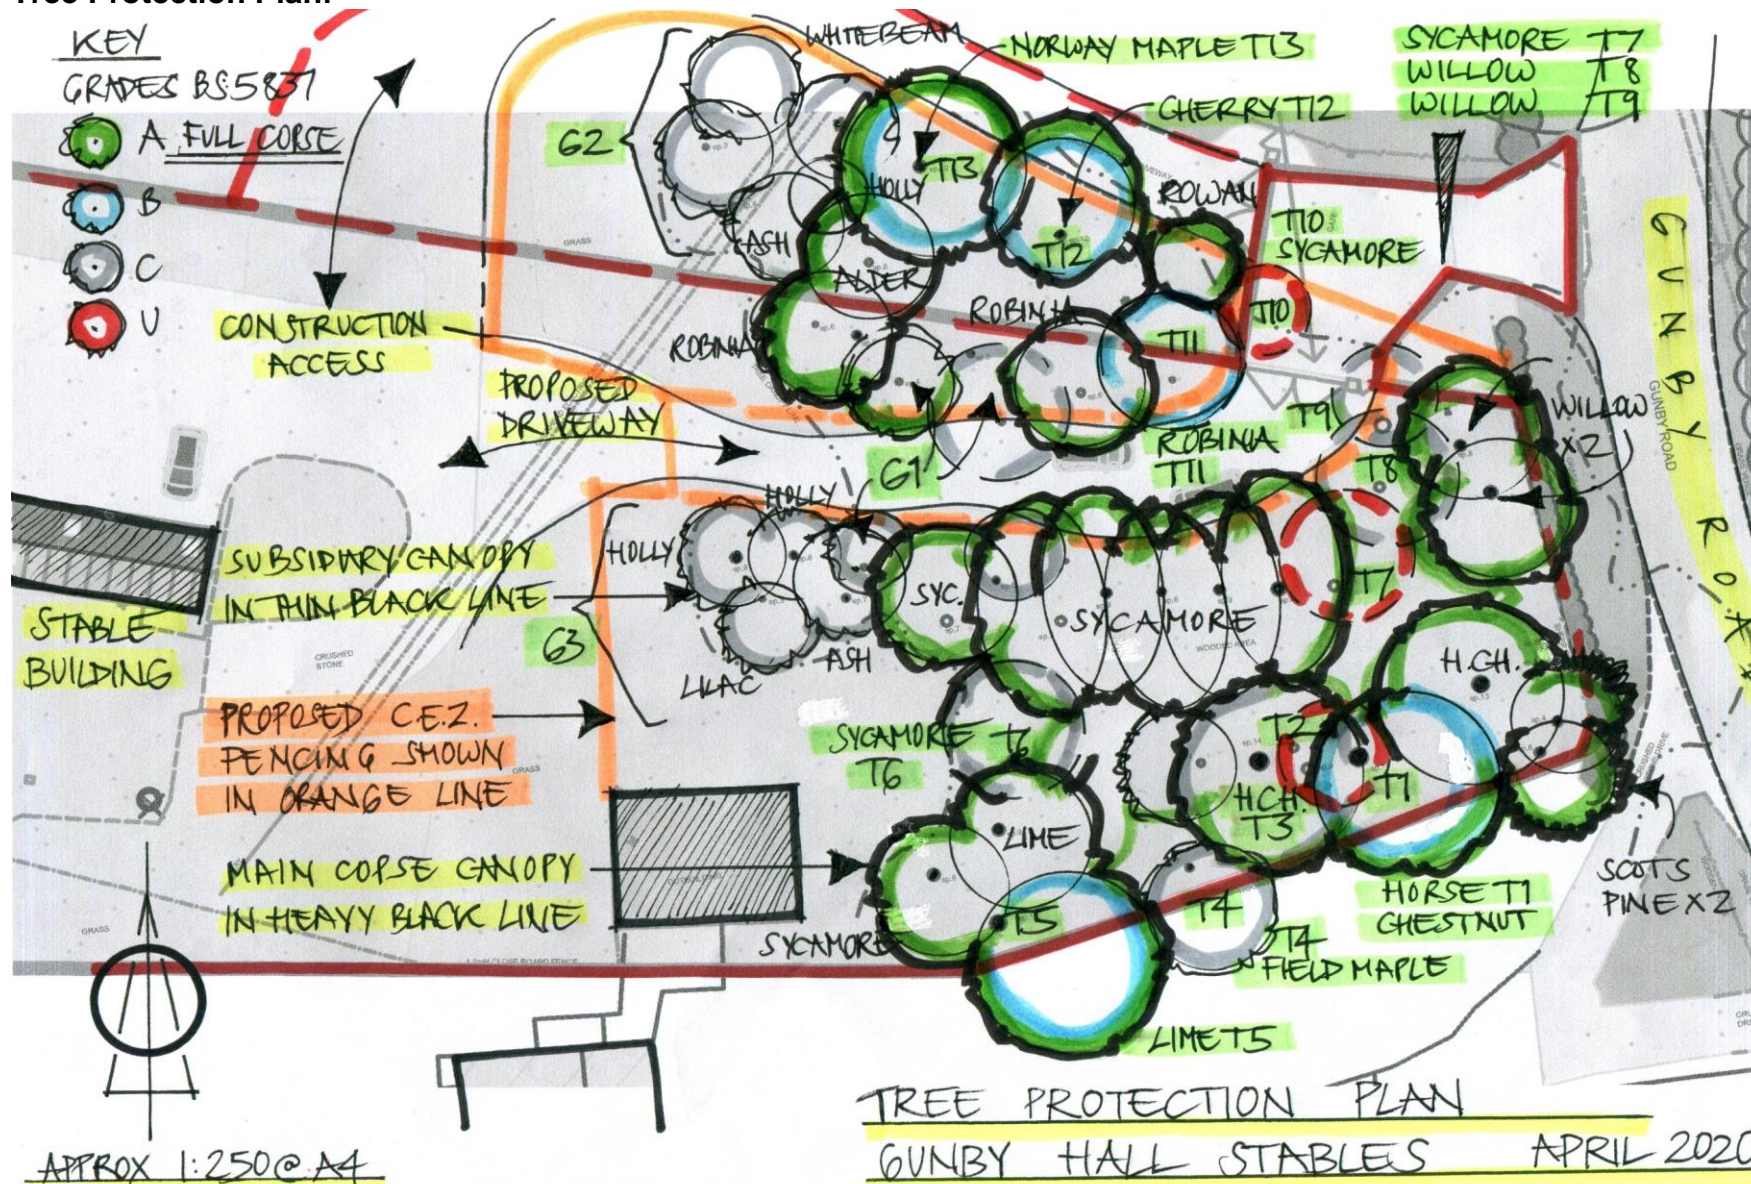
Tree Protection Plan:

The new proposed drive route is shown on the Brian Scott Design drawings and the attached Tree Protection Plan (TPP).

Ideally the new drive should be constructed in the late summer or autumn period to optimize drier ground conditions and to avoid potentially more damaging root impact should construction be done in the more active growing season, i.e. early spring to mid-summer. The TPP proposes CEZ fences immediately along the drive perimeter to give tight control of the construction space. These can be relatively simple and low level but must be fixed to avoid creep back into the copse i.e. secured to driven timber posts.

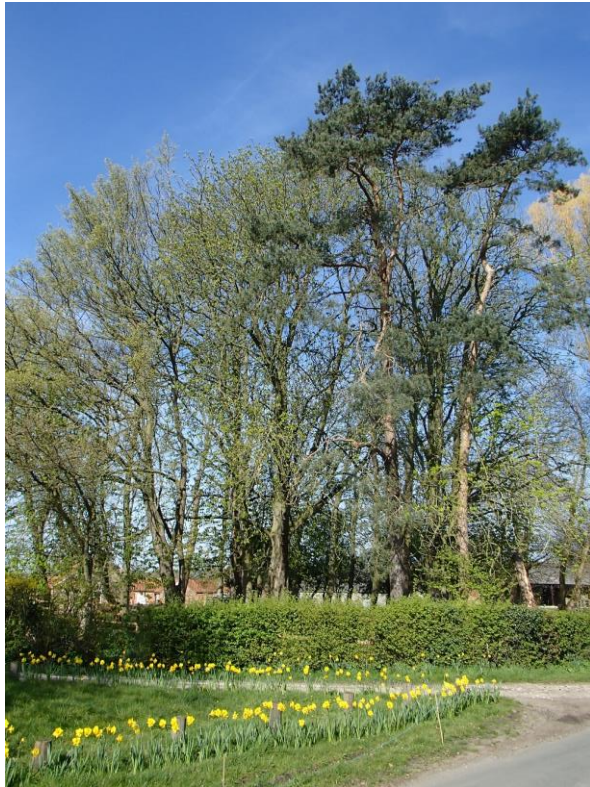
Photo 1: Scots Pine from south east, Horse Chestnuts behind

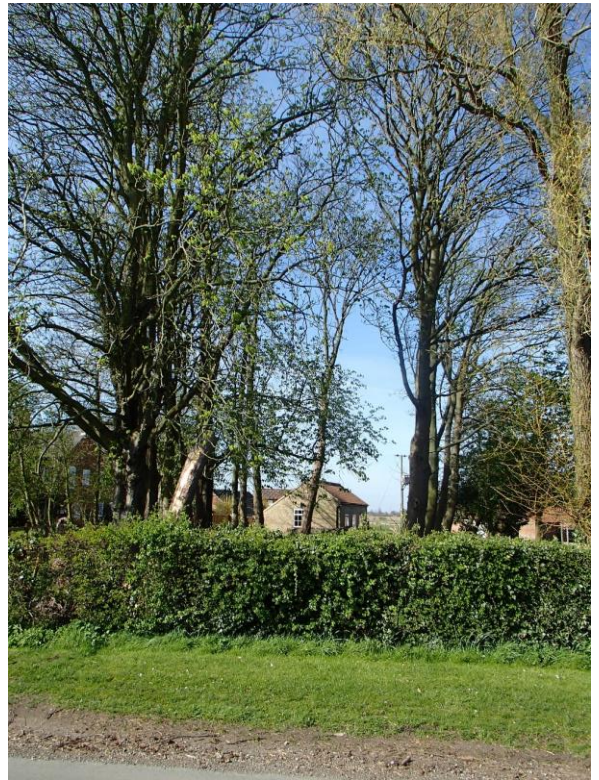
Photo 2: Group from Gunby Road to east

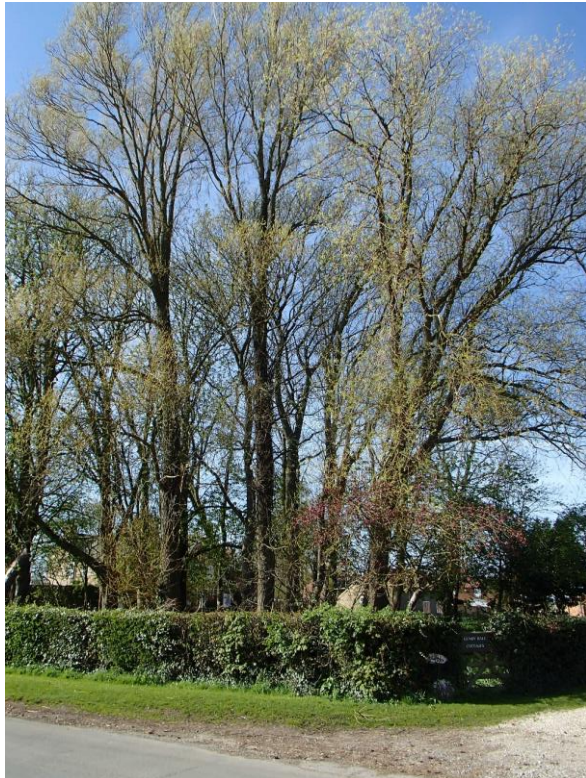
Photo 3: Willow group from north east

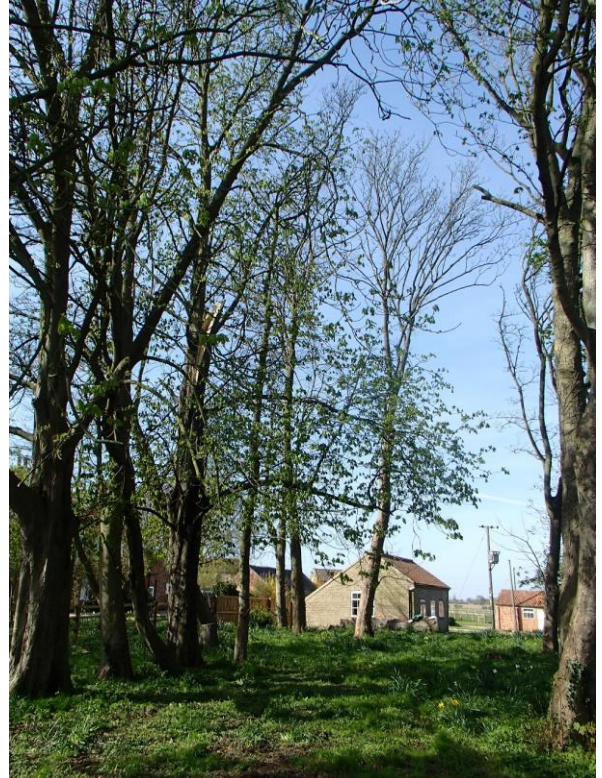
Photo 4: Within southern section, looking west.

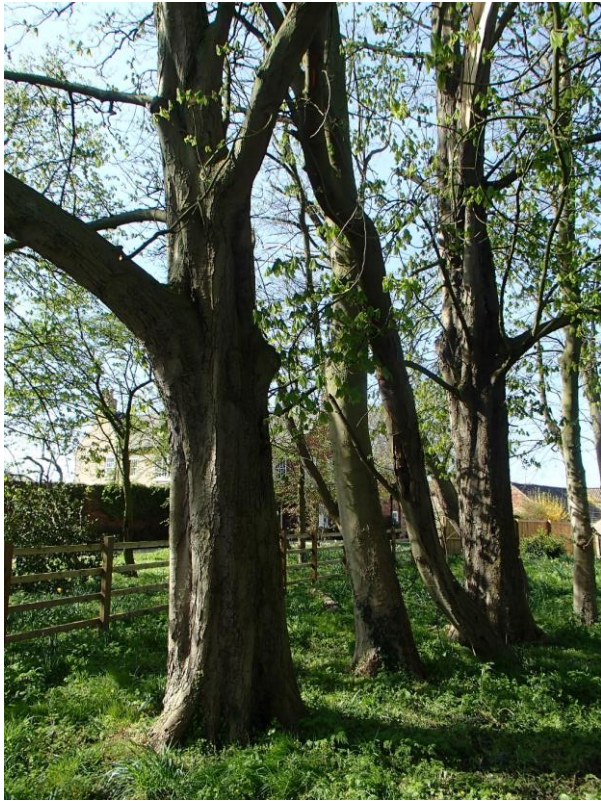
T1	Horse Chestnut <i>Aesculus hippocastanum</i>	18	650	6, 8, 5, 6	3	3	M	Seemingly sound and healthy, no clear signs of Bleeding Canker infection (<i>Pseudomonas</i>). Stem base appears to be sound. Large overextended limb at 3m projecting over garden to south-east. <i>Recommend 30% weight reduction of limb to SE.</i>	20-30	B	7.8 190	4, 5
T2	Horse Chestnut <i>Aesculus hippocastanum</i>	14?	350	2, 5, 3, 0	2	2	M	Severe decline, tree base has failed and is leaning into T1. Probably in stable position but rubbing causing damage to T1 & considered unsightly. <i>Recommend full removal</i>	0-10	U	N/A	5
T3	Horse Chestnut <i>Aesculus hippocastanum</i>	18	600	5, 5, 6, 6	3	3	M	Apparent decline, foliage fair at present but two large limbs have already been shed at 6.5m & 8m. Bark death and wood decay in stem base west side, honey fungus present. Stem hole @ 4.5M N <i>Carefully monitor decline, fell as desired.</i>	10-20	C	7.2 165	5, 6, 7

Photo 5: Horse Chestnut T1 LHS, and failed T2 in centre leaning into tree to left.

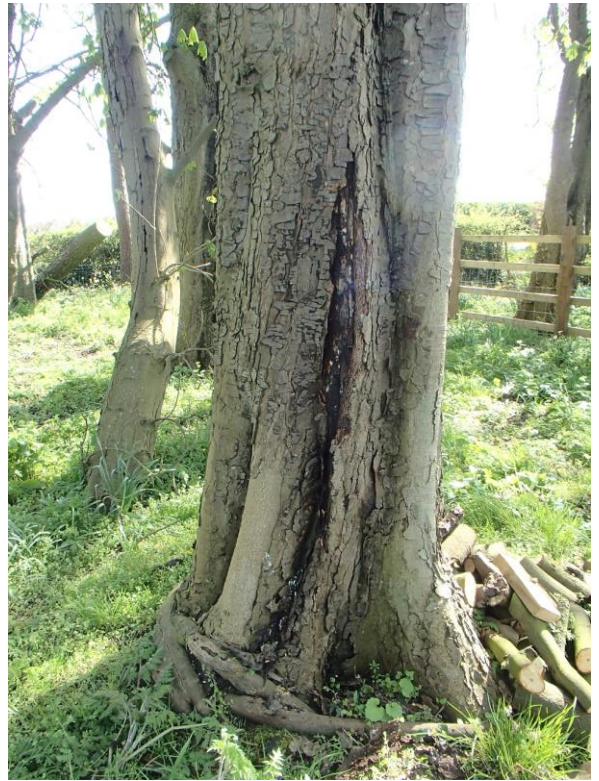
Photo 6: Base of Horse Chestnut T3

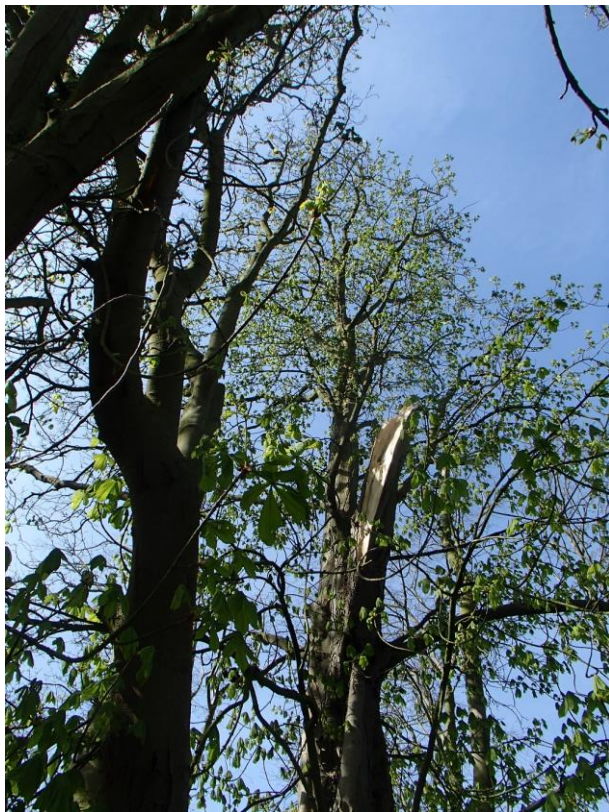
Photo 7: Broken limb in Horse Chestnut T3

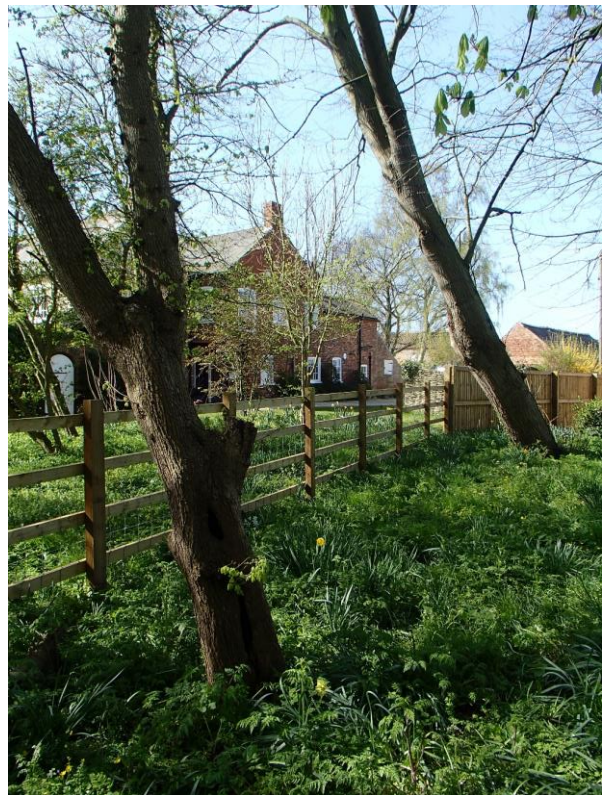
T4	Field Maple <i>Acer campestre</i>	14	325	2, 5, 5, 3	2	2	M	Fair foliage health, very hollow stem and leaning south over neighbouring property. Strong tree but some risk of breakage/failure. <i>Recommend pollard between 2 and 4m AGL</i>	10-20	C	N/A	8

Photo 8: Field Maple T4 LHS, leaning Lime T5 RHS

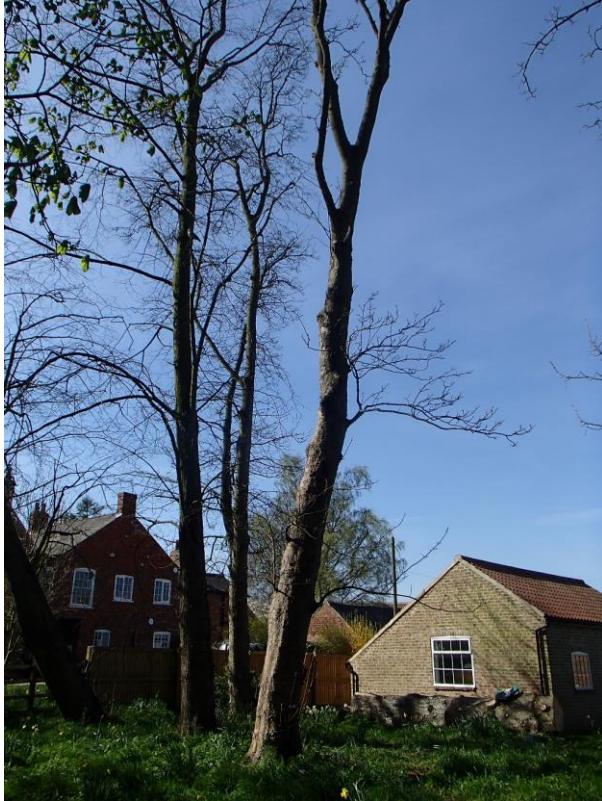
Tree No.	Species	Ht (m)	DBH (mm)	Spread N, E, S, W	Ht 1 st branch	Ht to crown	Age Class	Physiological and Structural Condition. Preliminary Management Recommendations	Est RC years	Grade BS5387	RPA (rad, m2)	Photo
T5	Lime <i>Tilia species</i>	18	725	1, 9, 8, 2	3	3	M	Fair health with significant lean over garden to south. Not over the driveway but any failure would be dramatic. Extensive deadwood, typical of Lime. Stem base appears to be stable and secure in ground, but this ground is soft. <i>Recommend overall crown reduction of nominal 30%, including crown clean & rebalance to north.</i>	20-30	B When pruned	8.7 240	8, 9
T6	Sycamore <i>Acer pseudoplatanus</i>	18	575	6, 4, 1, 5	2	2	M	Fair foliage health, thin & high crown, deadwood and decline evident. Slight outlier from group. Close to outbuilding and adjacent trees have previously been lost, but not considered a significant safety hazard. <i>Carefully monitor decline, fell if desired to create space & light for replanting (3 new trees).</i>	10-20	C	N/A	9

Photo 9: Lime T5 to left, Sycamore T6 centre front

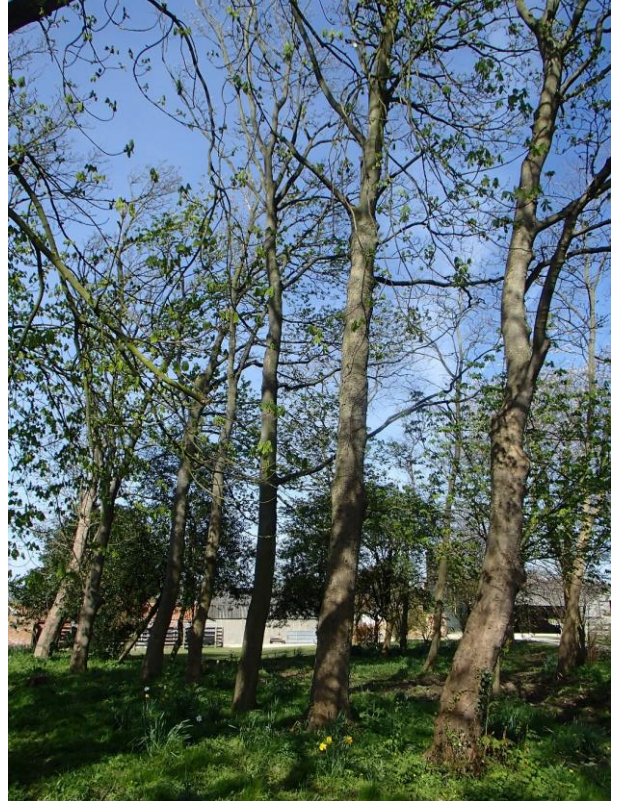
Photo 10: Sycamore group, centre of site. Part of group 1 below canopies.

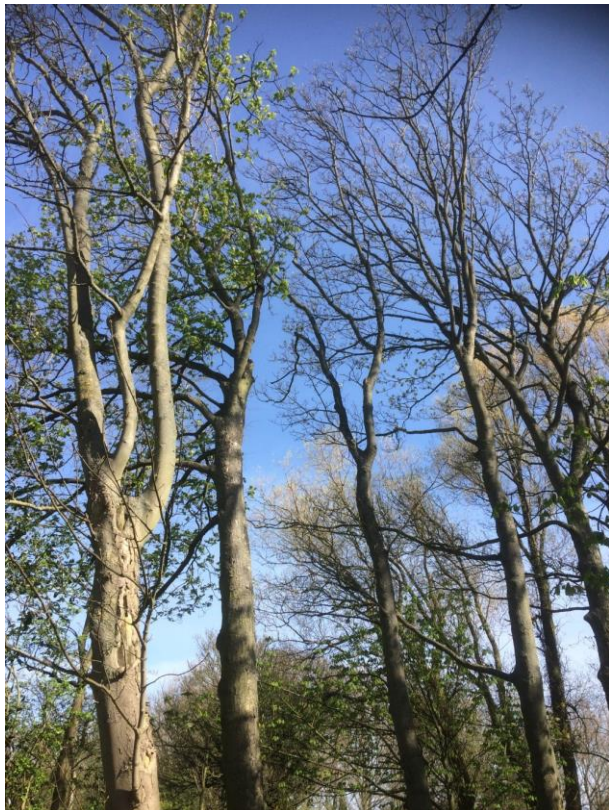
Photo 11: Canopy detail, central Sycamore group

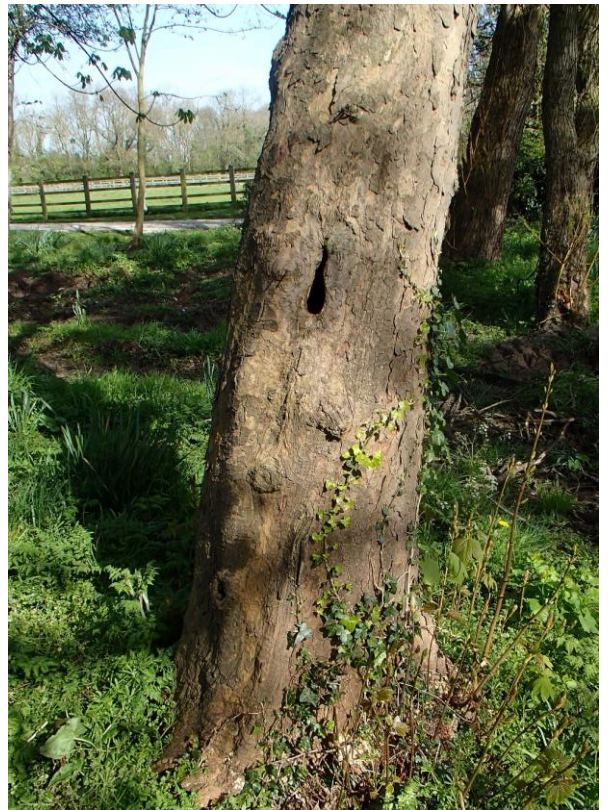
T7	Sycamore <i>Acer pseudoplatanus</i>	16	475	6, 4, 3, 3	4~	4~	M	Fair foliage health, very hollow stem and leaning north towards proposed drive. Deadwood in canopy above and some risk of failure. <i>Recommend full removal and replanting.</i>	0-10	U	N/A	11 12
T8	Willow (Crack?) <i>Salix species</i>	15	350	6 north	4~	4~	M	Fair foliage health, unbalanced, leaning north towards proposed drive and gate. Deadwood in canopy and soft ground may contribute to failure. <i>To be removed for development purposes and to create space for new planting. Alternatively, coppice at ground and allow shrubby regrowth.</i>	10-20	C	N/A	3 13
T9	Willow (Crack?) <i>Salix species</i>	15	450	7 north	4~	4~	M	Fair foliage health, unbalanced, leaning north towards proposed drive and gate. Deadwood in canopy and soft ground may contribute to failure. <i>To be removed for development purposes and to create space for new planting.</i>	10-20	C	N/A	3 13 16

Photo 12: Hollow base of Sycamore T7

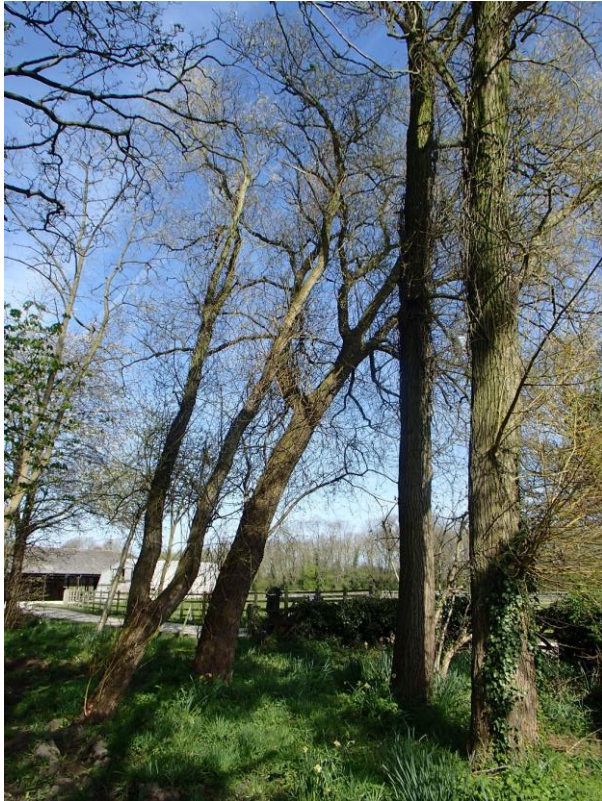
The proposed drive follows an obvious route through the copse without any mature trees, though the roots of the Sycamore group to the south are likely to see some minor impact. Some smaller trees are to be removed or coppiced (Sycamore T10, Robinia T11, and some of G1) and two larger adjacent trees (Willows T8, T9) are identified for felling on safety grounds due to their northward lean.

Photo 13: Willow group, T8 & T9 to fell to LHS

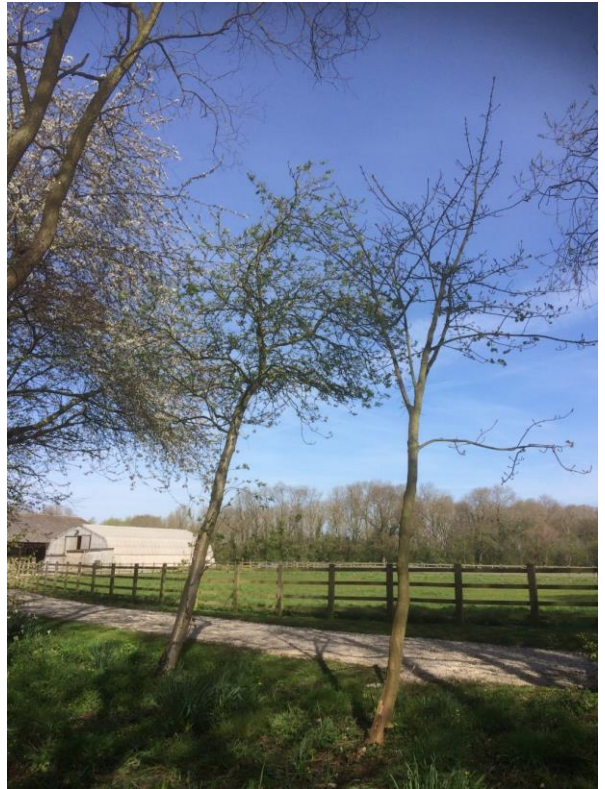
Photo 14: Small trees on drive, T10 to fell to RHS.

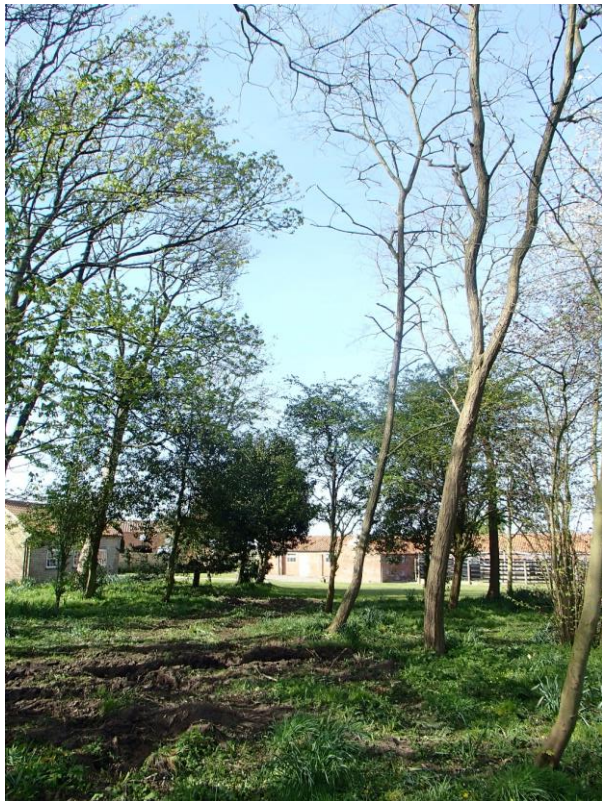
Photo 15: Route of proposed drive, looking west. Robinia T11 to fell centre right. Group 1 at end.

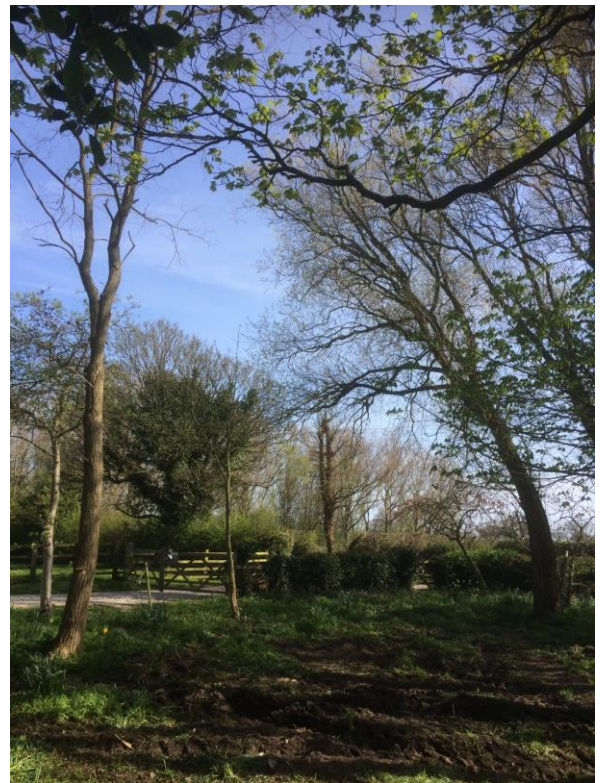
Photo 16: Route of proposed drive, looking east towards gate. T8 & T9 in view.

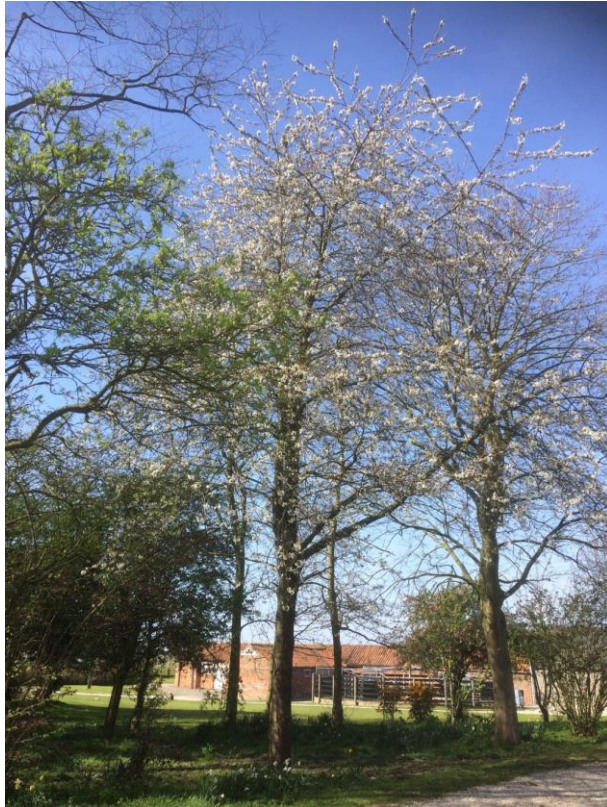
Tree No.	Species	Ht (m)	DBH (mm)	Spread N, E, S, W	Ht 1 st branch	Ht to crown	Age Class	Physiological and Structural Condition. Preliminary Management Recommendations	Est RC years	Grade BS5387	RPA (rad, m2)	Photo
T10	Sycamore <i>Acer psd'platanus</i>	7	100	3, 2, 0, 1	2	2	Y	Small tree, fair health, stem damage, leaning. <i>To be removed for development purposes.</i>	10-20	C	N/A	14
T11	Robinia <i>Robinia pseudoacacia</i>	16	300	3, 4, 3, 3	4~	5~	M	Fair foliage health, typical thin & high crown, deadwood evident, weak twin stem at 5m. <i>To be removed for development purposes.</i>	20-30	B	N/A	15
T12	Cherry <i>Prunus avium var.</i>	14	350	8, 5, 4, 4	3	2.5 drive	M	Sound and healthy, fair form, low and unbalanced over access drive to north. Some deadwood. <i>Crown lift to 4m clear over drive, clean if desired.</i>	20-30	B	4.2 55	17
T13	Norway Maple (Purple?) <i>Acer platanoides</i>	14	550	5, 6, 5, 4	3	3 drive	M	Sound and healthy, fair form, low unbalanced over access drive to north. Tight x2 junction at 3m currently appears sound but possible future risk. <i>Crown lift to 4m clear over drive, clean if desired.</i>	20-30	B	6.6 140	17 18

Photo 17: Existing drive, Cherry T12 centre. T13 to RHS

Using the existing northern approach for the construction access will avoid any increased stress and damage from these vehicle movements if the new drive was to be used instead. On the northern drive two trees are to be crown lifted (Cherry T12 and Maple T13) to 4m to increase clearances. And a CEZ fence is required to avoid any vehicles straying onto the adjacent verge and thus root spread from retained trees.

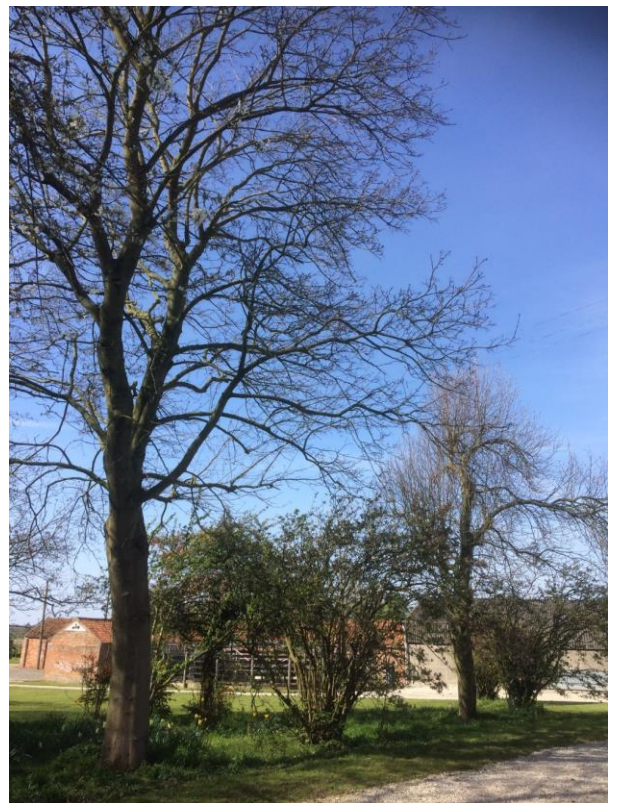
Photo 18: Existing drive, Norway Maple T13

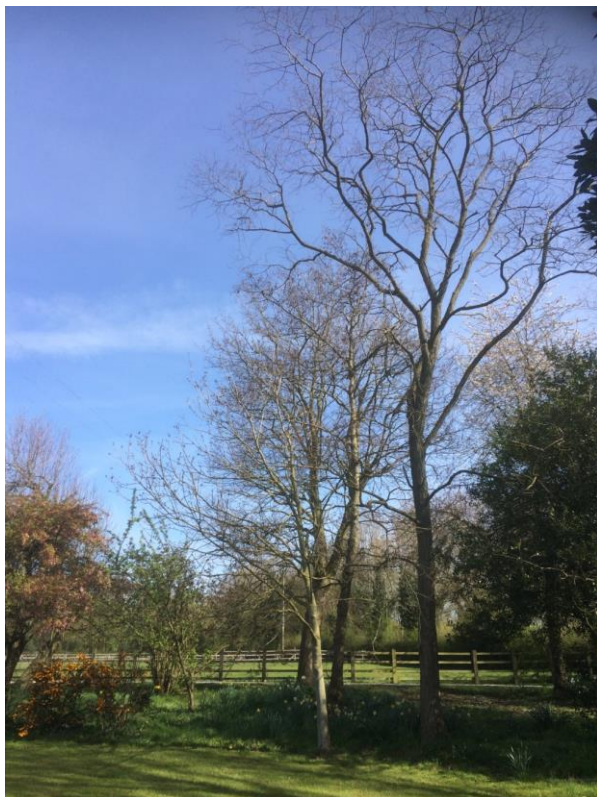
Photo 19: Small mixed group, some below overhead wires, north-west corner.

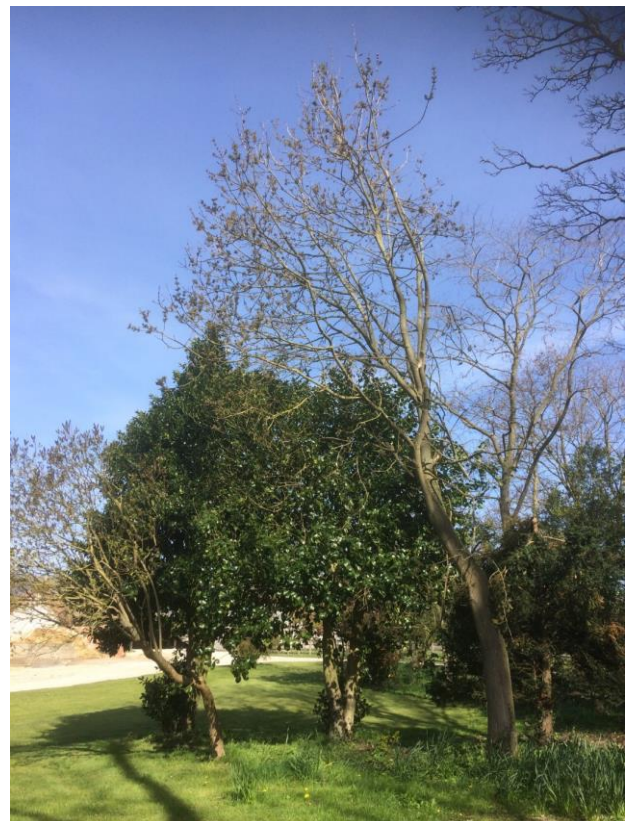
G1	Holly Hawthorn Yew	4 to 10	100-300 M/S	Plan	1	1	SM M	Various small trees and shrubs along proposed drive. Fair condition, some evergreen, though limited external amenity value <i>Retain or prune/coppice as required.</i>	10-20	C	Plan	10 15
G2	Whitebeam Ash, Alder Malus, Holly and mixed Shrubs	2 to 12	100-300 M/S	Plan	0-2	0-2	SM M	North-western group, in fair condition overall. Ash and Alder sound and healthy, Whitebeam because of overhead cables. Some shrub content and evergreen screen value. <i>Retain with fenced protection, from drive access.</i>	10-20	C	Plan	19
G3	Holly, Yew, Lilac, Ash	4 to 10	100-300 M/S	Plan	1	1	SM M	South western group, in fair condition overall. Ash probably self-seeded, broken branch in Yew. Evergreen screen value. <i>Retain with fenced protection</i>	10-20	C	Plan	20

Photo 20: Small mixed group, centre west, at end of proposed drive. Part of group 1.
