Arboricultural Consultancy for Lloyds Bank

Insured	Mr Charles Southern	Address	3 Woodlands Avenue, Shrewsbury, SY5 8NG		
Client	Subsidence Management Services	Contact	Kyza Derby	Claim No.	IFS-LBG-SUB-20-0085780
ES Ref	SA-246106	Consultant	Giles Mercer	Contact No.	0330 380 1036
Report Date	05/08/2020

GEOTECHNICAL

Drainage Investigation Report

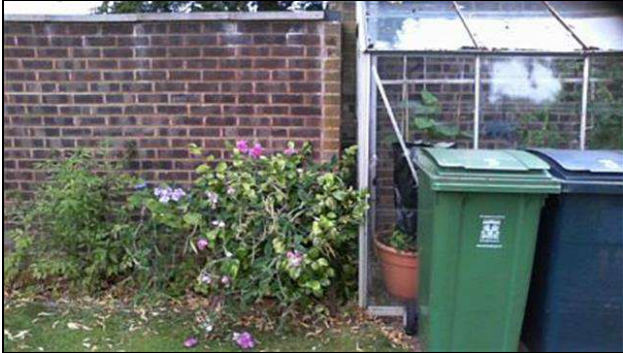
S1 - Shrub

Please note that the footing of the insured property fall within the anticipated rooting distance of additional vegetation which we believe presents a foreseeable risk of future damage and accordingly we have made recommendations in respect of this.

Tree No.	Species	Age Cat	Approx. Height (m)	Distance to Building (m) *	Ownership	Action	Requirement
S1	Shrub	1	1	1.4	C - Insured	Action to avoid future risk	Maintain at current dimensions by way of regular pruning.
T3	Lime	3	20	6.8	C - Insured	Action to avoid future risk	Crown reduce overall canopy by 30% (minimum) to achieve a crown volume reduction in line with BRE IP7/06. maintain at reduced dimensions by re-pruning back to points of previous reduction on a strict 2-3 year cycle.
T4	Lime	3	18	3.	C - Insured	Action to avoid future risk	Crown reduce overall canopy by 30% (minimum) to achieve a crown volume reduction in line with BRE IP 7/06. Maintain at reduced dimensions by re-pruning back to points of previous reduction on a strict 2-3 year cycle.
T5	Lime	3	18	8.3	C - Insured	Action to avoid future risk	Crown reduce overall canopy by 30% (minimum) to achieve a crown volume reduction in line with BRE IP7/06. maintain at reduced dimensions by re-pruning back to points of previous reduction on a strict 2-3 year cycle.

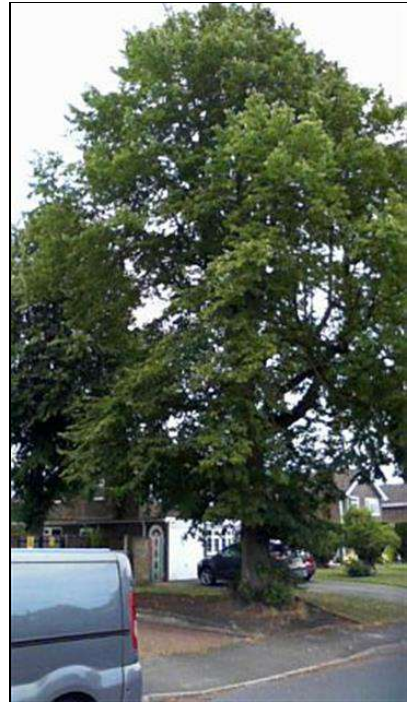
T1 - Lime

Our survey of the site identified the Limes (T1 & T2), given its position relative to the damage it is our opinion that the roots identified will emanate from this vegetation and accordingly we have identified it as the principal cause of the subsidence damage.

Note: Electricity board replaced wall approx 1 year ago and also dug alongside policyholders foundation; roots from T1 were identified all the way to rear.

Consequently, complete removal of T1 & T2 will offer the most certain arboricultural solution likely to restore long-term stability.

Tree No.	Species	Age Cat	Approx. Height (m)	Distance to Building (m) *	Ownership	Action	Requirement
T1	Lime	3	19	7.9	D - Unknown	Remove	Remove close to ground level; do not treat stump due to translocation risk. Where such a risk exists, we advise that any emergent regrowth is removed annually.
T2	Lime	3	16.1	4.45	C - Insured	Remove	Remove close to ground level; do not treat stump due to translocation risk. Where such a risk exists, we advise that any emergent regrowth is removed annually.

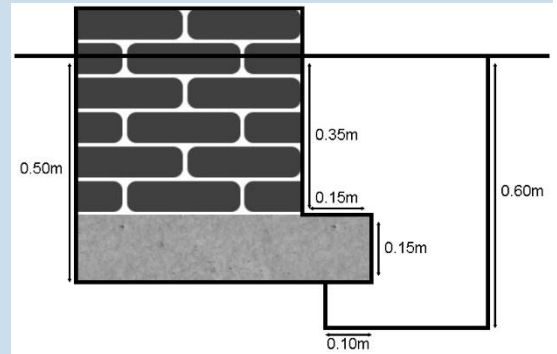
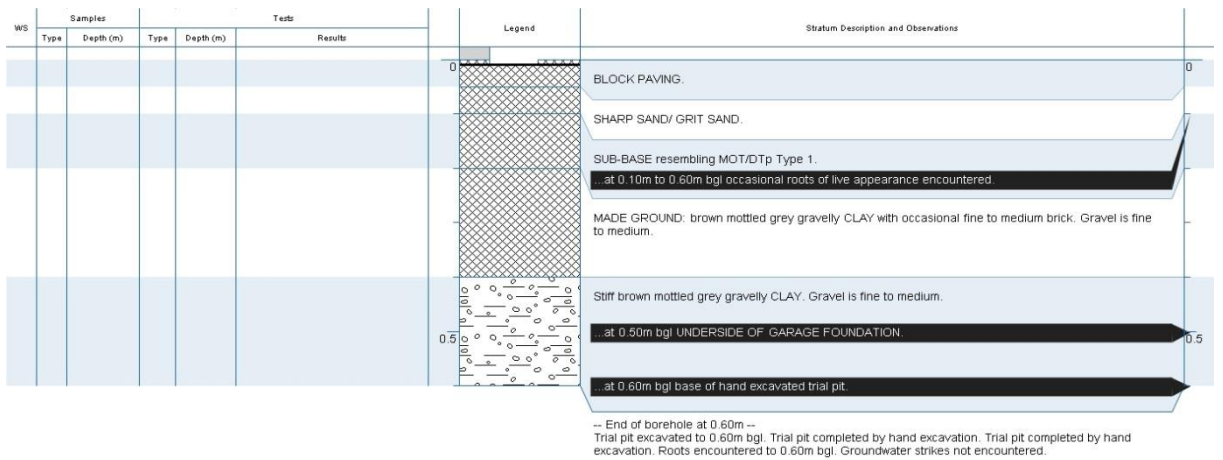
TP1 Foundation Detail and Borehole Log

Garage foundation comprised of brick wall to 350mm bgl, bearing on stepped concrete to 500mm bgl with a total projection of 150mm from the elevation. Underside of foundation (USF) was exposed to 100mm back from the face of the foundation and probed 450mm back from the face of the foundation.

At 0.50m bgl UNDERSIDE OF GARAGE FOUNDATION in TP1.

At 0.10m to 0.60m bgl occasional roots of live appearance encountered in TP1.

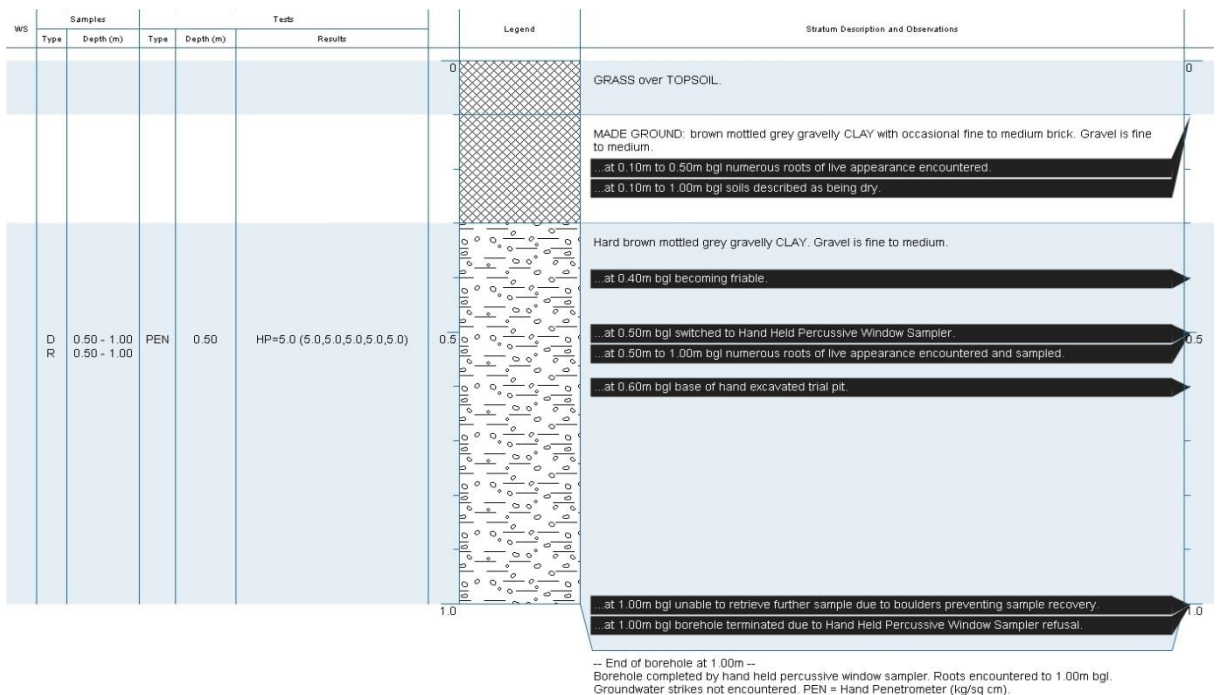
BH2 Borehole Log

At 1.00m bgl unable to retrieve further sample due to cobbles preventing sample recovery in BH2.

At 0.10m to 0.50m bgl numerous roots of live appearance encountered in BH2.

At 0.50m to 1.00m bgl numerous roots of live appearance encountered and sampled in BH2.

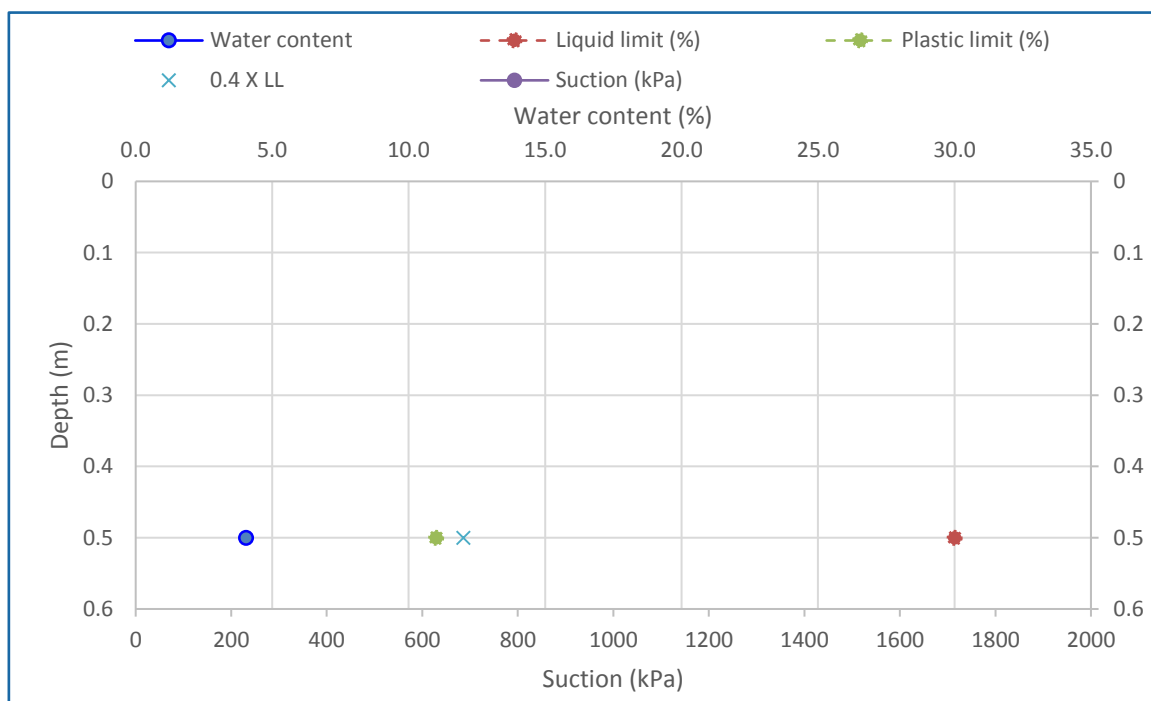
Samples from BH2

Lab Ref	Depth (m)	MC (%)	LL (%)	PL (%)	PI (%)	.425 mm(%)	mod. PI (%)	Av. Suc. (kPa)	Description
1	0.5	4.0	30	11	19	43	8		Dry brown very gravelly silty CLAY. Gravel is fine, medium and coarse.

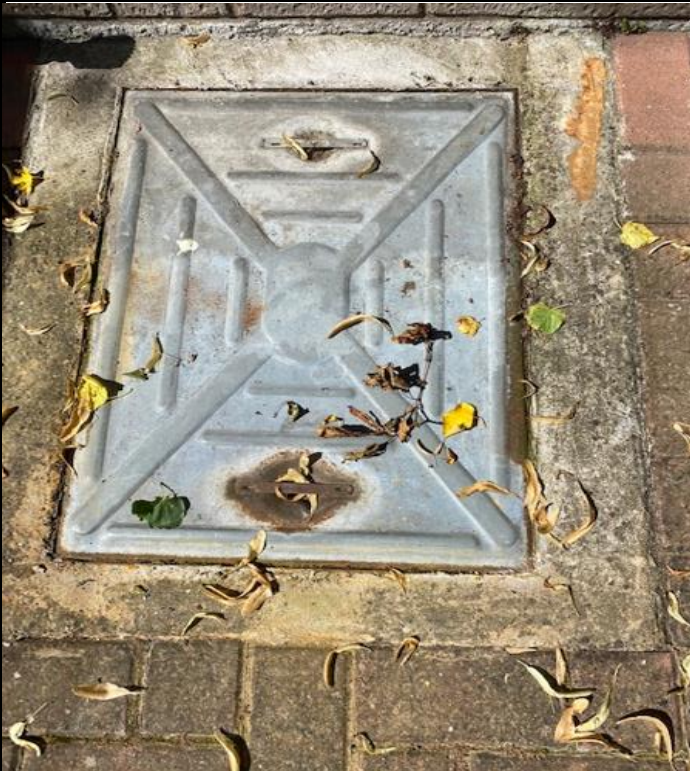
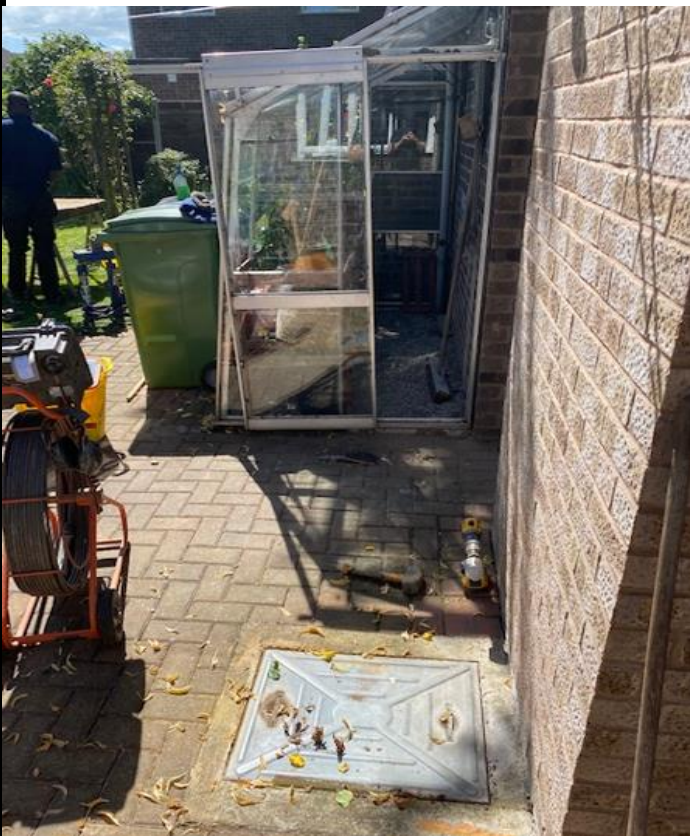
CCTV Survey Result: Structural damage

We were unable to remove the cover on MH1 to check if any drainage runs into the area of concern. It is thought the main drain from MH1 runs away from the property but it is unknown if there are any branch lines coming into it.

Excavate and replace the rest bend at the base of RWP1 together with a section of pipework.

Survey from excavation and report on findings.

Break out the cover and frame on MH1 and replace

Survey any and all pipework, within the area of concern, and report on findings

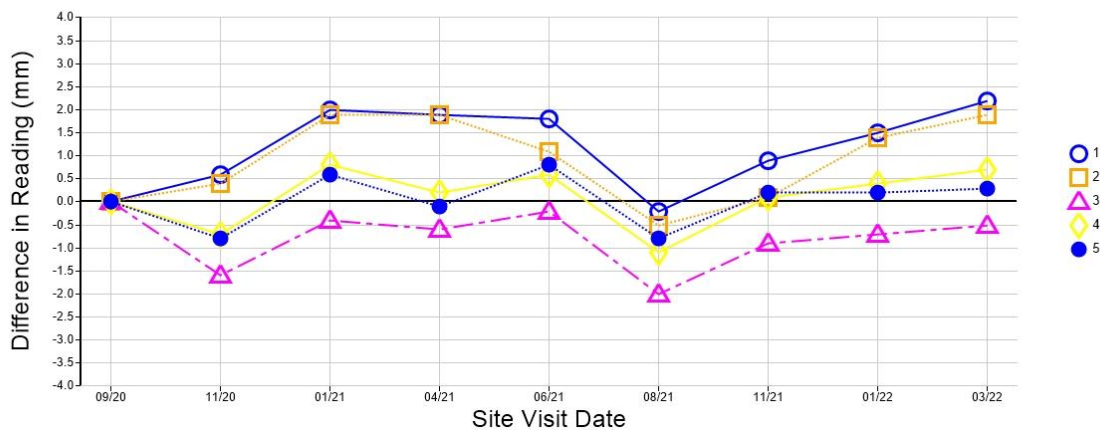
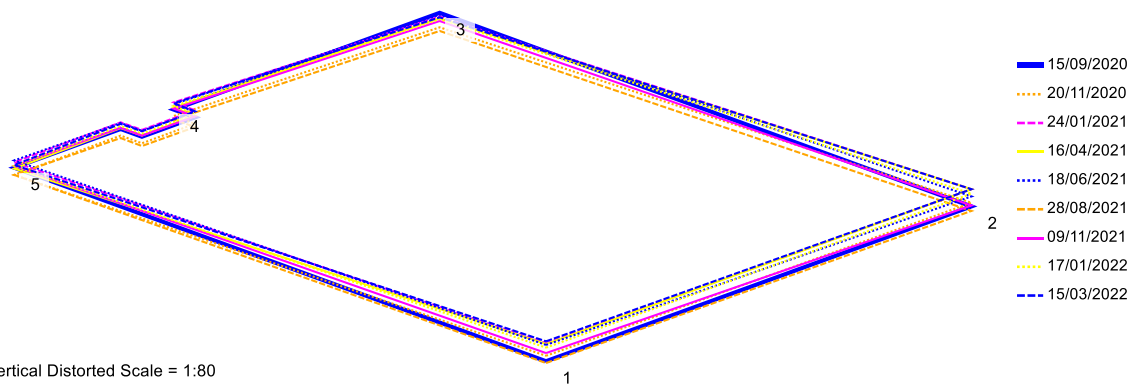
Level Monitoring Displacement Map

Slight movement noted - tree to rear RHS.

Movement noted. Trees to front and rear RHS
