Barn Conversion

Bedingfield

STRUCTURAL ENGINEER'S APPRAISAL REPORT

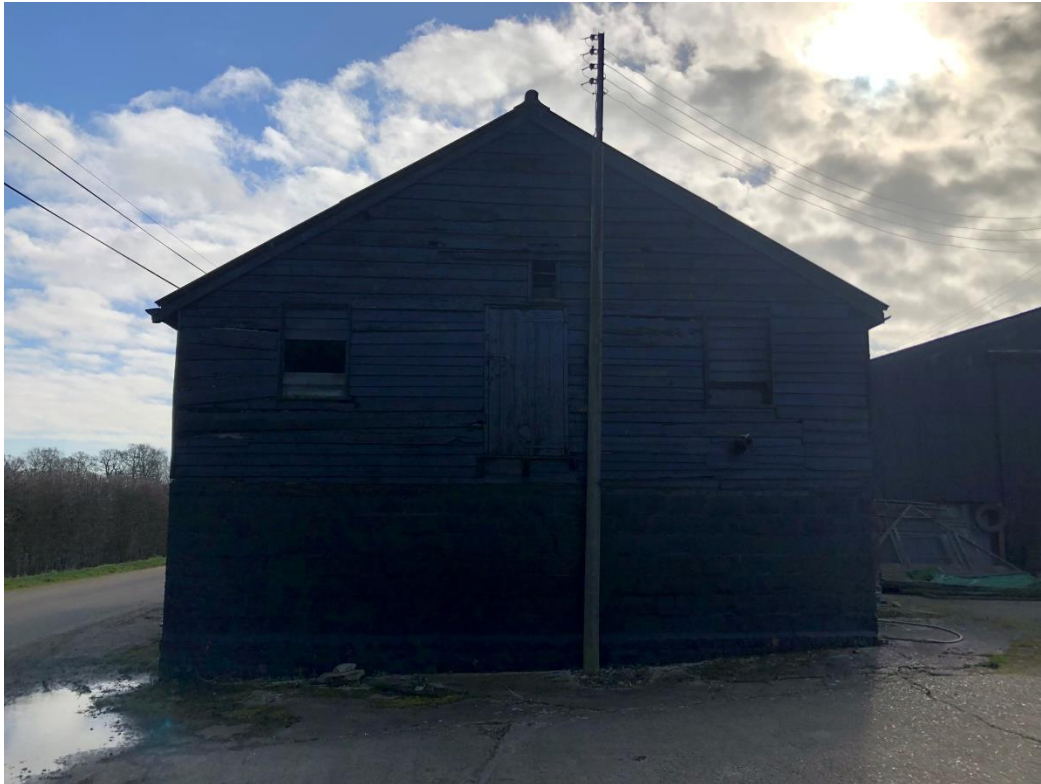
4.1 Photograph 1 shows a general view looking towards the northwest gable. This elevation comprises timber clad studwork above first floor level, with a predominantly block wall constructed from a

low level brick plinth enclosing the ground floor storey. Both the timber cladding and blockwork have been subject to a black pitch or similar painted finish.

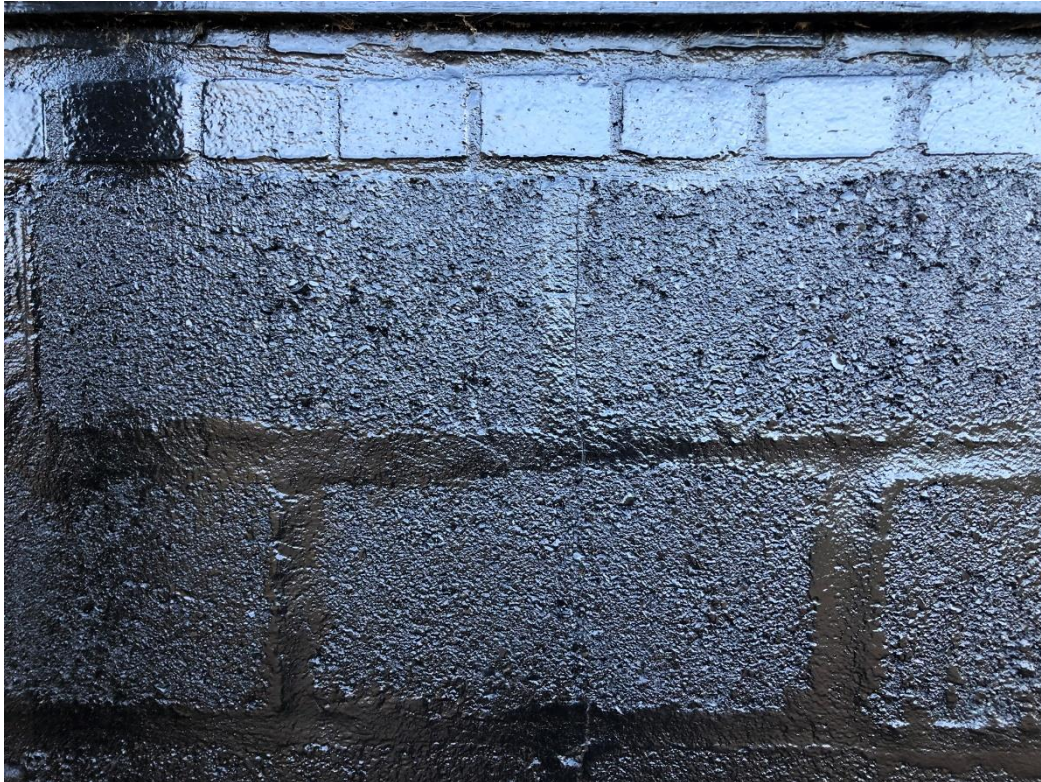
Photograph 2

- 4.2 Looking along the wall line, both the masonry and timber sections appear reasonably plumb, with little evidence of significant movement in the lower level blockwork. Of note, however, is that there are a number of hairline vertical cracks in the blockwork, an example is shown in photograph 2, but these generally seem to pre-date the painted finish and as such, are not thought to be structurally significant.

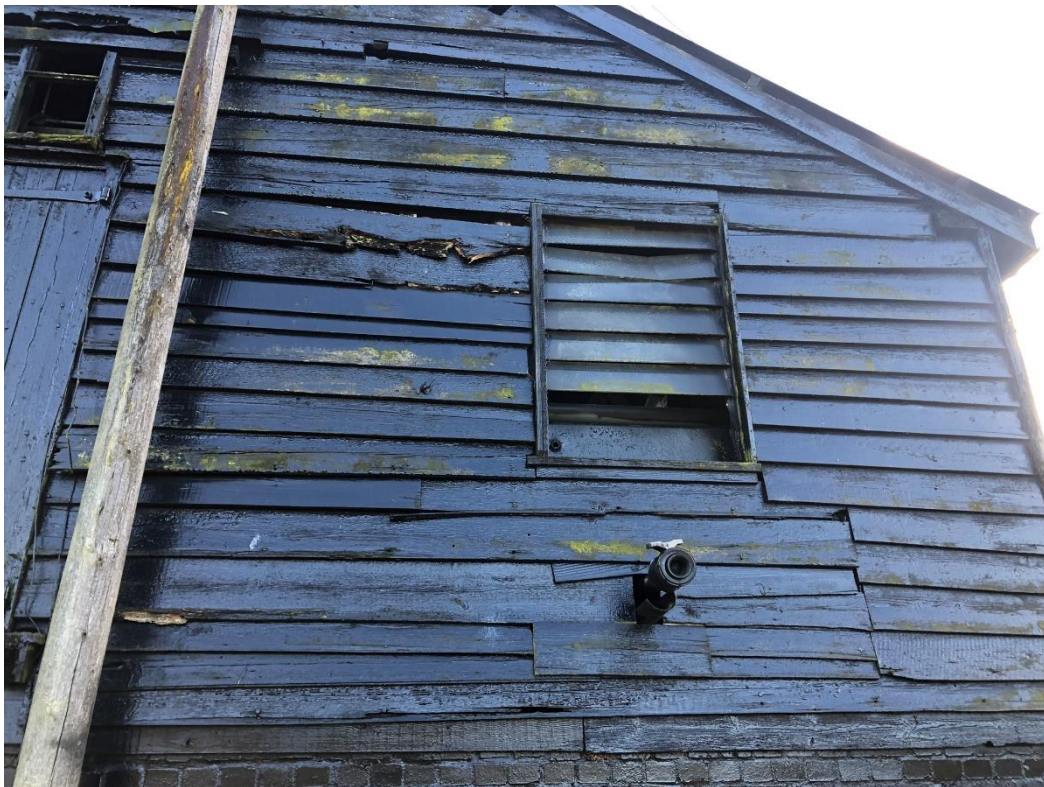
Photograph 3

- 4.4 The condition of the timber cladding is variable with some loose and / or rotten boards in various locations across the elevation. (See photographs 3 and 4). The majority of cladding does, however, remain in situ.

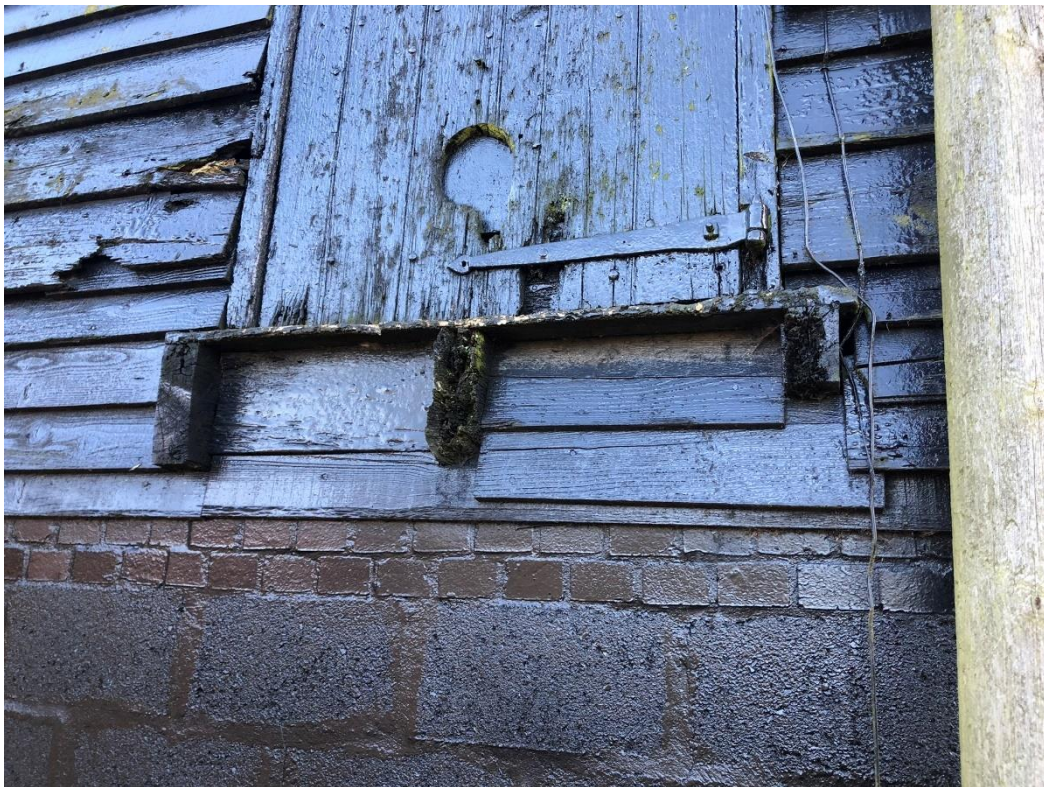
Photograph 5

- 4.5 To the centre of the elevation there is a first floor level door, we understand the previous access to the grain store above. There are three timber beams, which look as though they previously supported a small external deck outside the door, and these are suffering from various degrees of rot. The central one, in particular, is in poor condition. (See photograph 5).

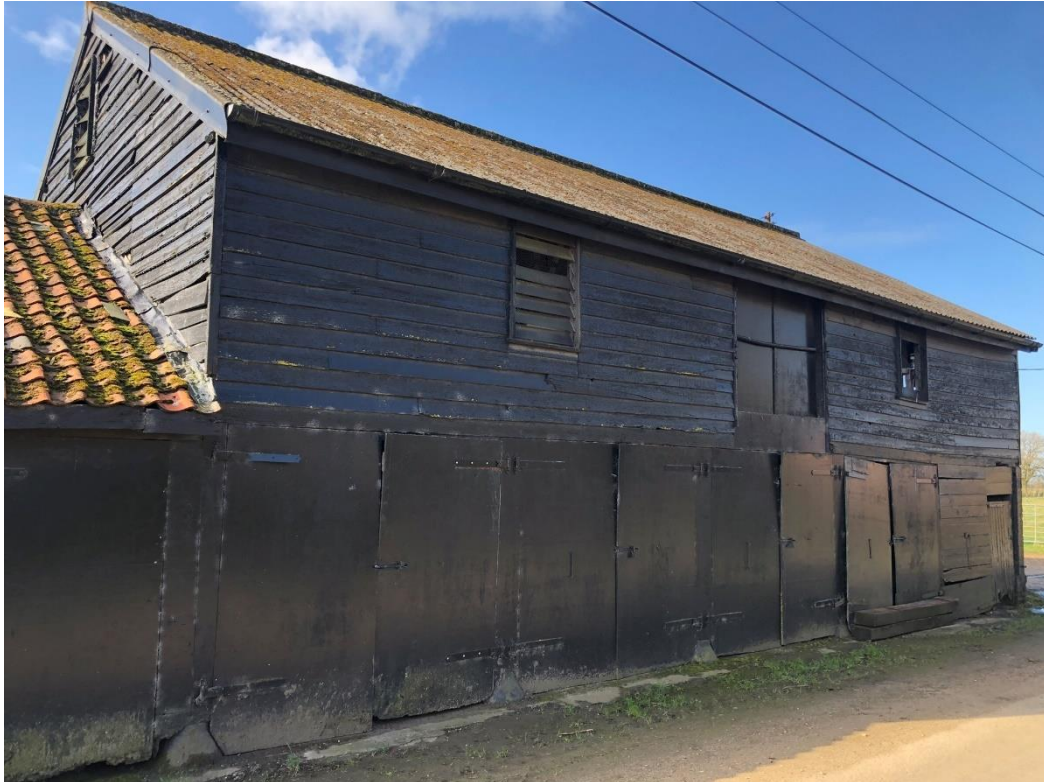
- 4.7 Photograph 6 shows a general view of the northeast elevation of the two storey barn. To this elevation, the first floor is timber clad, whilst the ground floor comprises a series of openings, with 4 No. pairs double doors present. There is a short timber clad panel and a pedestrian door at the northern corner of the building.

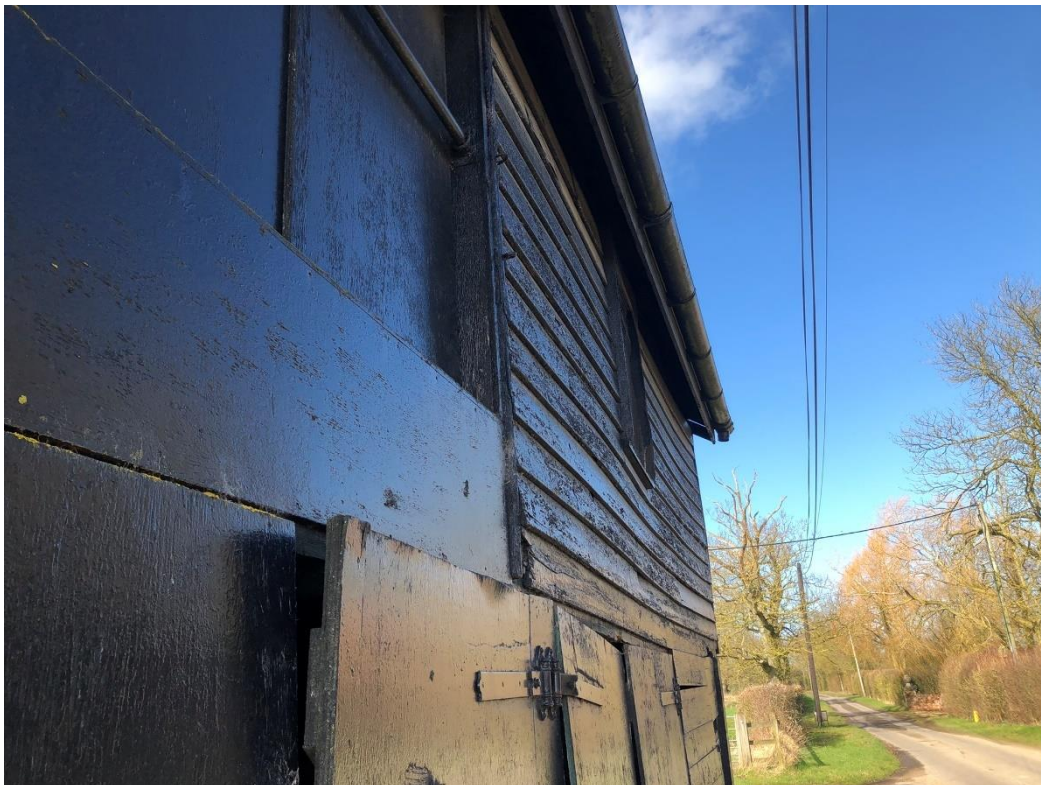
Photograph 7

- 4.9 There is some distortion of the wall line at first floor level, with an inward bow evident to the right hand side of the elevation. (See photograph 7). Directly below this area there is some damage to the timber framing, in particular the studs to the side of the pedestrian door do not appear connected at the base, and the first post to which the double doors are fixed, from the northern end of the building, is also showing signs of decay at the base. (See photographs 8 and 9).

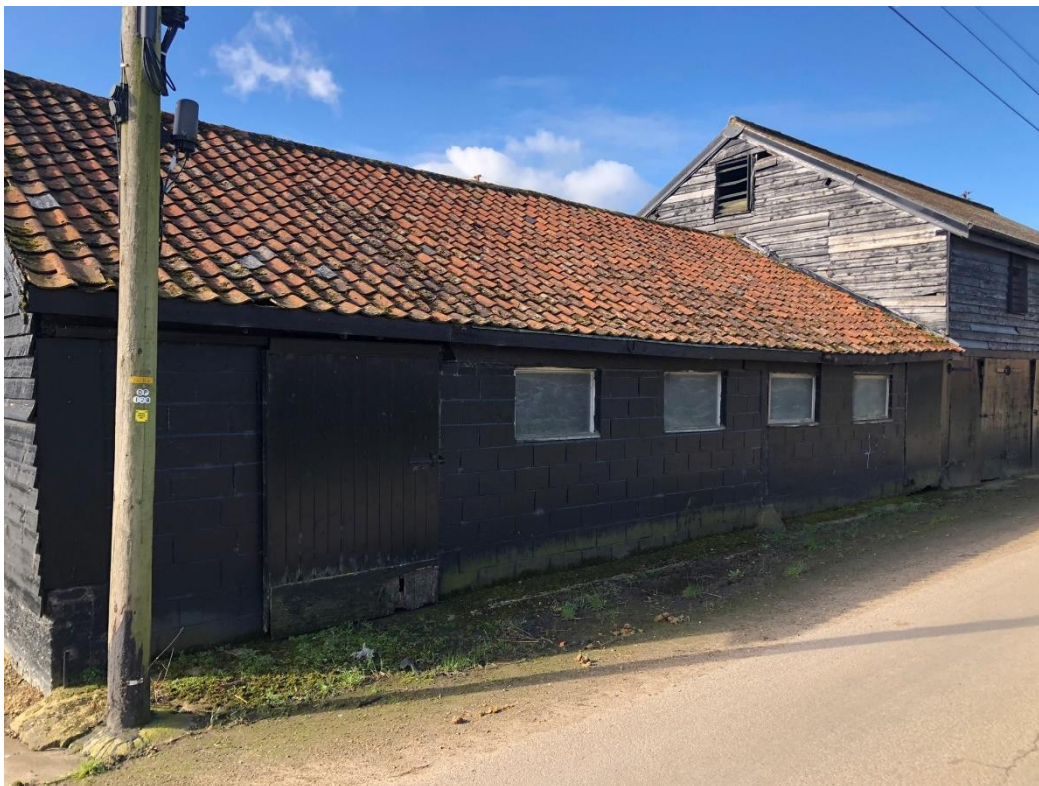
- 4.12 Photograph 10 shows a general view of the northeast elevation of the single storey section. This section of the property comprises a clay pantiled roof over blockwork walls at ground floor level.

- 4.13 The roof, as can be seen in photograph 10, does undulate both along the ridgeline, as well as having a slight sag evident to the roof slope. The eaves line is reasonably consistent to the left hand side, but does slope upwards towards the two storey section of the building. This may be by intent to accommodate a taller door at this end. (See photograph 11).

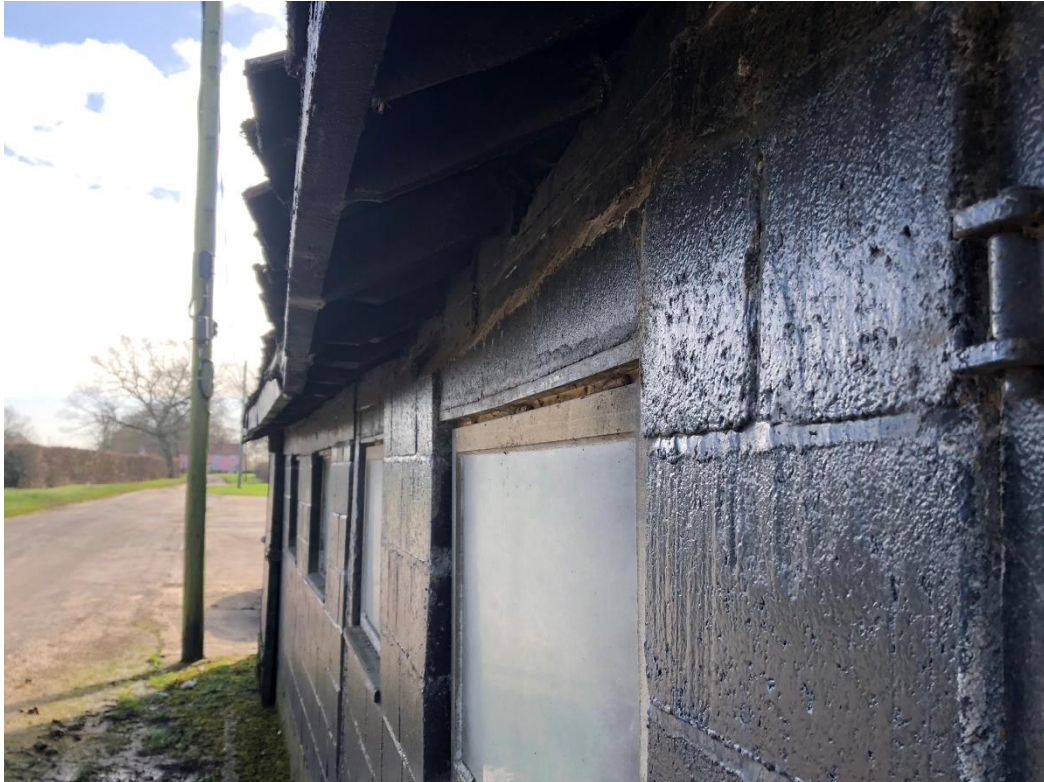
Photograph 12

- 4.14 The masonry line to this section of the building is not straight, but there is no obvious evidence of cracking, which suggests it may have been constructed as such, perhaps to replace an older distorted timber wall. (See photograph 12).

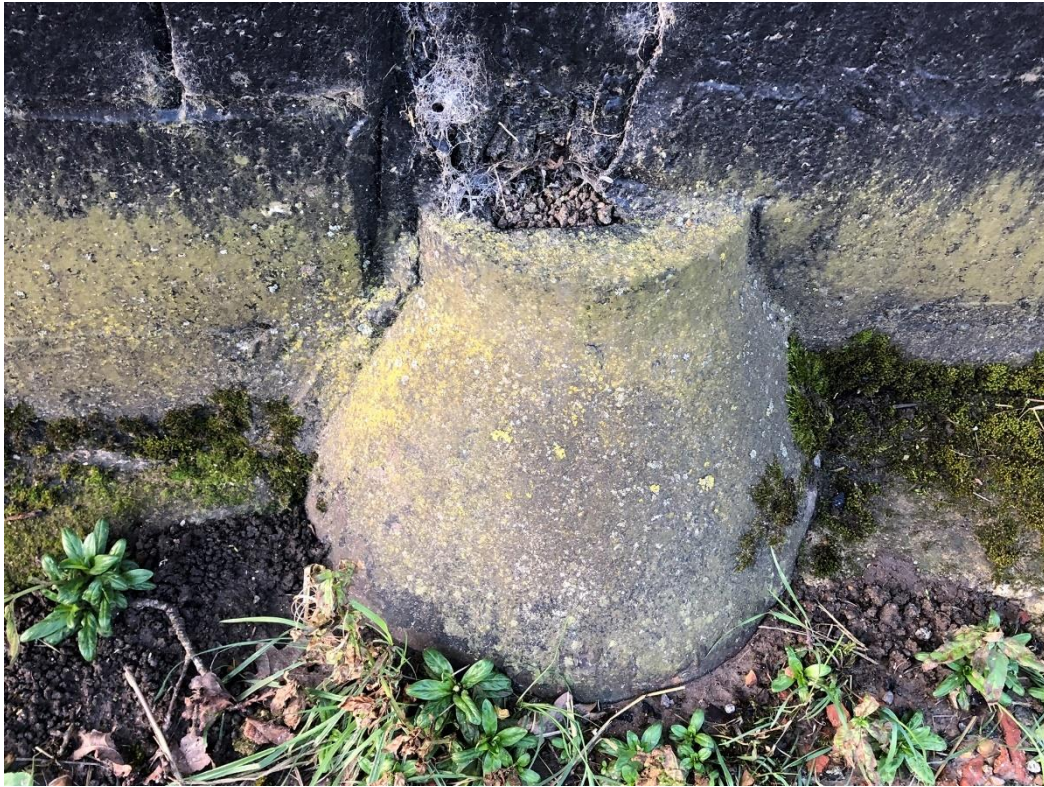
Photograph 13

- 4.15 There is a single visible timber post embedded within the masonry and there is some decay evident at its base, where it terminates on a truncated cone shaped rendered plinth. (See photograph 13). Of note is that there is no guttering present to the single storey section to this elevation. To the

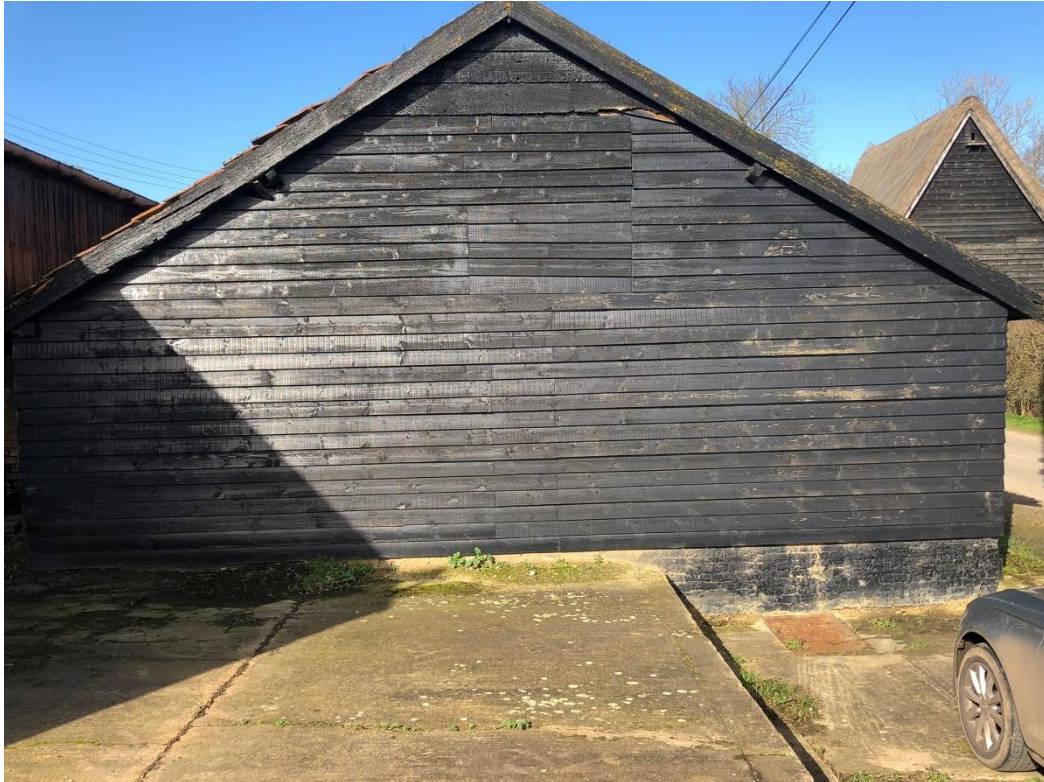
- 4.16 Photograph 14 shows a general view of the southeast gable, which is clad in shiplap timber boarding over a masonry plinth. There are two large grates at this end of the building over drainage or possible a culvert, the water seemed to be running constantly.
- 4.17 The eastern gable wall does step in slightly above eaves level. (See photograph 15). Also visible in photograph 15 are a number of missing tiles along the roof verge. Both the northeast and southwest facing roof slopes are missing a number of tiles. The cladding to this elevation again is largely intact. There is a small section of missing board to the left hand side of the purlin to the rear roof slope (see photograph 16) and a slope to the boards at higher level, visible in photograph 14.

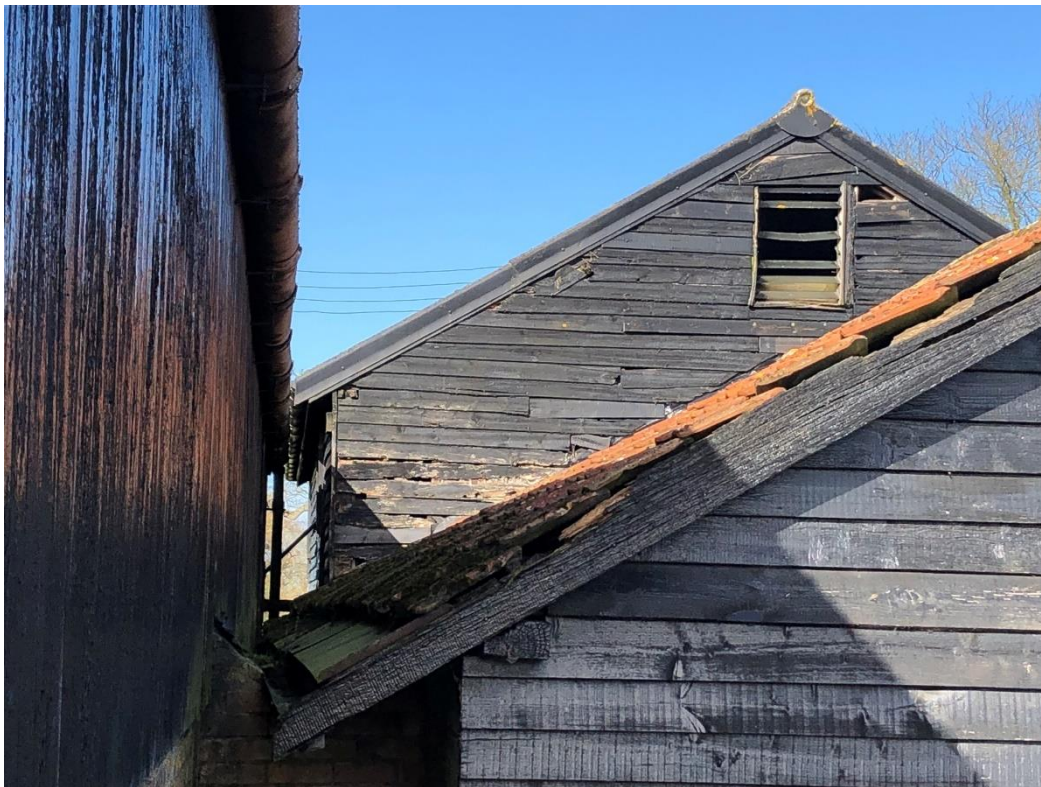
- 4.18 Photograph 17 is a view of the rear section of the southeast gable to the two storey element. Again, the shiplap cladding is largely intact and a verge board is also in situ in this location, however, the cladding does appear to be suffering from more serious decay, particularly to the section just above the lower roof slope.
- 4.19 To the southeast side, the cladding is in better condition, although the flashing between the two sections of building is in poor condition. (See photograph 18).

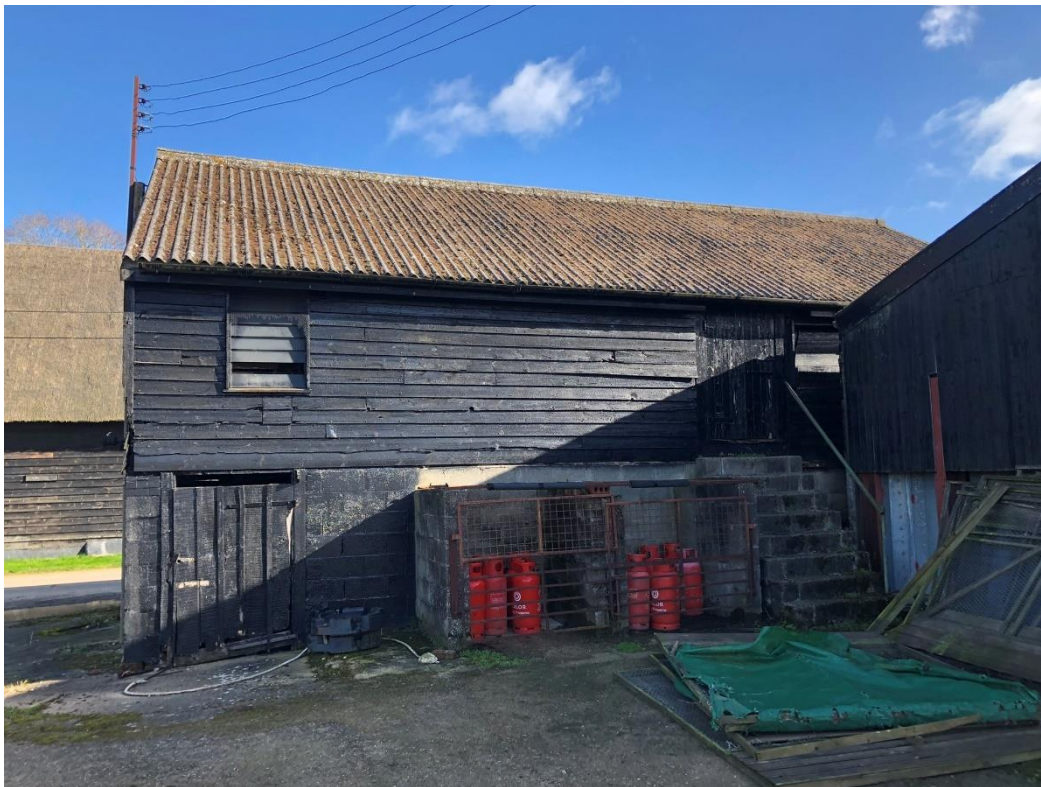
- 4.20 Photograph 19 shows a general view of the southwest elevation of the two storey element. Part of this elevation, and all of the single storey elevation, are largely obscured by the adjacent barn. This barn, which currently provides the subject building with some shelter from the prevailing winds, will be removed as parts of the proposals. There is a narrow, circa 600mm, gap between the buildings, with a concrete channel between the two. (See photograph 20). This is presumably to

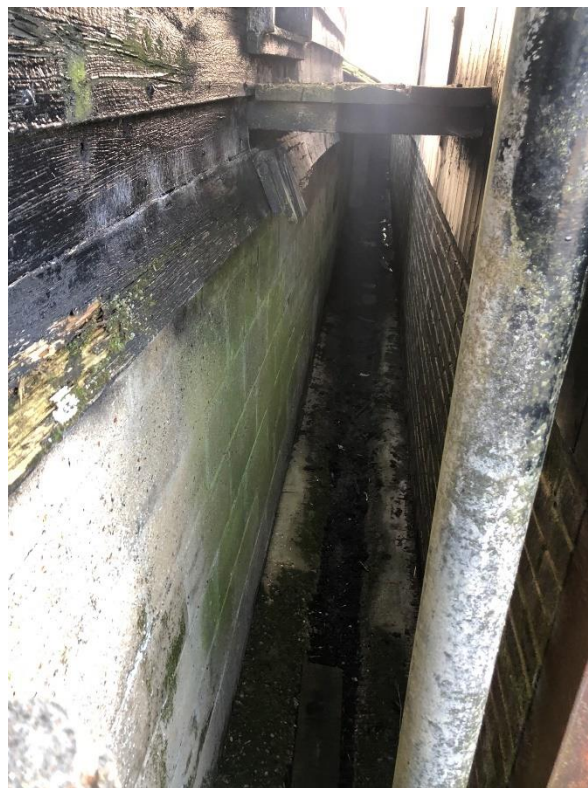
Photograph 20

allow for the fact that there are no rainwater goods on the single storey section of the building. However, at the present time the channel has largely silted up.

- It is also essential that new guttering is installed to the northeast and southwest flank walls, and properly connected, ideally below ground level, to facilitate disposal of the surface water away from the building.

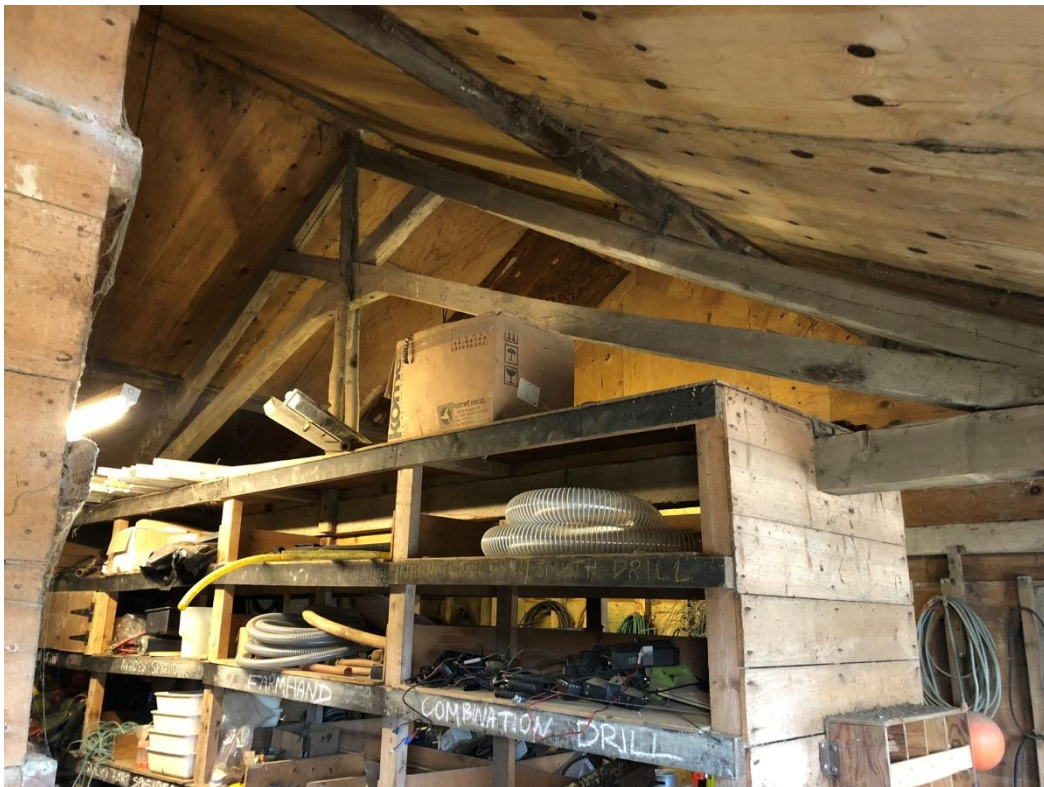
- 4.24 Photograph 21 shows an image of the typical modified scissor truss. In addition to the usual scissor configuration, there is also an eaves level tie beam around which, storage shelving has been constructed and additionally, two anti-sag timbers, which connects the apex of the truss to the bottom chord. These additional timbers are untreated round sections.

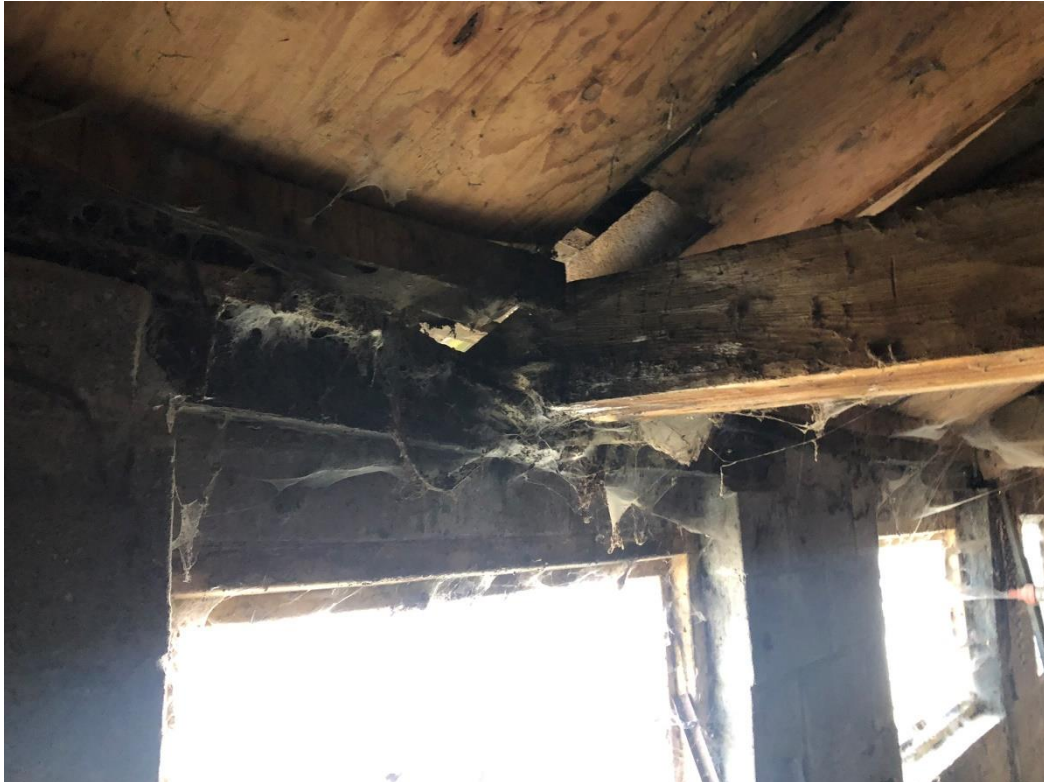
Photograph 22

- 4.27 To the northeast elevation, the final truss bears over an existing lintel opening with some staining to the truss itself and a possible failure of the lintel and / or bearing evident. (See photograph 22).

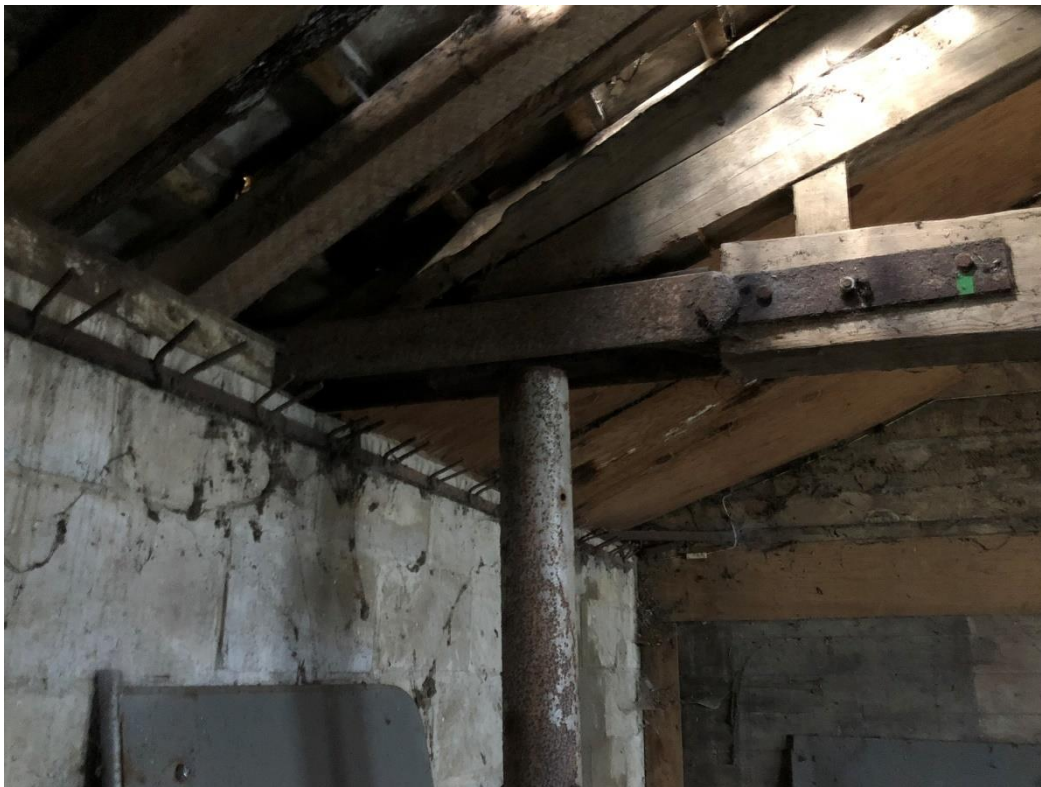
Photograph 23

- 4.28 To the rear (southwest) elevation, the two trusses in closest proximity to the two storey section, have also suffered from decay. At the bearing location to the final truss a crude repair has been undertaken comprising the splicing of the bottom chord to a section of 'I' joist laid flat, which is in turn propped onto a circular column. (See photograph 23).

the two trusses in closest proximity to the two storey element. These trusses will require a more suitable designed and sympathetic repair.

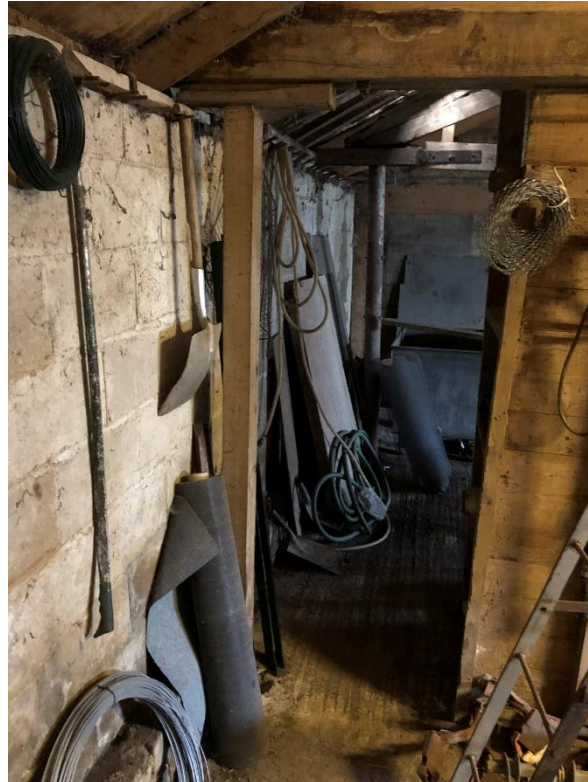
Photograph 24

- 4.29 On the adjacent cross wall line the tie bar is propped at its end with a timber post. (See photograph 24).
- 4.30 With the exception of these three areas the truss timberwork generally appears to be in good condition, with little obvious evidence of staining in visible areas. Some staining is however evident to the purlins, notably to the southeast gable rear roof slope at the gable end. (See photograph 25).

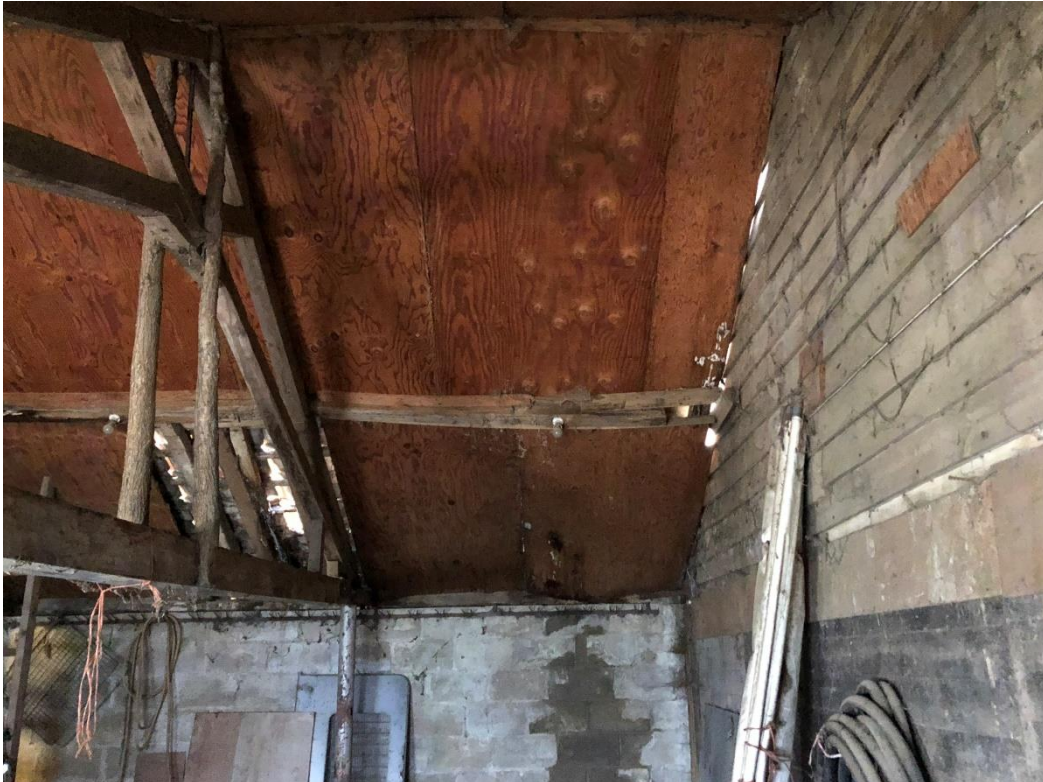
Photograph 26

- 4.31 To the front roof slope some remedial works have already been undertaken to the purlin. (See photograph 26). Whilst the roof structure is likely undersized by current standards, the trusses appear to be performing adequately, however, the purlins themselves do obviously sag between the points of support at the truss locations (also visible in photograph 26).

- It would be prudent to consider strengthening the purlins to the single storey section, which are visibly sagging . This level of deflection may cause damage to domestic internal finishes.

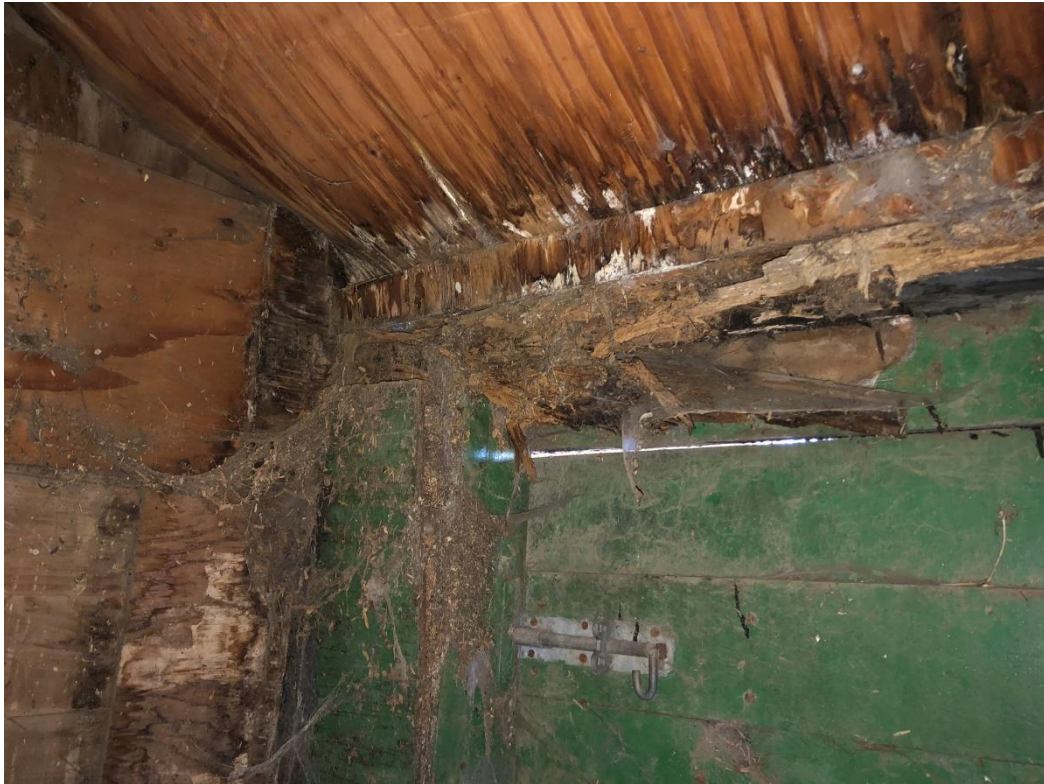
Photograph 27

- 4.32 Adjacent to the northeast corner of the single storey section there is some decay of the wall plate, (see photograph 27), although this issue is relatively localised.

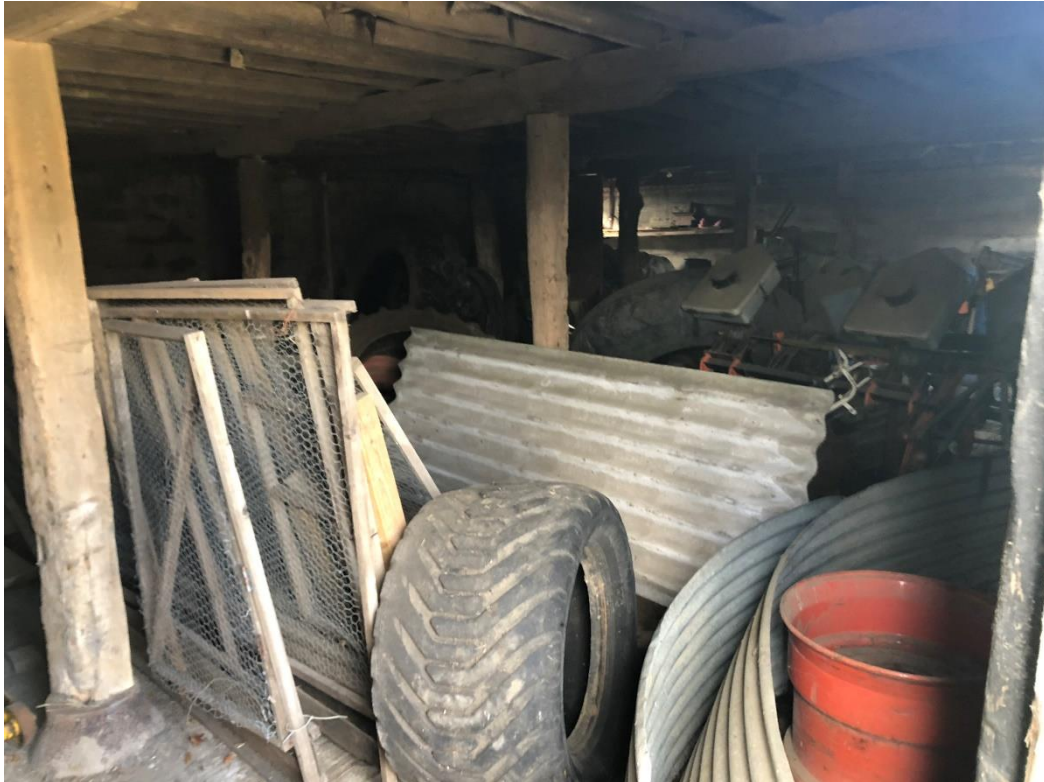
rectangular timbers and untreated logs. The posts either bear on a truncated conical plinth or directly onto the internal floor. These are all considered to be of sufficiently substantial section to adequately support the vertical floor loads from above. Photograph 28 shows a general view looking across the ground floor store.

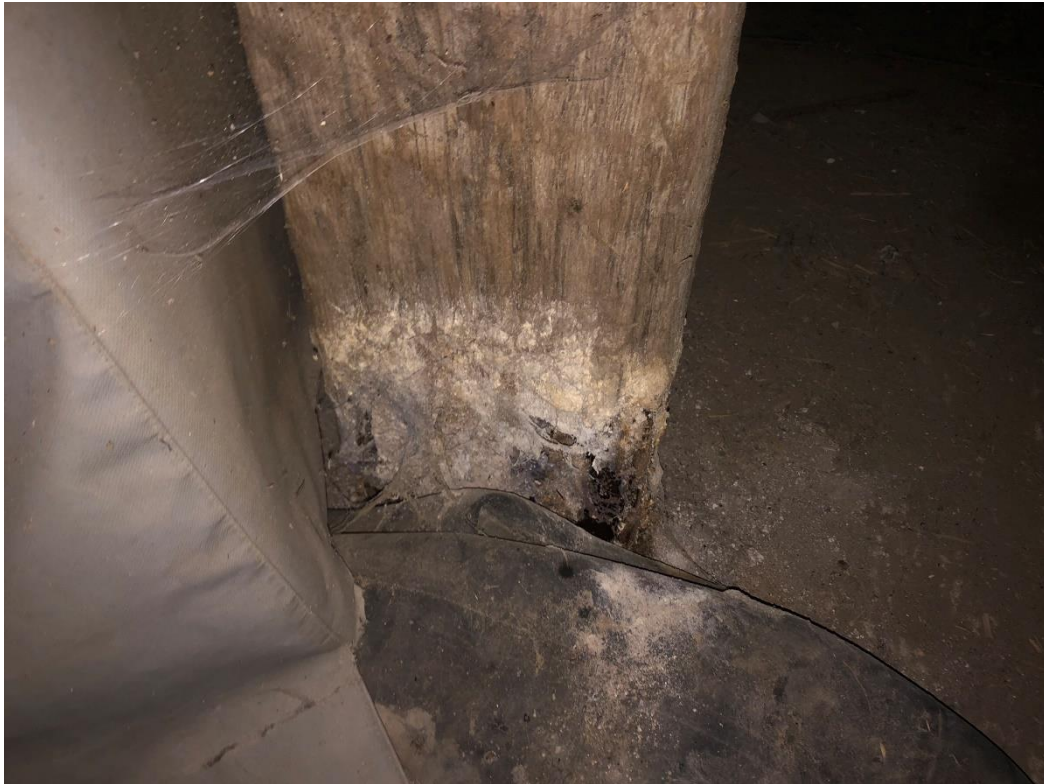
Photograph 29

- 4.35 Whilst much of the walls in this area are obscured were noted. In particular, at least one of the internal columns seems to be suffering from significant decay at the base. (See photograph 29). Towards the northern corner of the building, the first of the timber posts, which supports one of the external doors has rotten and appears to have moved off its plinth. (See photograph 30) Some damp staining was evident to the internal walls, but there were no significant signs of structural movement.

- To the two storey element, decay was noted to the base of at least two of the posts (not all could be inspected due to the stored materials) and it is essential that all post bases are exposed and inspected, with any remedial or revised detailing required being undertaken.

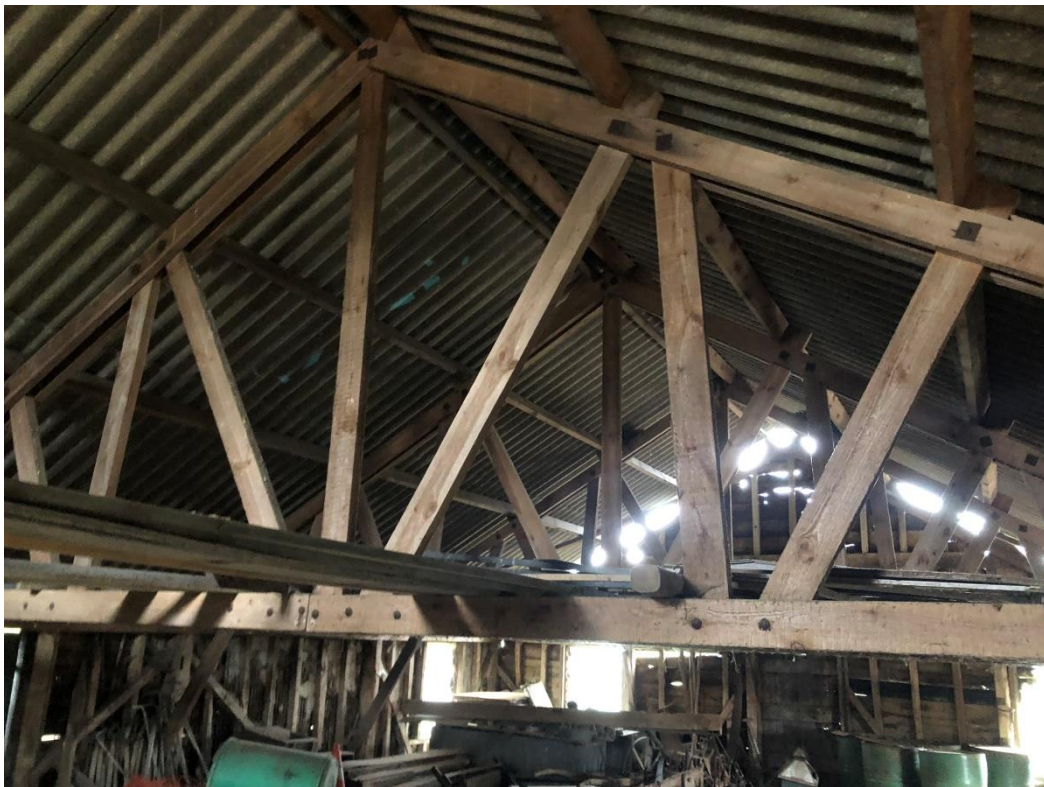
- 4.38 Photograph 31 shows a general view of one of the first floor trusses (seemingly a combination of Fink and Howe type truss), with an additional diagonal strut connecting the rafter and bottom chord of the truss to the timber post (see photograph 32). The trusses have been formed in 50 x 125 deep timber with the rafter and tie beams doubled up. The connections all appear to be single bolts.
- 4.39 Four purlins to each roof slope support the corrugated cement roofing sheets. Both the trusses and the purlins generally appear to be in good condition, albeit very likely undersized by modern standards. It is probable that some decay will be evident when the roof covering is removed, particularly to the northwest facing gable, where the end grain of the purlin is visible externally due to the lack of verge board.

- Trusses to the two storey element are very likely undersized by current codes of practice. Whilst these are adequately supporting the existing lightweight roof covering, some strengthening / augmentation cannot be ruled out to ensure that these are suitable to support alternative roof coverings or domestic finishes.
