7 April 2022

Ref: EPG/2022/TFW/CSS/Q002/01

### **Coelbren Health Centre, SA10 9PE, Mine and Landfill Gas Risk Assessment**

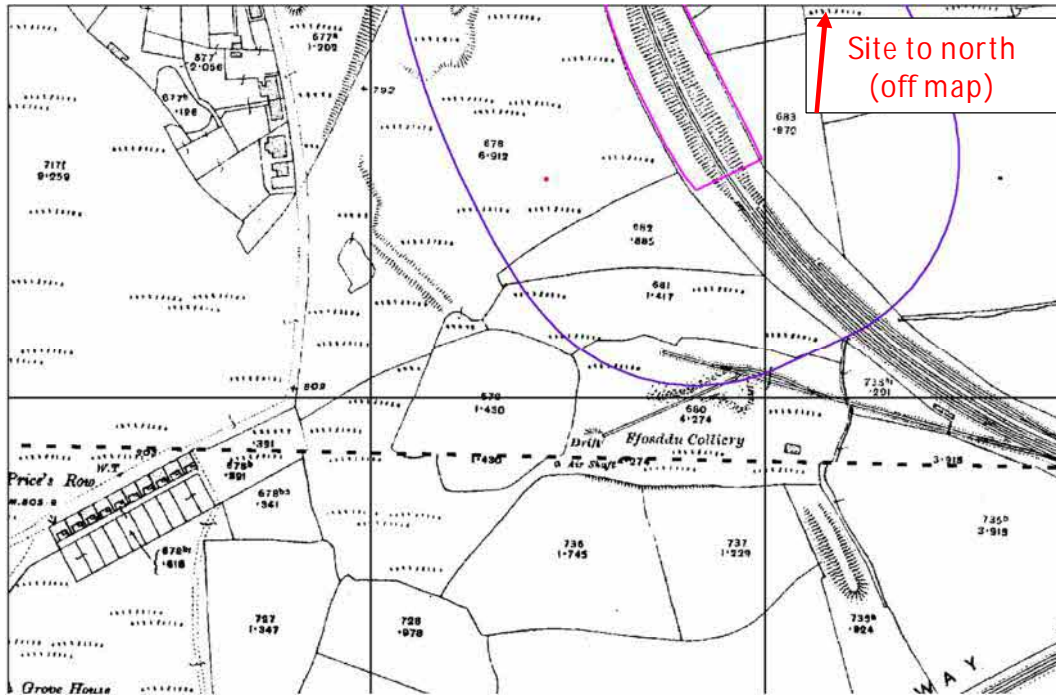
**Extract from 1919 map**

- There are no mine entries within 50m of the site boundary. The nearest entry will be the Ffoddu Colliery drifts and air shafts are shown on the 1919 Edition map which are located 105 m or more to the south of the site. This is down dip of the site and

therefore will not influence the site. The colliery is in the same area as a series of coal seams that terminate west of the site. The map (extract below) shows the drift enters the ground heading south west and there an air shaft further south. Thus it does not pose a risk of mine gas migration towards the site.

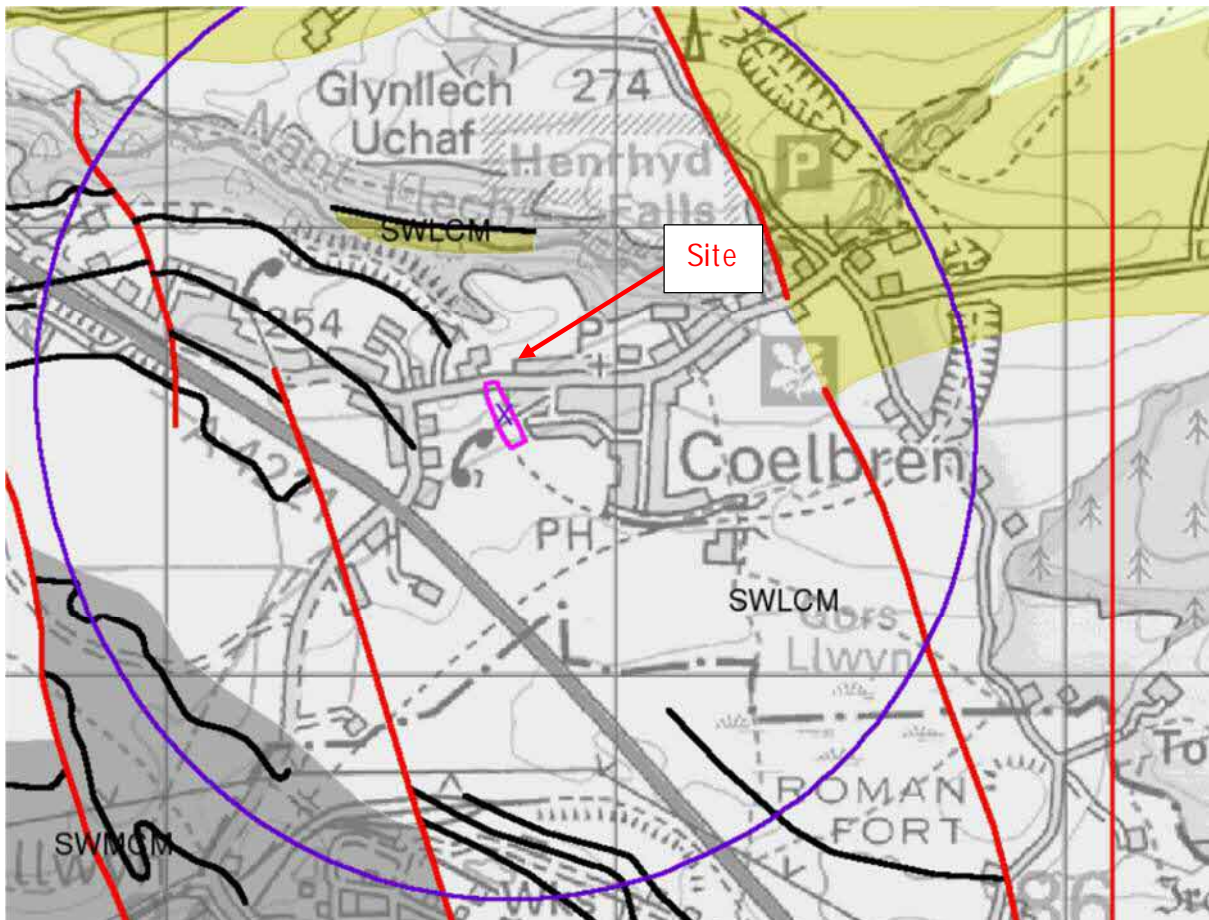
### Extract from geological map in Envirocheck Report

- The geological maps show that there are not likely to be shallow worked coal seams below the site. Coal seams outcrop to the north west of the site but appear to dip to the south west, ie away from the site (see extract below). The outcrop also terminates west of the site, probably as a result of faulting (there is a fault shown to the west as a single line but faulting more usually covers a wide zone and may not be shown on the map).

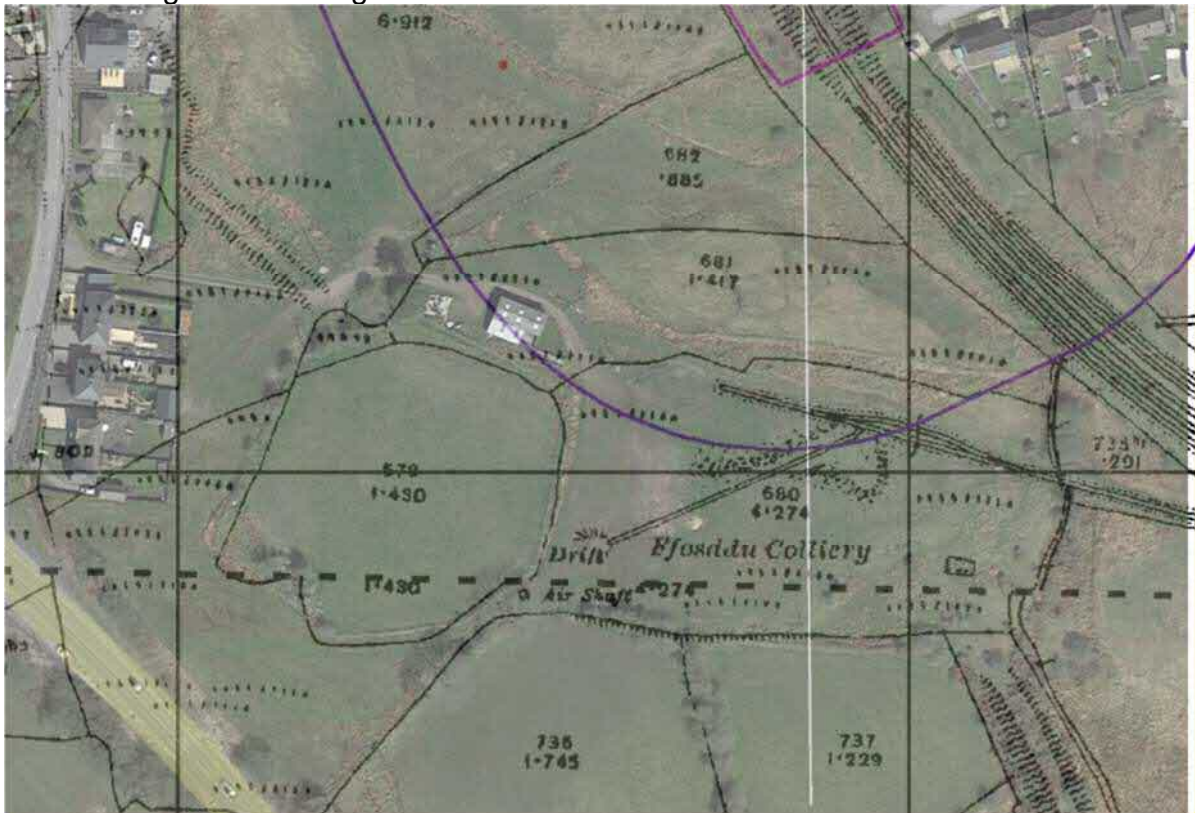
**1919 map overlain by current Google Earth image**

- Inspection of the old maps shows this is an old ironstone quarrying area which was extensive across the area on the 1888 map. The area of the refuse tip is shown as an old shallow quarry on the 1888 map. The 1919 map shows it is level with the surrounding area and the quarry excavations are no longer shown. Ffonddu Colliery is now present. The evidence shows that prior to deposition of waste the area of the tip was leveled with colliery spoil to

surrounding ground levels. An extract of the 1919 map overlain by the current Google Earth image is shown below.

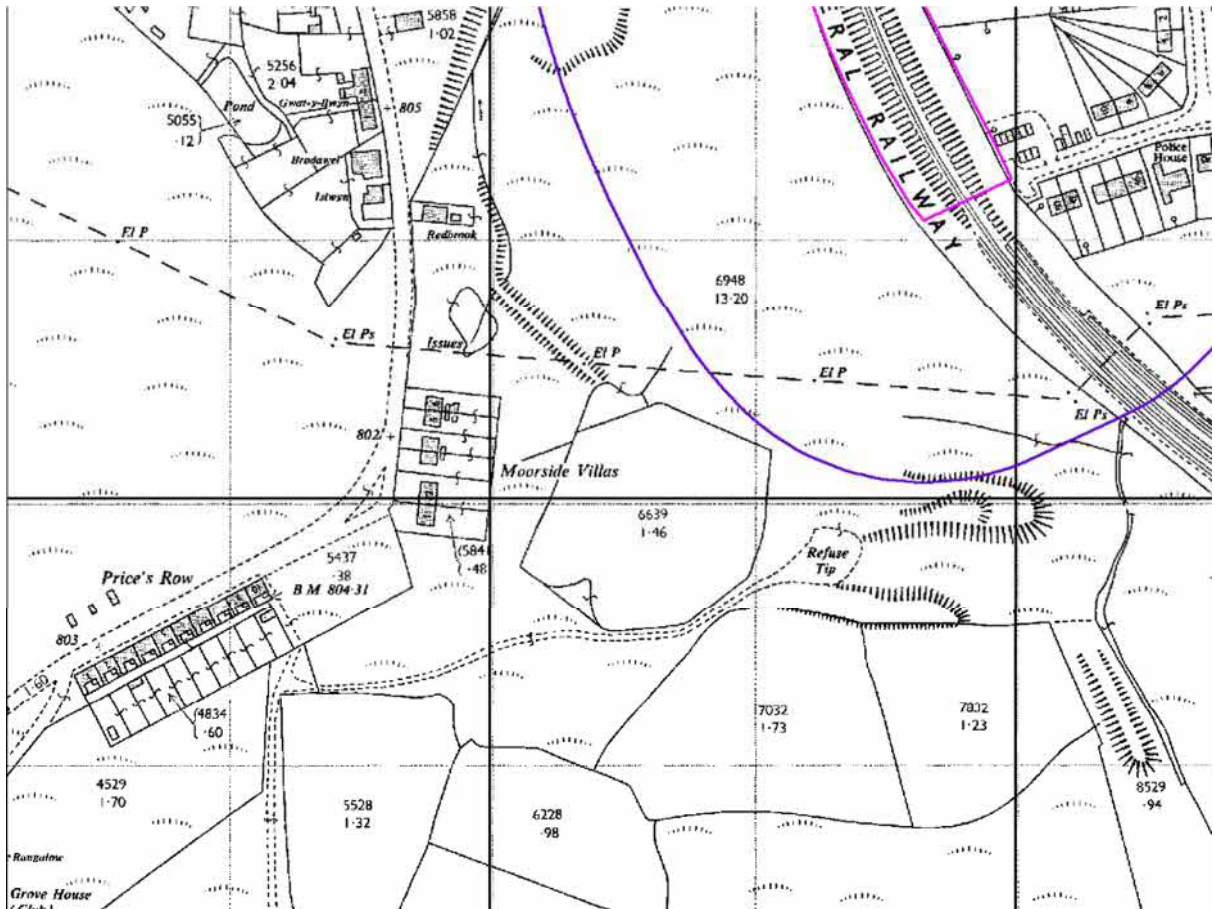
**Extract from 1962 map**

- The refuse tip is first shown on the 1962 map (extract below). At such time there would be limited degradable material in any domestic refuse and it would mainly be ash, glass, etc. The tip is last shown on the 1993 map although it appears that filling was complete by the 1987 map. Later waste may have a higher degradable content.

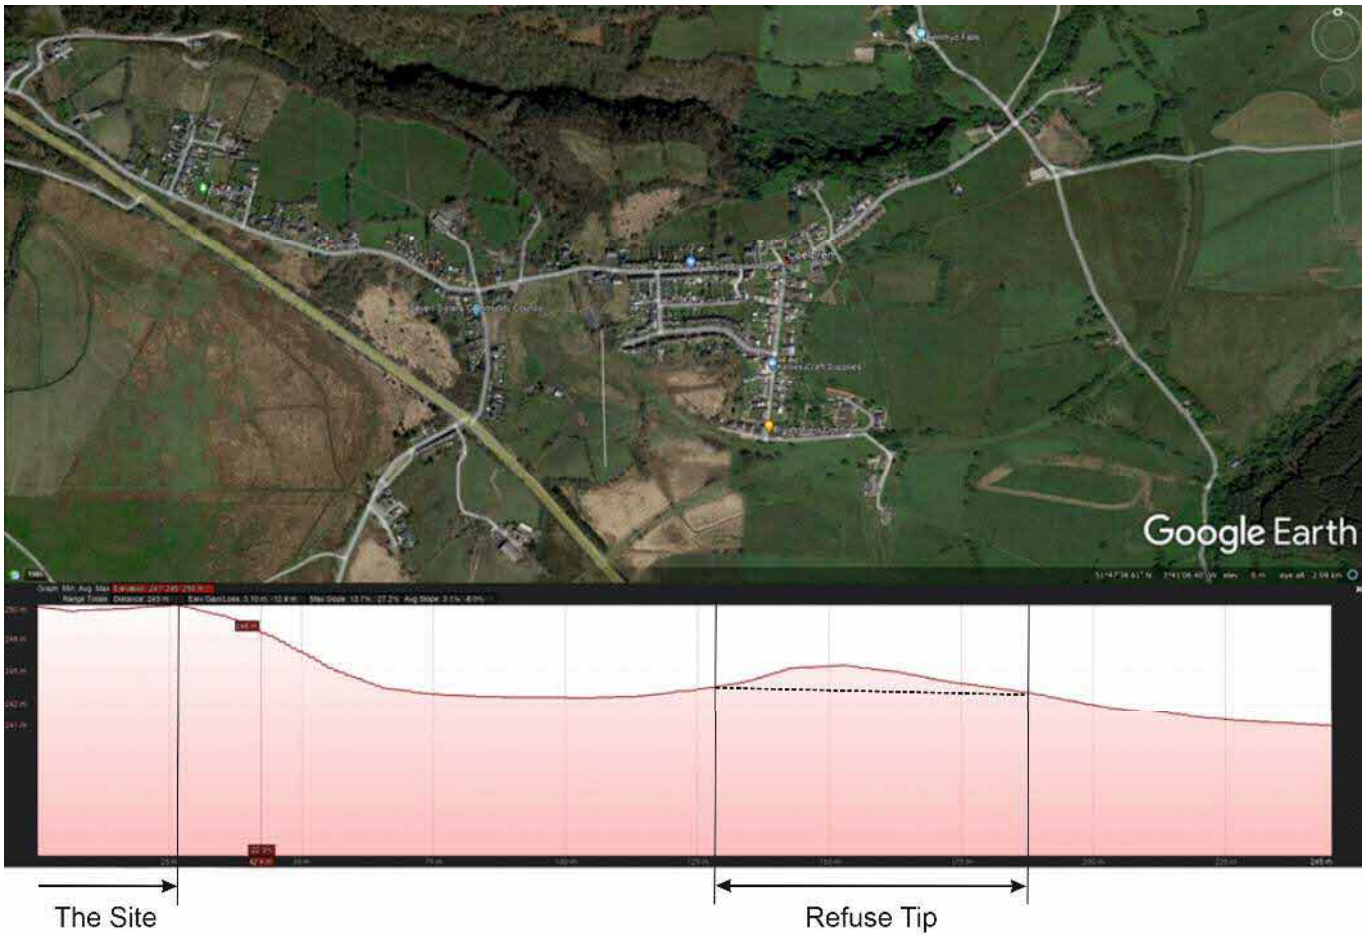
**Google section showing ground levels**

- There is no evidence on the maps of any deep excavations in the area of the refuse tip after the Ffonddu colliery was shown. Therefore, the refuse tip is a land raise. This is suggested by the historical maps which show the tip as an embankment. Furthermore the cross section of ground levels shown below shows the refuse site is above surrounding ground. It also shows that the development site it is at a significantly higher elevation.

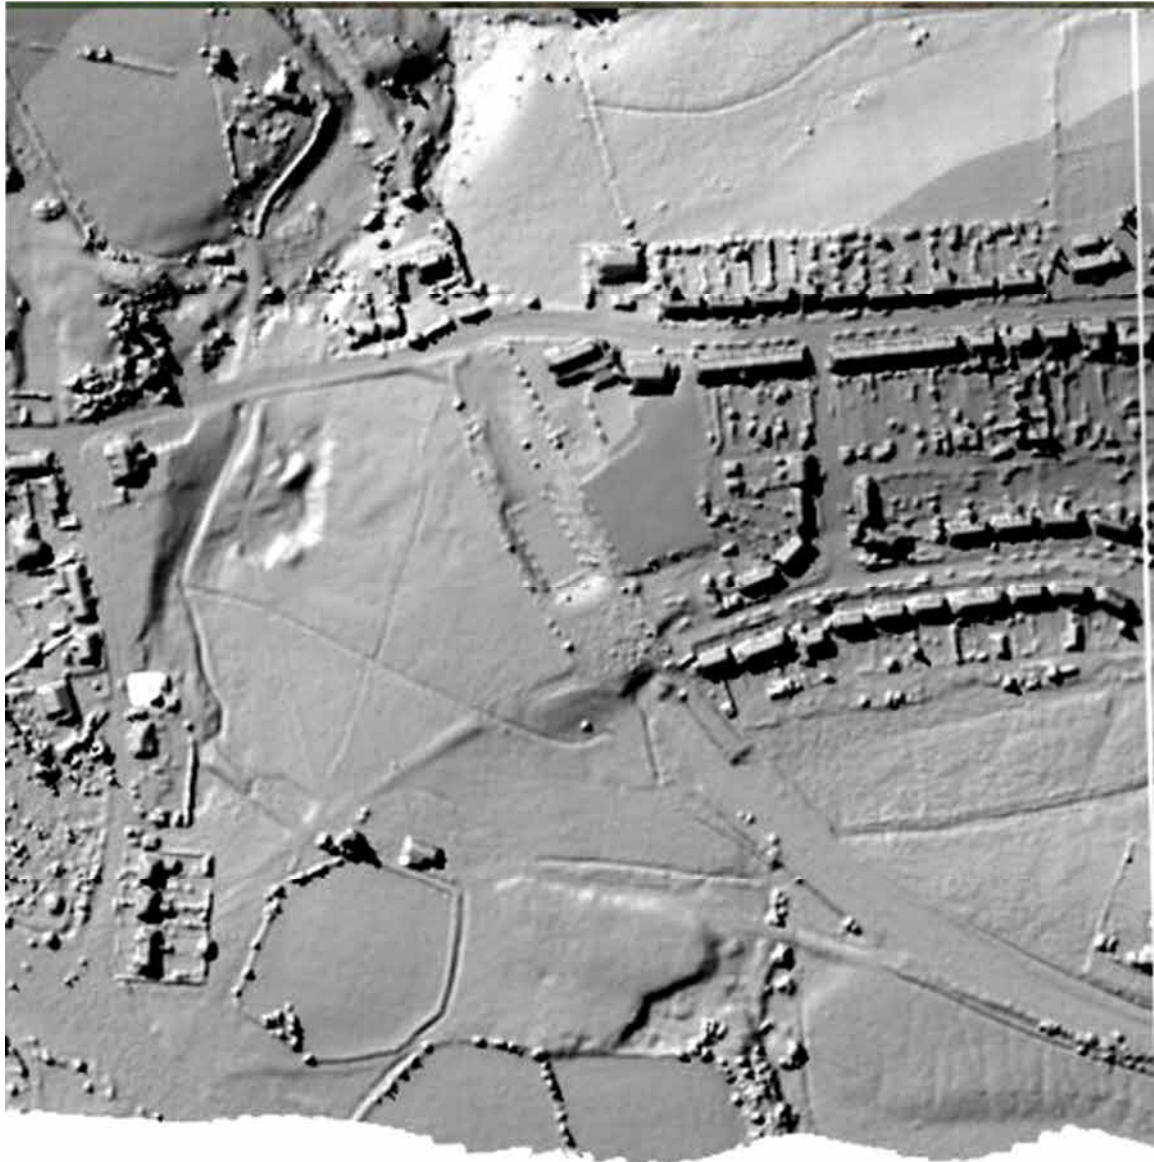
Lidar map

- The LIDAR map of the site provided below confirms that the landfill is a land raise (and it corresponds to the position shown on the maps as demonstrated by the overlay). It also shows that the former cutting below the site has not been completely filled and the site is lower than the surrounding ground.

Therefore even if the landfill was filled with domestic refuse, because it is above ground it would not cause landfill gas migration to this site. Furthermore the Glacial Till would also limit the potential for gas migration over 241m because of its low permeability.

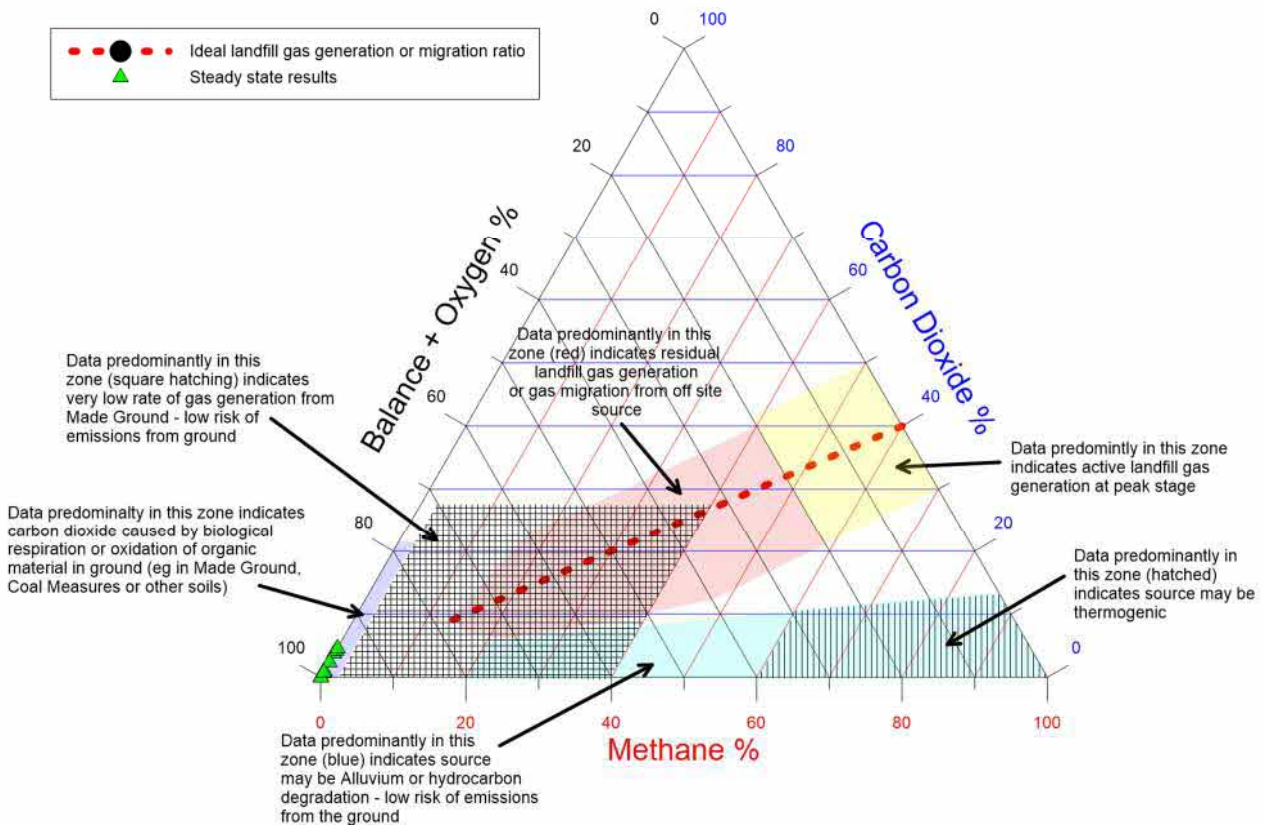
**Ternary Plot Steady State Data**

BS8485 and BS8756 indicate that steady state values of gas monitoring data should be used in a risk assessment. In particular peak flow rates on opening a gas tap are not representative of the surrounding gas regime. Steady state results show methane <0.1%, carbon dioxide up to 4.6% and flow rates up to 0.4l/h. The slightly elevated carbon dioxide concentrations are caused by biological respiration of organic material in the Glacial Till as shown in the Ternary plot in the Figure below. All the hazardous gas flow rates are less than 0.7l/h and the site is characterized as Characteristic Situation CS1 in accordance with BS8485: 2015 + A1: 2019.

Furthermore the gas monitoring data in the site as plotted above shows that there is no landfill gas migration from off site landfill sites.

The site is classified as Characteristic Situation CS1 and gas protection measures are not required in the building when it is changed to residential use.

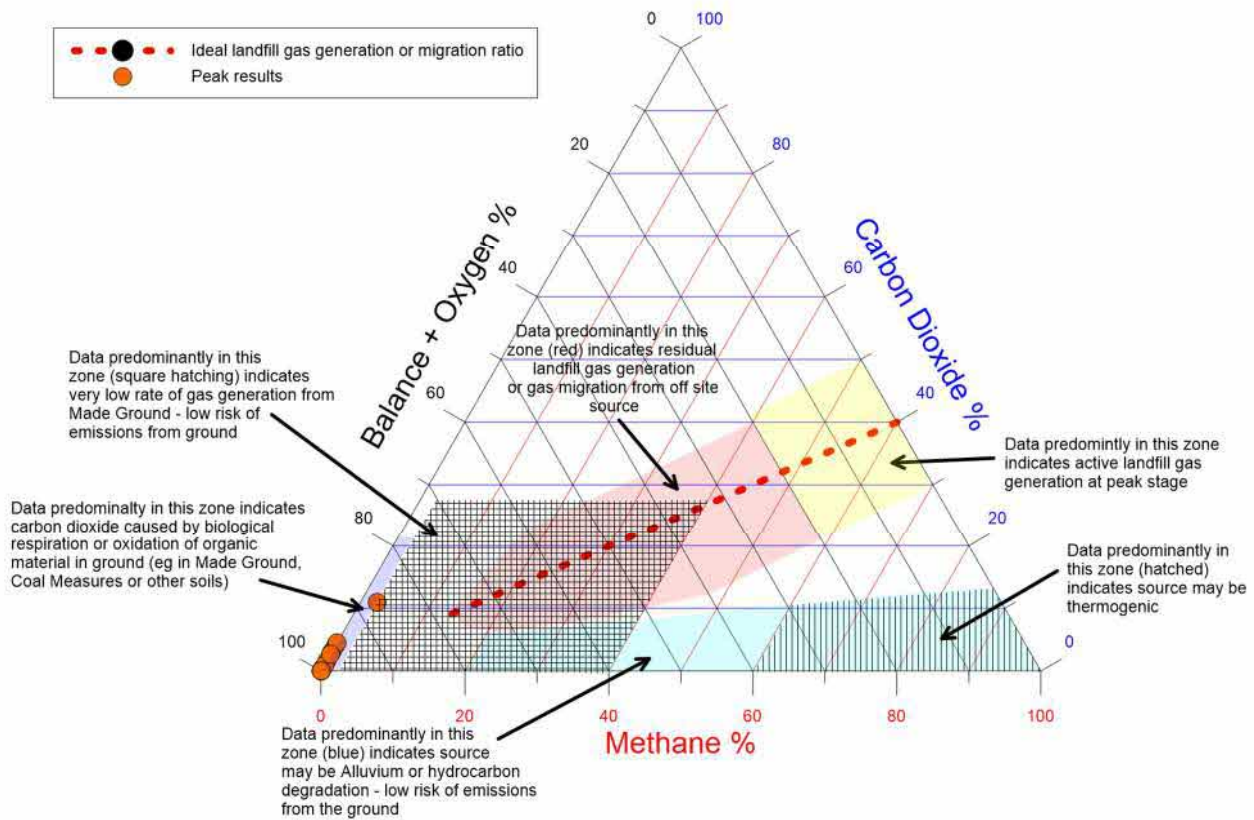
**Ternary Plot Peak Data**

Even plotting the peak data which is not representative of site conditions shows the gas concentrations recorded are not indicative of hazardous emissions. Again all the hazardous gas flow rates are less than the limit for Characteristic Situation CS1. Even a worse case check gives a GSV of 0.0138l/h which again indicates CS1. Given the CSM discussed above and absence of any significant high risk source of gas, plus the ternary plots it is reasonable to leave the classification at CS1 even though one reading recorded above 1% methane and two results were above 5% carbon dioxide. This is in line with the guidance in BS8485.
