The Old Cottages, Mellis Road, Thrandeston, Suffolk.

A schedule of repairs to the timber frame.

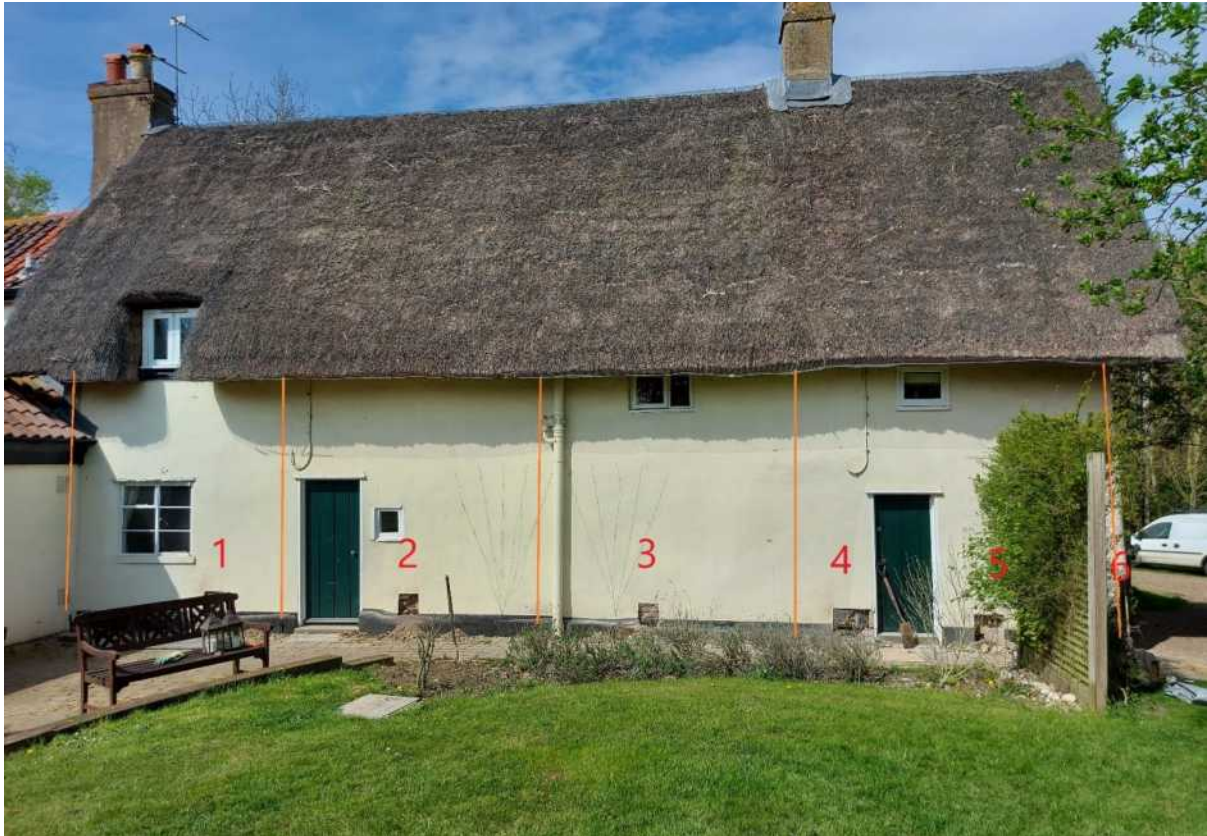
Above, the south elevation with six sections of render removed and crossframes marked in orange.

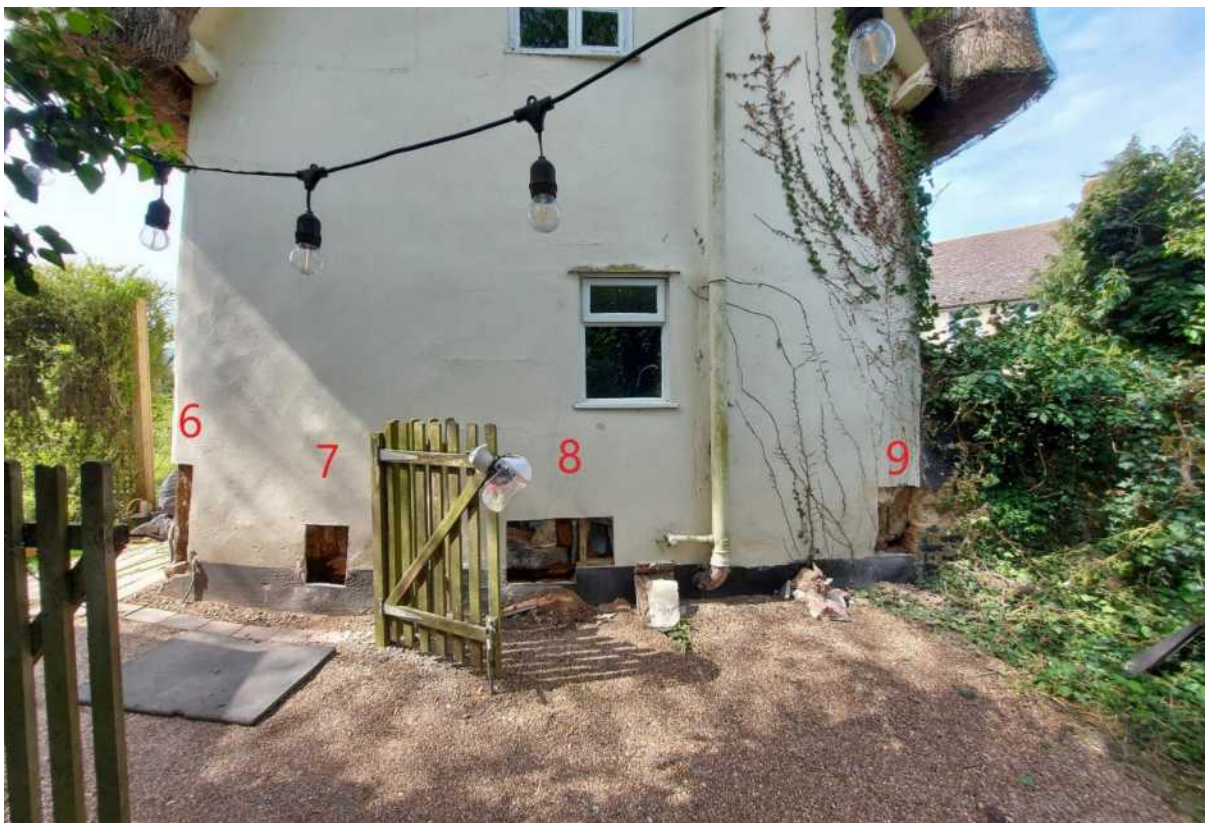
Below, the east elevation with four sections of render removed.

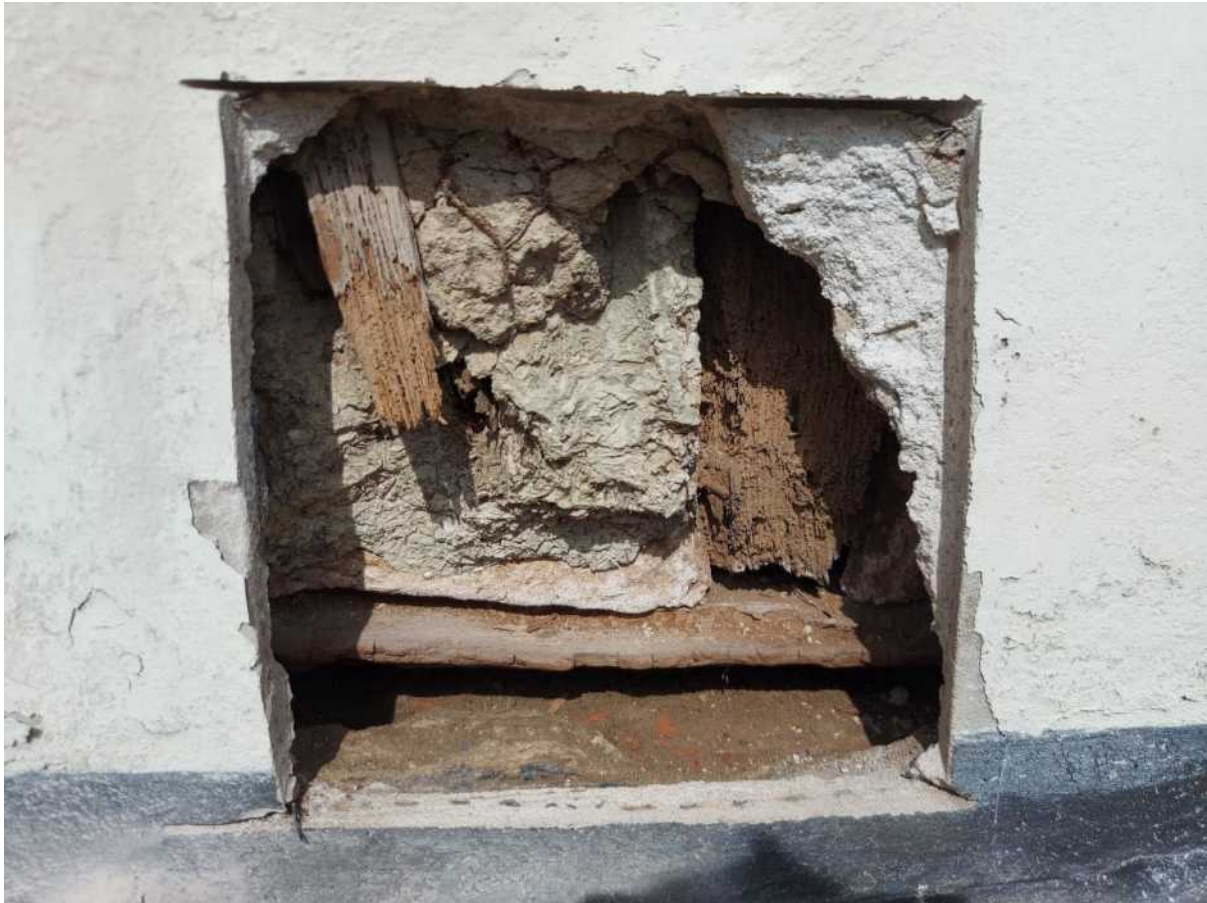
1. This bay-length of sole plate is in very poor order with the thin section remaining in a very friable condition. The stud to the right is extremely thin and has no connection to the plate, although it is probably a later, poor-quality replacement anyway.

Areas of wattle and daub infill remain and we would hope to retain these wherever possible but with the entire length of plate being removed and replaced this will be a challenge. If they are stable and solid enough they will be repaired with new daub as required but if they prove too friable they will be replaced with a sheep s wool insulation prior to the exterior rendering being applied.

We propose to remove this length of sole plate and replace it with a new, appropriately dimensioned section of approximately 180mm wide x 125mm 150mm tall. The stud, along with any others in poor condition will have simple patches to the outer face or half-lapped scarfs and fixed to the new sole plate with stainless steel L-brackets.

The reason for using brackets is that the plinth appears in reasonable condition; to use mortice and tenons would require two courses of brick plinth to be removed to allow the joinery to be assembled and given that the plinth appears acceptable this would be an expedient compromise that retains as much historic fabric as possible as well as not disturbing the internal floors too much by rebuilding elements of the plinth.

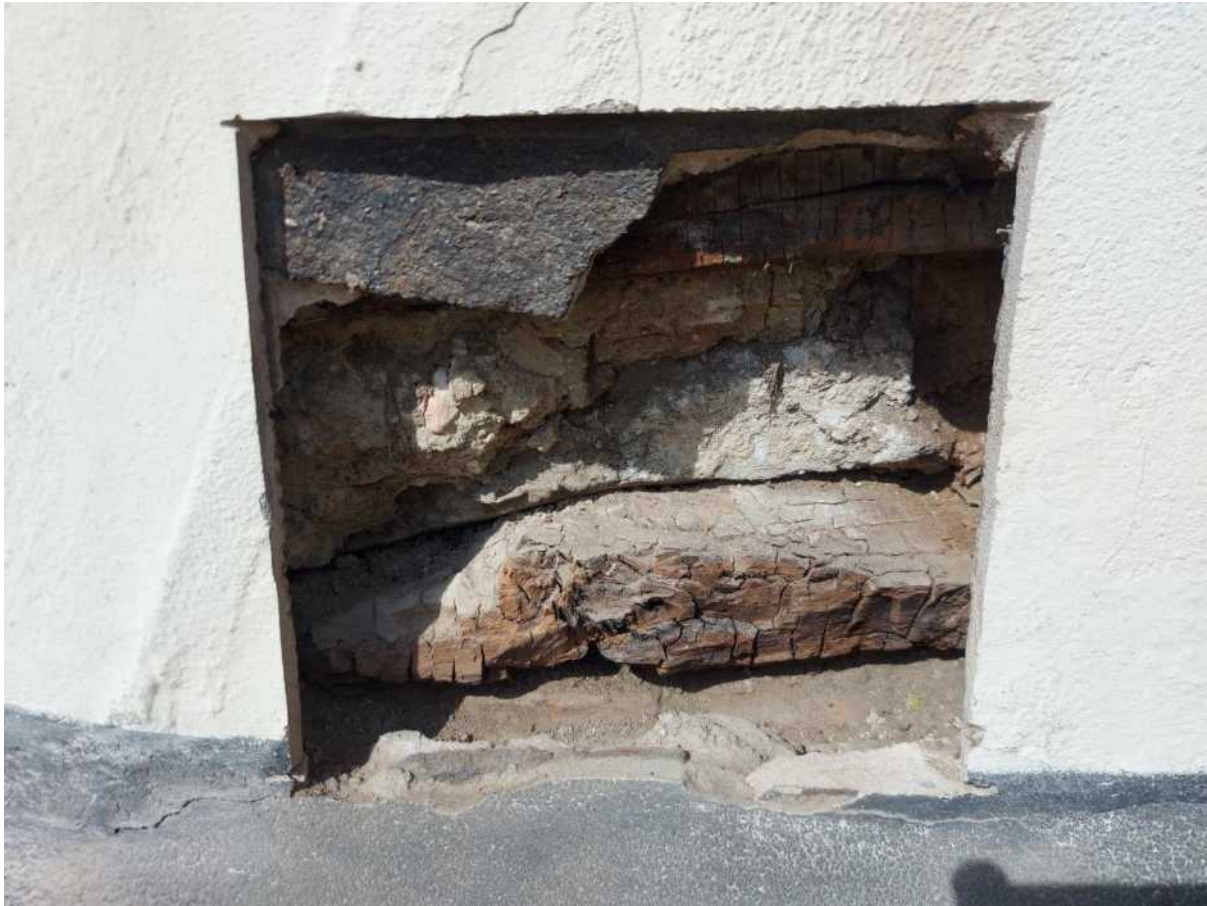
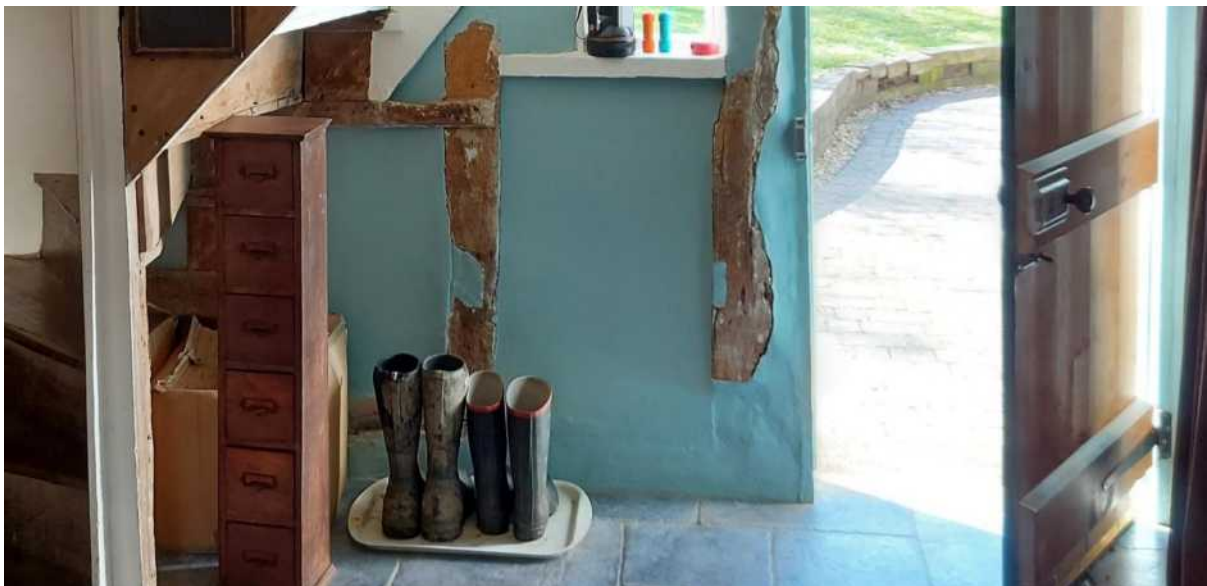
2. This length of sole plate is also in poor condition with poor quality timber having been used (once again, a later replacement timber) that has subsequently decayed and broken. Internally it had been mostly plastered over to hide the condition of it (see lower picture).

We propose to replace this bay-length plate with a new, appropriately dimensioned section of green oak approximately 180mm wide x 125mm 150mm tall. Any decayed studs will have simple patches to the outer face or half-lapped scarfs and fixed to the new sole plate with stainless steel L-brackets (as discussed above).

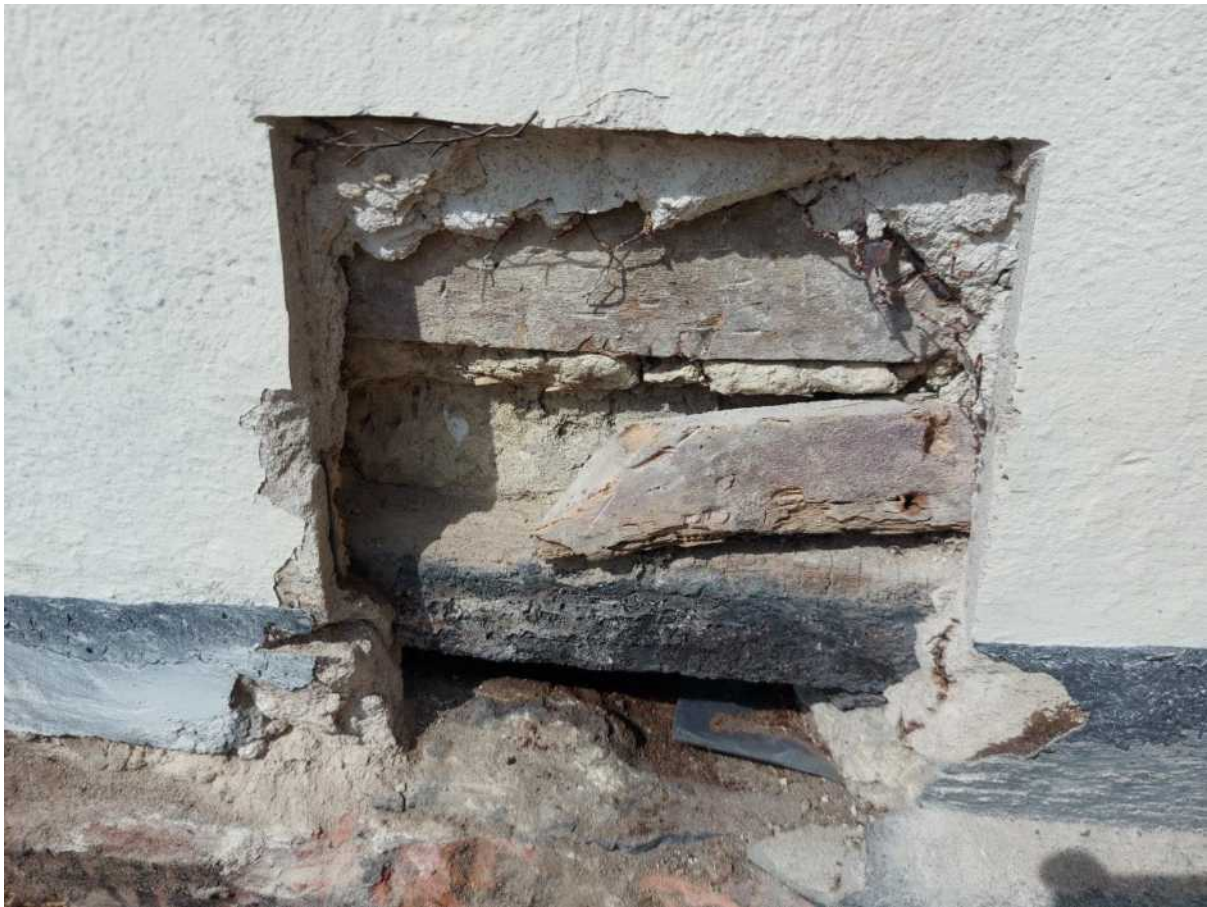
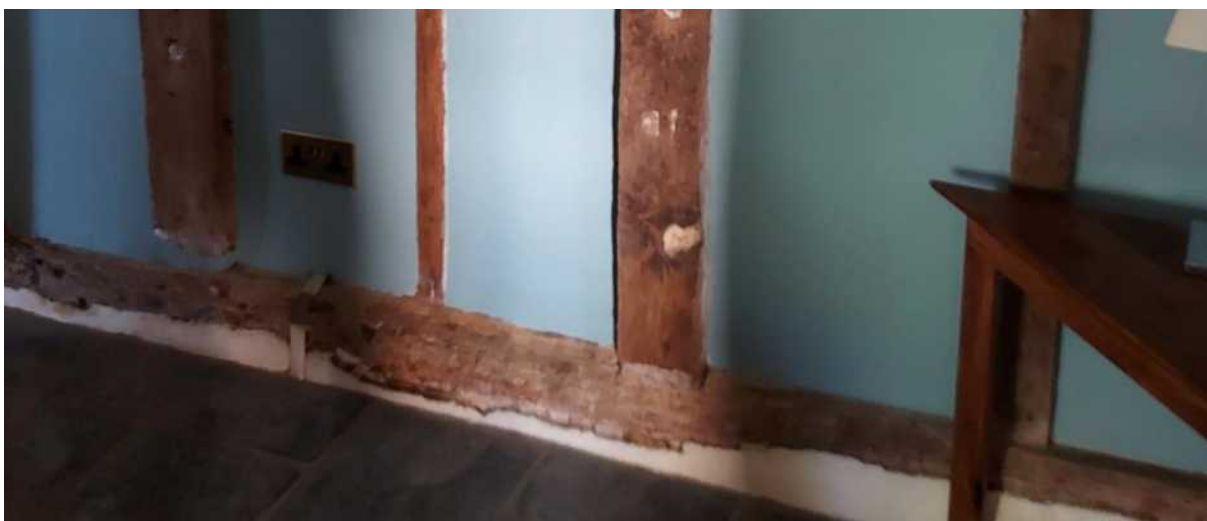
3. Where the render was removed this bay of sole plate seems to be in slightly better condition.

We propose that this bay is repaired by raking out any loose timber to the lower/outer half of the plate and packing the subsequent void with broken soft red brick, red tile and coarse lime mortar. This will give the plinth some load capacity while retaining as much of the historic fabric as possible particularly the infill panels above which will be undisturbed. This filler *within* the plate will act as a breathable concrete supporting the less capable sections of sole plate allowing the load from the wall, first floor and roof be resolved, down into the undisturbed plinth and ground below.

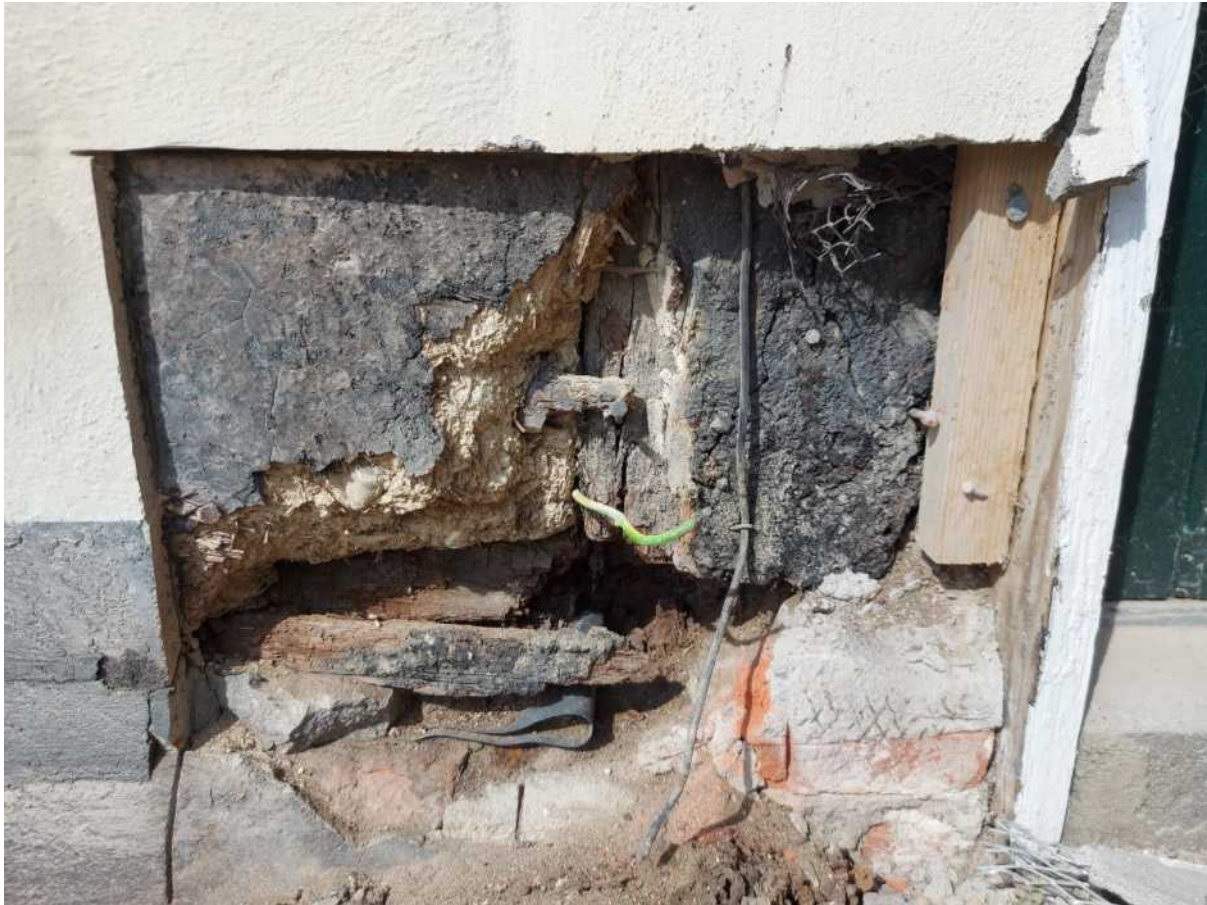
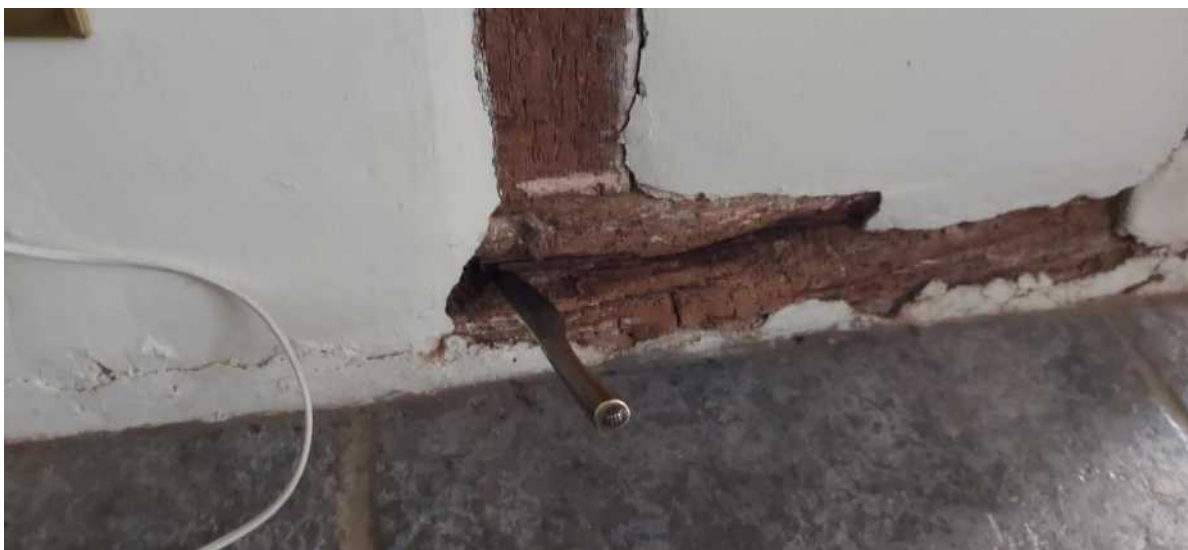
4. This section of plate is in very poor condition with much of it below the internal floor level. It is quite short and sits between a crossframe and one of the rear doorways.

We propose to fit a new length of plate in this position that will be scarfed somewhere close to the crossframe wherever the plate run becomes sound enough to accept a simple scarf joint. The new green oak section will match the existing in size and be fixed with M10 stainless steel coachscrews then pointed up below with a coarse lime mortar mix.

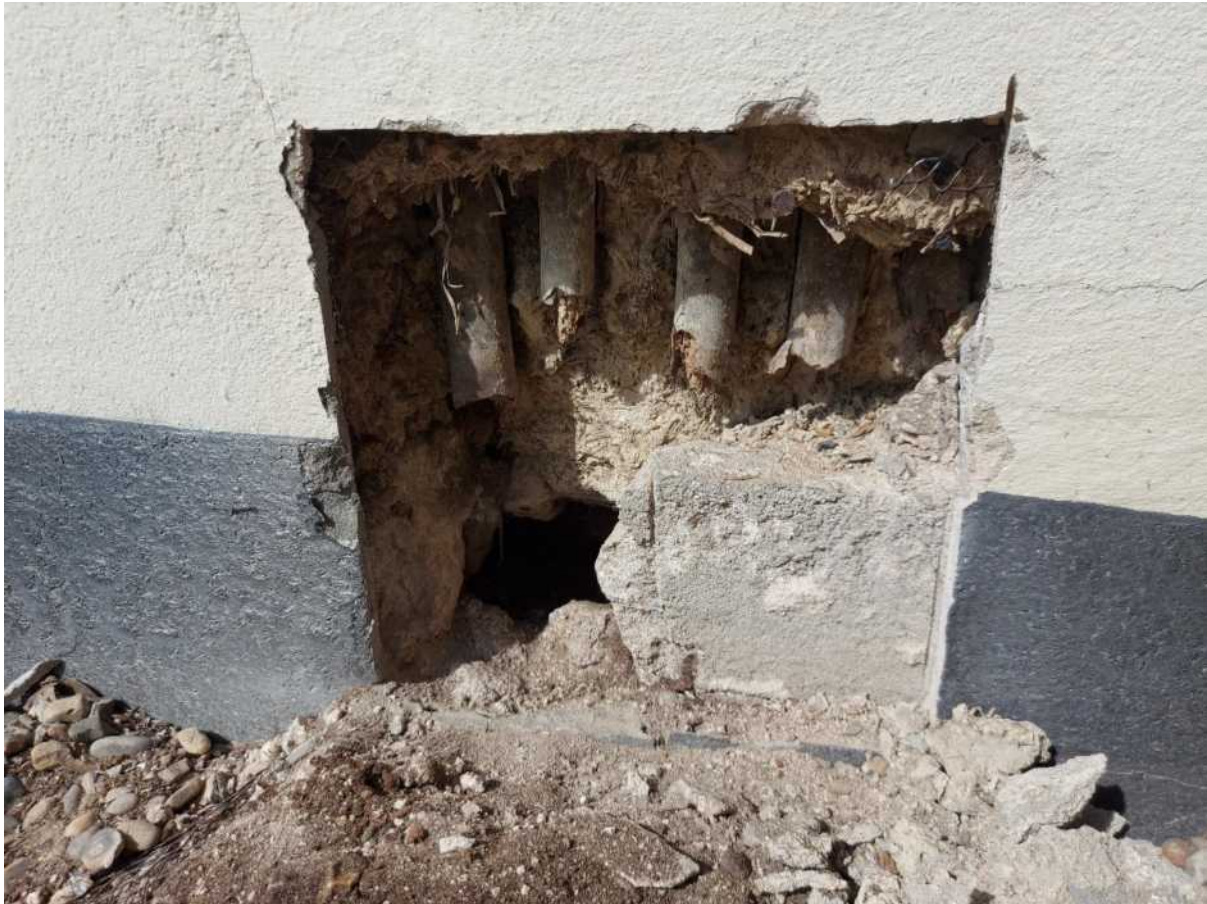
5. This length of plate sits underneath a staircase and behind the oil boiler it is very hard to see from inside as it is essentially flush with the internal masonry floor and almost wholly subterranean! Towards the east gable it ceases to exist at all and has been filled with fletton bricks and concrete.

Although the infill panel looks in passable condition, it has actually slipped down considerably and the wattles are extremely friable. The bottom of the wall is cast concrete which has basically buttressed the wall in the absence of the sole plate and any meaningful connections to the uprights.

The oil boiler will need to be disconnected, possibly also a considerable number of pipes and cables that are all hidden within this corner. The cast concrete will be broken out and a new length of sole plate introduced of an appropriate size and fixed to the (repaired?) studs with stainless steel L-brackets. The infill panels will probably need to be renewed using sheep s wool insulation.

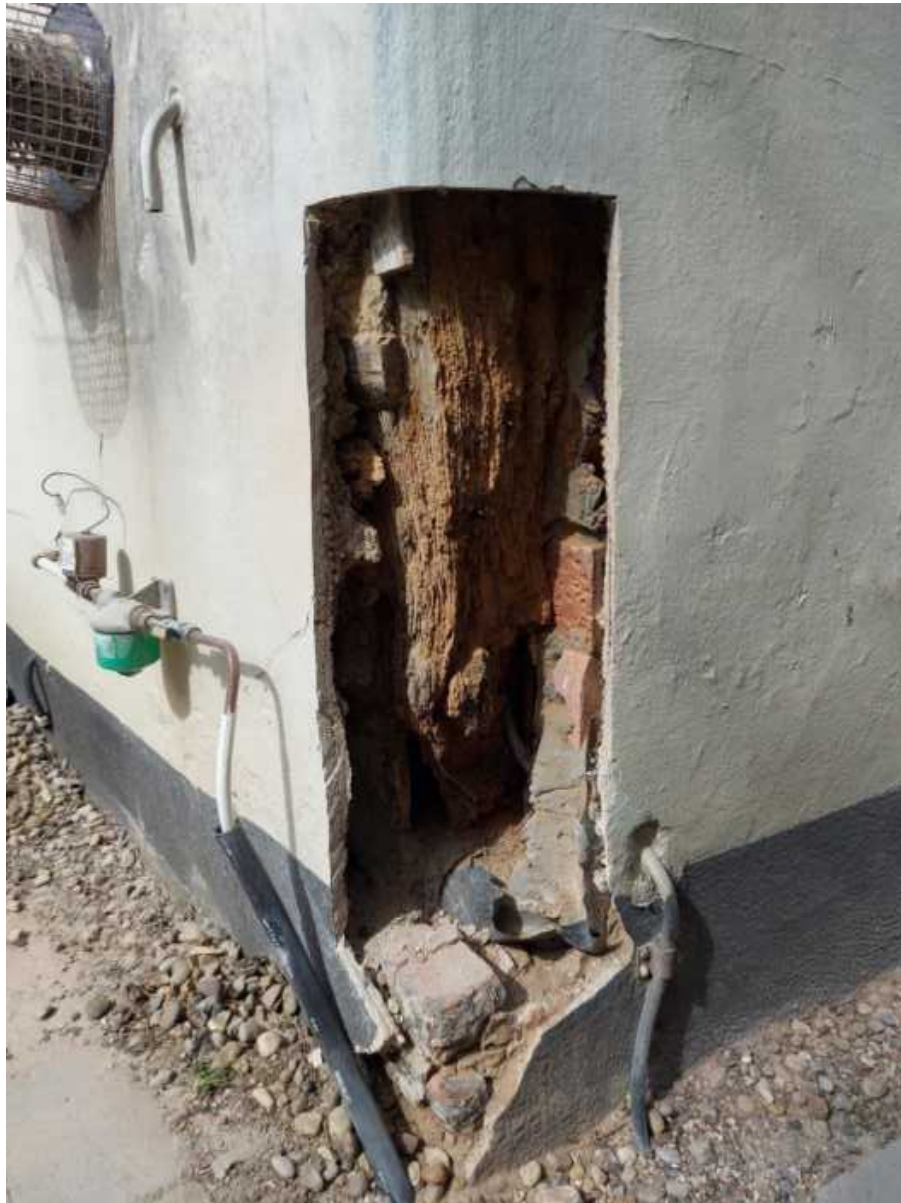
6. The south east corner post is poorly conditioned to the lower 700-800mm with no sole plate running immediately west and although a small, later section of plate has been inserted to the north there is no connection between any of them in this position. To the right/north is an infill panel of fletton bricks laid in hard cement mortar with a modern DPC inserted adjacent to the post.

We propose to lengthen the post with a new section of oak approximately 700mm long with a simple half-lap scarf of approximately 250-300mm fixed with M10 stainless steel coachscrews.

The new oak sole plate in the rear elevation (noted above) will fix to a new section of plate within the gable (see below) and sit underneath the post. Any deficiencies within the plinth will be repaired with a coarse [lime mortar mix](#).

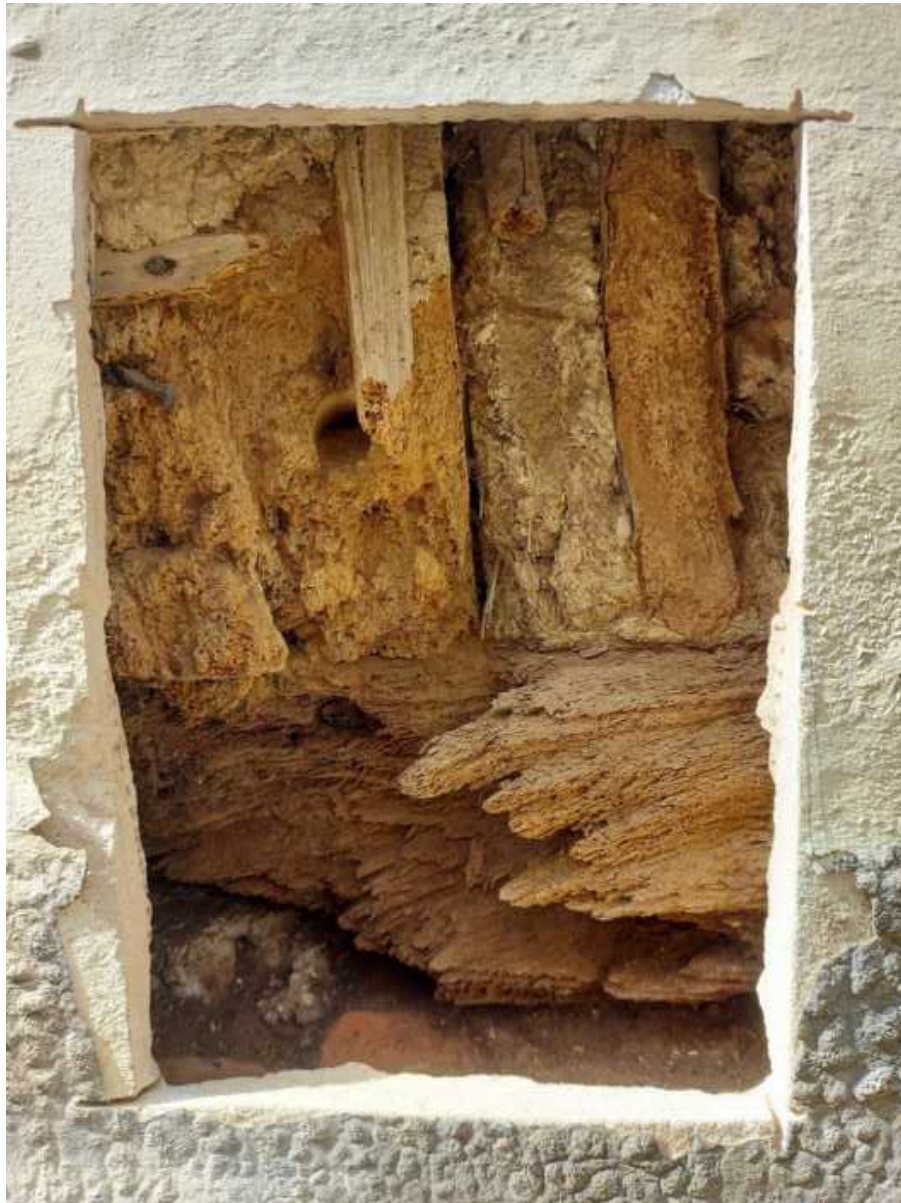
7. This section of gable sole plate appears in poor condition however, much of what is visible here is where a stud is jointed to the plate and thus a mortice is part of this section. To the left, a small section of later timber has been inserted whereas to the right, the original plate timber is reasonably solid for much of the section.

We propose to scarf a new section of plate at around this point, running south, and under the repaired corner post. The scarf timber to be of matching size oak, fixed with four no. M10 x 125mm stainless steel coachscrews and packed up underneath with a coarse mortar mix. The stud to be repaired appropriately hopefully just a patch to the outer face using dry timber but potentially a new section scarfed in at an appropriate length and fixed with M10 stainless steel coachscrews.

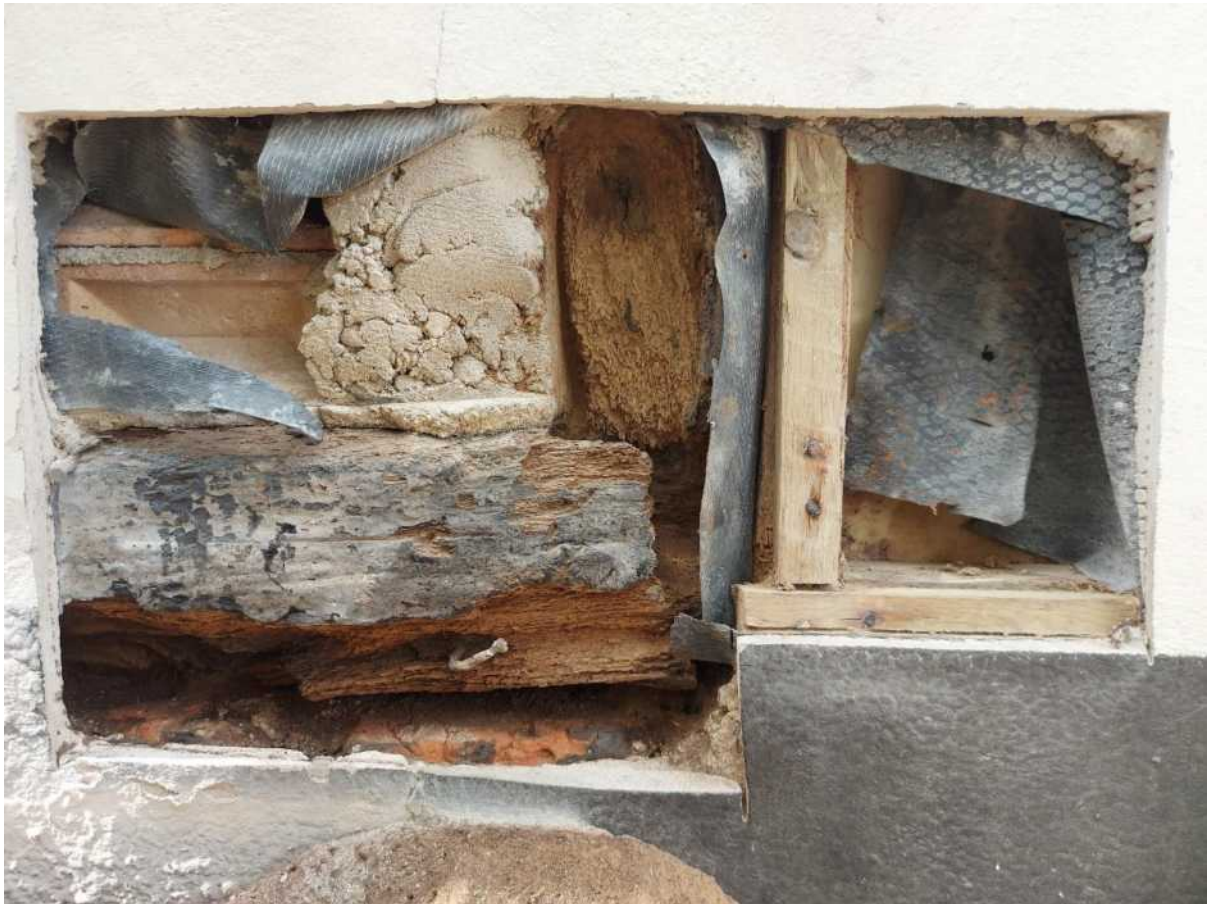
8. This is the opposite end of the previously discussed plate and looking at both ends it seems that much of the cross-section remains and is essentially sound. Note the coal tar painted on the outer face and (just visible) the plinth below this is a 19th century attempt at weatherproofing an exposed timber. Exposed plates are quite common, they protrude by about 25mm with the clay render stopped on the upper face. The render is usually limewashed and then during the Victorian era we see coal tar used on the sole plates and plinths below in an attempt to keep the weather out and damp-proof the building. A section of the gable has been replaced more recently with modern treated softwood and a proprietary plastic DPC, this is possibly a previous doorway being infilled during the 20th century.

We propose to rake out all loose material between holes **7** & **8** and then point up/make up with elements of red brick and lime as discussed in **3**. We will also trim the DPC so that it isn't in contact with any historic timbers.

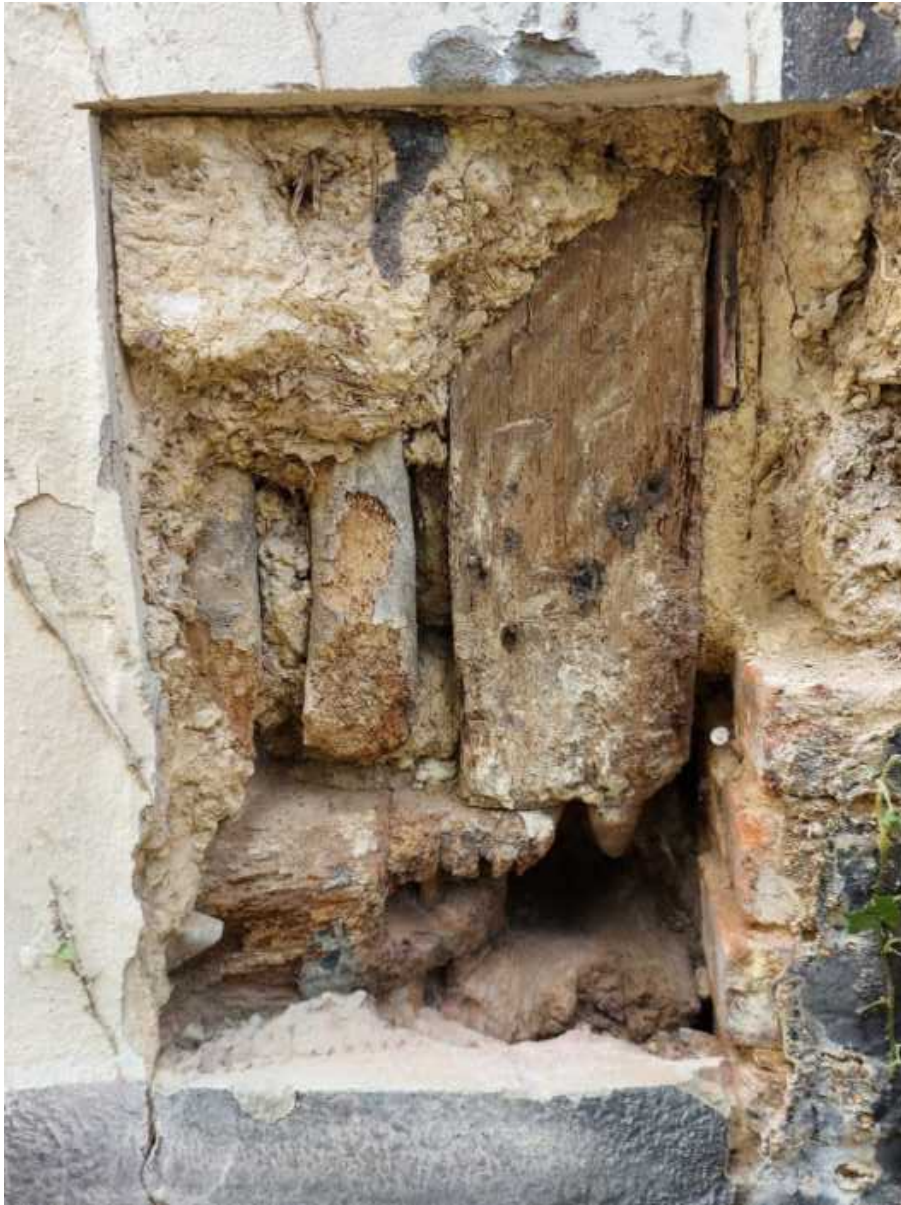
9. The northeast corner post and plates beneath are in good condition, albeit with a void in the front wall (north) sole plate beneath the post. Note the post tenon as well as the tenon (and peg) from the gable sole plate into the front wall plate

We propose to fill the void with red brick and coarse lime mortar as noted between 7 & 8 and in 3.
