**Christmas Tree Barn
Mill Lane
Weybread**

STRUCTURAL ENGINEER'S APPRAISAL REPORT

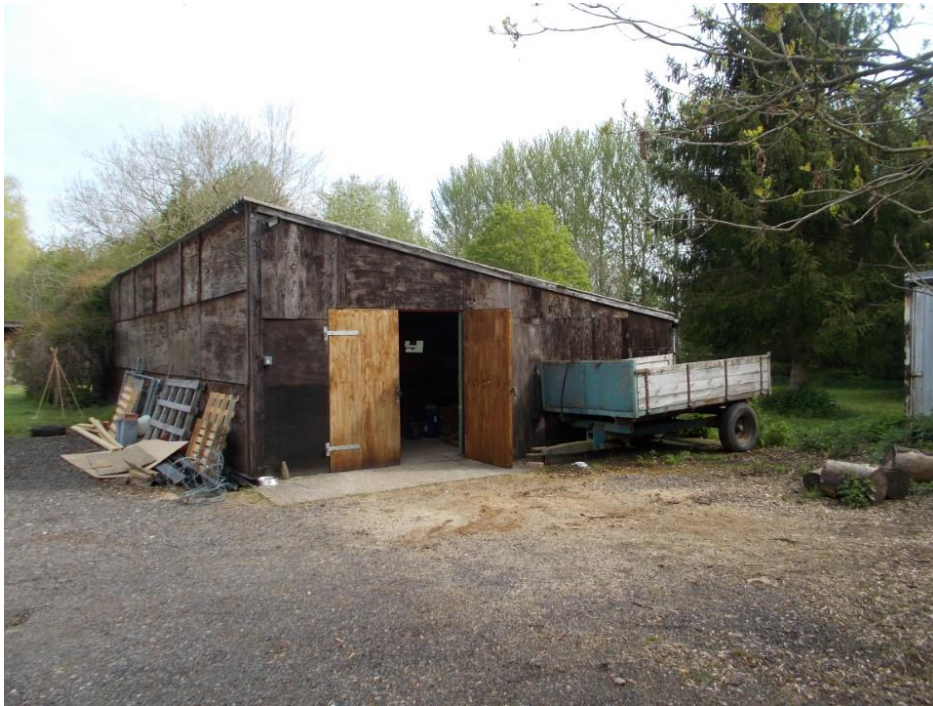
Photo 1 – South Gable End

4.3.1 The south gable end is of mono pitch construction featuring the plywood boarding constructed onto the timber frame. Large double doors are connected at the westward side with a smaller personnel door positioned on the east side of the elevation. Where exposed, the timber frame appears in good condition.

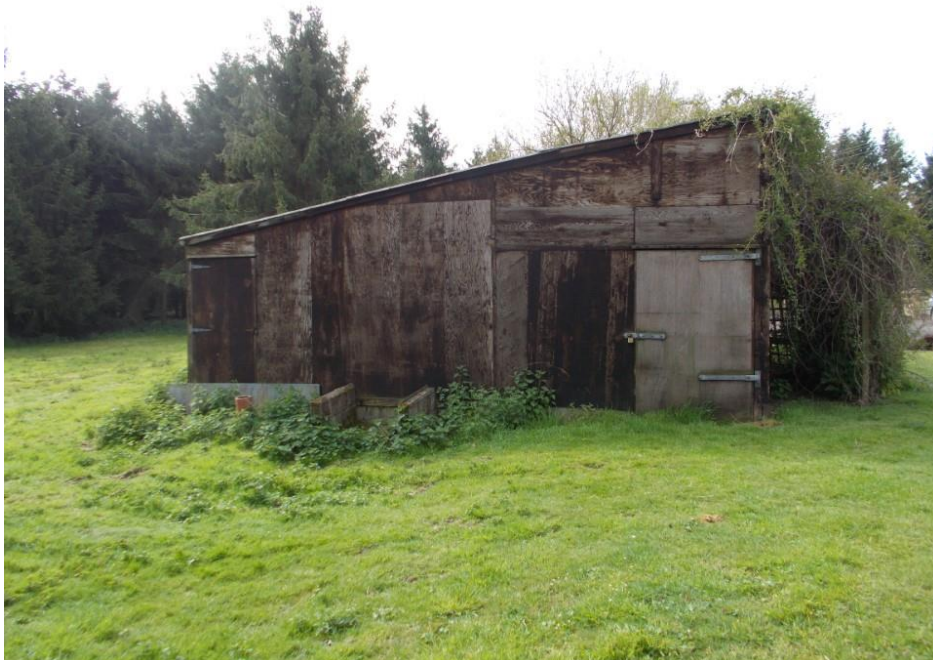
Photo 2 – North Gable End

- 4.1.1 The north gable end is clad in treated plywood and features personnel doors at both sides. The wall presents as plumb and in good alignment with no obvious distress. The principle timber support structures are in good condition with a modest degree of decay to the timber feet where they are constructed into the concrete pad footing and restrained within steel support brackets.

The timber frame wall infill is constructed on a shallow block plinth which appears to be performing satisfactorily with a modest degree of weathering associated with age present along the northeastern corner. There is a degree of vegetation, mostly in the form of nettles growing around the northeast corner and along the east elevation, which partly obscures the inspection.

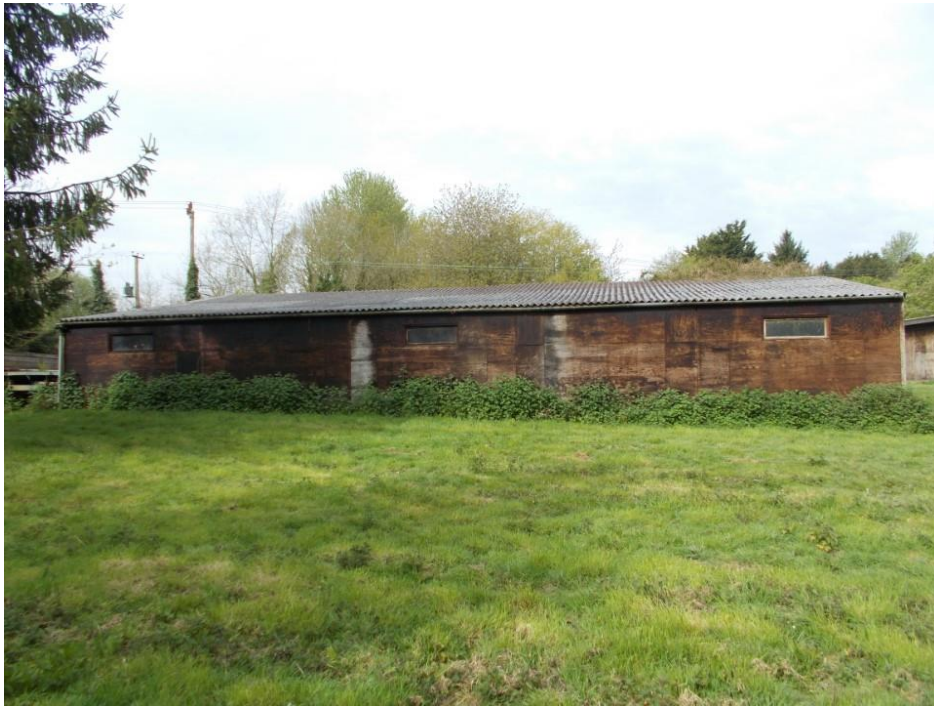
Photo 3 – West Elevation

4.4.1 The west elevation presents the high eaves side of the building and is clad with three tiers of treated plywood. The wall presents as plumb and in good alignment. At the north end on the northwest corner, vegetation in the form of a climbing plant is obscuring a portion of this end of the building, however where visible the condition appears reasonable. As before, the wall is constructed on a block plinth, however this is obscured generally by plywood boarding. The primary timber support posts can occasionally be observed between panels and these appear in good condition, anchored

to the concrete slab via embedded steel angle brackets. Where exposed the slab edge presents in good condition with occasional cracking associated with drying shrinkage though not considered to be detrimental to the performance as a whole.

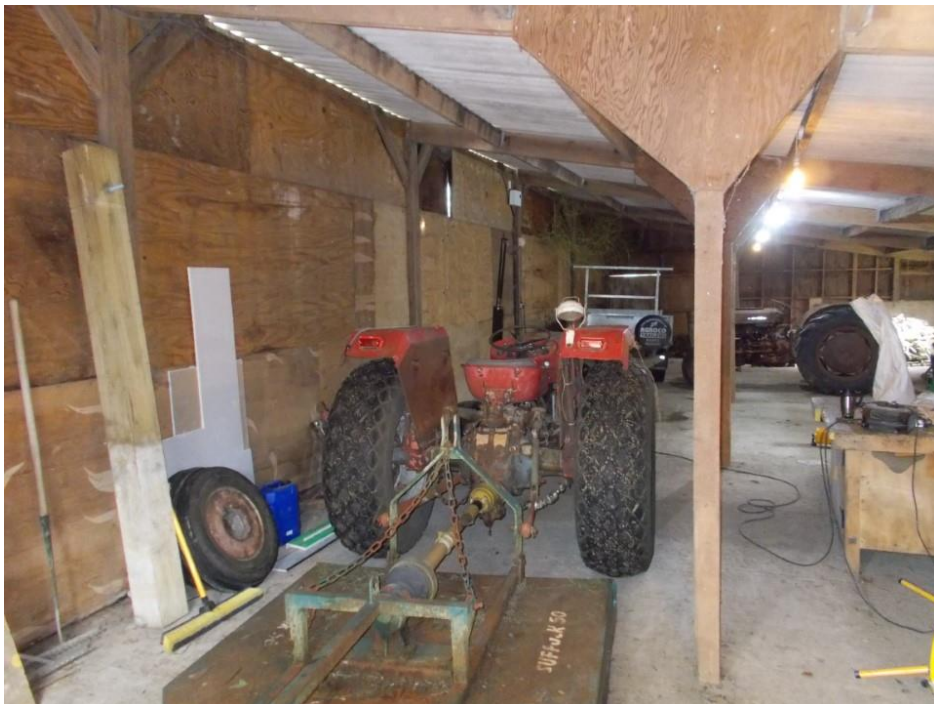
Photo 4 – Interior – intermediate post support

- 4.5.2 The rafter members are a composite of timbers comprising pairs of 25mm by 200mm deep and jointed with similar timber sections in between to provide a composite section that is approximately 70mm wide or thereabouts overall. Intermediate support to these rafters is obtained approximately within the centre span, located 3000mm from the west elevation. The intermediate posts are approximately 95mm by 95mm and are supported directly onto the concrete slab. The posts are embedded within the slab by an unknown amount, though are performing satisfactorily. Where the posts meet the principle rafters, a gusset structure is formed by adding a veneer of plywood to connect posts to rafters via 65mm wide timber bracing. This is commonly seen in structures of this nature.

- 6.6 The principle frames are supported intermediately via a timber post bearing on to the ground floor slab and at the top the post is stiffened at its connection with the principle rafter via plywood gusset. This arrangement or similar should remain in-situ to provide ongoing stability for the principle frames and a point of intermediate support to minimise the deflection of the roof structure. Therefore the structural posts will need to be incorporated into the proposed architectural layout of the conversion.

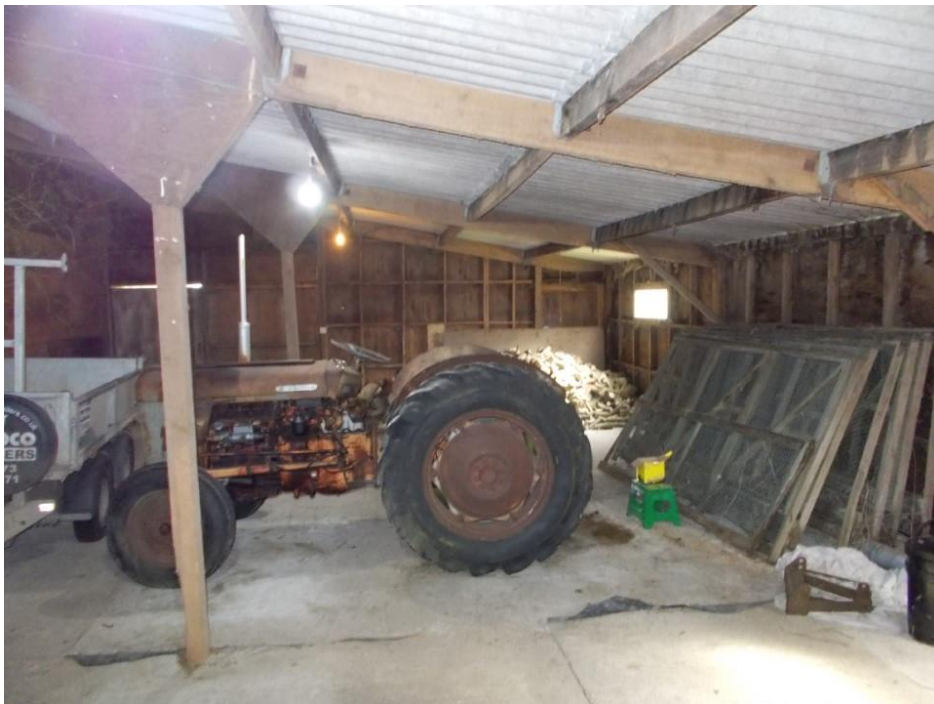
Photo 6 – Principal rafter and purlins

- 4.5.1 The structural format of the building comprises a series of mono pitched timber frames, 6 No. in total along the building which in turn support timber purlins that are providing the direct support to the current corrugated fibre cement roof sheeting. There are 5 No. purlins to each bay supporting the roof and these measure 50mm by 150mm and are spaced at approximately 1300mm centres. The purlins are supported directly on the principle rafters via joist hangers.

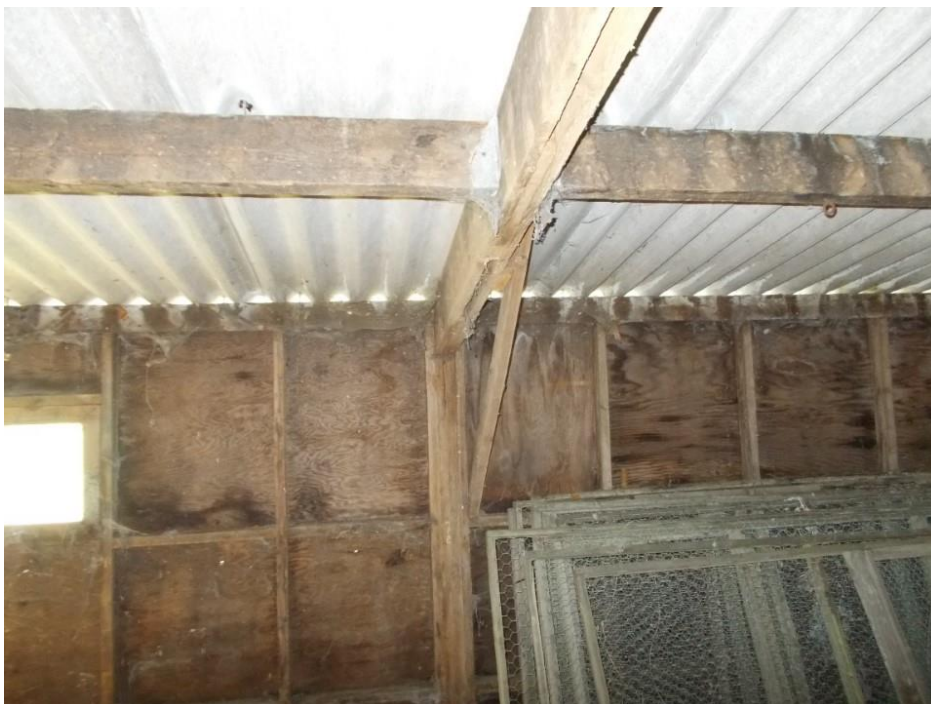
Photo 8 – Principal rafter, external post and wall panel detail

- 4.5.3 At the high end west facing elevation, the principle rafter is supported on two posts and these measure 75mm wide by approximately 150mm deep. At the head of the posts, diagonal bracing is provided to connect the posts to the eaves beam which provide longitudinal stability under wind loading. These posts are embedded into the concrete and appear in good condition and are performing satisfactorily under the current load arrangement.

- 4.5.5 At the northeast end of the building the intermediate timber panels to the external walls are visible locally and the studs measure 35mm wide by 70mm deep and are spaced at 600mm centres. There are two tiers of timber noggins placed between studs. The studs are 2000mm high at this location.
