Mrs J Thompson

TREE CONDITION SURVEY REPORT

The Hazels, Elkstone, GL53 9PB

Date: September 2021

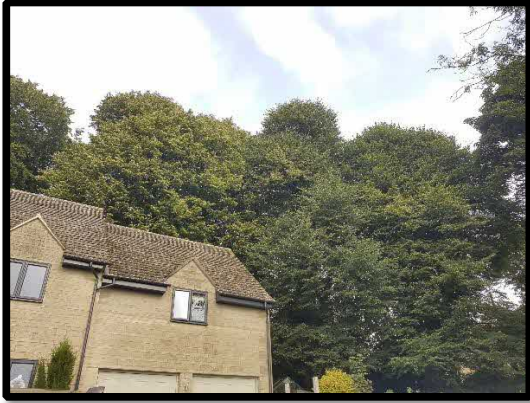
View of the Lime (T714-717) trees from the front of the property.

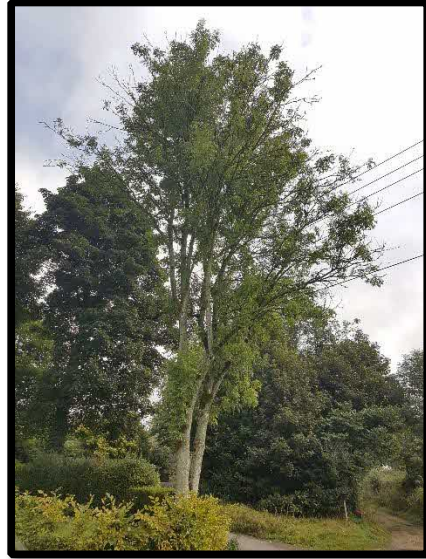
Tree No.	Tree Name	Botanical name	Size	Age class	Struct con	Phys con	Defects & relevant comments	Recommendations	Priority (in months)
717	Lime	<i>Tilia sp</i>	L	M	F	G	Twin stemmed from 4.0m. This main junction is showing signs of weakness similar to 715, with some swelling at the base of the junction on the southeast side indicating some movement of the junction. Crown previously reduced.	Reduce the height and spread to the previous reduction points (leaving the tree approx. 18-20m tall). Inspect cable brace for condition, and if found to be defective or overly tight, supplement with another steel brace approx. 30cm below the existing one (which must remain in situ).	6 Months
718	Ash	<i>Fraxinus excelsior</i>	M	MA	P	P	Twin stemmed from 1.0m. Crown over hanging the highway. Utility wires under the crown. Chalara Ash Dieback Class 2-3.	Fell.	6 Months

View of the Ash tree (T718) from the front drive.

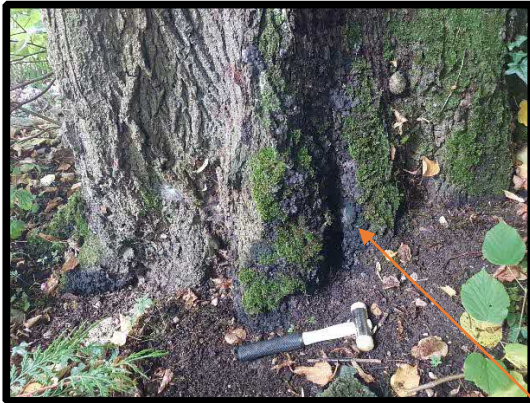
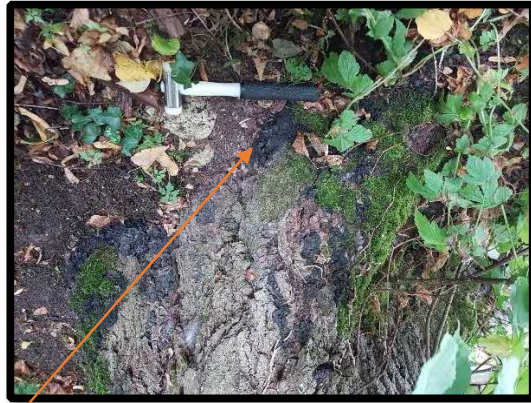
- 1.5 5 trees were inspected.
- 1.6 T714 contains significant defects which, although not imminently dangerous, require attention within 3 months of date of survey.

Kretzschmaria deusta fruiting bodies clearly visible at the base of T714

Client: Mrs J Thompson		Site: The Hazels, Elkstone							
Date: 15/09/20214		Consultant: Nick Organ							
Tagged: YES		Weather: Overcast, light wind							
Tree No.	Tree Name	Botanical name	Size	Age class	Struct con	Phys con	Defects & relevant comments	Recommendations	Priority (in months)
714	Lime	<i>Tilia sp</i>	L	M	TBC	G	Three main stems formed from main trunk at 1.75 – 2.5m. Crown previously reduced. Minor deadwood in crown. <i>Kretzschmaria deusta</i> found between the buttresses on the North and East sides from ground level to a height of approximately 40cm. Both mature and juvenile forms are present indicating this to be an active colony. This fungi is an aggressive decayer of wood and can lead to catastrophic failures. There are other cavities on the main stems from historic branch removal (possibly when the house was built) which are not likely to prove a safety issue at present. Otherwise the tree shows good vigour.	Further investigation with a Resistograph decay detector.	3 Months

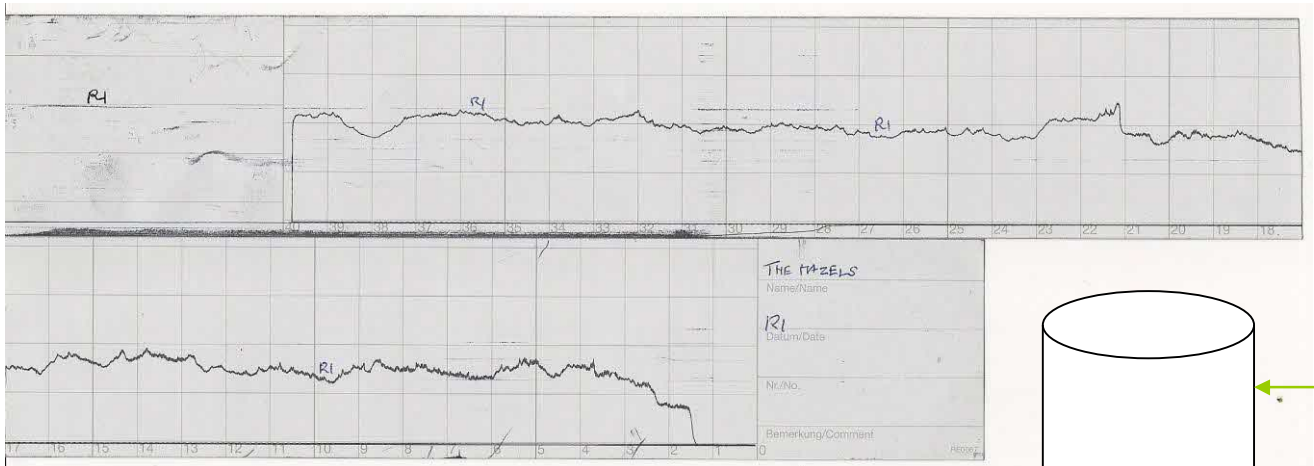
Measurement 1. Taken at 1.2m height to east of trunk, above area affected by *Ustulina deusta*. The measurement is used as a control sample, no defects are expected to be encountered and a sound wood reading expected. The result is that of a sound wood reading, however it is noted that there is little increasing resistance within the reading; a normal behaviour expected within broadleaf trees.

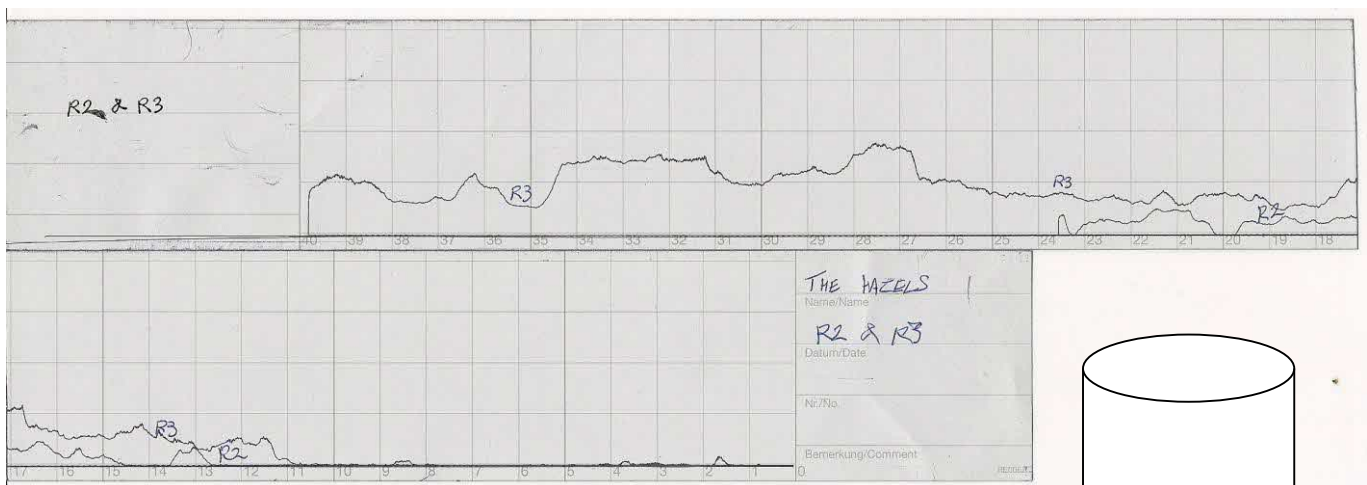
Measurements 2 & 3.

Measurement 2 taken at 100mm height to east, descending at an angle of some 30°. Very heavily decayed wood found (reading ends at 23.5cm).

Measurement 3 taken at 300mm height from east, entering the trunk horizontally. Clearly affected wood that lacks structure, though still provides some level of resistance (albeit reduced from healthy wood). Indications of decay within this zone.

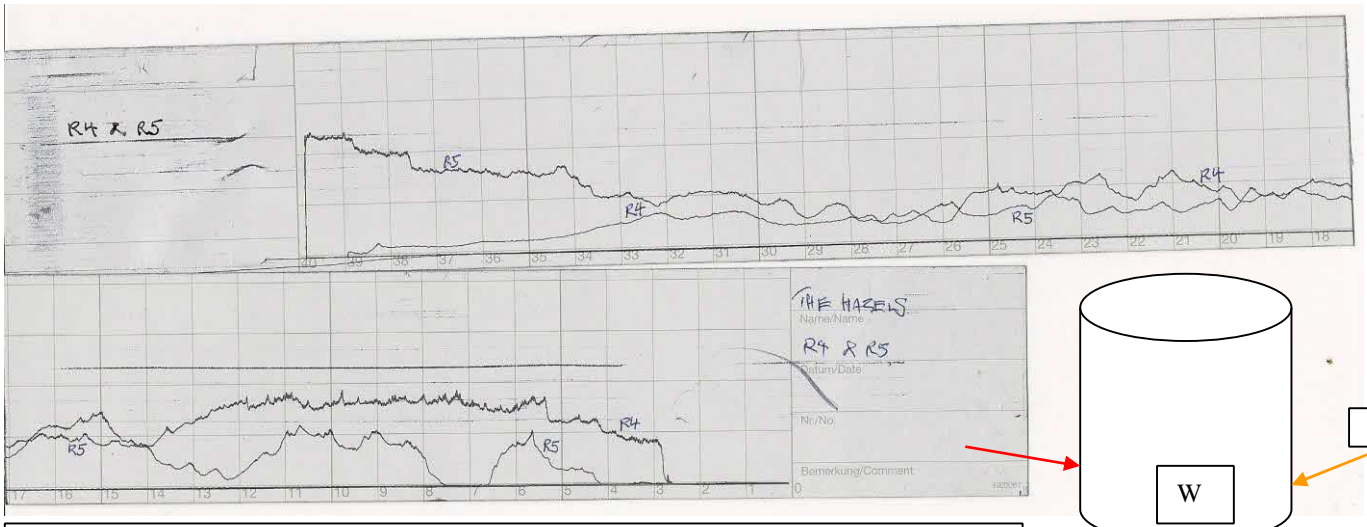
Measurements 4 & 5.

Measurement 4 is was taken from the south east at 300mm height with an approximate downward angle of 30° into a root buttress. Initially sound wood is present to a depth of some 12cm, before significant degradation of the wood structure is encountered.

R5 was a taken as a level reading at 400mm height from the north east. Reading indicates significant degradation within trunk, however sound wood is encountered at 35cm depth.

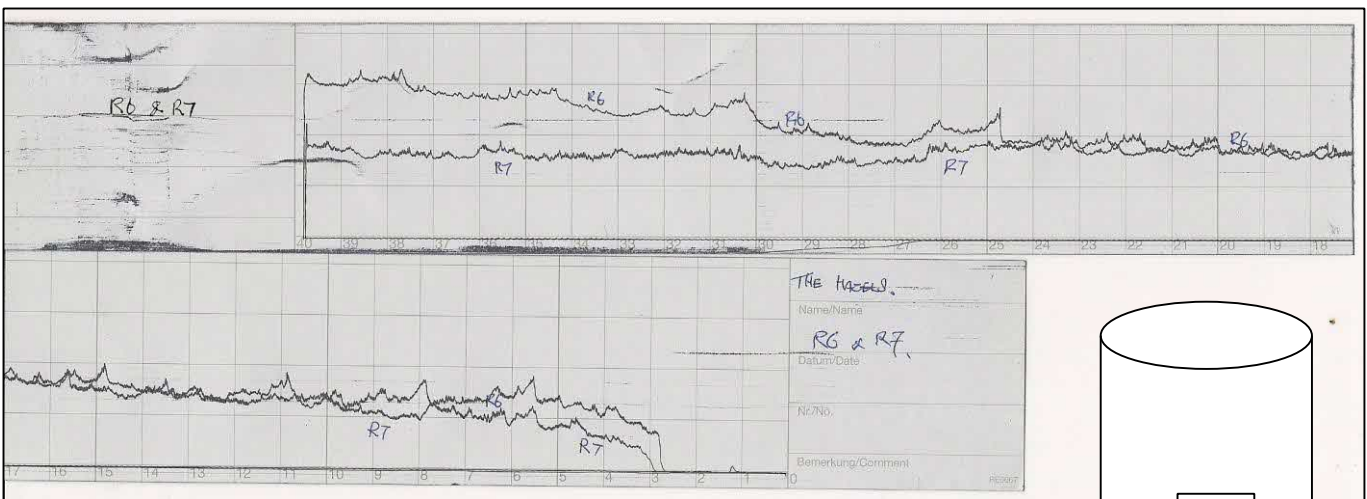
Measurements 6 and 7.

Taken at 300mm from the south west and north west on the side of the trunk that does not indicate any external defects. Both readings indicate a sound internal wood structure.

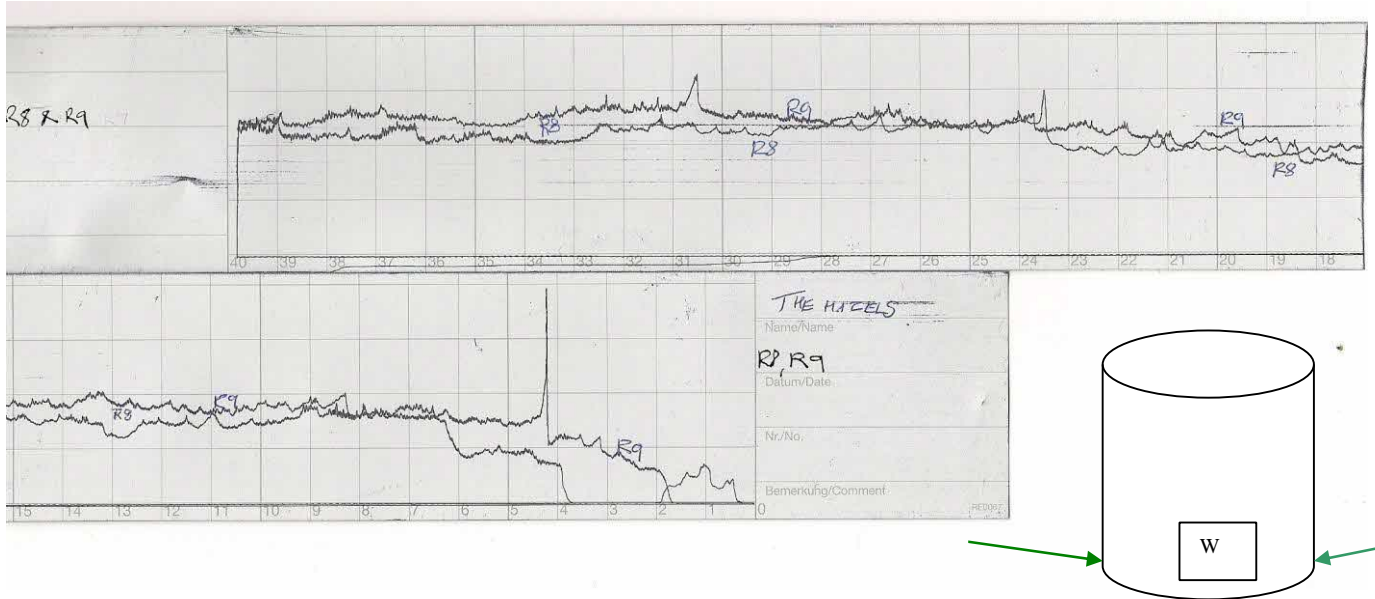
Measurements R8 & R9. Taken from north and south of the trunk at a height of 150mm with a downward angle of some 30°. Both readings indicated sound wood. The peak just after 5cm's on R9 is a result of the drilling needle stopping and re-starting.

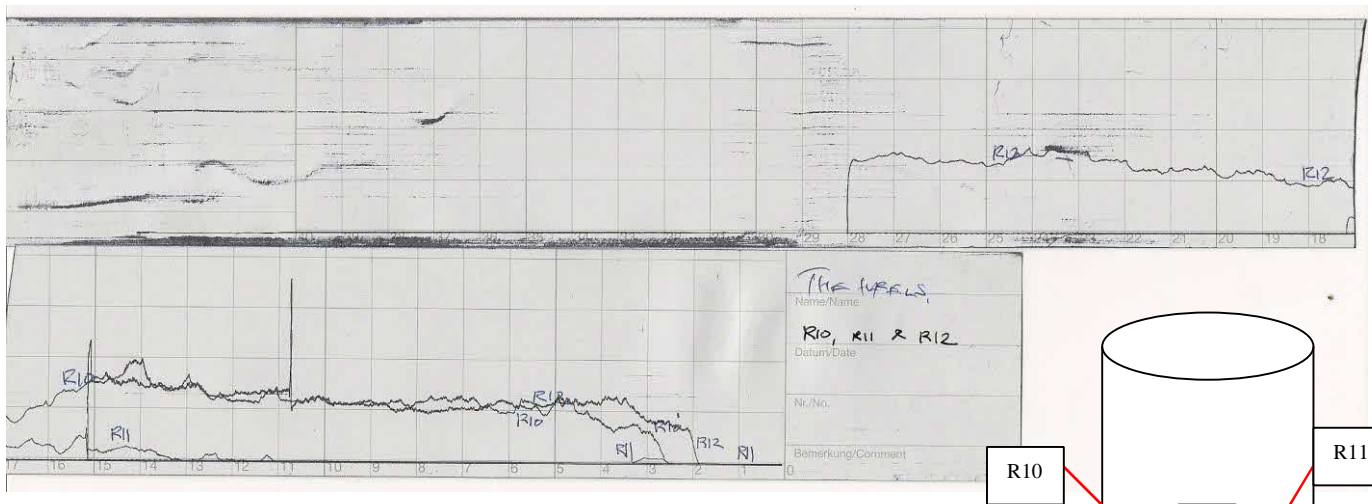
Measurements 10,11 and 12.
 Three measurements taken in the vicinity of the fruiting bodies of *Ustulina deusta*. All three measurements were taken at a 45° angle down into the trunk to establish the condition of the rooting area. R10 was taken at a root buttress, the buttress was found to be in reasonable condition. R11 indicated virtually no remaining sound wood, while R12 indicated some resistance (albeit of an amorphous form before further weakening at a depth of some 15cm).

- 4:1 1) Undertake a canopy reduction of the tree by approximately 30% to 40%, to lower wind loading and reduce structural stresses.
- 4:2 2) An additional inspection should be undertaken no longer than two years from the date of this report. The inspection should incorporate use of a decay detection device (providing recommendations as/if necessary).

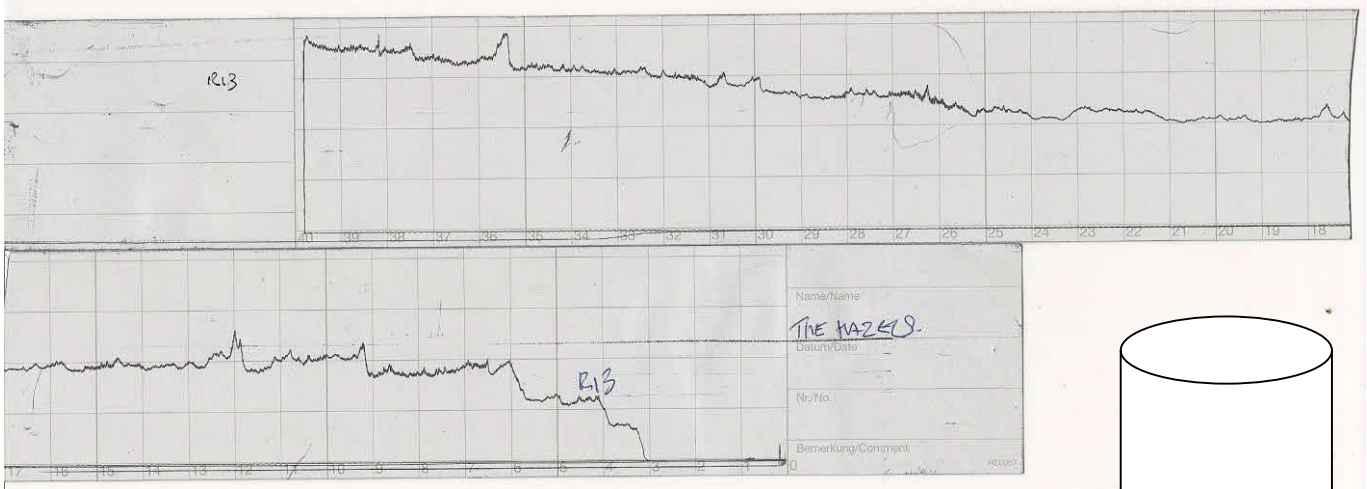
Measurement 13. A single measurement taken from near the south east corner of the trunk at a height of some 10mm, bearing horizontally towards the centre. Overall a sound reading though possible indications of brittle wood decay occurring from 16 to 24 cm distance.
