Structural Survey

Ty Mawr, Penybontfawr, SY10
0HN.

Date of Inspection: Wednesday 2nd February 2022.

Building Description and Age: The building comprises an agricultural barn. The original stone walled part is believed to date back to the eighteenth century, whilst the larger steel framed structure has presumably been added in the latter half of the twentieth century.

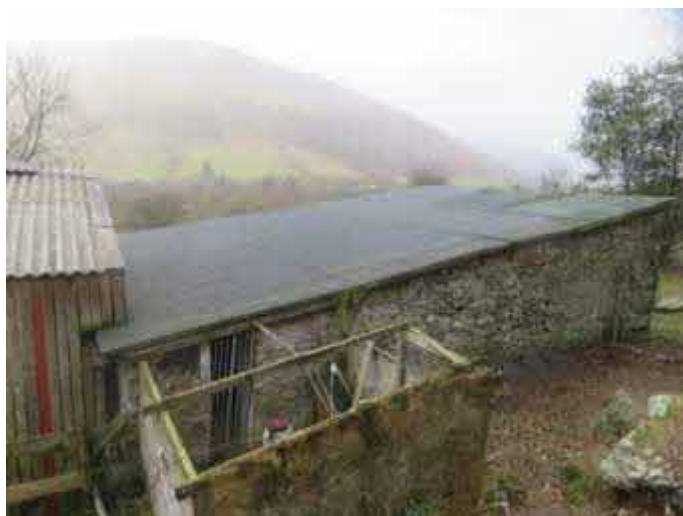
Minor evidence of corrosion to metal sheeting over stone barn.

Metal coverings over stone barn

Recover roof with suitable lightweight cladding, subject to architectural design.

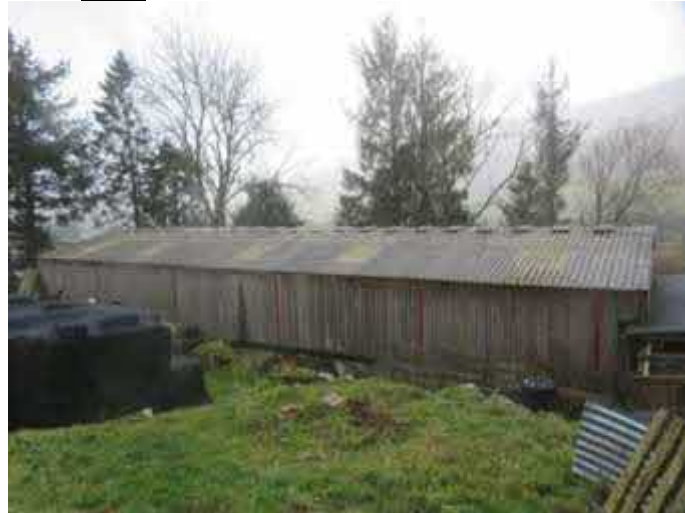
Coverings over steel barn appear to be asbestos cement.

Assumed asbestos cement over steel framed structure

Removal of existing coverings in line with HSE guidelines.

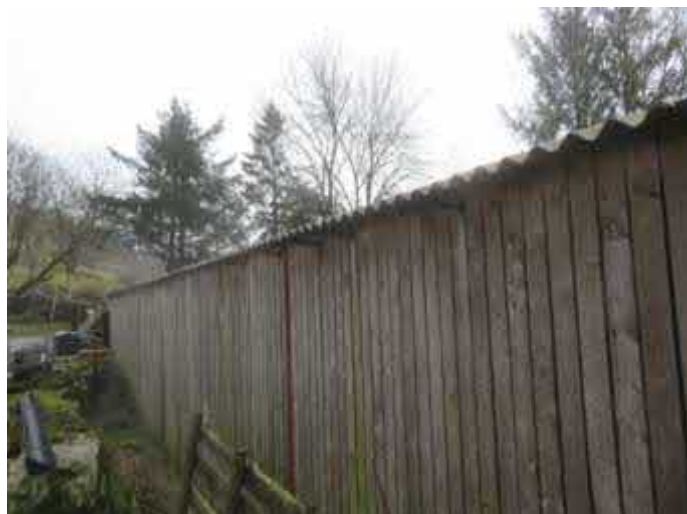
The rainwater fittings remain incomplete.

Missing gutter to rear roofline

Installation of new rainwater fittings; to be connected to soakaway drains via storm gullies.

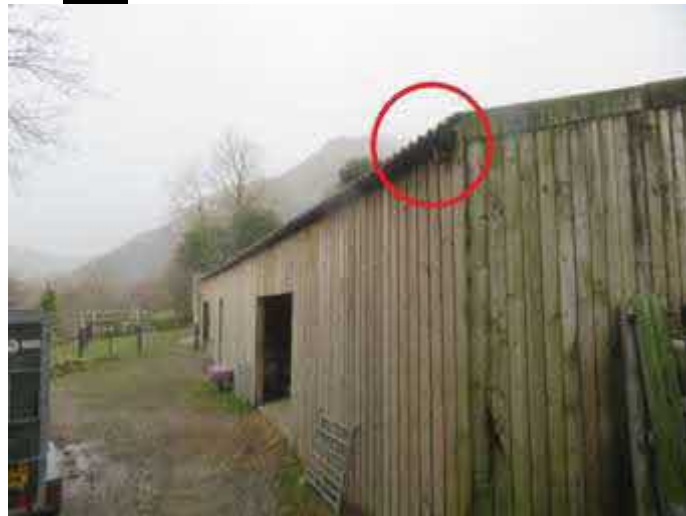
No downpipe connected to front gutter

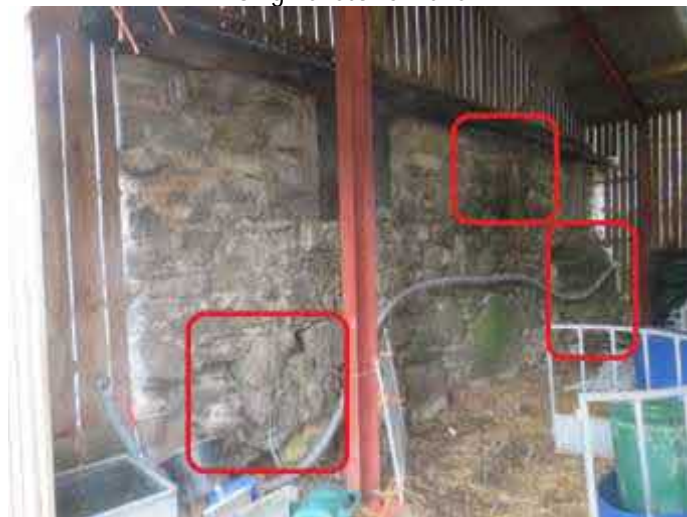
Evident distortions and unevenness, particularly to the right-hand side gable wall. Likely caused by compaction of the internal rubble fill. These do not appear to impact upon the structural integrity.

Distortions to right gable side wall

Localised repairs to address distortions within wall, e.g. helical bars etc.

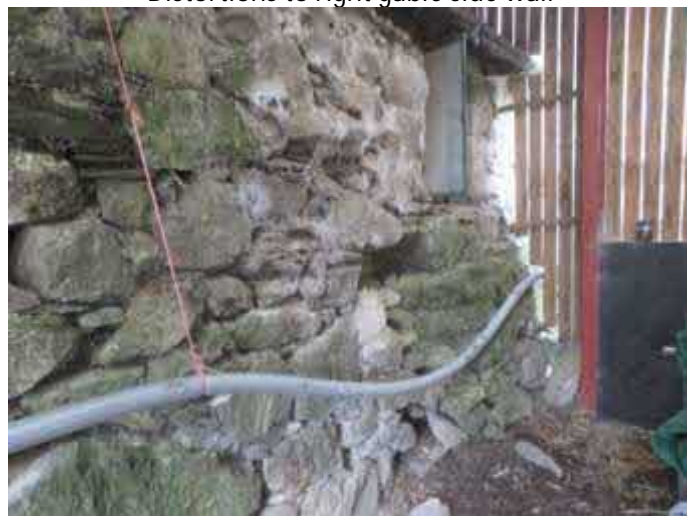
Distortion at bottom corner

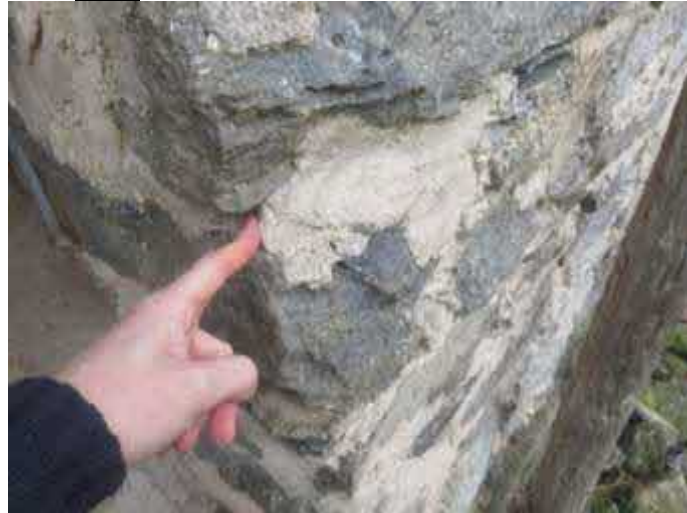
Previous re-pointing with hard cement mortars in most areas.

Re-pointing with cement mortar

Areas of cement mortar (where possible to do so) to be raked out and walls re-pointed in more appropriate mix e.g. Ty-Mawr lime.

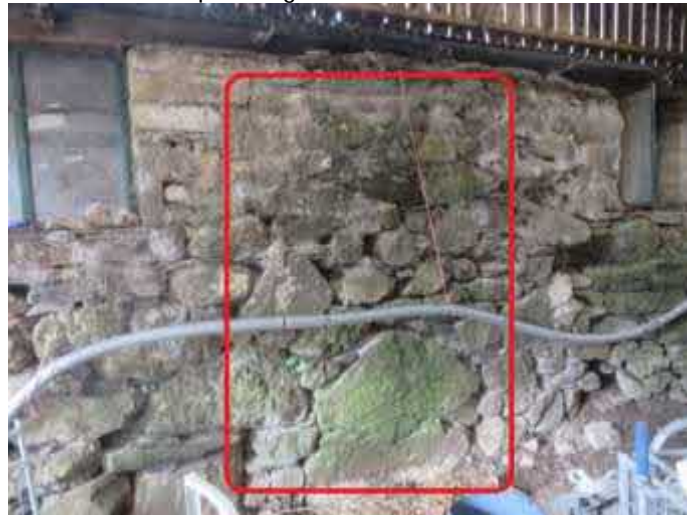
Biological growth evident to brickwork on right-hand gable wall. Indicates previous dampness to the masonry.

Green 'biological growth' staining

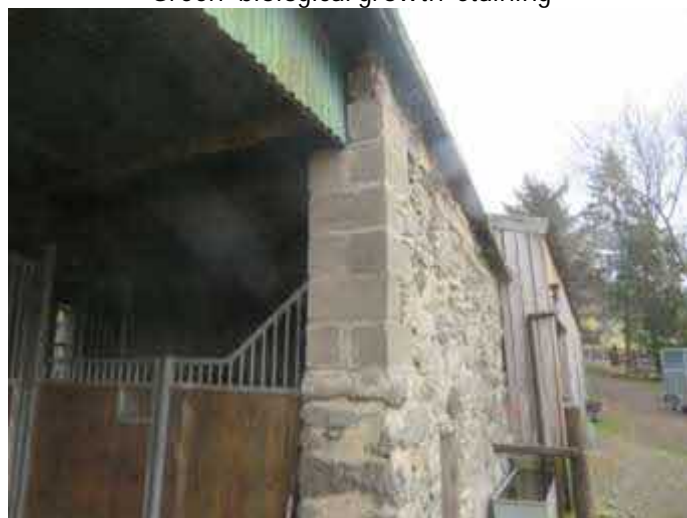
Localised rebuilding with concrete blocks around openings and to the front elevation at roof level.

Sections rebuilt in concrete block

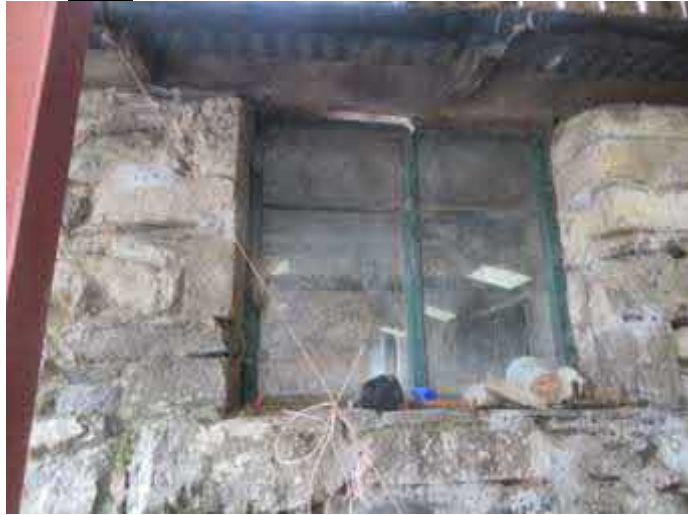
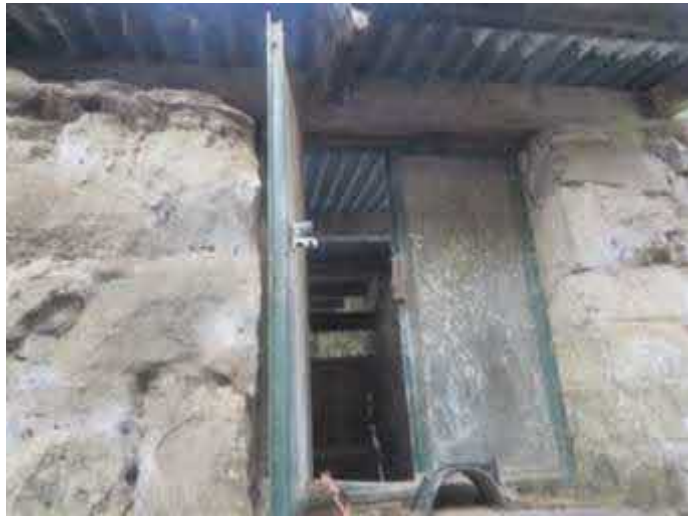
Window framing displays typical degradation to the timber and painted finishes, although these remain serviceable.

Window openings

Complete replacement/redesign of door and windows – to be informed by project design.

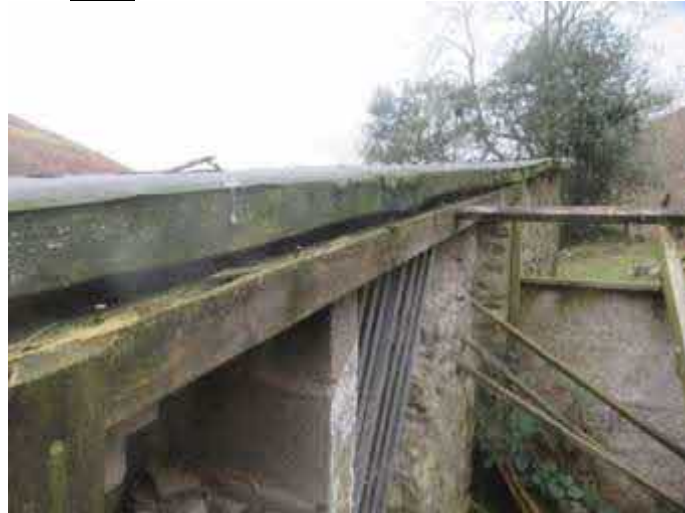
Fascia boards display usual signs of timber decay and replacement is required.

Deterioration to bargeboard timber

Replace fascia boards.

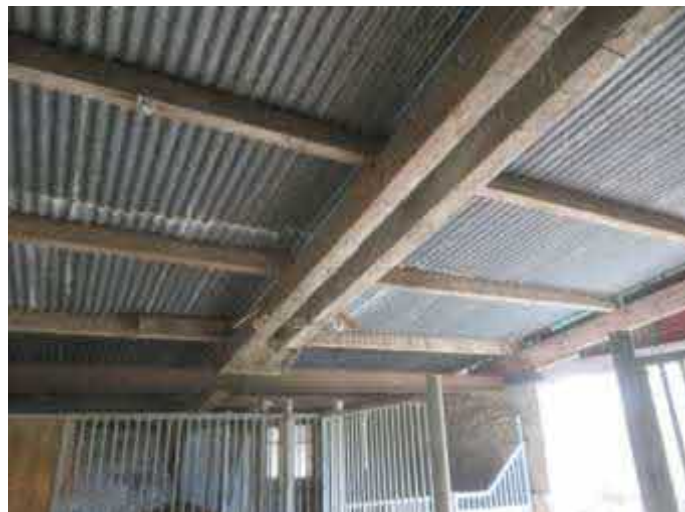
Minor sagging noted to crossbeam within stone barn. Established feature and the risk of further movement occurring is low.

Beetle activity noted to joists within the stone barn; appears to be historical.

Joists and central crossbeams to stone barn

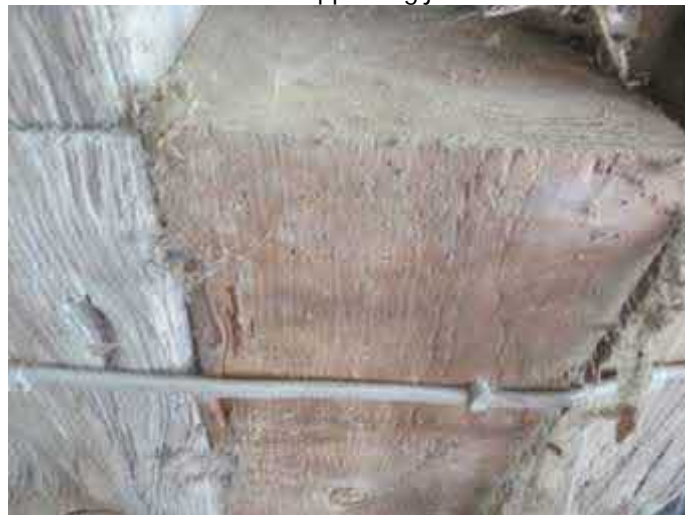
Active beetle activity noted to central crossbeam, assumed to be common furniture beetle.

Active beetle attack to crossbeam

Recommendations: Localised treatment for wood-boring beetle.

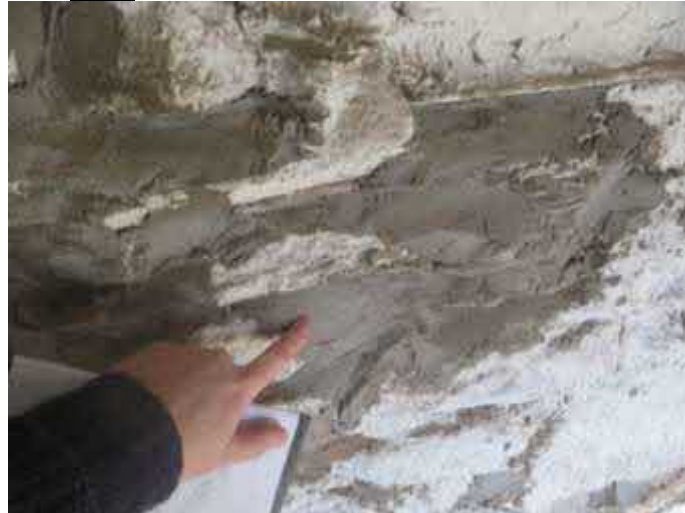
Condition: Significant use of cement mortar pointing to interior walls within the barn.

Internal cement usage

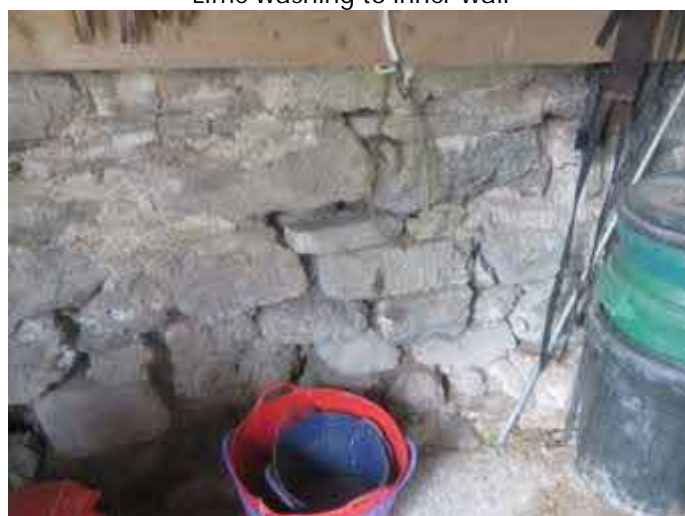
As highlighted in section 3.4, some localised helical bar repairs (or similar) will be required to areas of distortions.

Inner distortions to stone walls
