Drawn by: JACK HENDERSON	Title: EXISTING CONDITION AND LAYOUT	Version: 1-A
Company Address: COB SOLUTIONS 80 WINDSOR ROAD TORQUAY TQ1 1SU	Client Name: ALISON JONES	Scale: 1:5
Date: 11th March 2022	Client Address: 7 CLAPHAM SQUARE, LEAMINGTON SPA, WARWICKSHIRE, CV31 1JH	
	Site Address: THE VERY COTTAGE, 2 BRIDGE COTTAGES, EAST BUDLEIGH, EX9 7DJ

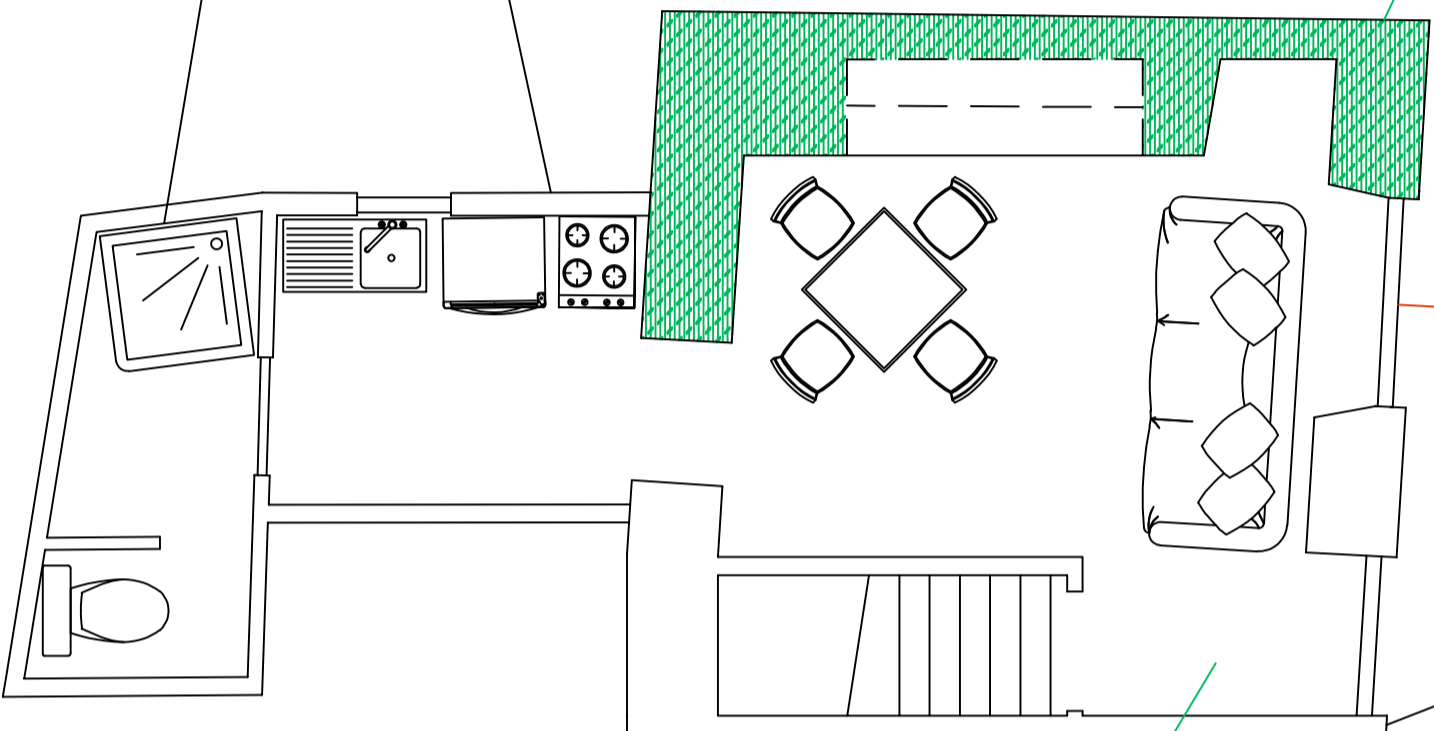
GROUND FLOOR

Rebuild of the lower part of ground floor cob walls carried out several years ago due to decay in cob from damp.

Heavily decayed window in need of replacement (see design)

Original section of the house is constructed from cob with a brick filled timber stud party wall.

Much of the plaster in the cob section of the house has been removed and backing coats of lime putty plaster applied as part of the earlier phase of work.

Extension housing the kitchen is constructed of un-insulated single skin brick walls with un-insulated single pitched lean-to roof.

Toilet and shower in a basic brick extension composed from small enclosed yard with basic roof.

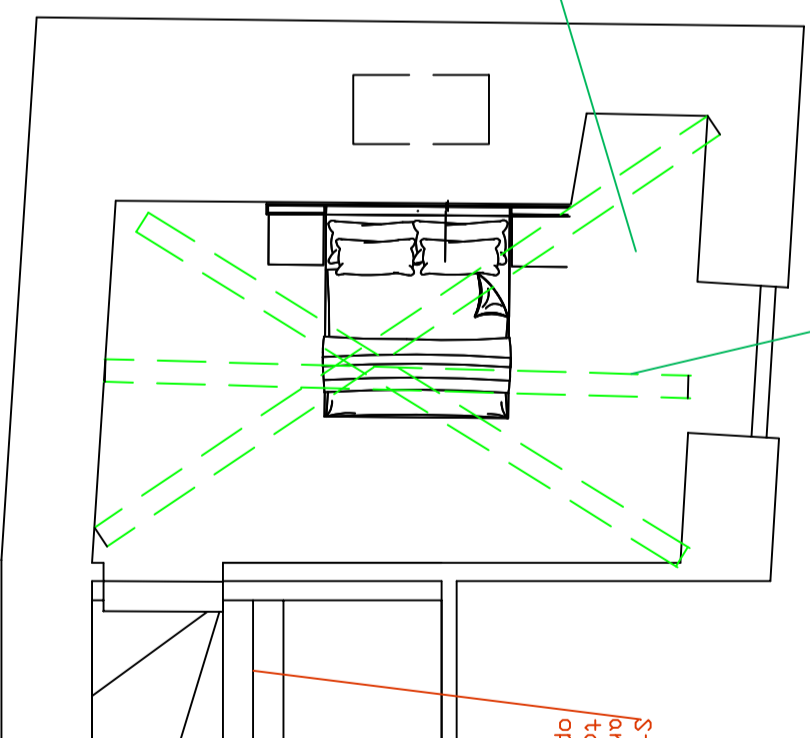
FIRST FLOOR

Structural timber ties have been installed as specified by engineer to restrain potential roof spread.

Staircase is heavily decayed and unstable and not deemed to be repairable although this option will be investigated.
