RECENT AND CONTINUING SURFACE WATER DISCHARGING

October 2021 update

20 MILL STREET ROOF WORKS 2021 – 22 MILL STREET PROPERTY DAMAGE EVIDENCE

Ref: W/21/0100

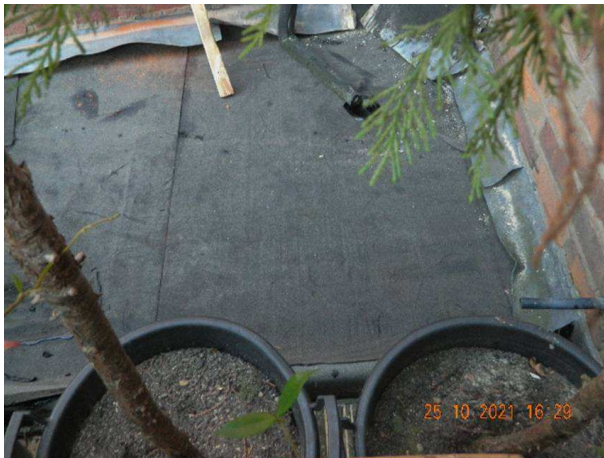
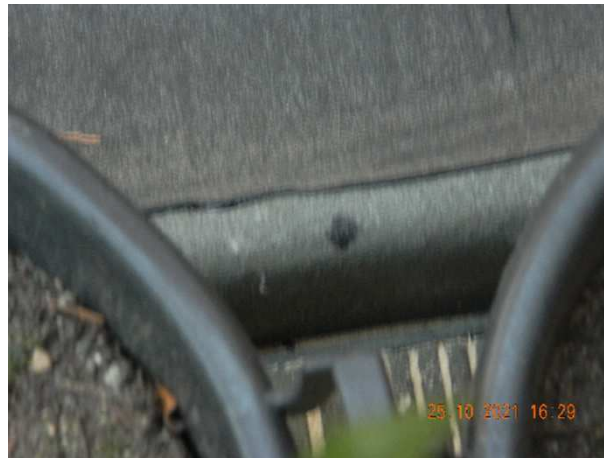
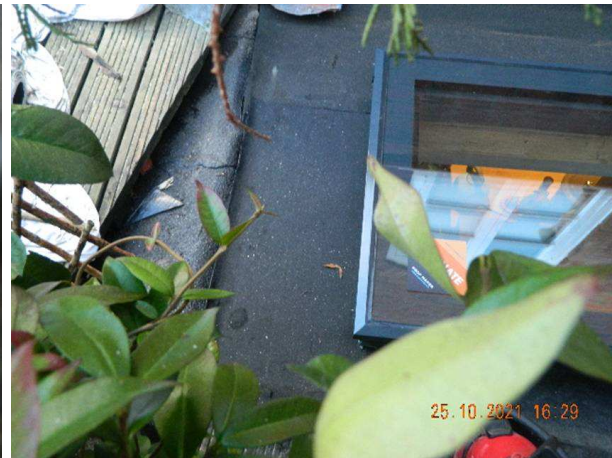
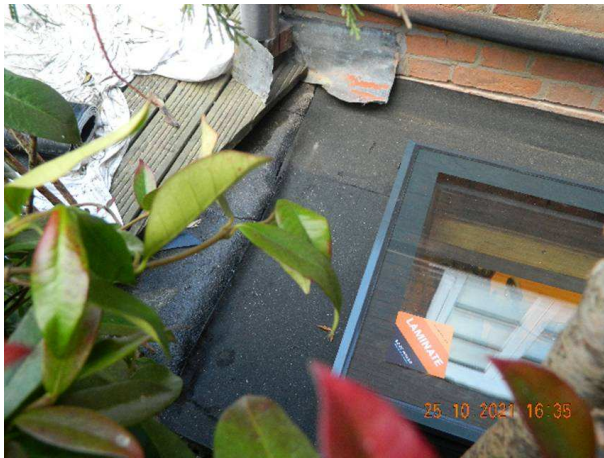
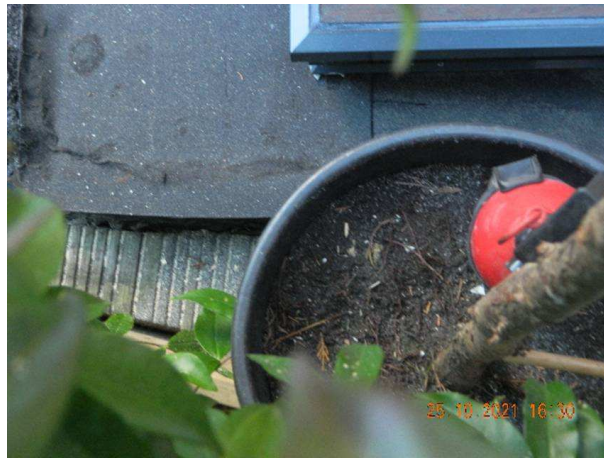
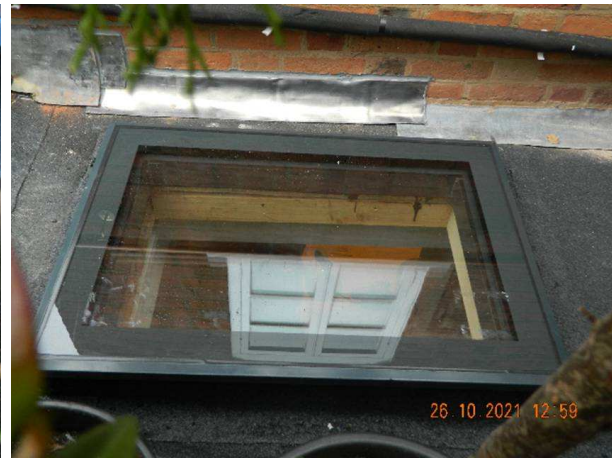
Unlawful first floor flat roof works. Roof height deliberately increased to top of existing 22 Mill Street upstand. No new preventative/protective measures put in place to prevent discharging. No reduction in width of rooflight to facilitate roof access and maintenance within confines of own property.

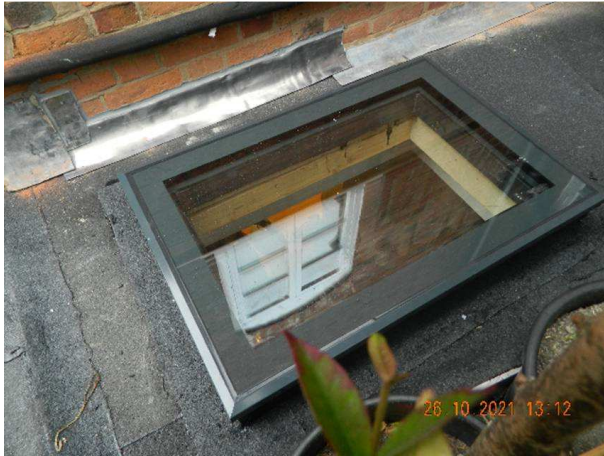
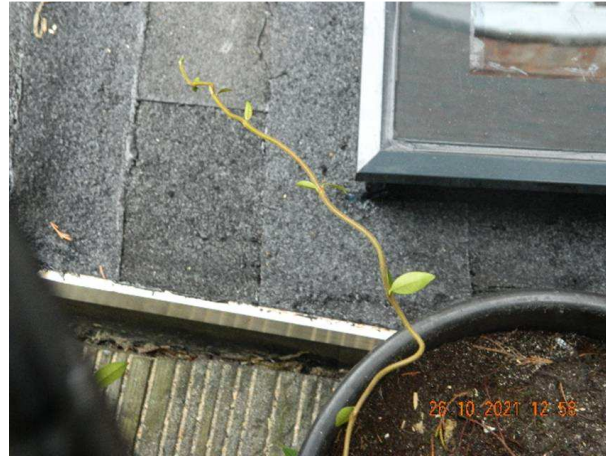
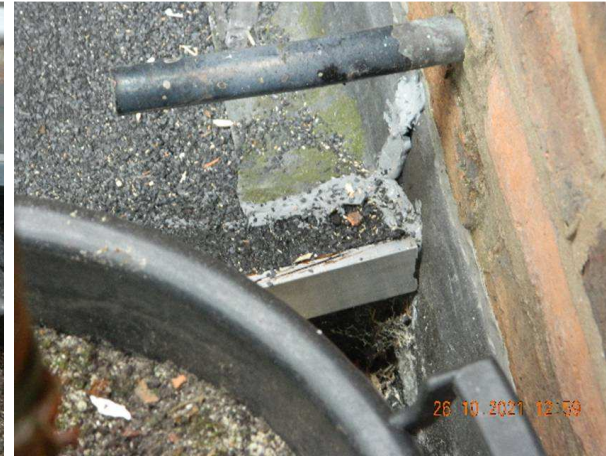
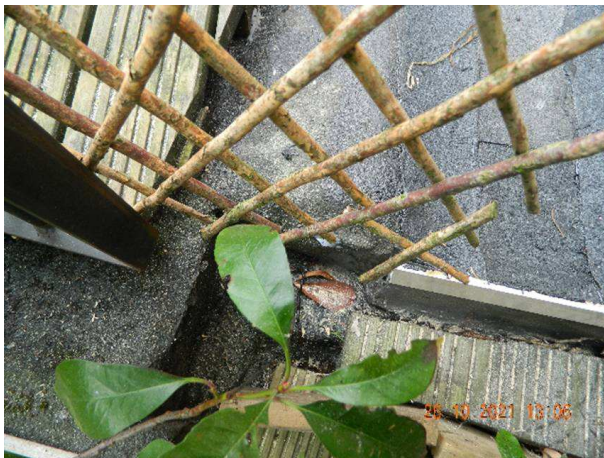
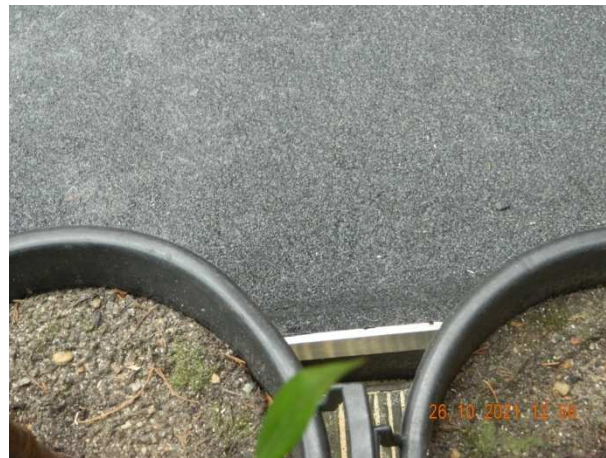
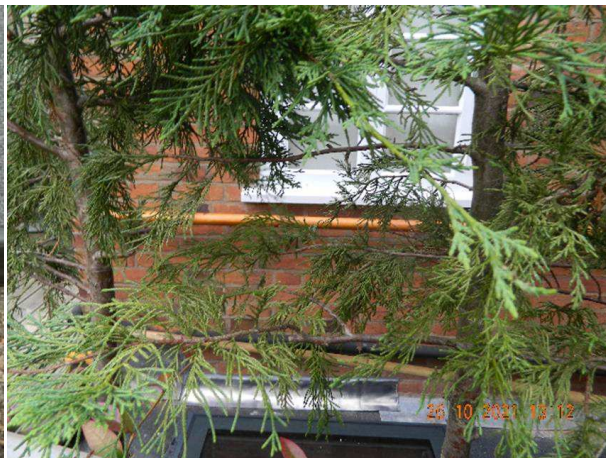
Boundary infringement. Aluminium finishing trim attached to top of 22 Mill Street upstand to cover where new felt had been lapped over it.

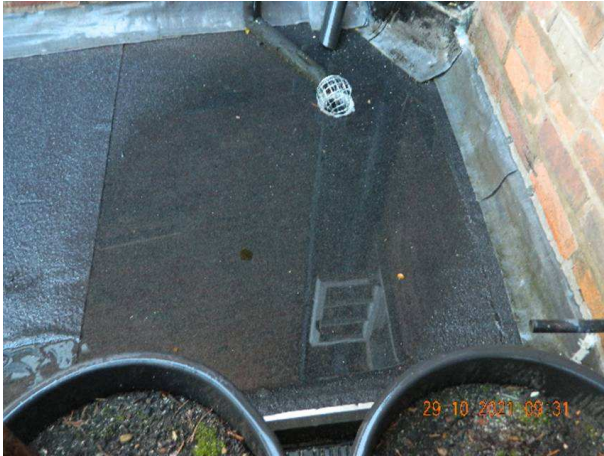
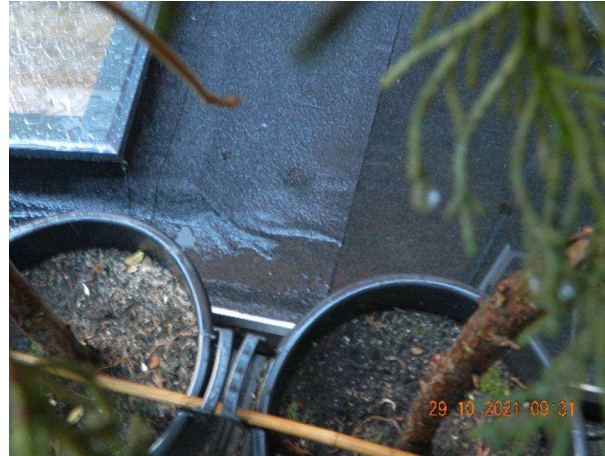
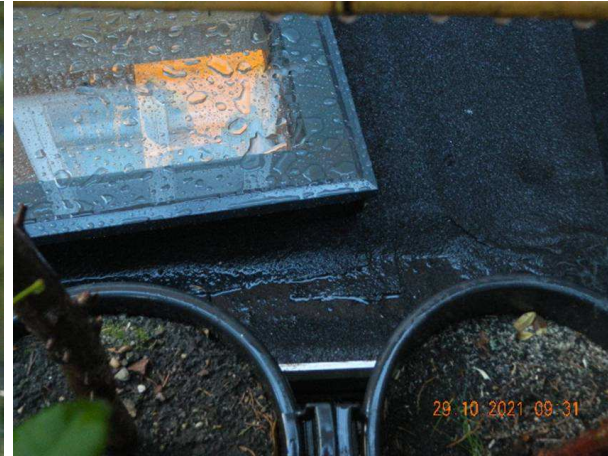
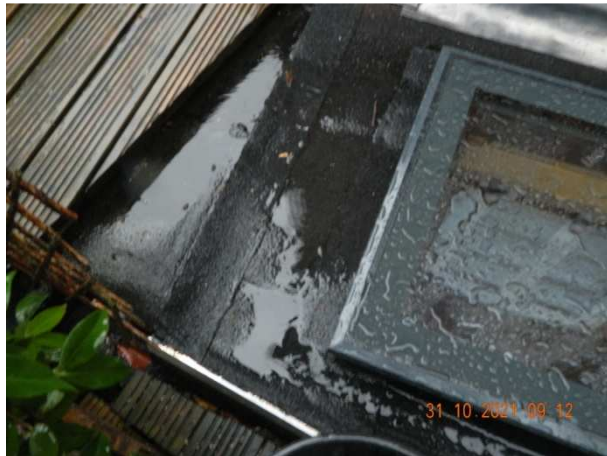
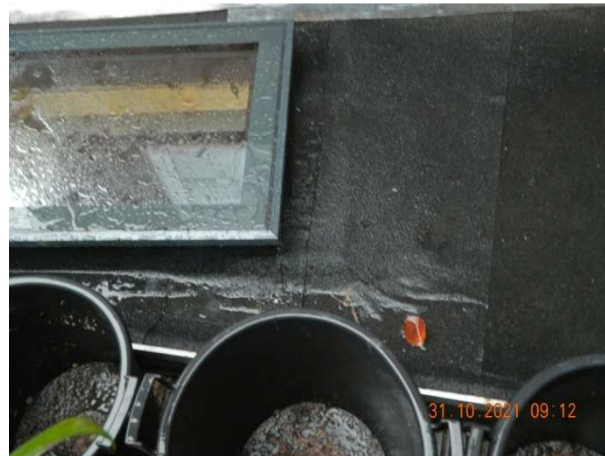
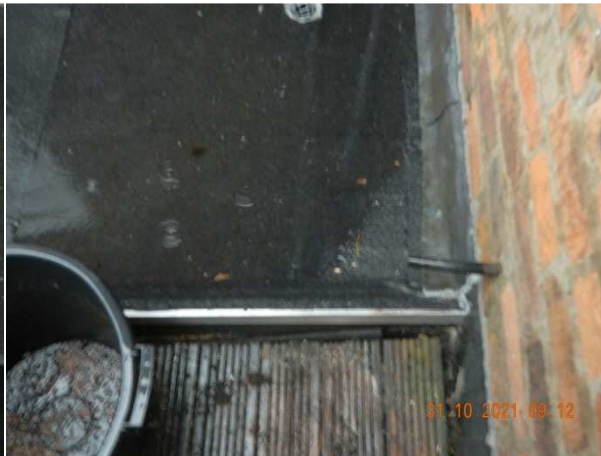
The slope of new roof fails to gather and transport rain/surface water to the other end of the flat roof and dispose of it via the installed roof drain gully inlet. Instead, water is allowed to pool on various areas of the roof, including next to the 22 Mill Street upstand/boundary marker.

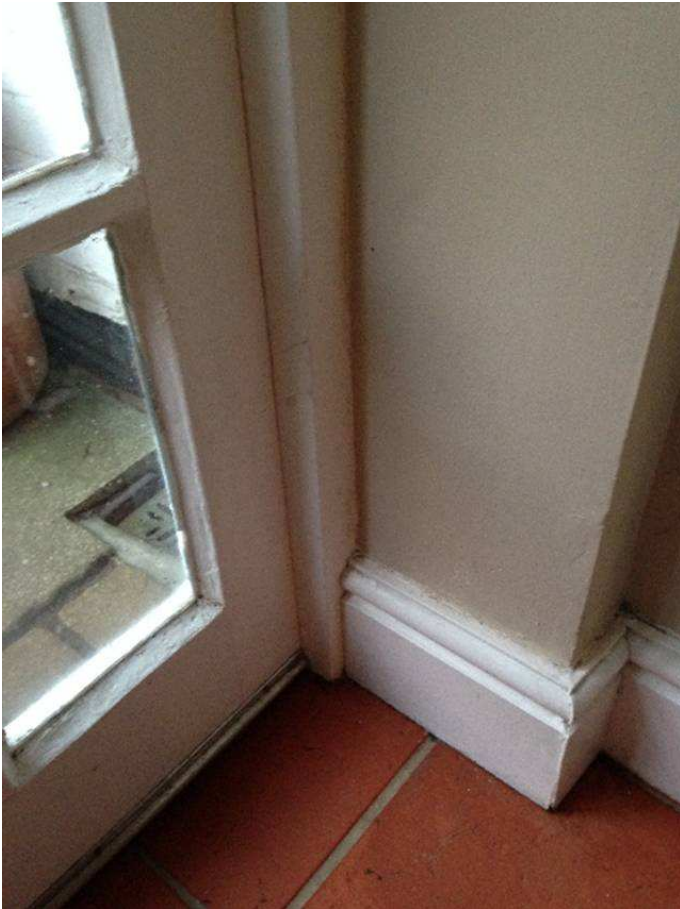
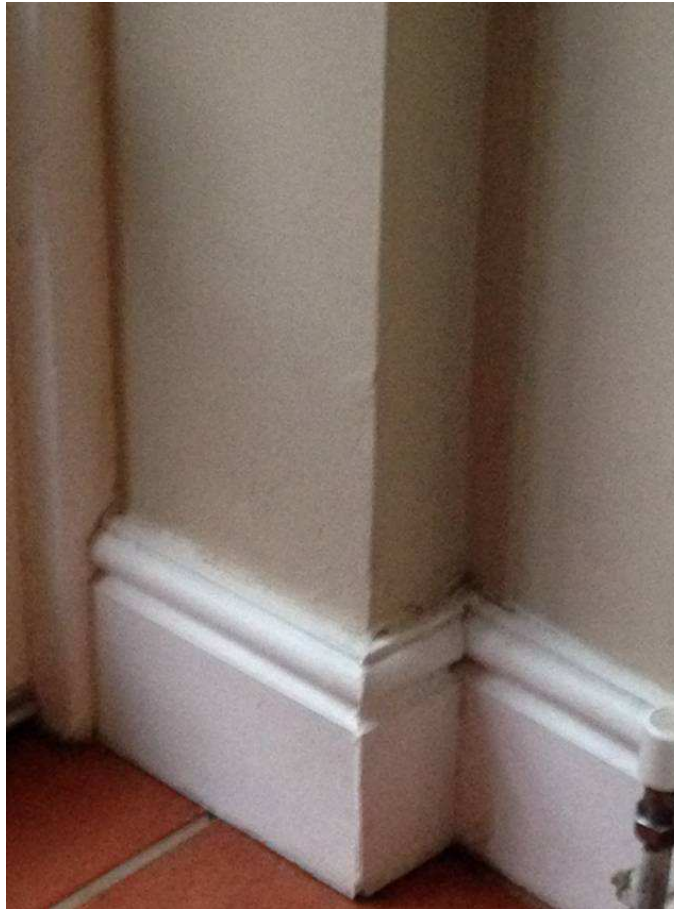
There is now visible dampness on the corner of the kitchen wall. The degree is currently to a height of around 35cm and moisture meter readings are 80 per cent above the maximum guideline. This damage occurred less than 12 weeks after my neighbour's new roof works were not carried out, not to the Council's approved standard, running these roof works up to the height of and over my existing protective upstand, undermining it and ultimately resuming their water discharging onto 22 Mill Street.
