**TREE SURVEY
&
ARBORICULTURAL ASSESSMENT REPORT**

Trees At: 1 Barbon Close, Heatherside, Camberley

Prepared for: PBS Holdings

February 2022

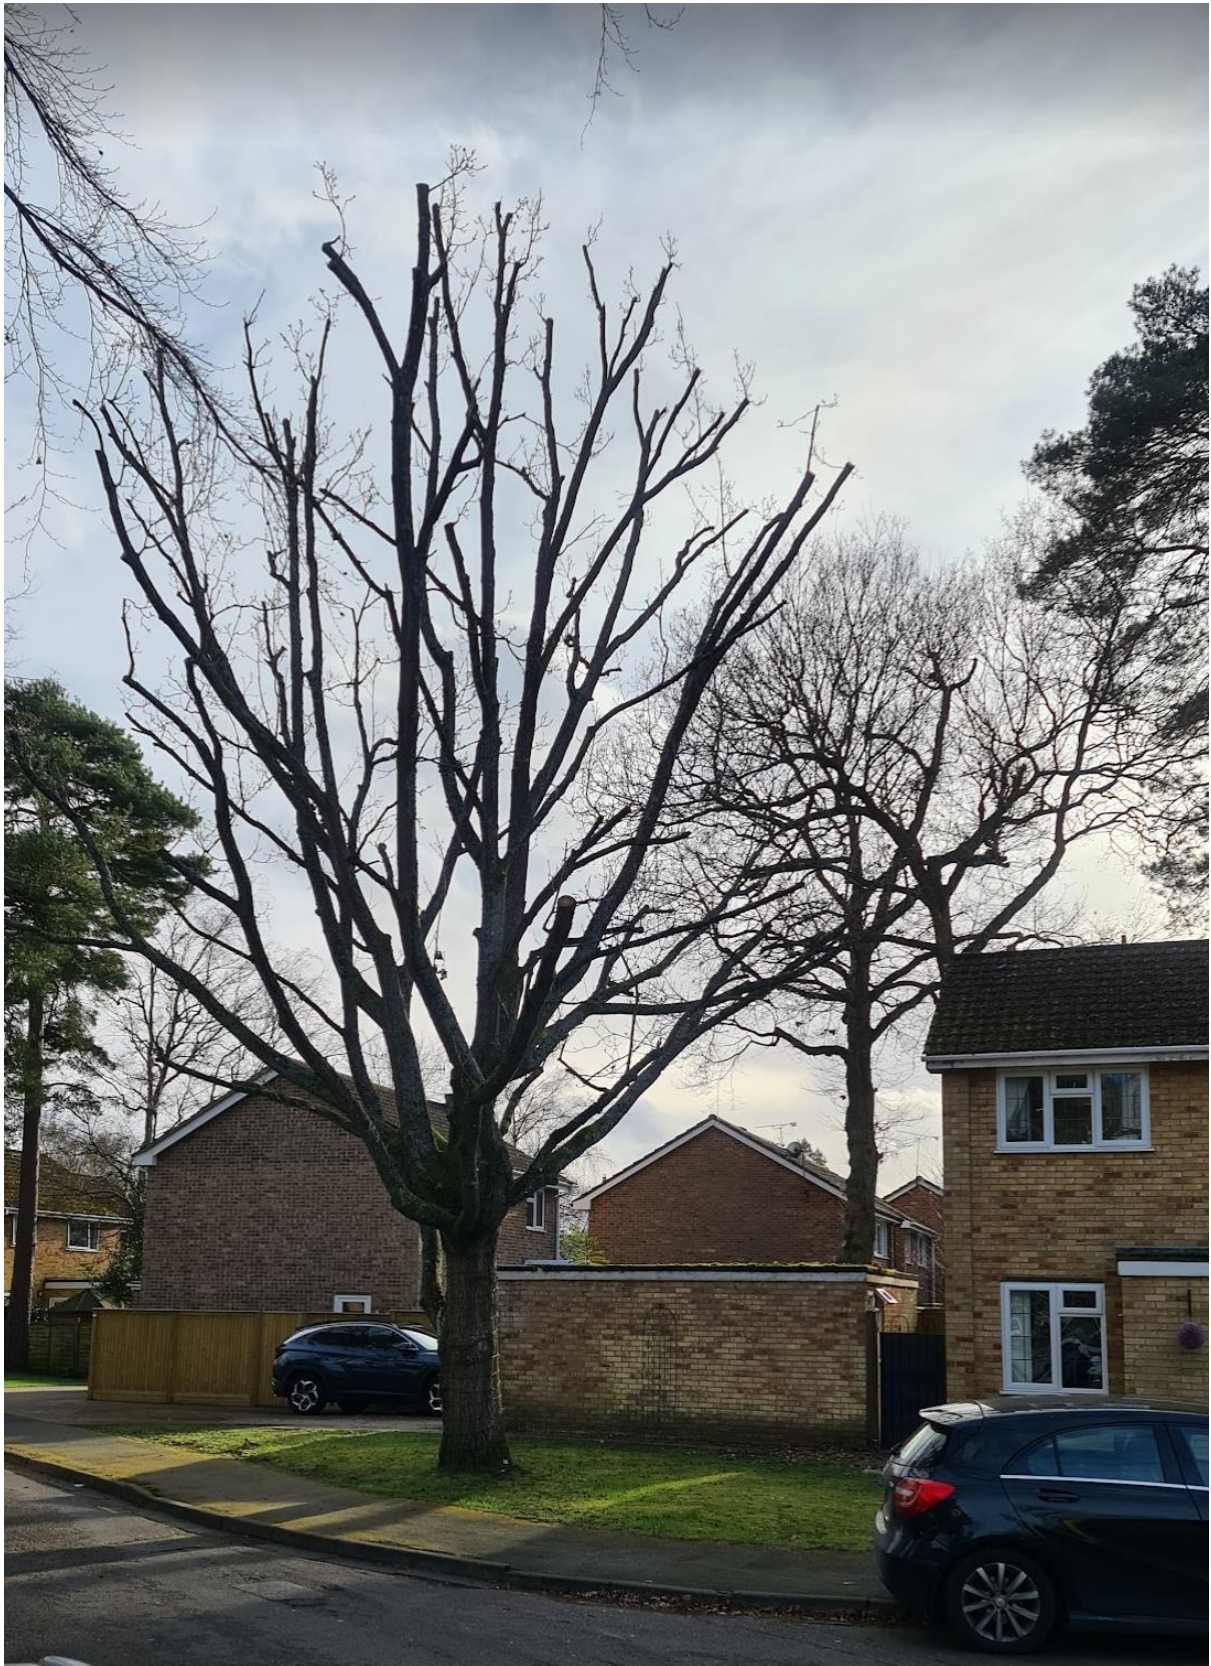
Photograph 1. Oak T1 to the front of the property recently reduced.

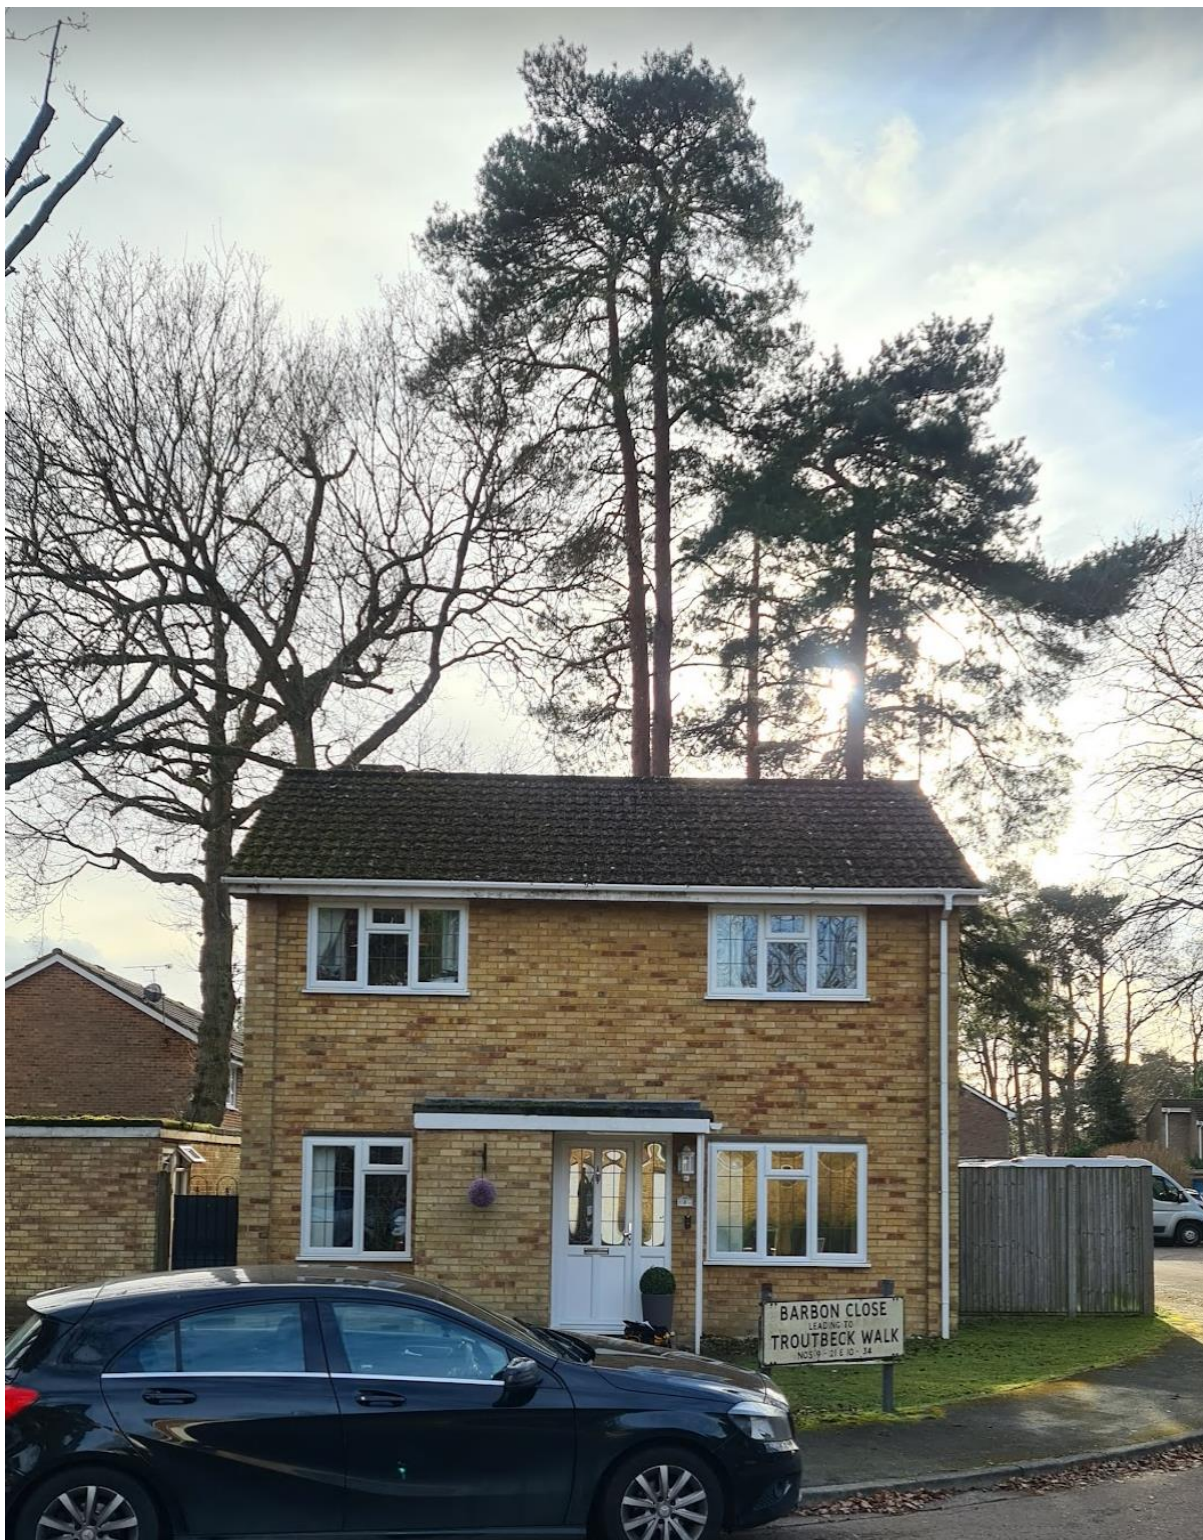
Photograph 2. Two third party Oak and Pines T1-T3 from the north of the property.

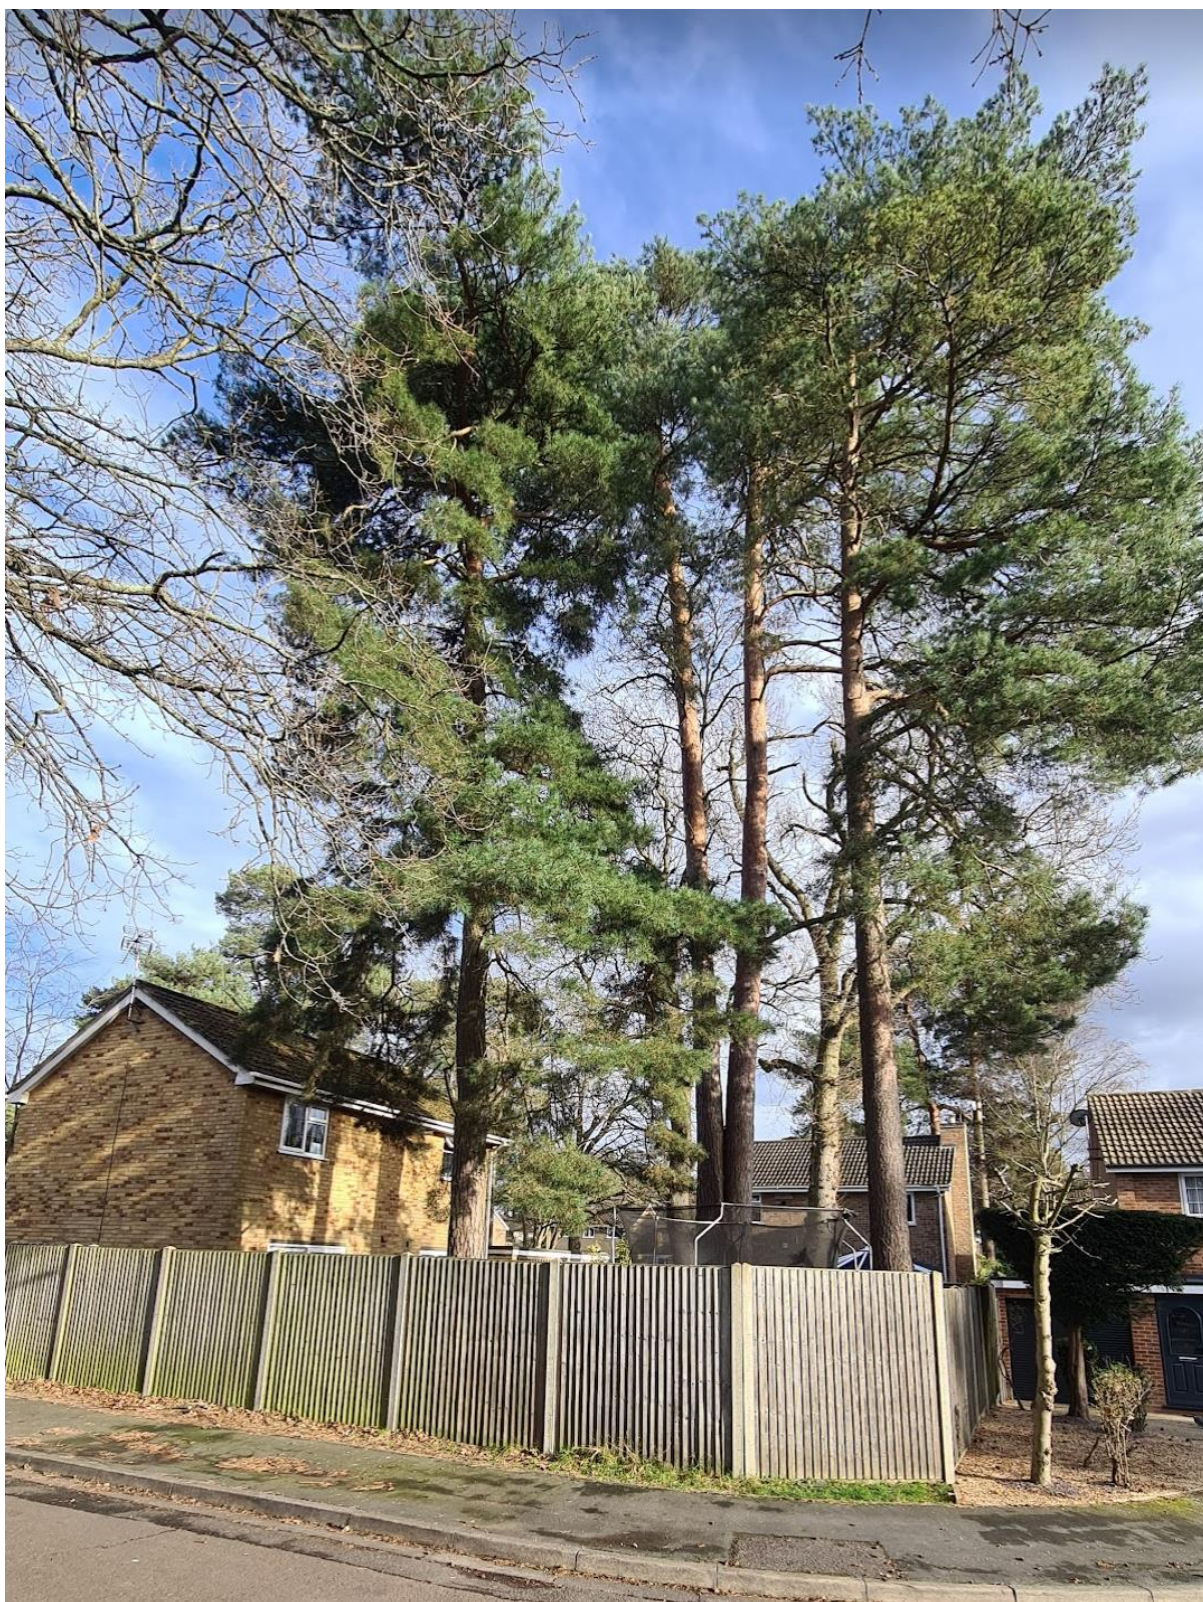
Photograph 3. Pines T1, T2 and T3 from left to right respectively.

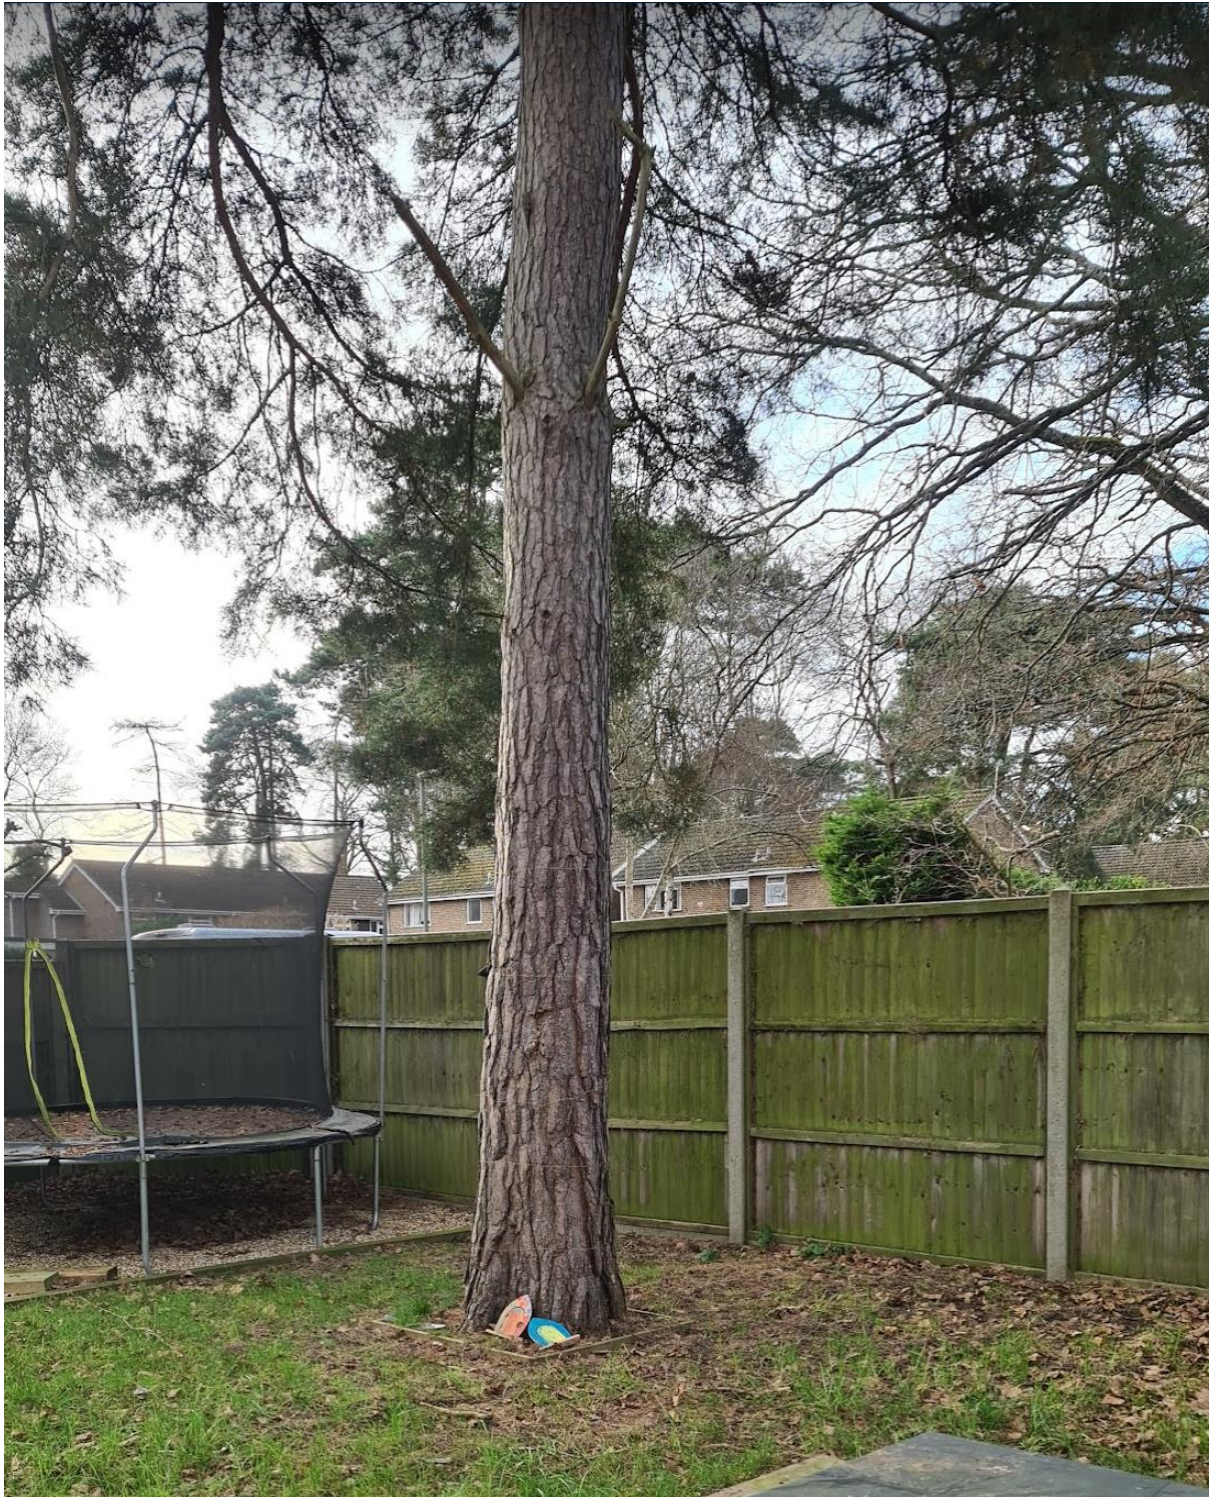
Photograph 4. Pine T1.

Scots Pine T1. Located within the rear garden of the property and close to the common boundary with the adjacent road, this is a mature tree with a generally spreading upper canopy form and typical of the species which often spreads either naturally or occasionally from storm or pest damage to the leading shoot. Inspection of this tree was open, and all observations and measurements were made from the subject property.

The crown profile of Scot Pine T1 is entire and balanced. The canopy has the greatest density of foliage of the three trees present. There is no evidence of current or past ivy infestation noted on other Pines within the general area. The main stem shows no signs of damage or structural compromise at this time. The use of a sounding mallet failed to indicate the presence of any advanced decay or cavity and there was no evidence of “stem fluting”. The basal area is sparse grass and also shows no signs of past movement.

Pine T1 appears to be outwardly sound and healthy, with good foliar cover and annual extension growth consistent with a tree of this age and maturity.

Pine T1.

Remove all dead wood and stubs. Reduce upper canopy lateral spread by a maximum of 1m, pruning branch tips back to suitable growing points within 1-2 years. Inspect on a 12–24-month cycle.

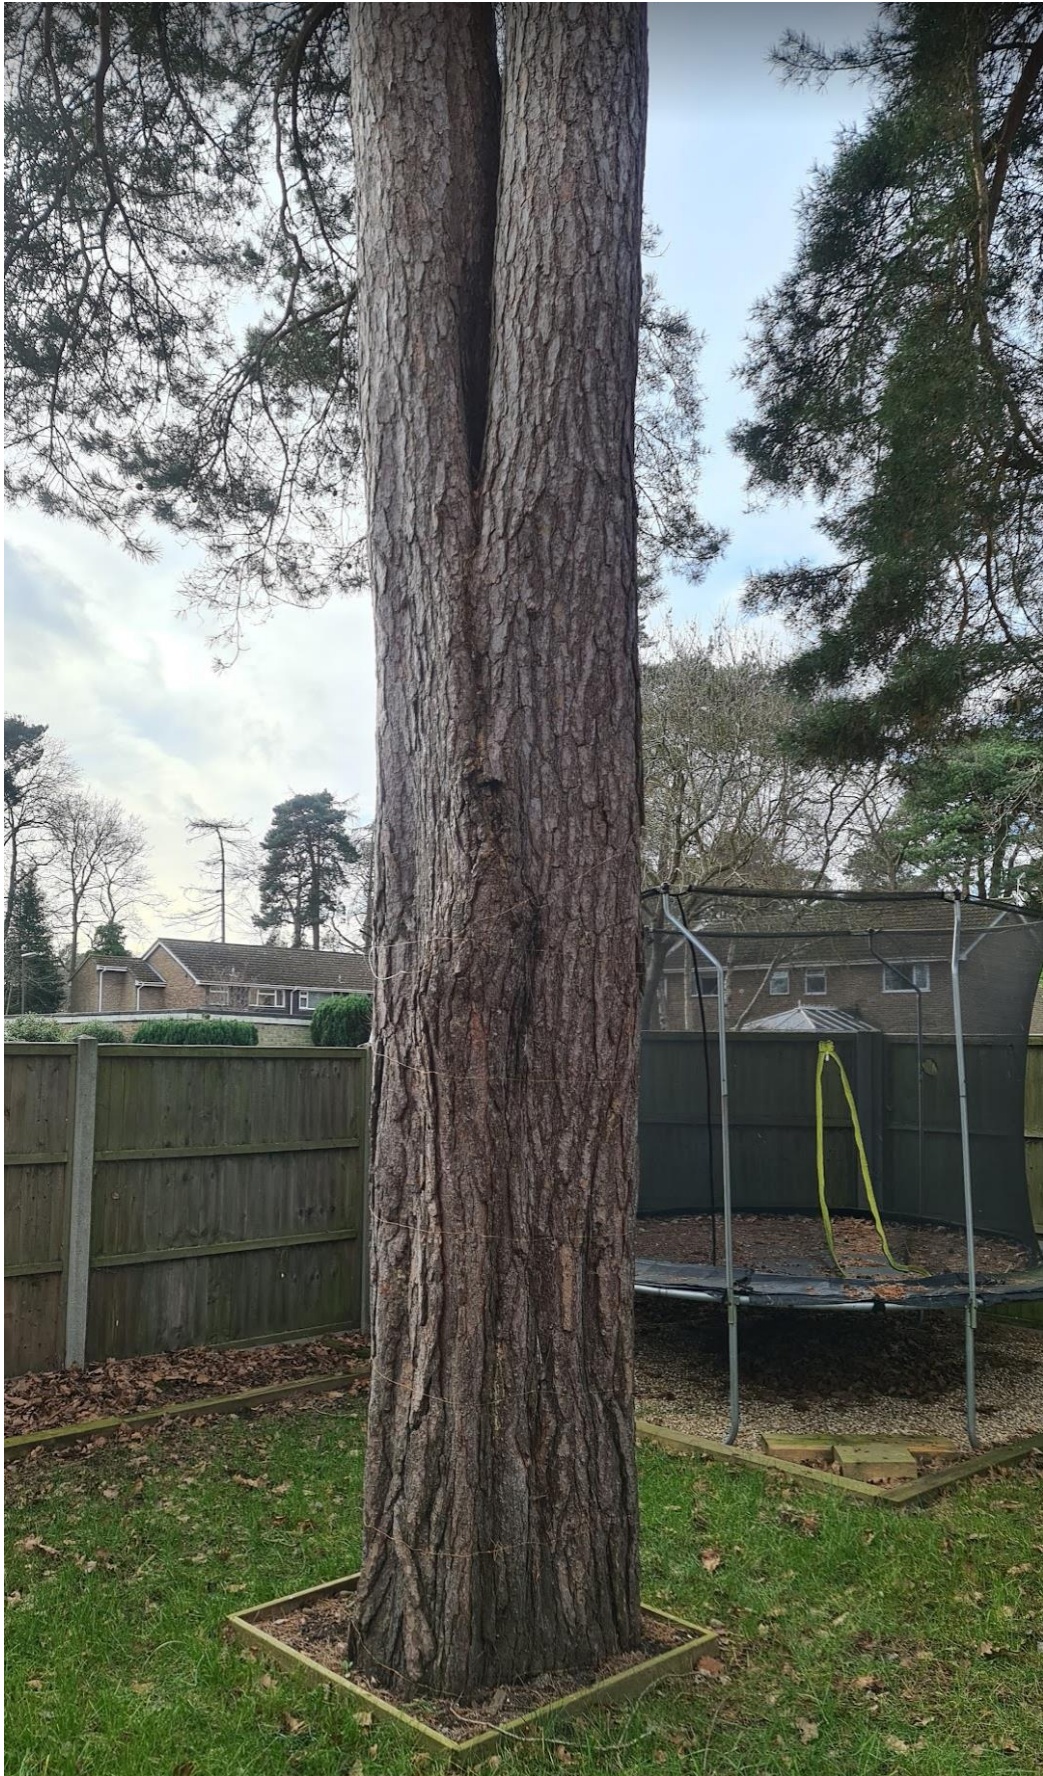
Scots Pine T2. Located within the rear garden of the property and within 7.64m of the rear elevation of the dwelling, this is a mature tree with a bifurcated [twin stem] form at 3m from ground level. Inspection of this tree was open, and all observations and measurements were made from the subject property.

The one potential area of concern would be the co-dominant form of the tree which bifurcates at approximately 3m above ground level. The tendency for the wood in a co-dominant union to split apart can be considered to be increased if there is a “bark inclusion” between the stems. As a result, the strength of the structure can become increasingly compromised. A high proportion of structural compromise and resultant tree failure is associated with unions featuring included bark.

Photograph 5. Pine T2 showing tightly forked co-dominant stems.

Pine T2.

Option 1: Remove all dead wood and stubs. Lift lower “dropper” branches to provide a 5m ground clearance Inspect on a 12–24-month cycle.

Option 2: Remove all dead wood and stubs. Install Cobra dynamic tree support system [or similar] and reduce upper crown by a maximum of 1.5 – 2.0m to reduce stress on co-dominant stems. Inspect on a 12-month cycle. **See Note below.**

Option 3: Remove entirely to ground level and replace with a minimum large standard fastigate form tree species. The removal of this one tree would have an insignificant impact on the landscape profile of the location and will allow for the start of a phased removal and replacement programme to ensure the maintenance of visual amenity for the long term. It is likely a Planning Inspector would concur with this view should an appeal be required.

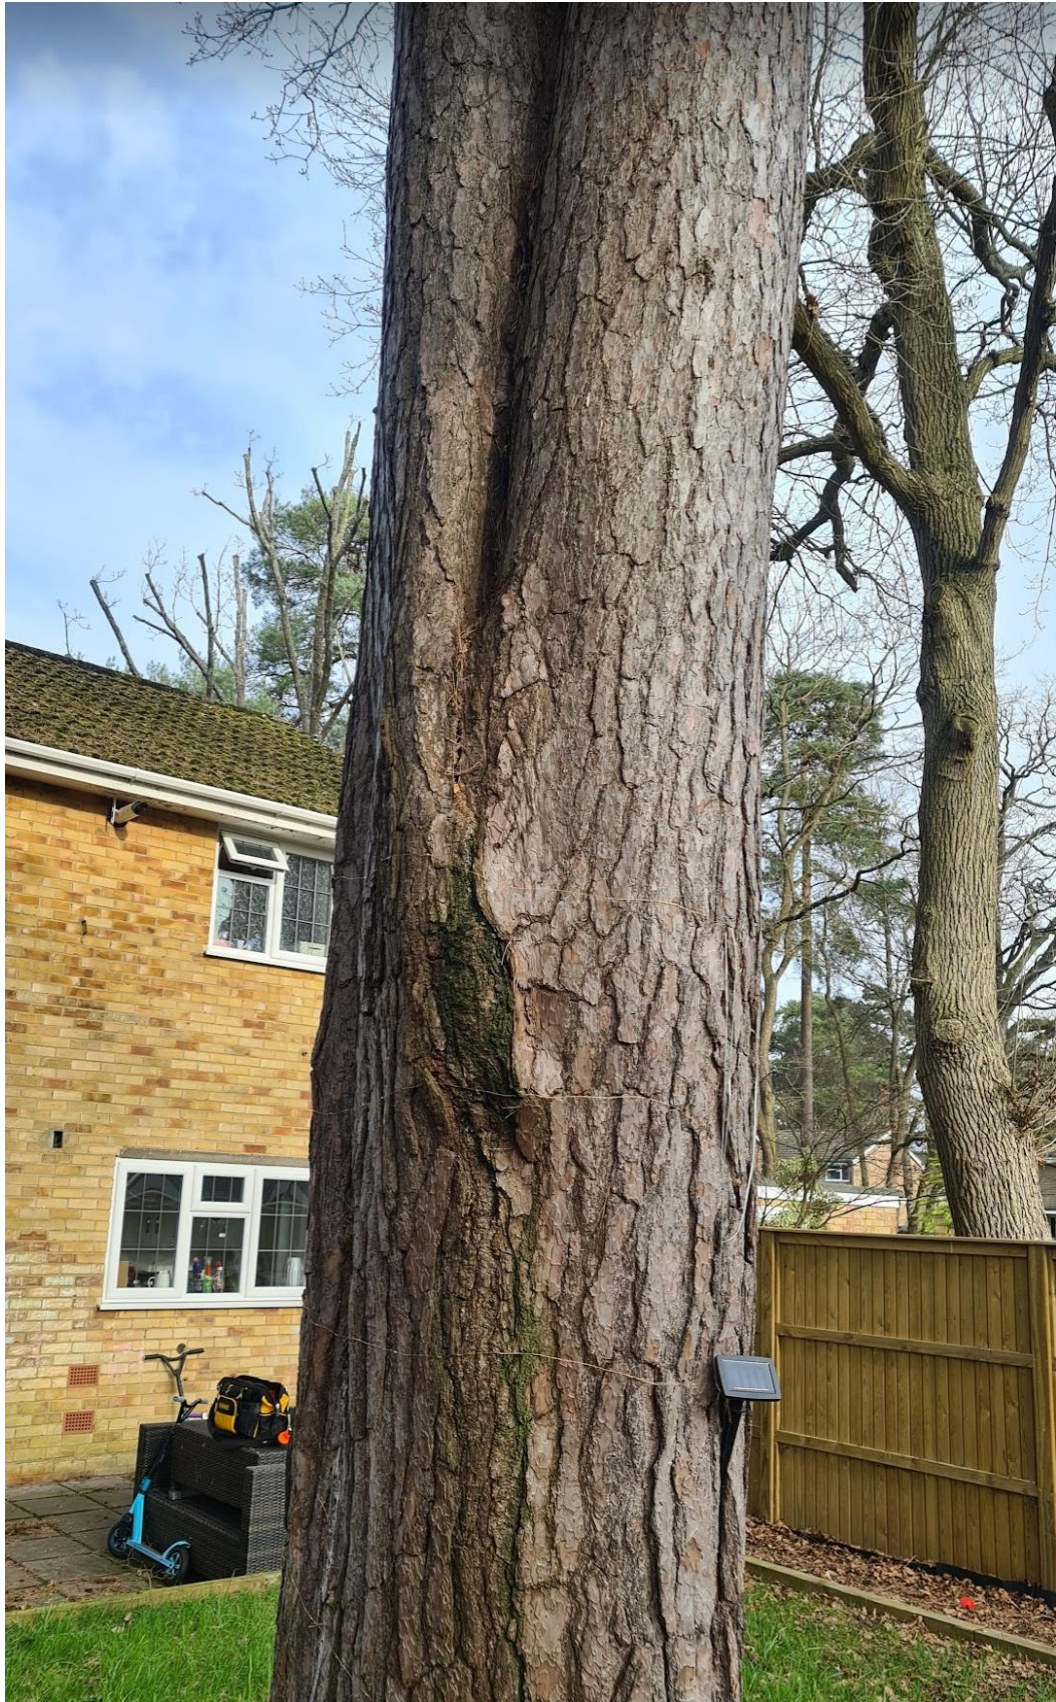
Photograph 6. Pine T2 with included bark at the co-dominant union from the south side.

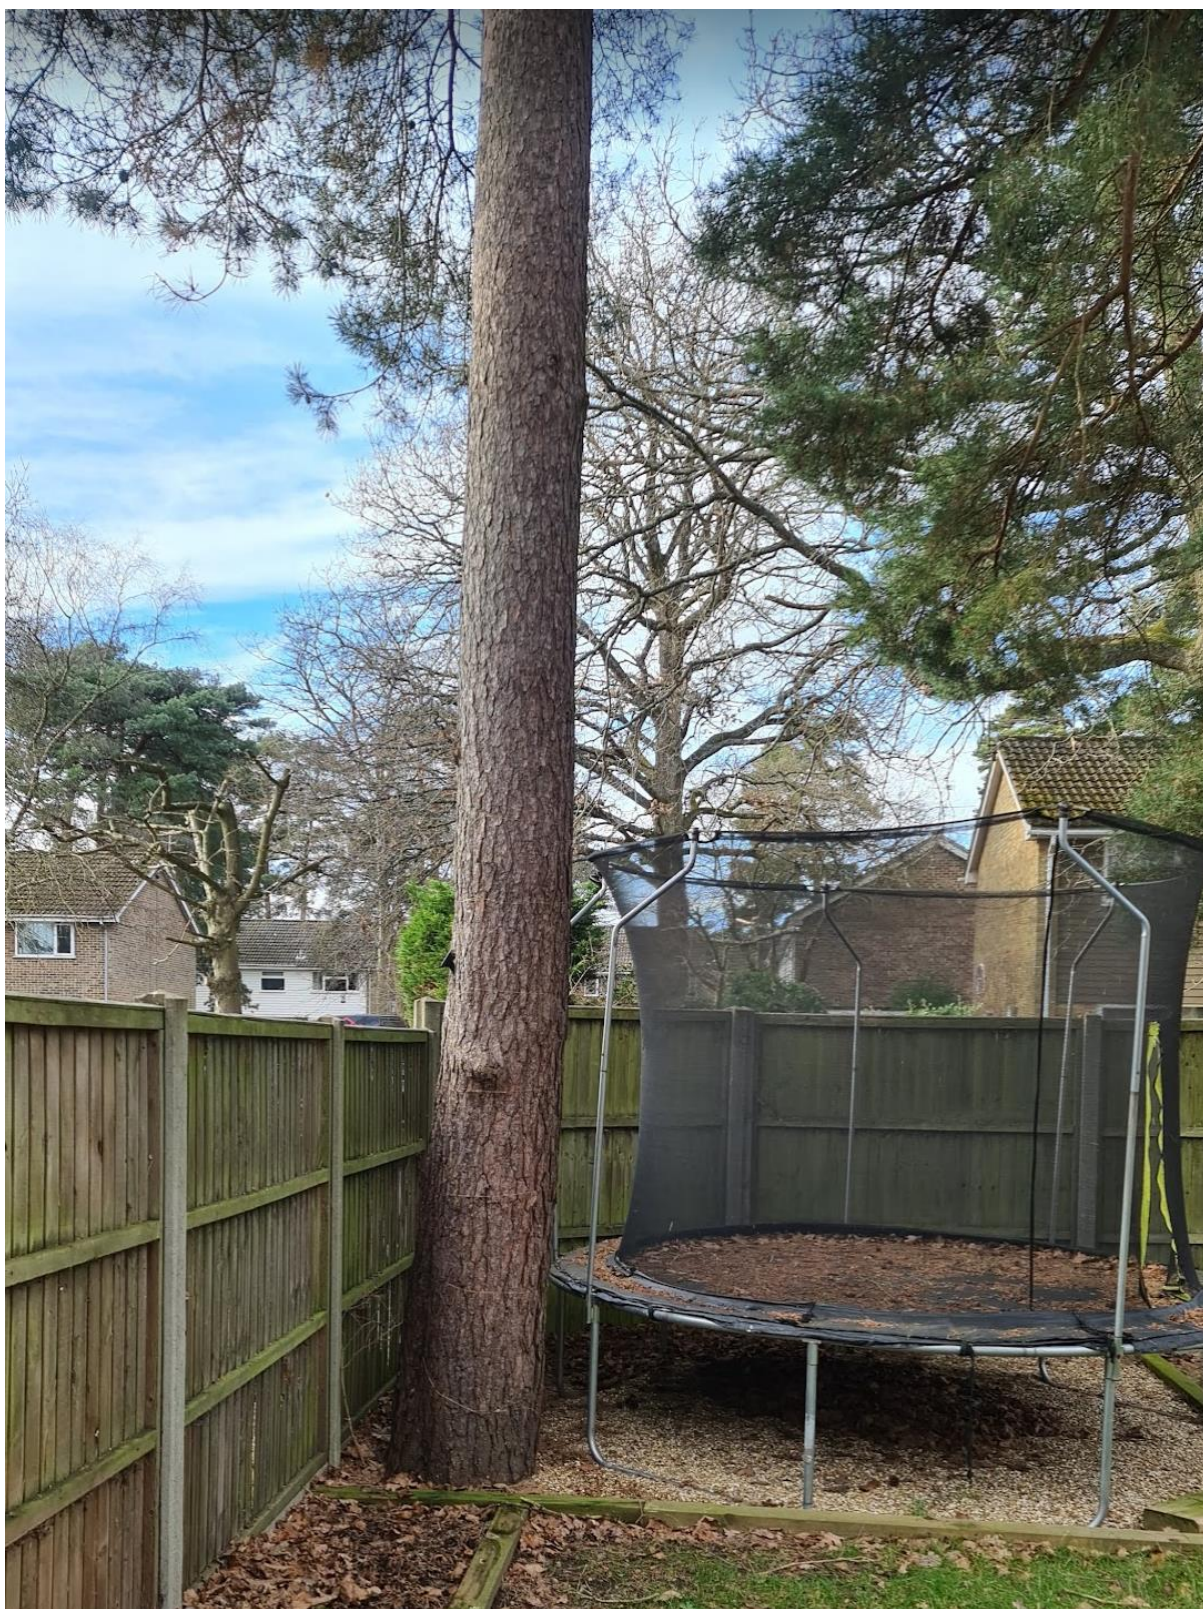
Photograph 7. Pine T3.

Scots Pine T3. Located within the rear garden of the property and within 10.78m of the rear elevation of the dwelling, this is a mature tree with a single stem. Inspection of this tree was open, and all observations and measurements were made from the subject property.

The crown profile of Scot Pine T1 is entire and balanced. The canopy has below average density of foliage perhaps indicative of poor vigour and progressive decline. There is no evidence of current or past ivy infestation noted on other Pines within the general area.

Pine T3

Remove all dead wood and stubs. Reduce upper canopy lateral spread by a maximum of 1m, pruning branch tips back to suitable growing points within 1-2 years. Inspect on a 12–24-month cycle.

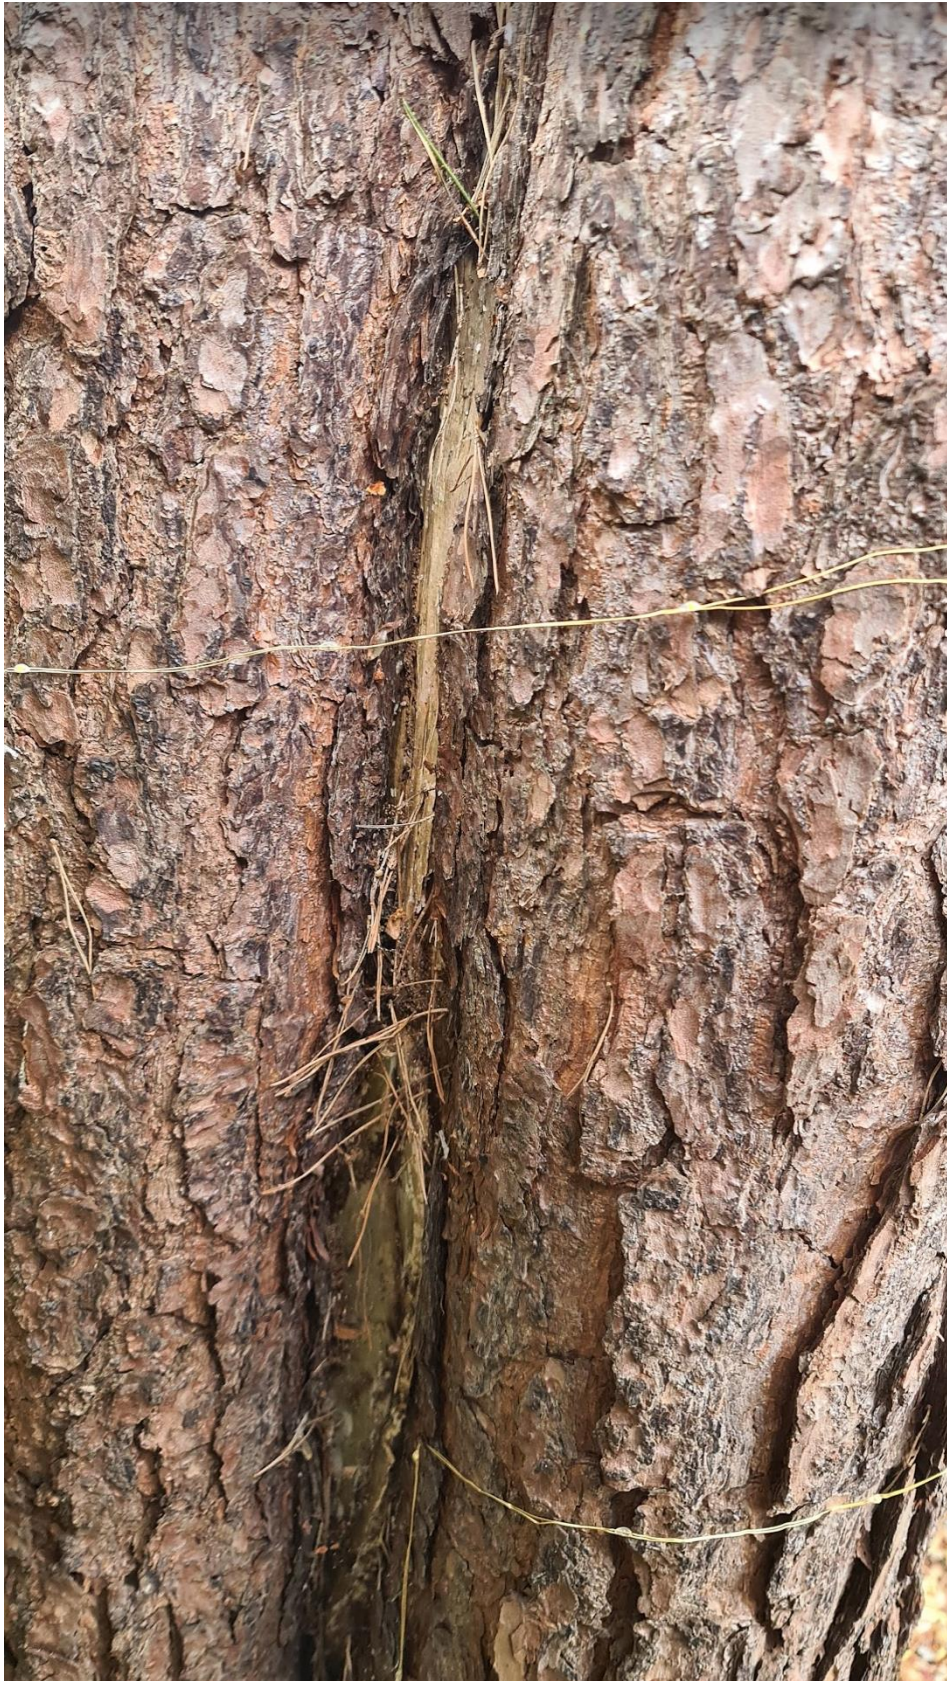
The main stem shows signs of damage with a 1m long lesion noted on the south side, possibly caused through past construction or fencing works. This is currently localised and of little significance. The use of a sounding mallet failed to indicate the presence of any advanced decay or cavity although there was evidence of "stem fluting". The basal area is used as the location of a trampoline.

Photograph 7. Lesion to south side of Pine T3.
