**RE: SPECIFIC DEFECT REPORT: STRUCTURAL REPORT ON BARNs AT DUTTON  
PARK FARM, DUTTON, CHESHIRE, WA4 4HL**

**BARNS AT DUTTON PARK FARM, DUTTON, CHESHIRE, WA4 4HL**

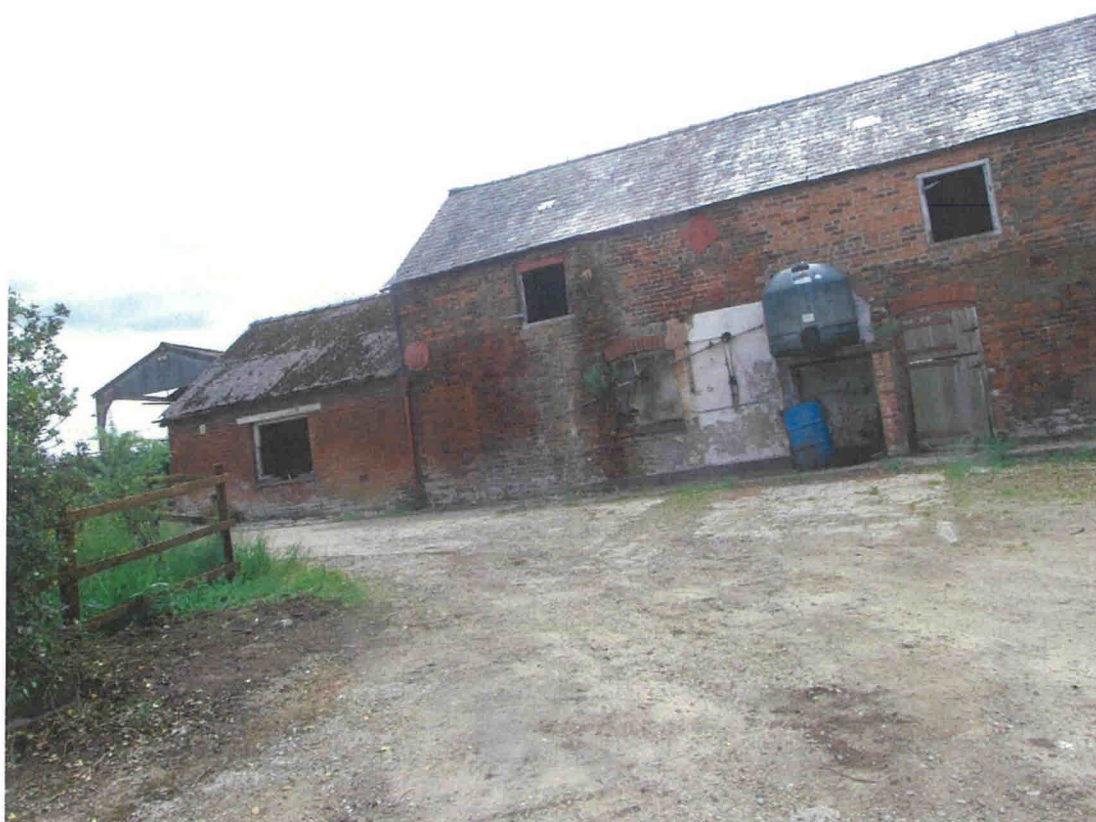
Barn A Front elevation

- E.2.1 FRONT COURTYARD ELEVATION: The elevation is 330mm to ground floor and 225mm to first floor with brick arches and timber lintels being provided over doors and windows.

- E.2.2 The pointing was weathered in places to the elevation and spalling was noted. The walls have been patched in the past but this is only an aesthetic matter.

- E.2.3 Lateral restraint plates are noted to ends of first floor beams to this and rear elevation. This elevation has a self-seeded tree growing to the left side which has caused damage to the wall and loss of lateral restraint has occurred. Part of this wall will need to be removed and rebuilt.

- F.1 BARN A  
EXISTING WALLS:  
FRONT ELEVATION: The front elevation will require some rebuilding due to self-seeded tree and loss of lateral restraint, normal thermal upgrade required internally and aesthetic repair externally.

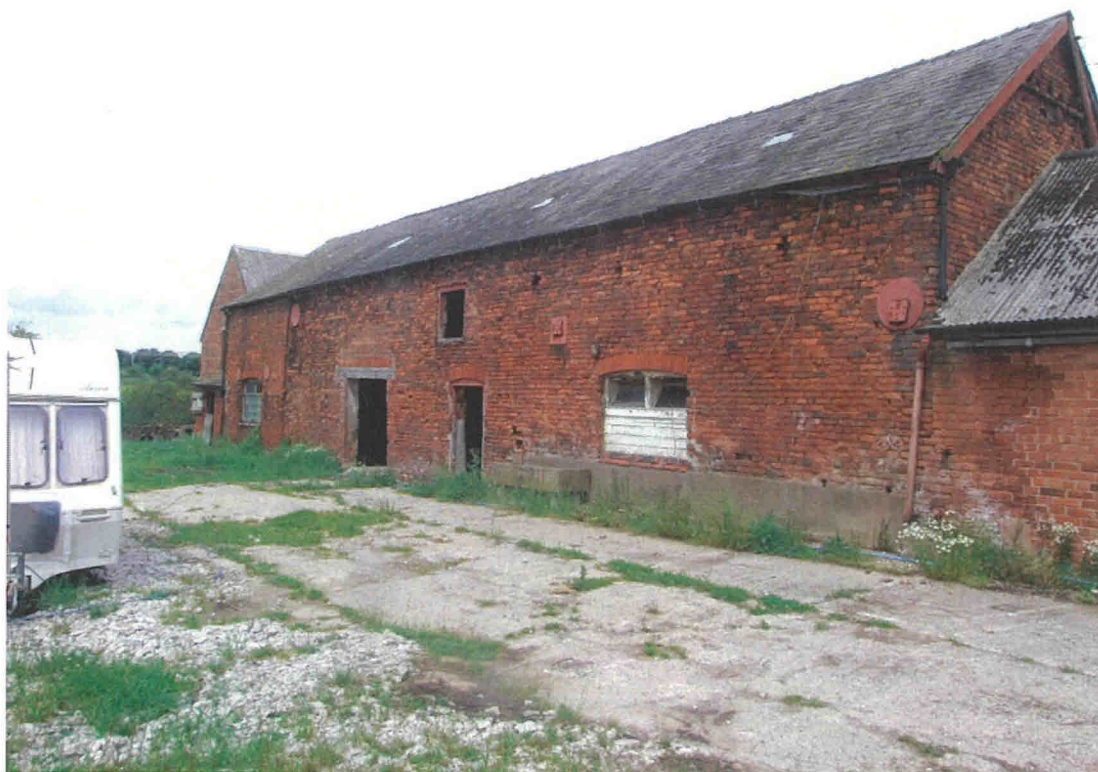
Barn A Rear elevation

- E.2.5 REAR ELEVATION: The rear elevation has the single-story element to the right with link to left. The single storey element to the right has been affected by impact damage to the 225mm wall and this will need to be rebuilt in any conversion.

- E.2.6 The main walls were again of 330mm and 225mm with 5 lateral restraint plates at ends of steel beams. A render plinth was noted to the right side. The bricks again were weathers with some spalling and isolated reinstatement would be required.

- F.1.1 REAR ELEVATION: The single storey element will require to be partially rebuild due to impact damage, normal thermal upgrade required internally and aesthetic repair externally.

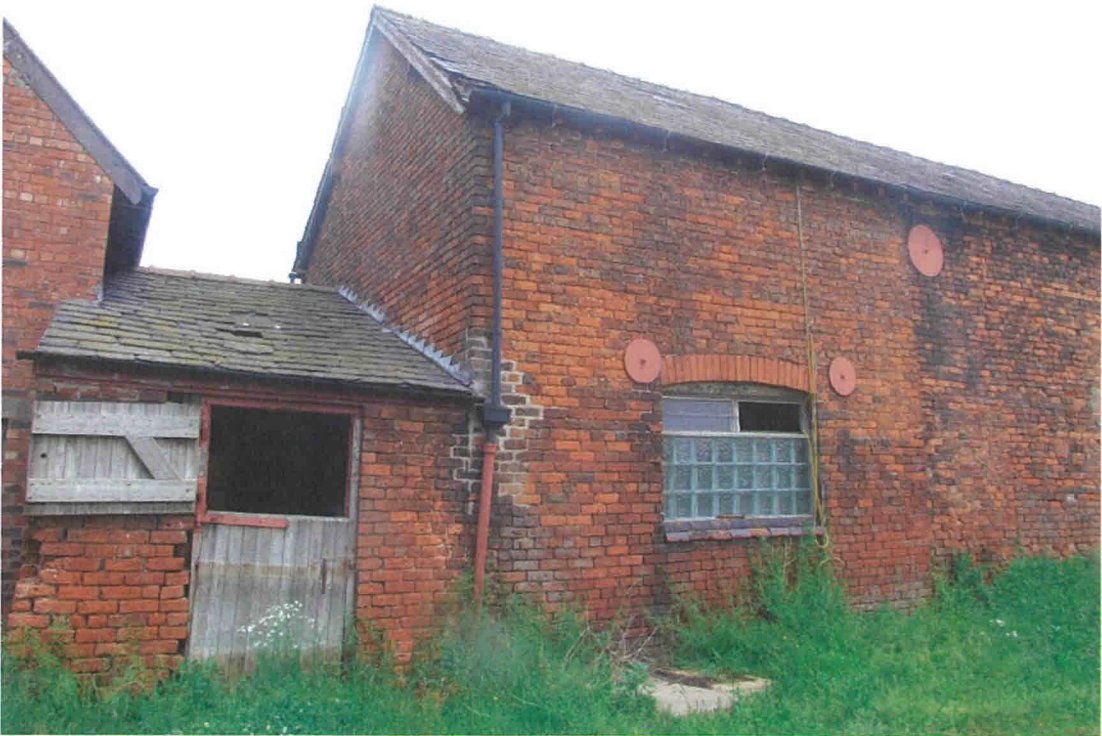
Barn A Right elevation

- E.2.7 RIGHT GABLE ELEVATION: This gable was again noted to be 330mm and 225mm and was of English garden wall bond, minor spalling but no major defects. This is partially concealed by single storey link.

- F.1.2 RIGHT ELEVATION: No major issues, normal thermal upgrade required internally and some aesthetic repair externally.
- F.1.3 LEFT ELEVATION: No major issues, normal thermal upgrade required internally. Some aesthetic repair.

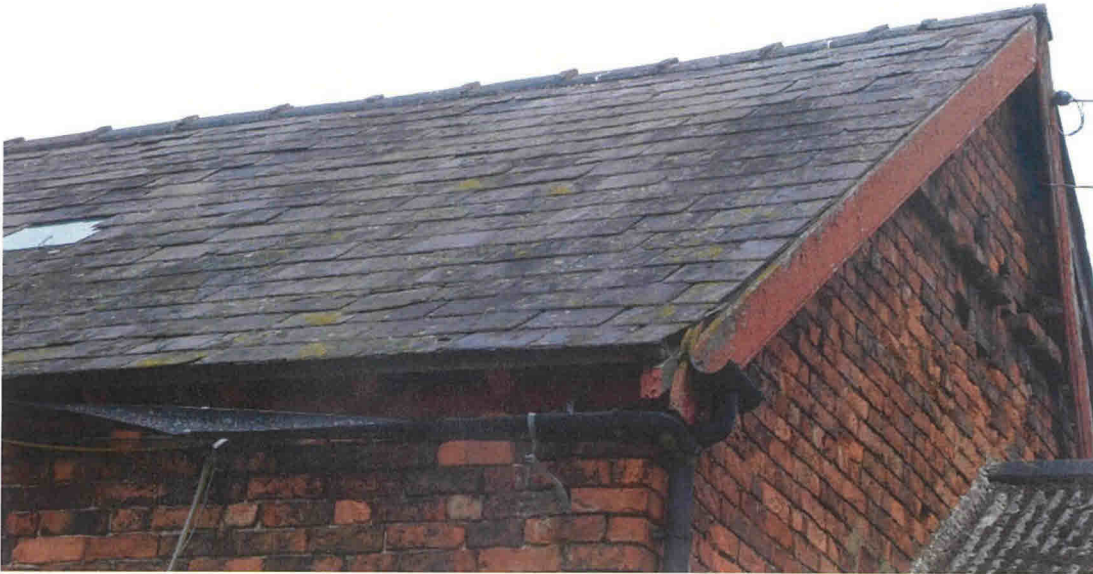
Barn A Left elevation gable.

- E.2.4 LEFT GABLE ELEVATION: This gable with single storey element. This is in a fair condition and a Dove cot was noted at high level, minor weathering of pointing that will require rectification.

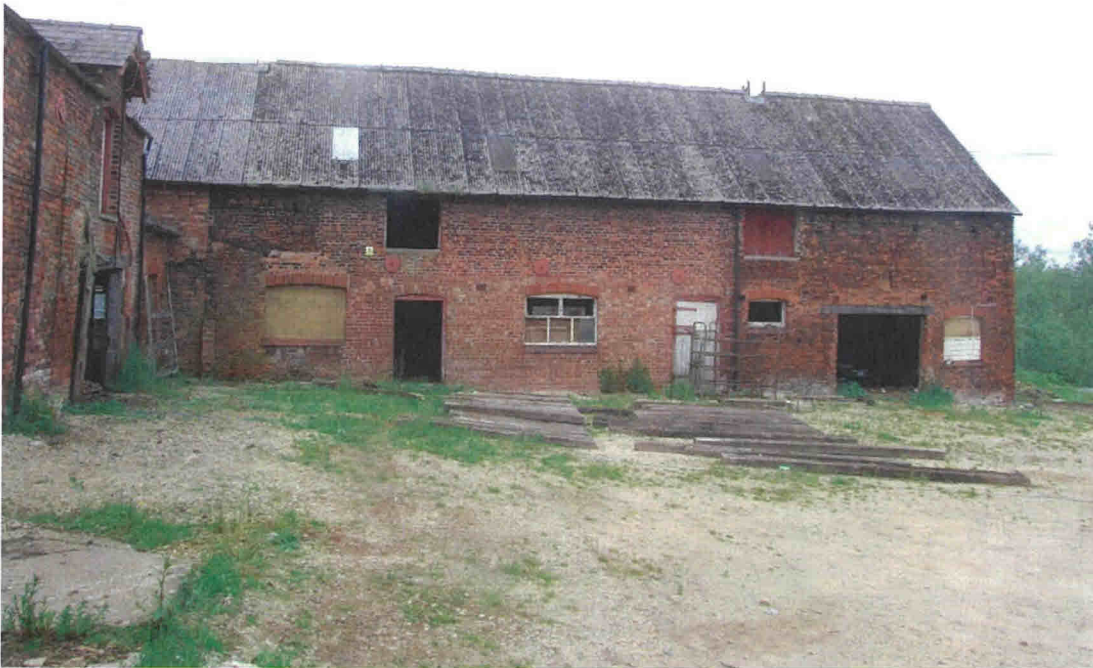
Barn B Front elevation

- E.8.1 COURTYARD ELEVATION: The elevation is 330mm to ground floor and 225mm to first floor with brick arches and timber lintels being provided
- E.8.2 The pointing was weathered in places to the elevation and a small amount of spalling was noted. Past patching and infill of windows is noted and the right side is an addition but of some age.

- E.8.3 The left side of the elevation has also been rebuilt in the past with differing bricks being noted.
- E.8.4 LEFT GABLE ELEVATION: This gable was noted to be of a stock brick with large ground floor opening and all lintels to elevation were of concrete. No major issues noted.

- F.3 BARN B  
EXISTING WALLS:  
FRONT ELEVATION: No major issues, normal thermal upgrade required internally and aesthetic repair externally.
- F.3.1 REAR ELEVATION: No major issues, normal thermal upgrade required internally and some aesthetic repair externally.

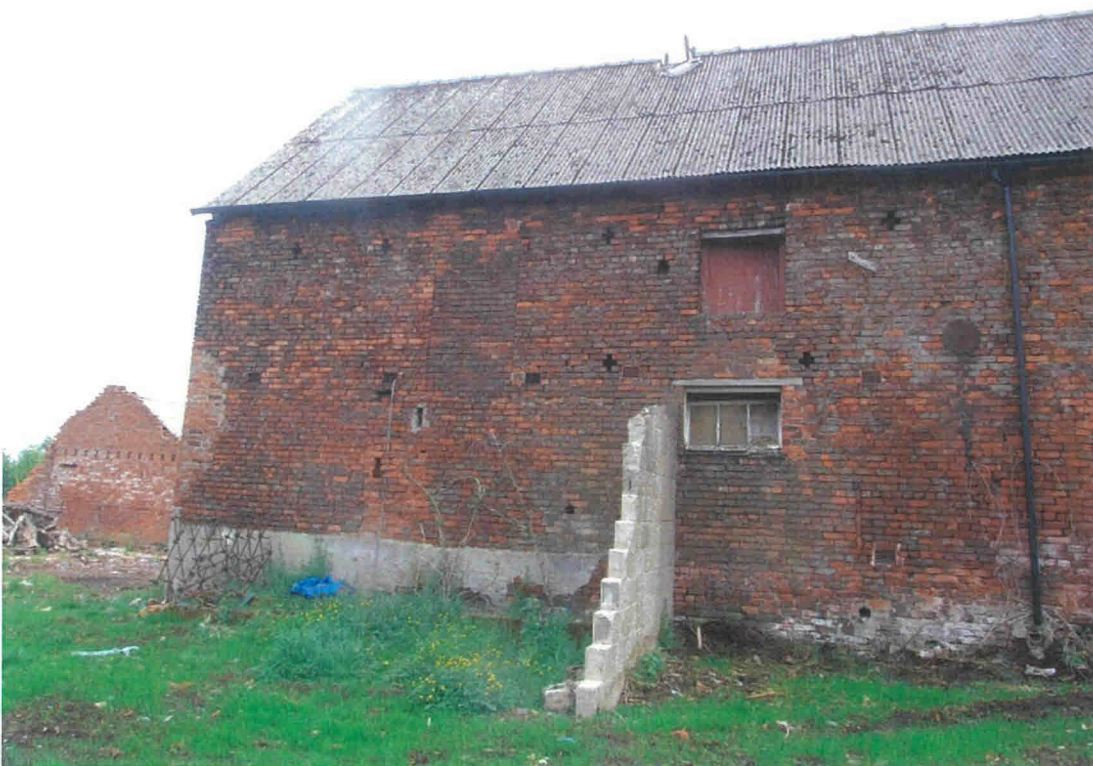
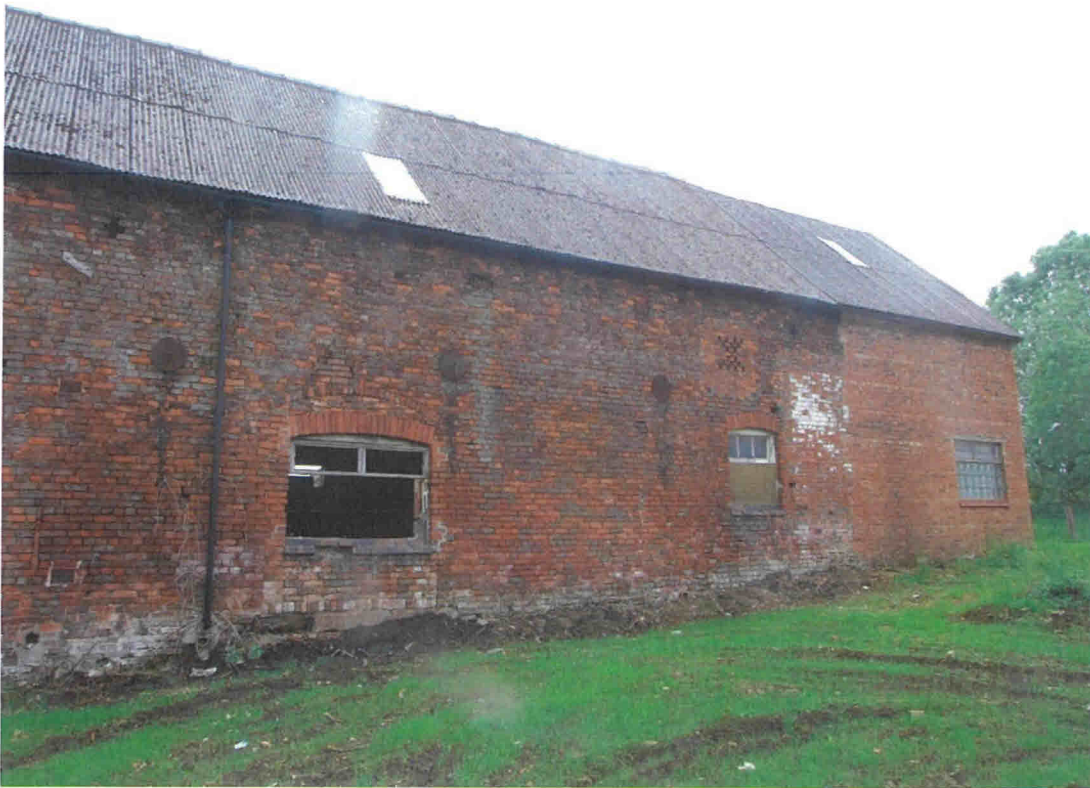
Barn B Rear elevation

- E.8.5 REAR ELEVATION: The rear elevation is of two differing bricks with the right side being rebuilt in the past, lateral restraint bars noted to the older right-hand section. The walls were noted to be relatively plumb however.

- E.8.6 Spalling of bricks and weathered pointing was noted to the elevation. A render plinth being present to the left side along with past rebuilding of left corner element.

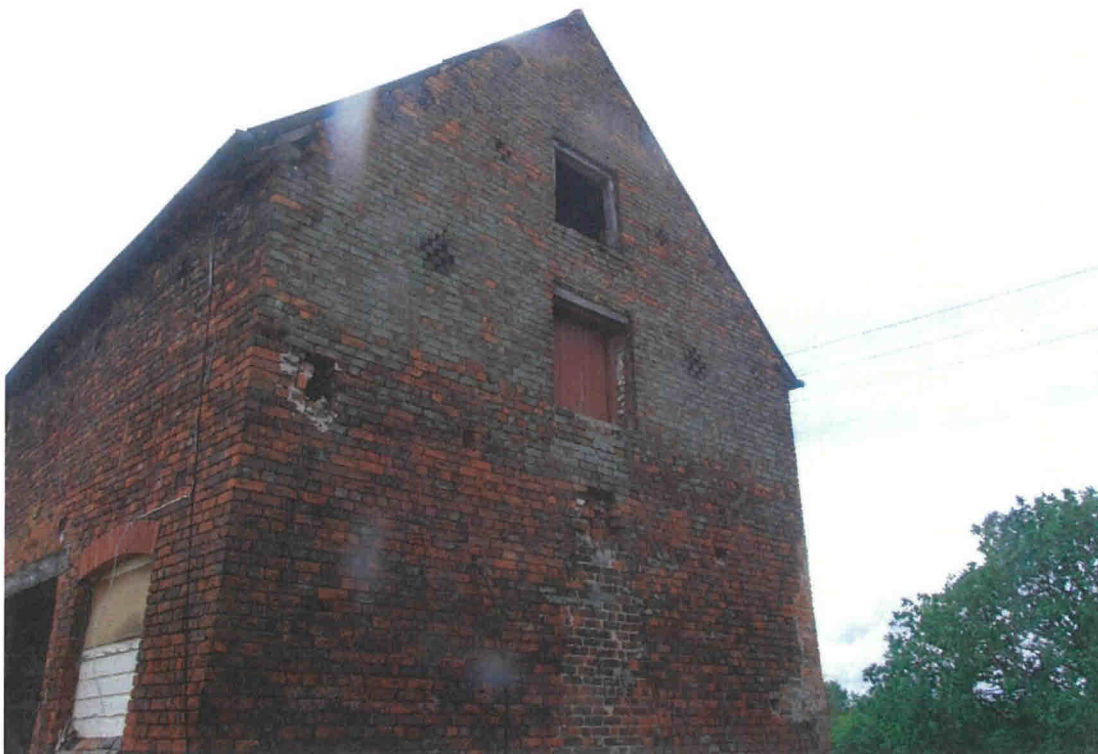
Barn B Right elevation

- E.8.7 RIGHT GABLE ELEVATION: This gable was again noted to be 330mm and 225mm and was of English garden wall bond, minor spalling of bricks and mortar but no major defects.

- F.3.2 RIGHT ELEVATION: No major issues, normal thermal upgrade required internally and some aesthetic repair externally.
- F.3.3 LEFT ELEVATION: No major issues, normal thermal upgrade required internally. Some aesthetic repair required.

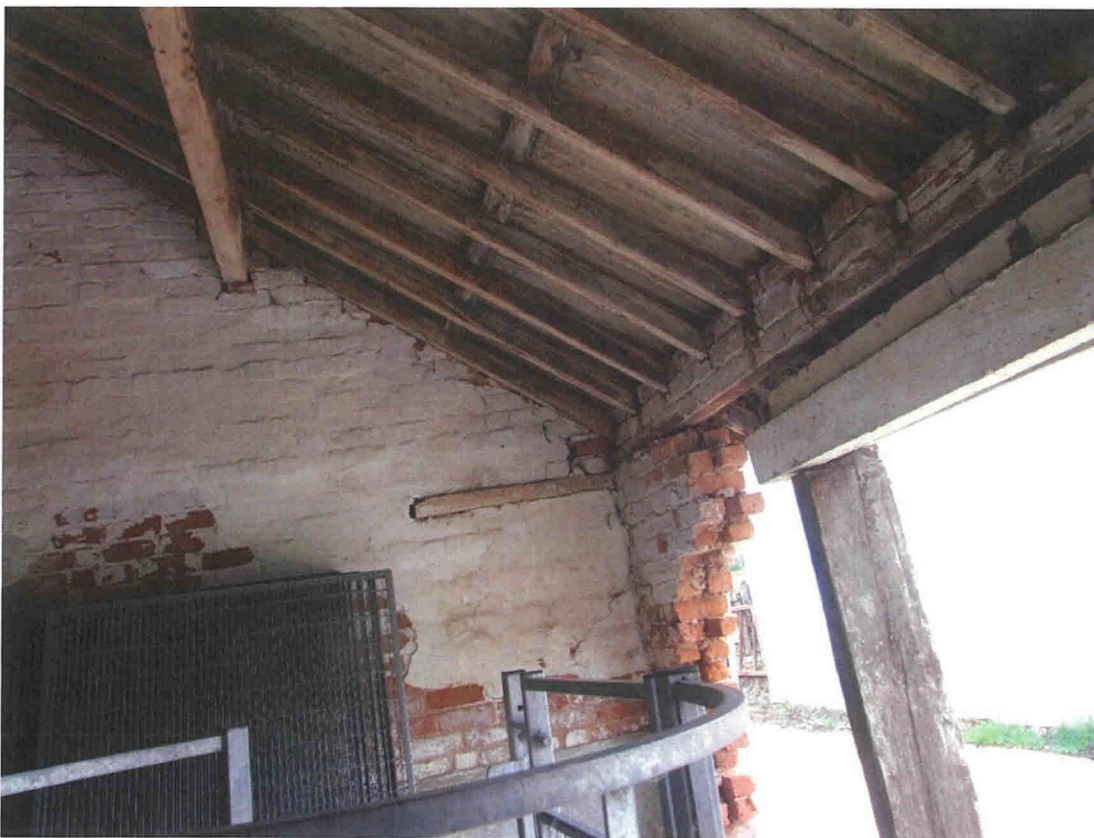
Barn A impact damage to single story.

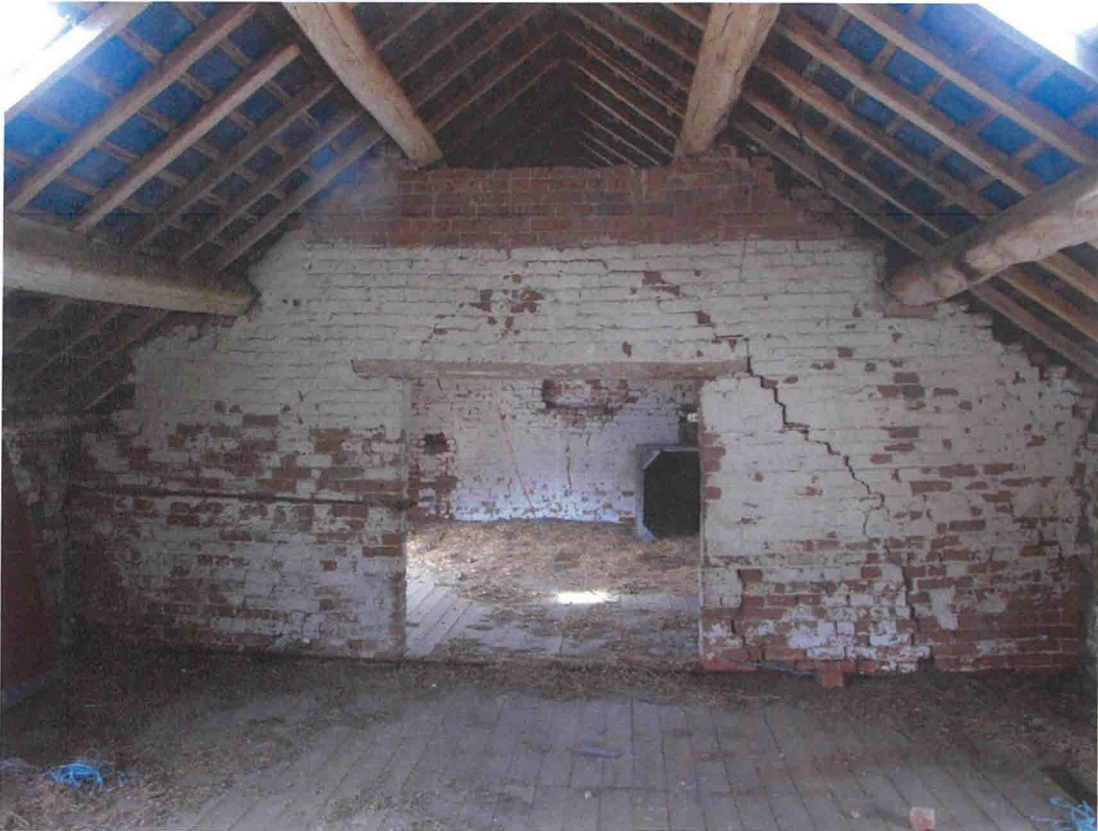
Barn A first floor, minor cracking due to deflected beam.

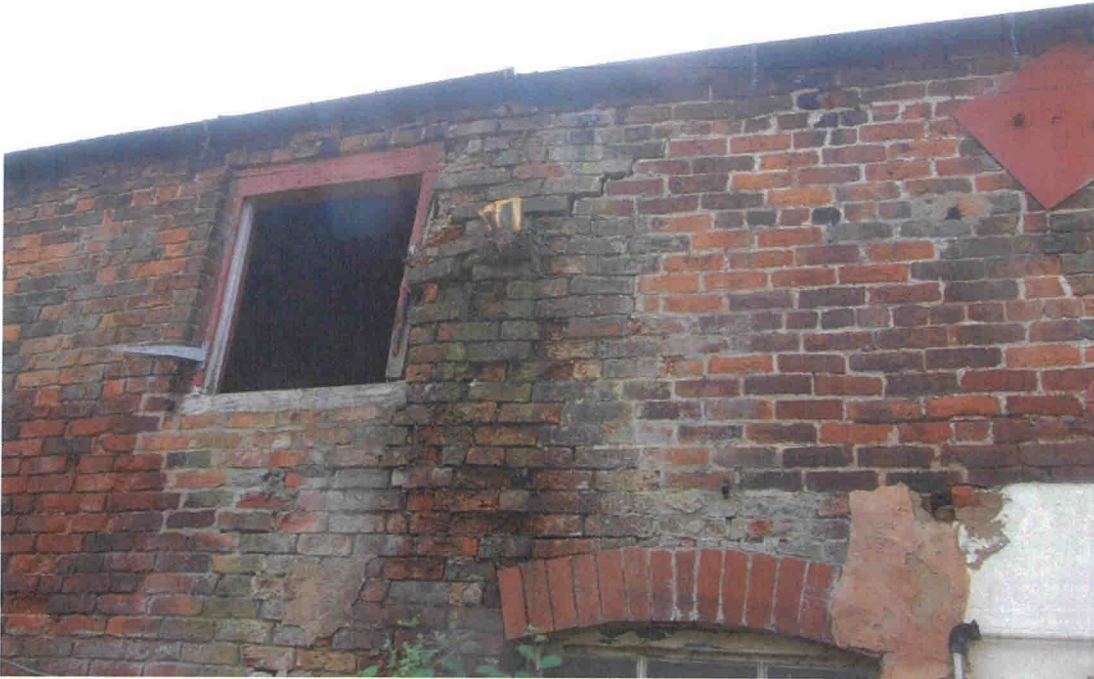
Barn A showing self-seeded tree and damage.

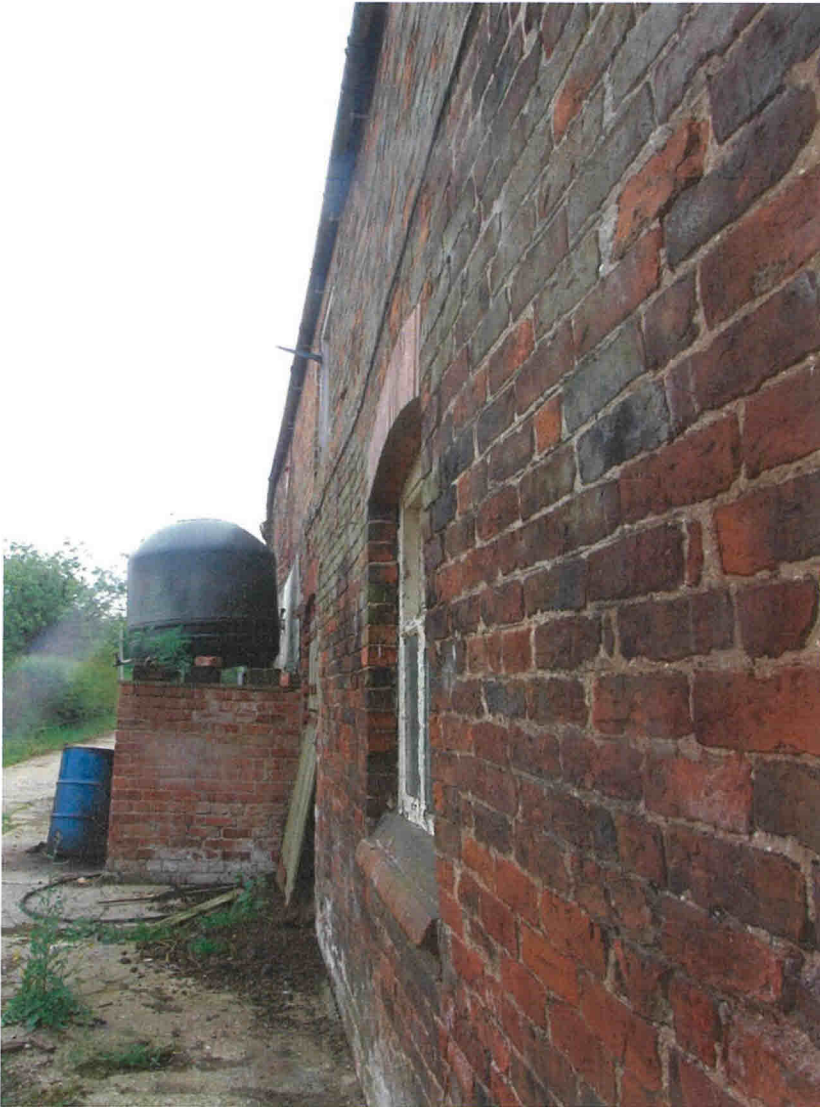
- E.4 INTERNAL STRUCTURE: The internal brickwork was generally plumb but some cracking was evident due to loss of lateral restraint.
- E.4.1 When checked with a laser level and plumb bob the inner side of the external walls were relatively plumb to side and rear but the front elevation dis belly out due to action of self-seeded tree and loss of lateral restraint and part of elevation will need to be lowered and rebuilt..

Barn A front elevation, showing undulation due to self-seeded tree and some loss of lateral restraint.
