BS5837:2012 Tree Survey
Land adjacent to Crown Business Park
Old Dalby
Leicestershire
NGR SK686 138

Survey by
Christopher Barker CEnv dipHort AIEEM

Report prepared by: C Barker	Date Issued: January 2013
	Reviewed by: KB	Report Version: V1
	Report ref: P413 / 0113- 02	C B E Consulting Highbank, 5 Grantham Road, Navenby Lincoln. LN5 0JJ. Telephone (01522) 810086. www.cbeconsulting.co.uk

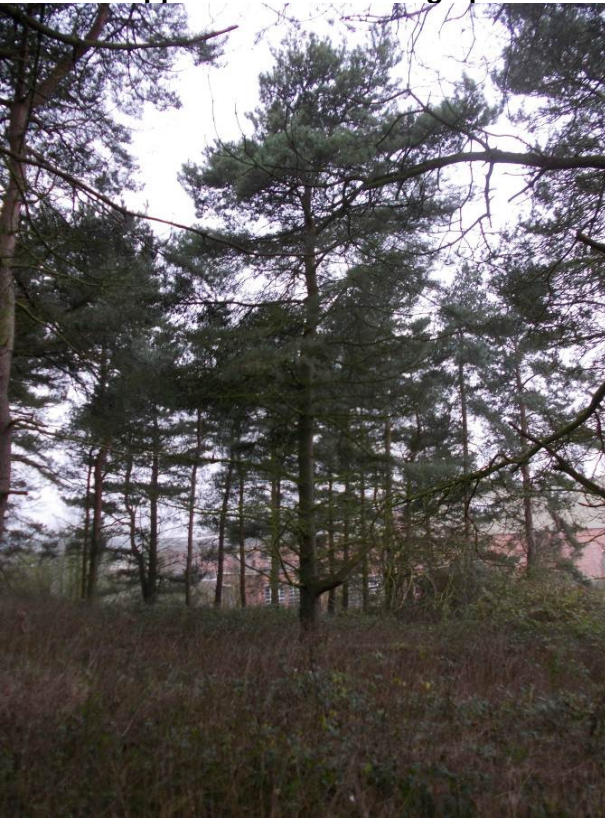
This is a dense group of Pine trees, presumably established originally to provide a place of shelter in a corner position when this land was still used as a field. The trees are closely planted and the canopies merge into a single structural feature. These trees are now situated at the bottom of a sloping field area, close to an existing industrial building. These trees are not visually significant in the landscape but do provide cover and shelter. The Hawthorn hedgerow on the east boundary provides a linear link to the deciduous woodland in the south east corner of the site. None of the trees is individually large size of stature.

Given the position of these trees in a corner area and the age and quality of the individual specimens, these trees are placed within Category C.

Pine copse TG1.

Retention of the Pine (TG1) is desirable to provide some additional cover, however, these are not high quality trees and they do not provide any strategic screening. It is possible that any development of the site may lead to these trees becoming isolated and of limited landscape value. If it is practical to retain these and maintain their links to the surrounding natural environment then retention is desirable.

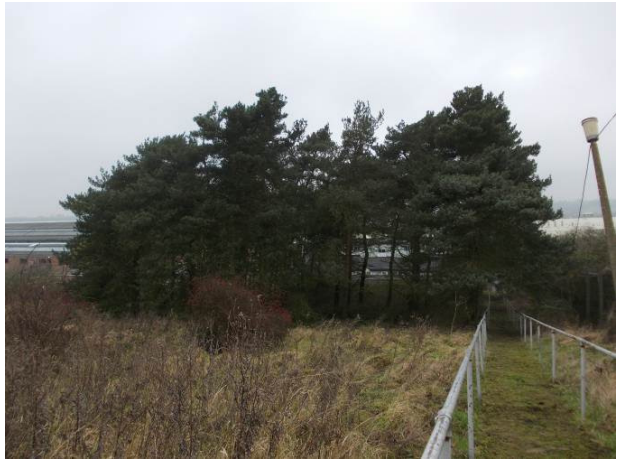
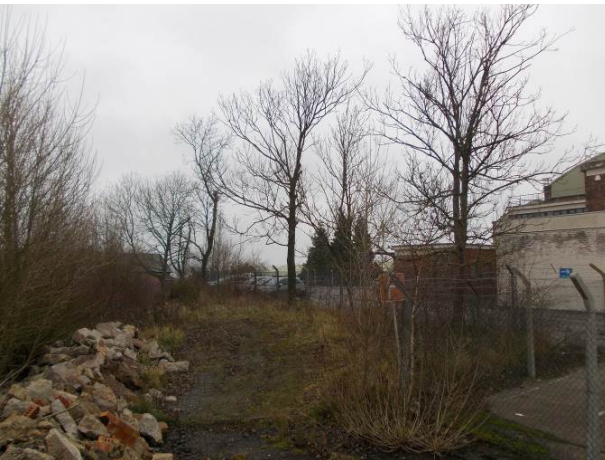
Trees T1 – T6 are all self – set Ash (*Fraxinus excelsior*) occupying a boundary position along the original access road into the site. These trees are all relatively small in stature and have low landscape significance. These trees are of quite poor quality and this, combined with their position, places these into Category U.

T3	ASH (<i>Fraxinus excelsior</i>)	11	34	N-4 S-4 E-5 W-4	Clearance 2m agl.	SM	20	P	A single trunk specimen with a damaged canopy where it crosses the fence line. Has a poorly developed open canopy. Low bat roost potential. No nesting bird activity visible at the time of the survey. No obvious structural faults visible from ground level.	Poor quality tree of low landscape significance.	U	n/a	n/a
T4	ASH (<i>Fraxinus excelsior</i>)	11	22	N-3 S-3 E-3 W-3	Clearance 2m agl.	SM	20	P	A single trunk specimen a poorly developed open canopy. Low bat roost potential. No nesting bird activity visible at the time of the survey. No obvious structural faults visible from ground level.	Poor quality tree of low landscape significance.	U	n/a	n/a

Ash T2 –T5 along access road

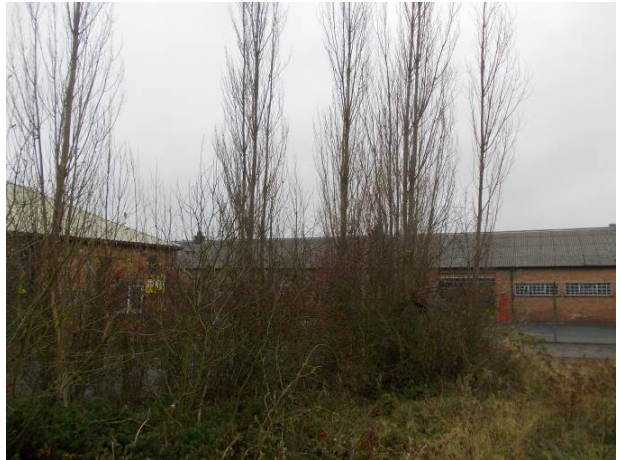
Close to the Ash, occupying a corner position is a dense copse of young Poplar and Birch. These trees are all small and crowd one another. Visually they are not prominent and are place within Category U.

Poplar copse TG2

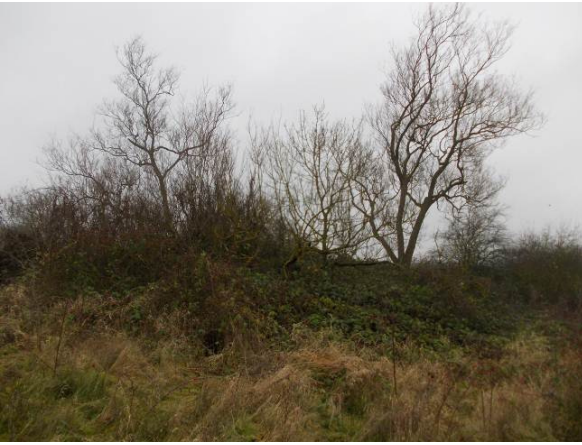
Trees T7 and T8 are large multi stemmed Poplar trees centrally positioned adjacent to the boundary chain link fence on the west boundary. These two trees are visually prominent from within the site since they occupy slightly higher ground and are surrounded by level open ground. These two trees have very open canopies that merge. One tree (T8) is in decline with evidence of a broken remnant trunk and is over-mature. Tree T7 appears in better condition but the canopy of this tree is very unbalanced and spreads out across the boundary. Both trees have significant dead wood visible. Due to its obvious decline T8 is placed within category U. Tree T7, being in better condition but nearing the end of its useful life is placed within Category C.

Tree No	Species	Ht (m)	Stem Diam cm@ 1.5m	Canopy Spread (m)	Height of Crown Clearance	Age Class	Est yrs	Overall Condition	Structural condition	Recommendations	BS 5837 Category	RPA (m ²)	RPA Radius (m)
T8	Poplar (<i>Populus nigra</i>)	12	40	N-3 S-1 E-8 W-0	>5	OM	10	P	Large tree with a dead stump visible. Remaining branch at ground level has regenerated to support a large unbalanced poorly shaped canopy. Moderate bat roost potential. No nesting bird activity visible at the time of the survey. No obvious structural faults visible from ground level BUT IN DECLINE.	Poor quality tree showing signs of decline. Consider removing for arboricultural reasons if development proceeds.	U	n/a	n/a
TG3	3 No WILLOW (<i>Salix fragilis</i>)	14 - 17	30 - 60	Varies up to 6m	1	OM	10	P	Three large willow tree with dead wood and fallen branches visible. All have large, unbalanced poorly shaped canopies that merge. Under canopy Hawthorn providing ground cover. Moderate bat roost potential. No nesting bird activity visible at the time of the survey. No obvious structural faults visible from ground level BUT IN DECLINE.	Poor quality trees showing signs of decline. Consider removing for arboricultural reasons if development proceeds.	U	n/a	n/a

Poplar T7 and T8 on west boundary

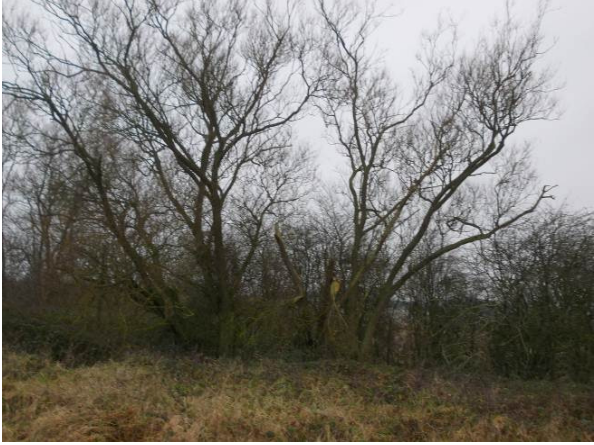
In the south west corner is a stand of over mature Willow trees with under canopy Hawthorn identified as TG3. The Willow trees are in decline being over mature and displaying significant dead wood, broken and trailing branches. Since these trees are in decline they are classified as Category U.

Willow TG3 in south west corner.

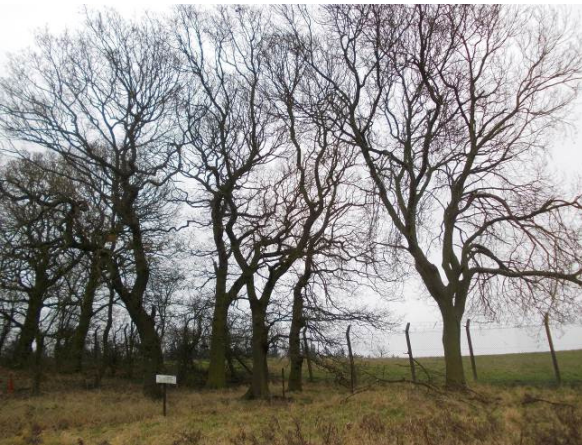
The primary group of six Oak trees and one Ash tree is placed within Category A since these are high value trees in terms of landscape value and visual impact on the surrounding environment. The single mature Ash noted slightly to the east of the group of Oak is placed within Category B. The remaining trees are not considered to be of particularly high value as they are visually less prominent, are of lesser quality and are placed within Category C.

Mature Oak and Ash TG4 Category A

Retention of the mature Oak and Ash in the south east corner is strongly recommended since the quality and stature of these trees makes them of value in the wider landscape and for ecological purposes. In addition, these trees lie adjacent to a Local Wildlife Area and removal of the chain link fencing will help to incorporate this copse of trees and the surrounding smaller specimens into the wider landscape.

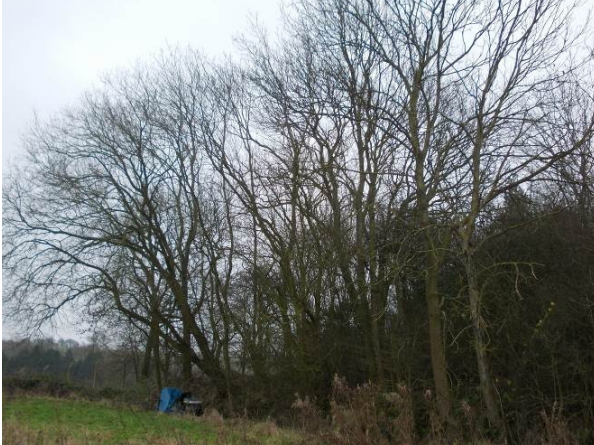
Dense semi-mature Ash / Hawthorn TG4 Cat C2

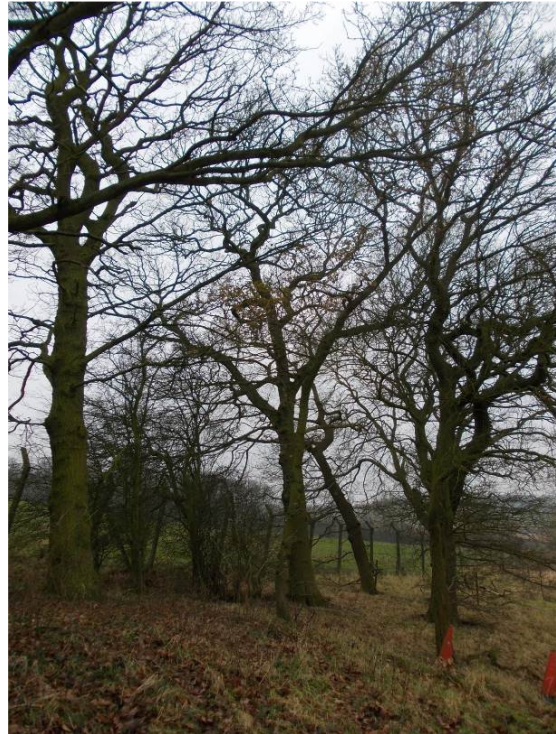
High quality Oak TG4

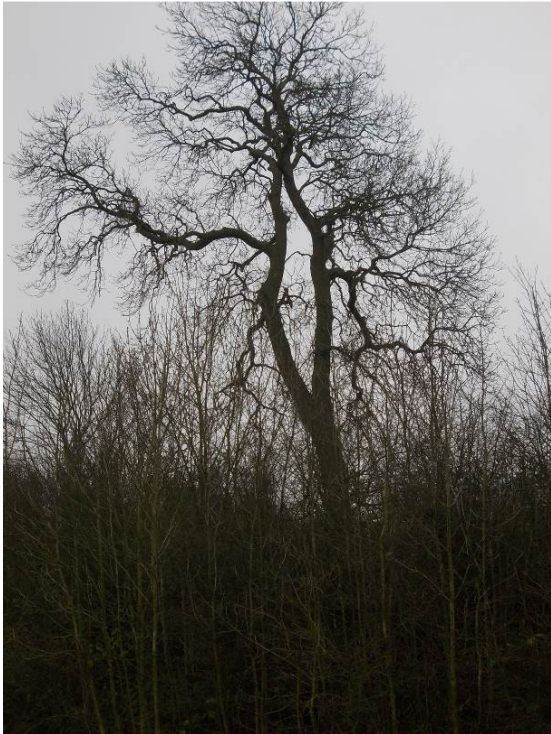
Large individual Ash in TG4 above juveniles
