MR P MYATT

DECAY ASSESSMENT REPORT

1 BARRINGTON PLACE, GL53 8BY

Date: 01 July 2021

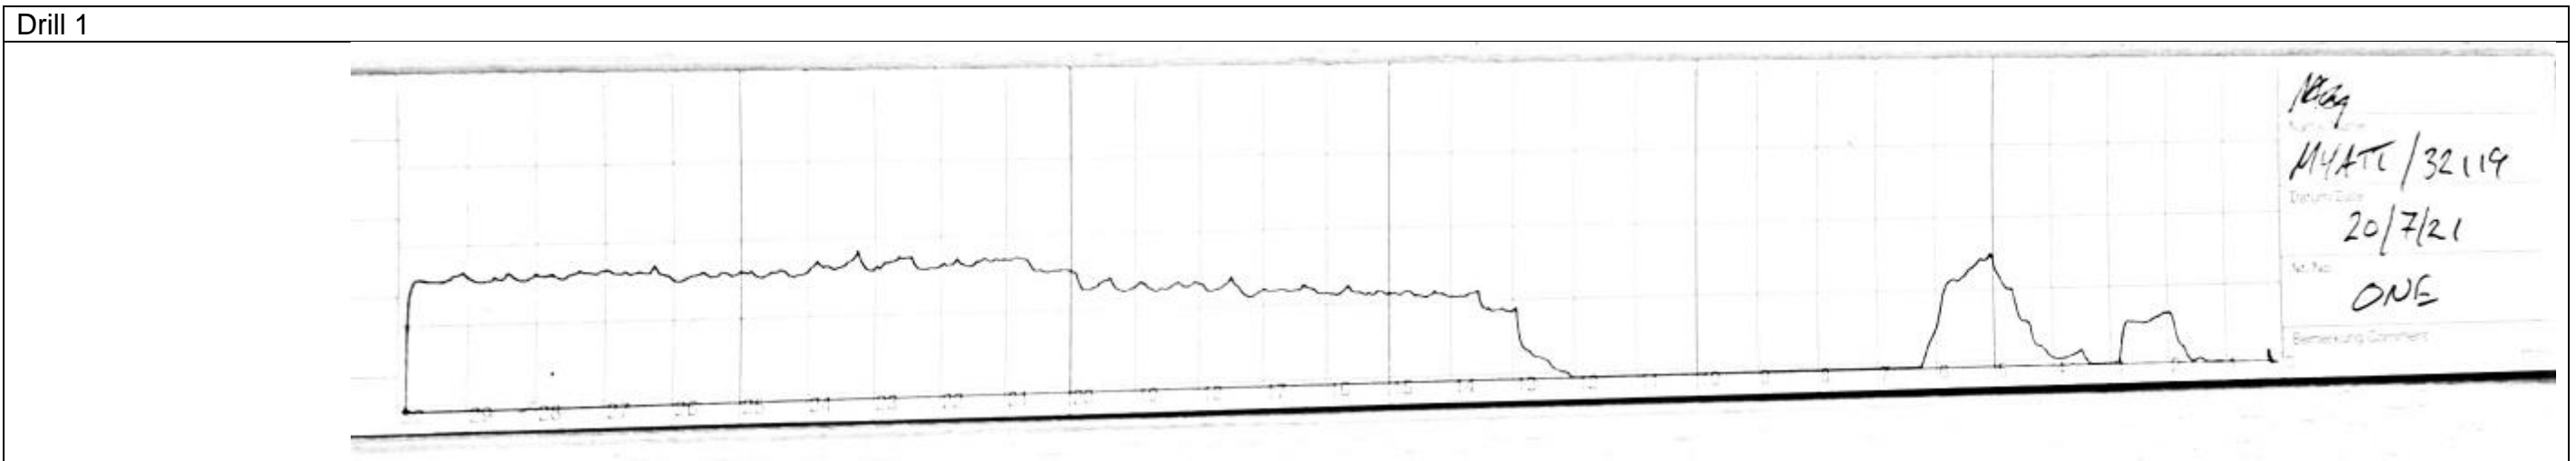
Drill points 1 and 2	Drill points 2 and 3	Drill points 4 and 5	Drill points 5 and 6

1.4 The tree has a circumference at the drill height of 5050mm (diameter of 1607mm). The only live cambial tissue I could find was between drill points 4 and 5 and measures approximately 300 – 400mm wide (approximately 7 - 8% of the circumference).

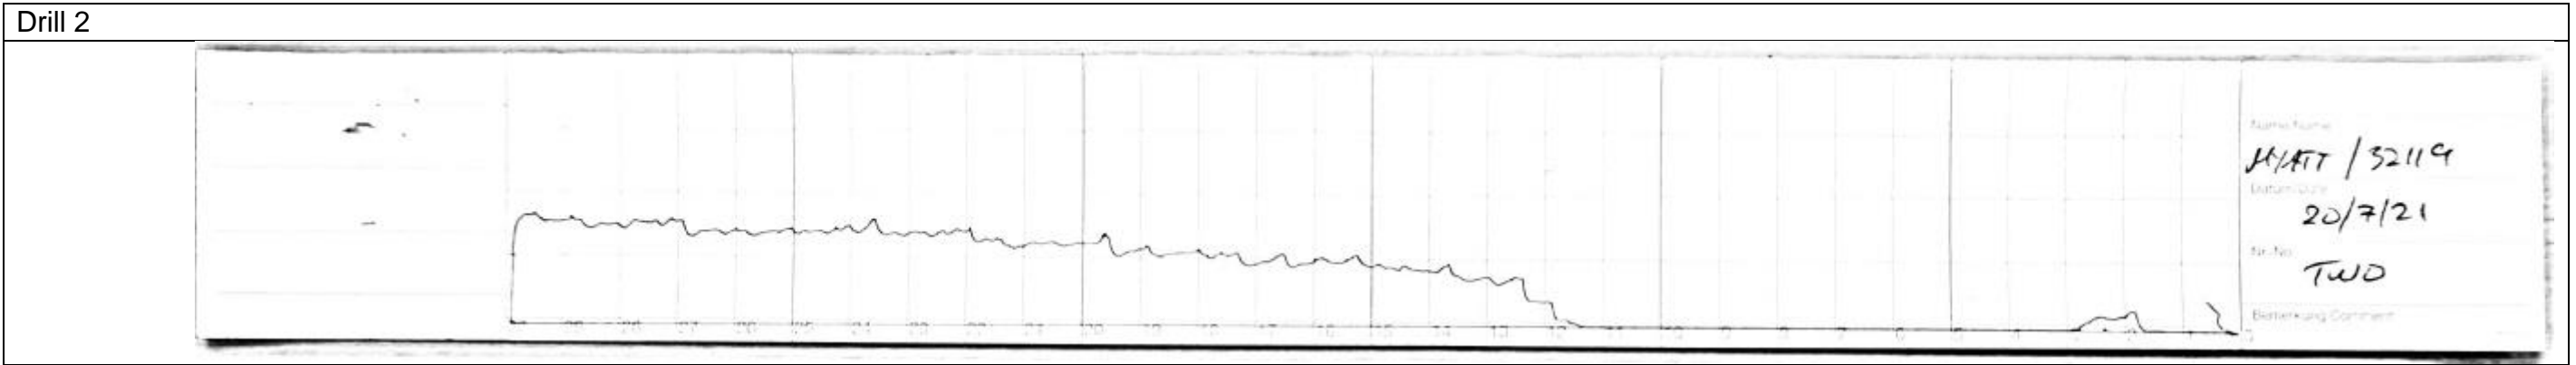
Some advanced decay of the outer timber (brown cubical decay) was observed at the base of the tree, and this is supported by drillings 1, 2 and 6.

Notes and Discussion. This drill shows the bark with a small void beneath (delaminated from the sap wood), some sound but dead sapwood with an area of decay beneath, then going back into sound wood.

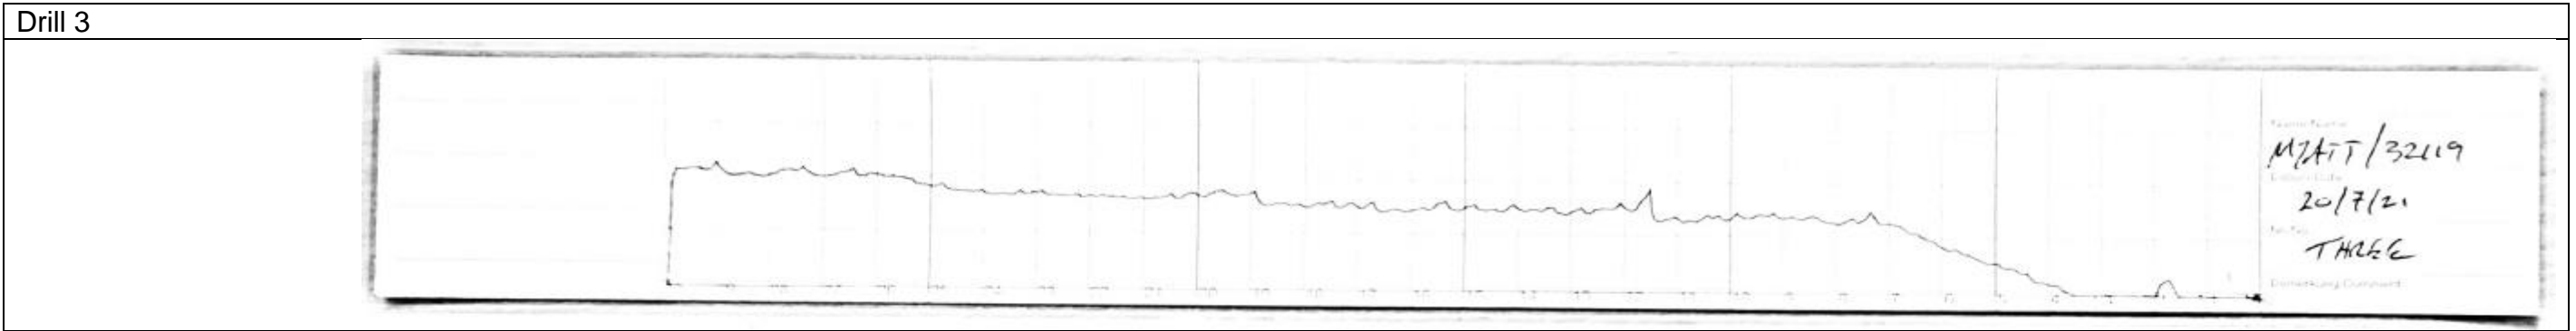
Notes and Discussion. This drill shows the bark with an area of decay beneath, then going back into sound wood.

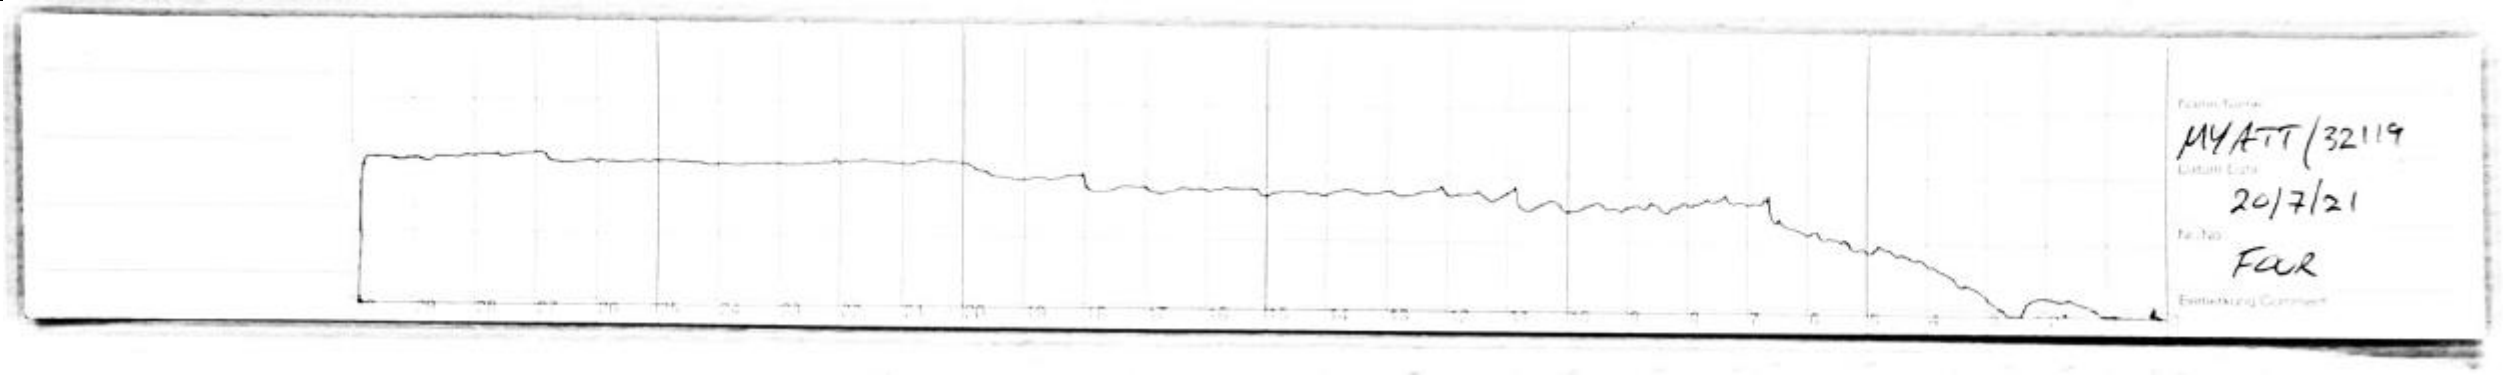
Drill 4

Notes and Discussion. This drill shows the bark with a small void beneath (delaminated from the sap wood), followed by some wood that is not of full strength, followed by sound wood.

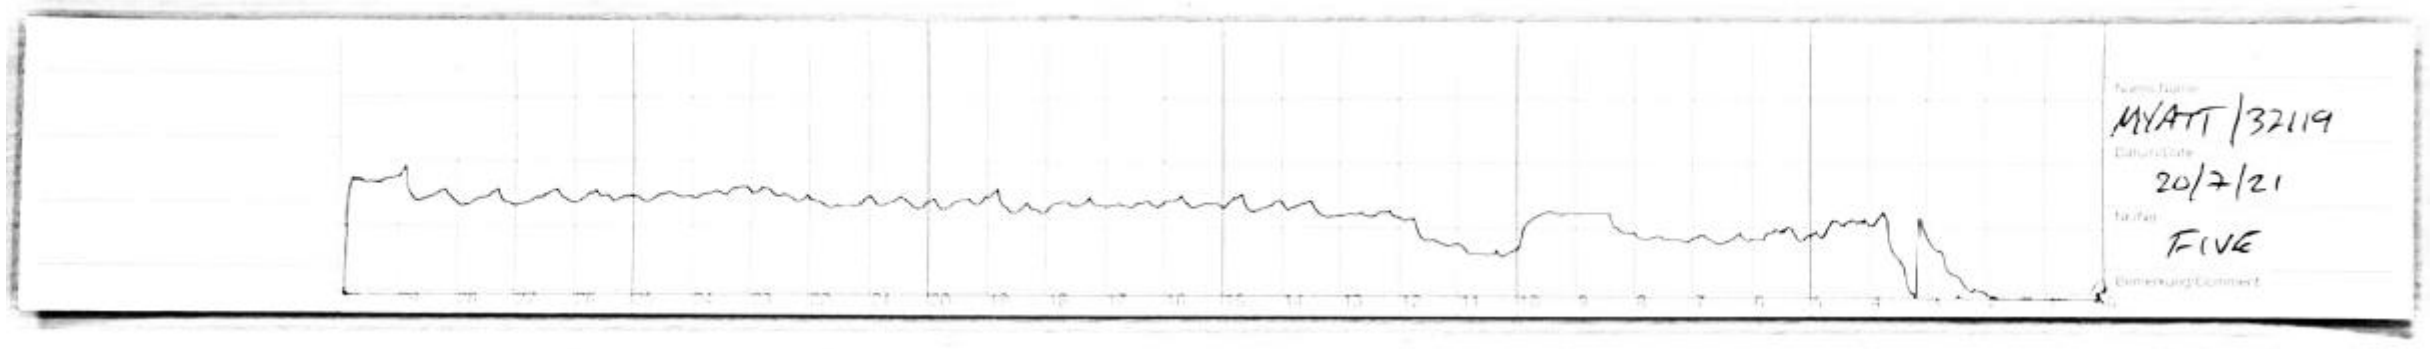
Drill 5

Notes and Discussion. This drill shows the bark with a very small void beneath (delaminated from the sap wood), followed by some wood that is not of full strength, followed by sound wood.

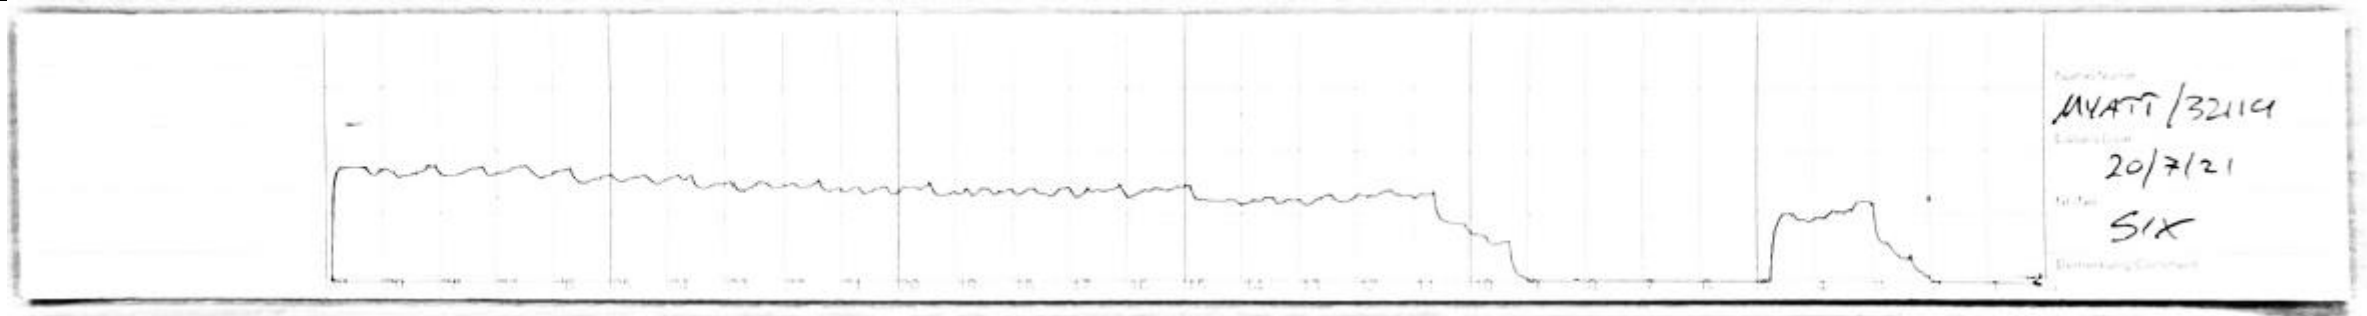
Drill 6

Notes and Discussion. This drill shows the bark with a very small void beneath (delaminated from the sap wood), followed by some sound wood, although this appears to be slightly degraded compared to drillings 1 – 4.

Notes and Discussion. This drill shows the bark with an area of decay beneath, then going back into sound wood.
