04 May 2022

Our Reference: 15272 / 67734

**Cedar tree TPO application PP-11215352, supporting evidence.**

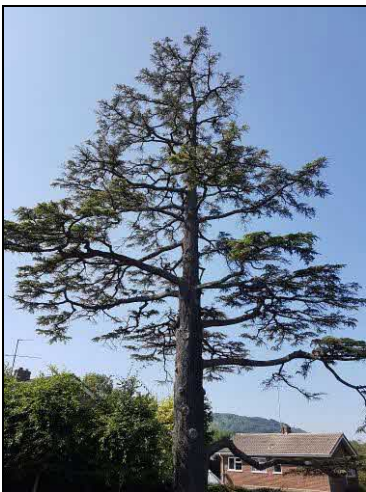
As has been previously stated in my report of July 2021 (ref: 15272/65690), included in the original application, the physiological condition of the tree is in decline as indicated by the sparse crown (50 – 75% needle loss) and the amount of continual needle drop being experienced.

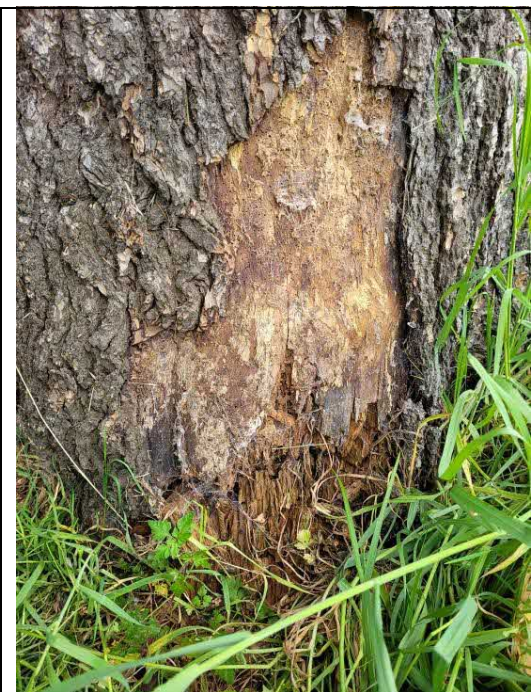
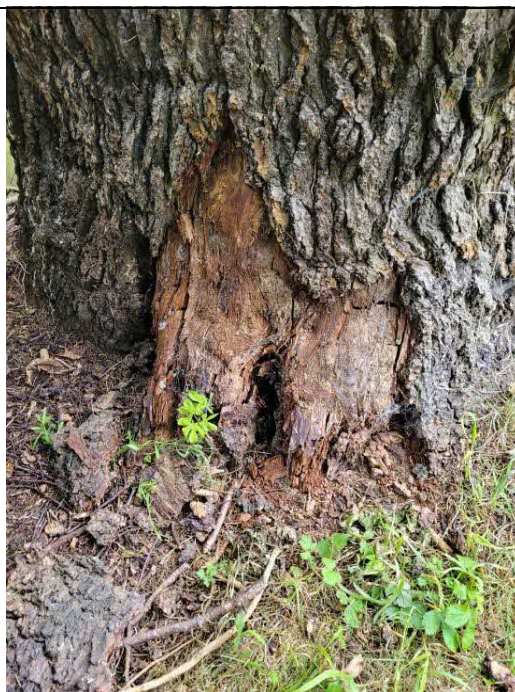
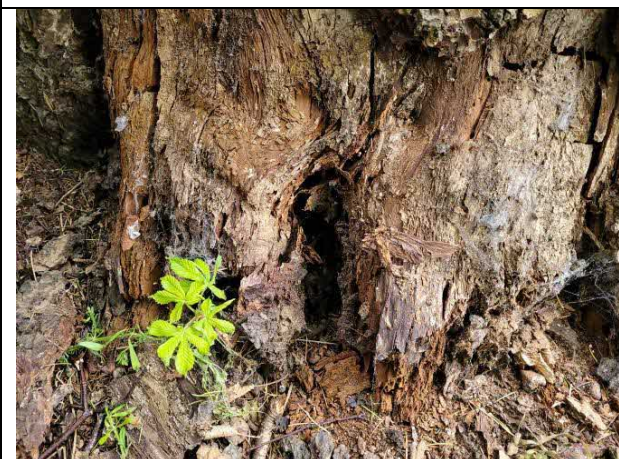
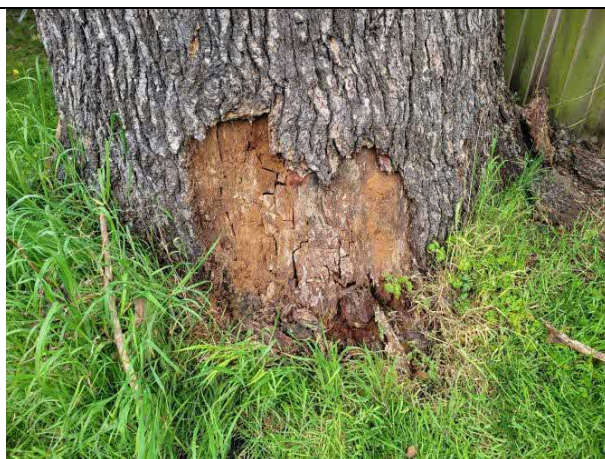
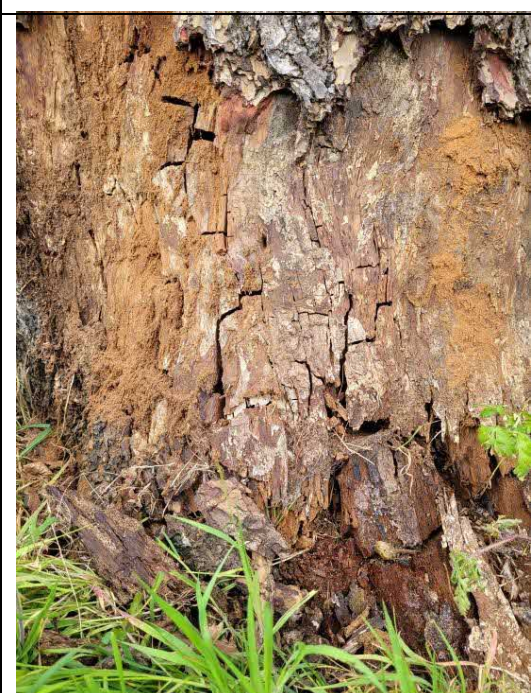
The tree has a circumference of 5050mm (diameter of 1607mm) at approximately 400mm above ground level. The only live cambial tissue I could find measures approximately 300 – 400mm wide (approximately 7 - 8% of the circumference). Some advanced decay of the outer timber (brown cubical decay) was observed at the base of the tree, which can be seen in the photos overleaf.

Given the extremely small amount of live cambial tissue, I would expect the crown to continue to deteriorate. The presence of the brown cubical rot near the base (currently to a depth of 120mm) and large plates of delaminated bark, I would expect the decay to slowly advance, compromising the structural strength of the lower stem. It would be reasonable to surmise that with the decay being present at ground level, this decay would also affect the buttress roots and therefore the tree's overall stability, especially in high winds.
