PROPOSED EXTERNAL REPAIR & RESTORATION WORKS
'MAYBANK', 95 ALBERT ROAD, GOUROCK

'MAYBANK' 95 ALBERT ROAD, GOUROCK

PROPOSED EXTERNAL REPAIR AND RESTORATION WORKS

SPECIFICATION OF PROPOSED TREATMENT & FINISHES

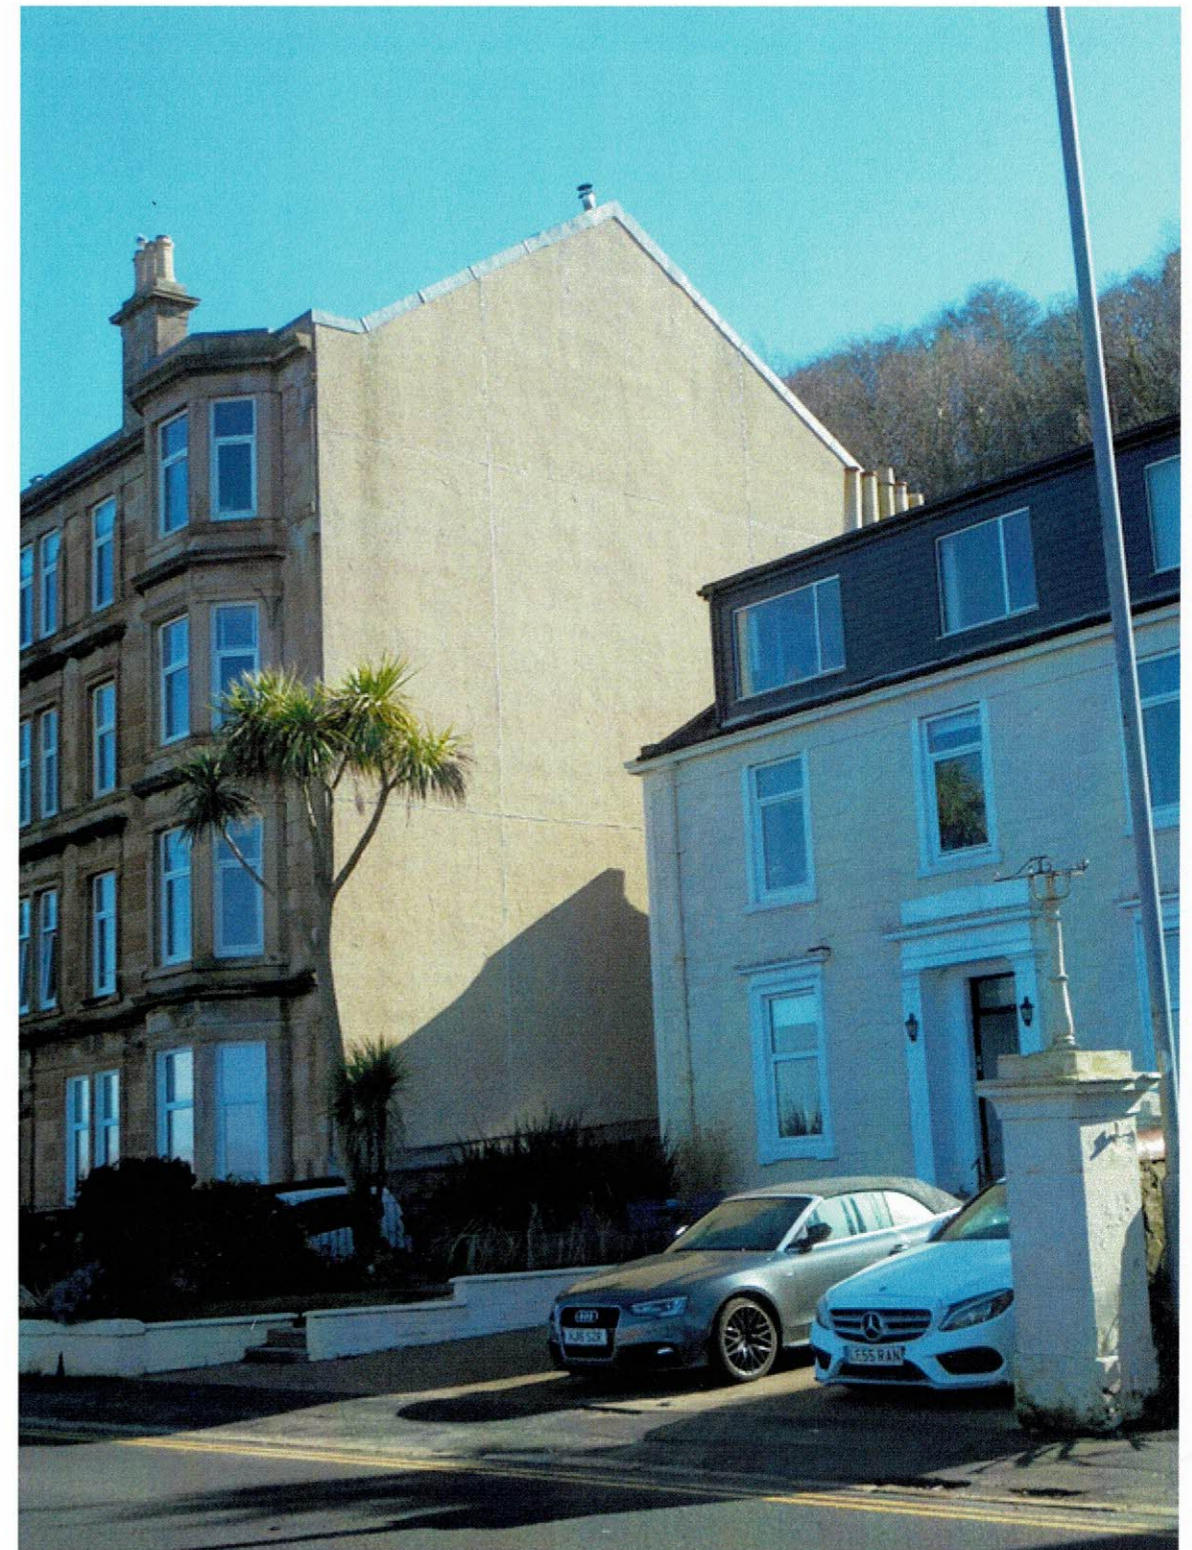
SOUTH-WEST GABLE ELEVATION

Rendered in 2016 stain at overflow to be cleaned off.

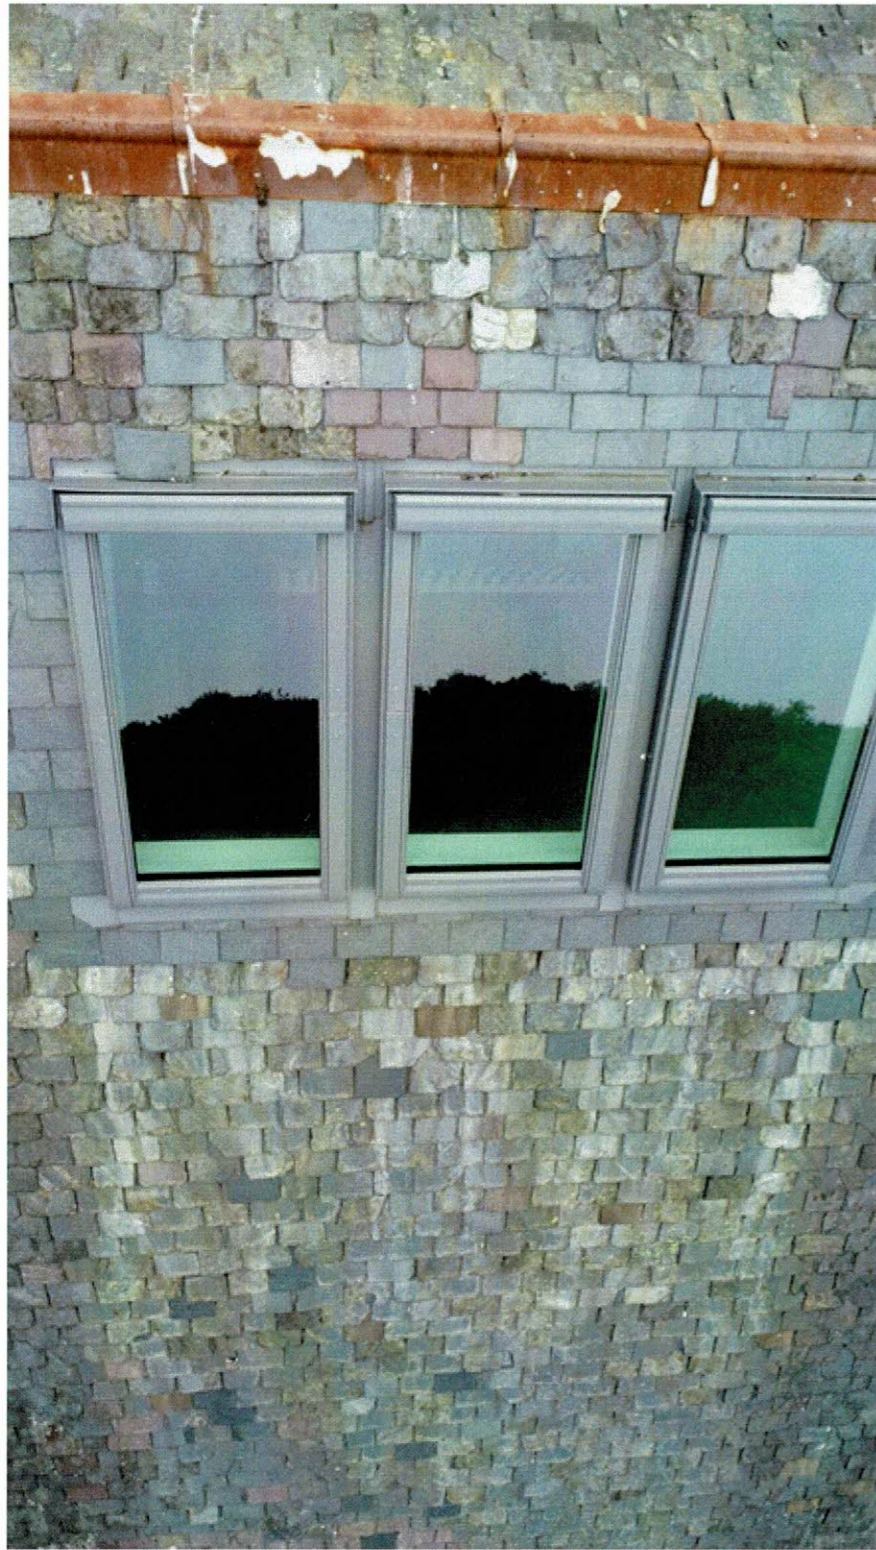
REAR SLOPE : TRIPLE BAY VELUX OVER COMMON STAIRCASE

Perished flashings to be replaced. Condition of rooflights to be ascertained and replaced if necessary.

Condition of bank of 3No. Velux roof windows on rear slope to be properly examined; flashings replaced with new Velux flashings and rooflights to be replaced to match existing, if need be.

Roofslopes to be stripped and re-slatted.
