# Remedial design Interventions to The Old Chapel Residence

Date : 21/02/2022

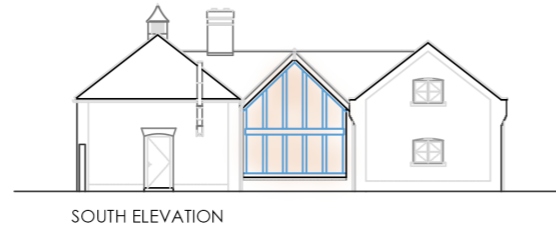
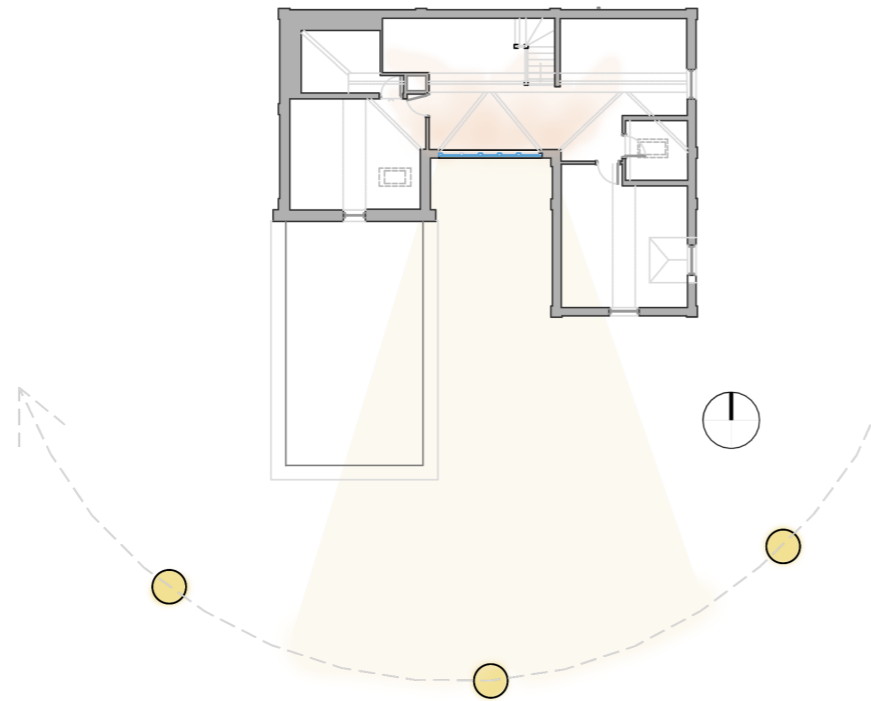
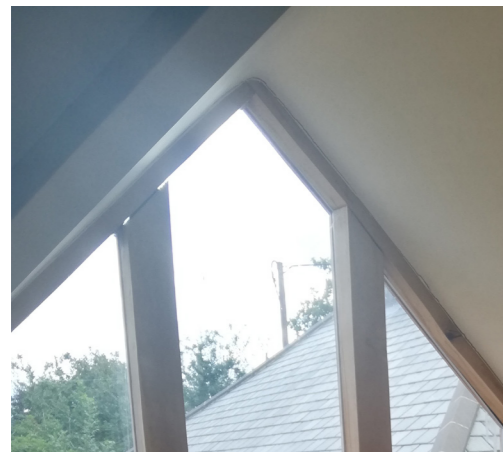
The existing south facing Glazed gable end is formed of an Oak timber frame with fixed glass that is of inadequate construction quality. There are visible gaps that allow the ingress of water. Daylight gaps are visible at some junctions of mullions / posts.

In addition to the defects above, being south facing, this element is prone to high solar gain and discomfort in the central core of the home on both the ground and first floor zones.

Interior view of the glazed gable construction quality

The lack of sufficient fenestrations on the first floor make the existing spaces dark and poorly ventilated. This coupled with the overheating caused by the south facing glazed gable end make the home unpleasant for inhabitation. In addition, the unseasoned oak used for the existing construction of the south facing central gable shows multiple gaps and faults that allow the ingress of water and air into the home.

- Minimise solar gain within the home
- Improve ventilation within this area
- Install a superior quality more dependable glazing system that is structurally sound and secure against water ingress while also being airtight.

The south facing gable glazing is proposed to have operable doors that, along with the roof lights, create cross ventilation within the home. Proposed in an aluminium frame, the intention is that the south facing gable is secure and requires minimal maintenance. Shading devices have been proposed to minimize solar gain as well.

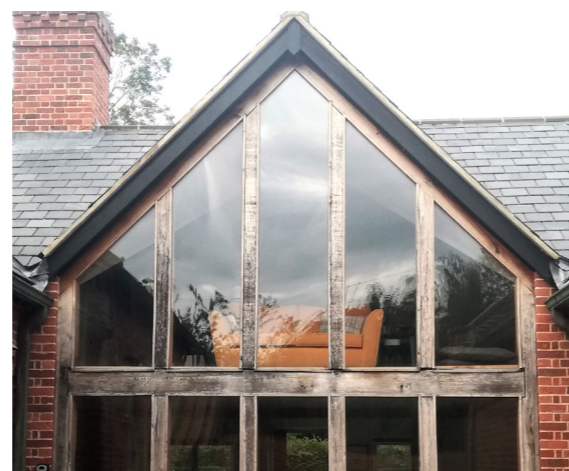
Exterior view of the South Courtyard Face of the Residence

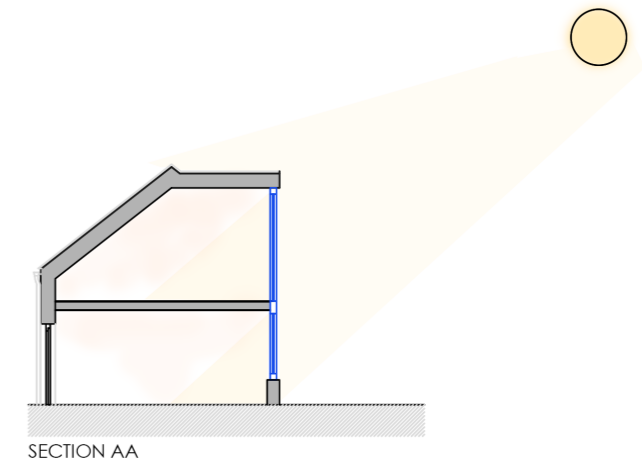
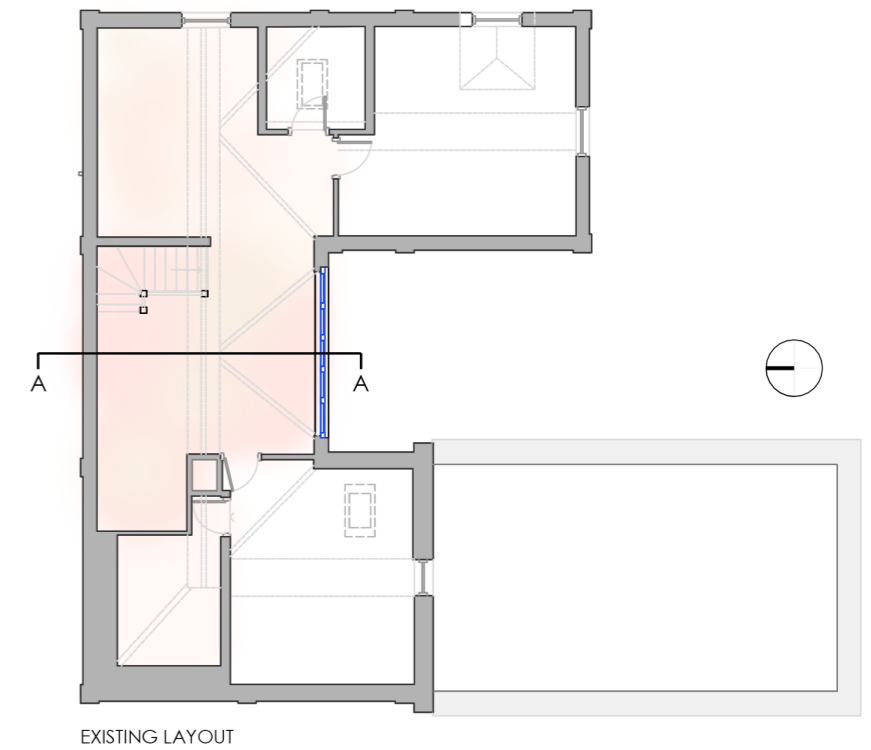
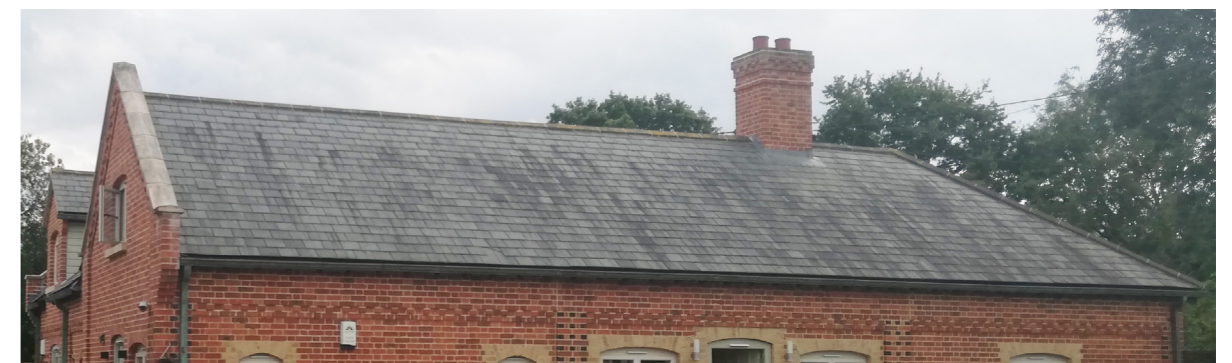
North Facing roof

The common areas on the first floor fall below the sloped roof.

The absence of adequate ventilation in this area makes the space stagnant and relatively uncomfortable.

- Create new manually controllable openings
- Improve ventilation within this area

1. The introduction of 3 new roof lights on the north facing slope of the roof to bring in light and ventilation to the office, toilet and lobby on the first floor
2. The removal of the failing Oak framed glazing of the south facing gable end
3. The provision of an aluminium 3 panel glazed sliding door system on the ground floor to offer connectivity from the house to the courtyard.
4. On the first floor, a large glazed panel has been proposed centrally with two small side hung opening windows on both sides to allow ventilation to the first floor. As a shading strategy, vertical fins have been proposed in front of the glazing that will be fixed to a 300mm extension of the roof from above and the floor beam below.
