PHASE I GEO-ENVIRONMENTAL SITE ASSESSMENT

Land at Haverton Hill Road,
Billingham,
TS23 1PZ

Report Ref: 21-1063-r01
Date Issued: November 2021

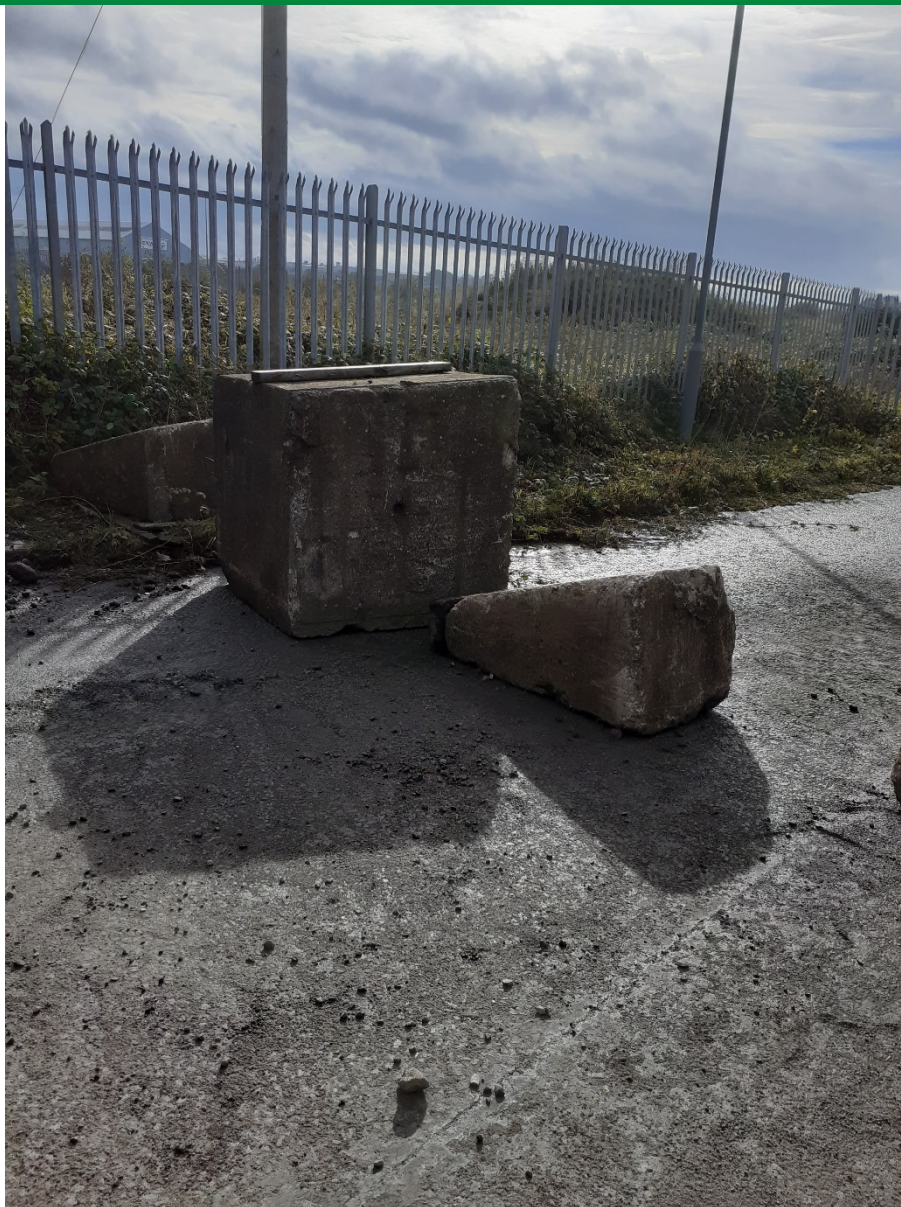
PLATE 1 – CONCRETE BLOCKS ACROSS ACCESS ROUTE

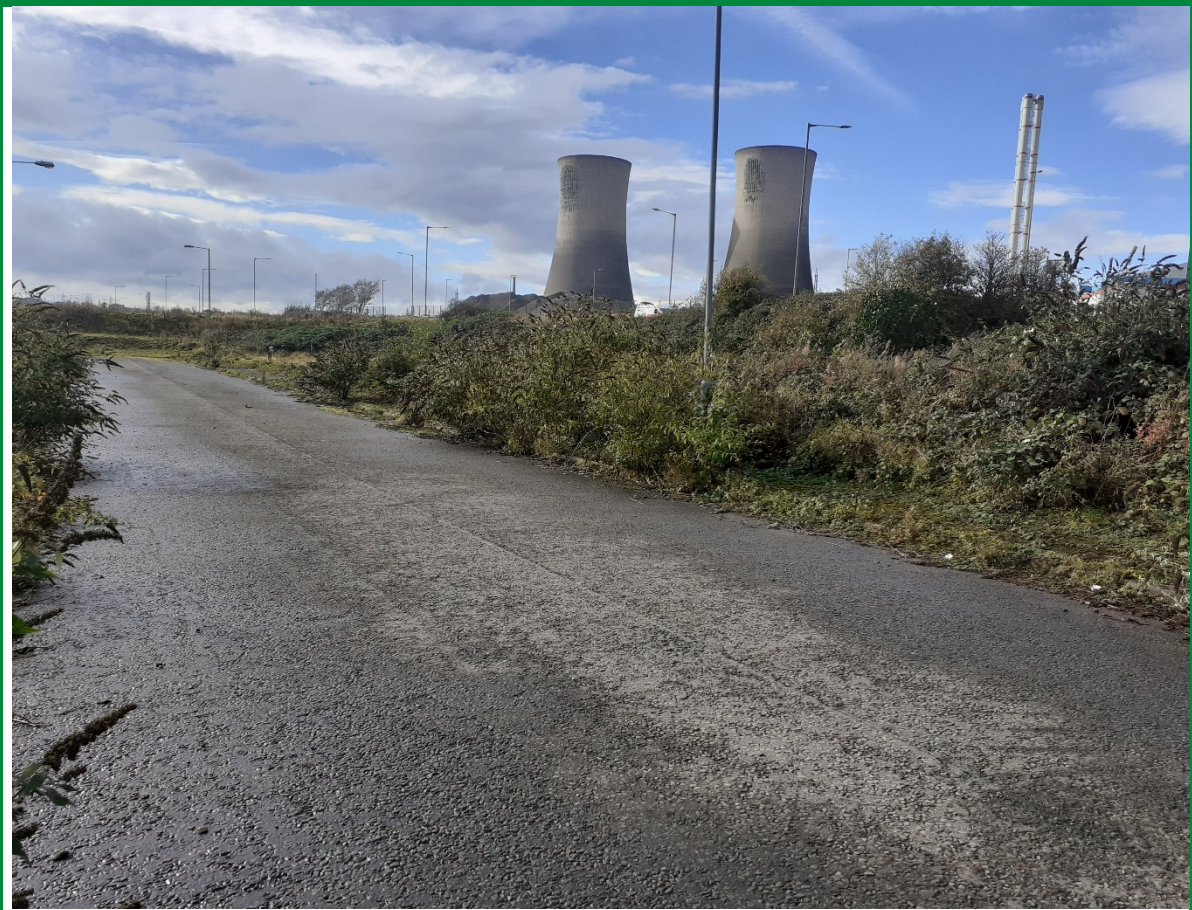
PLATE 2 – ACCESS ROAD IN NORTHERN SECTION LOOKING WEST

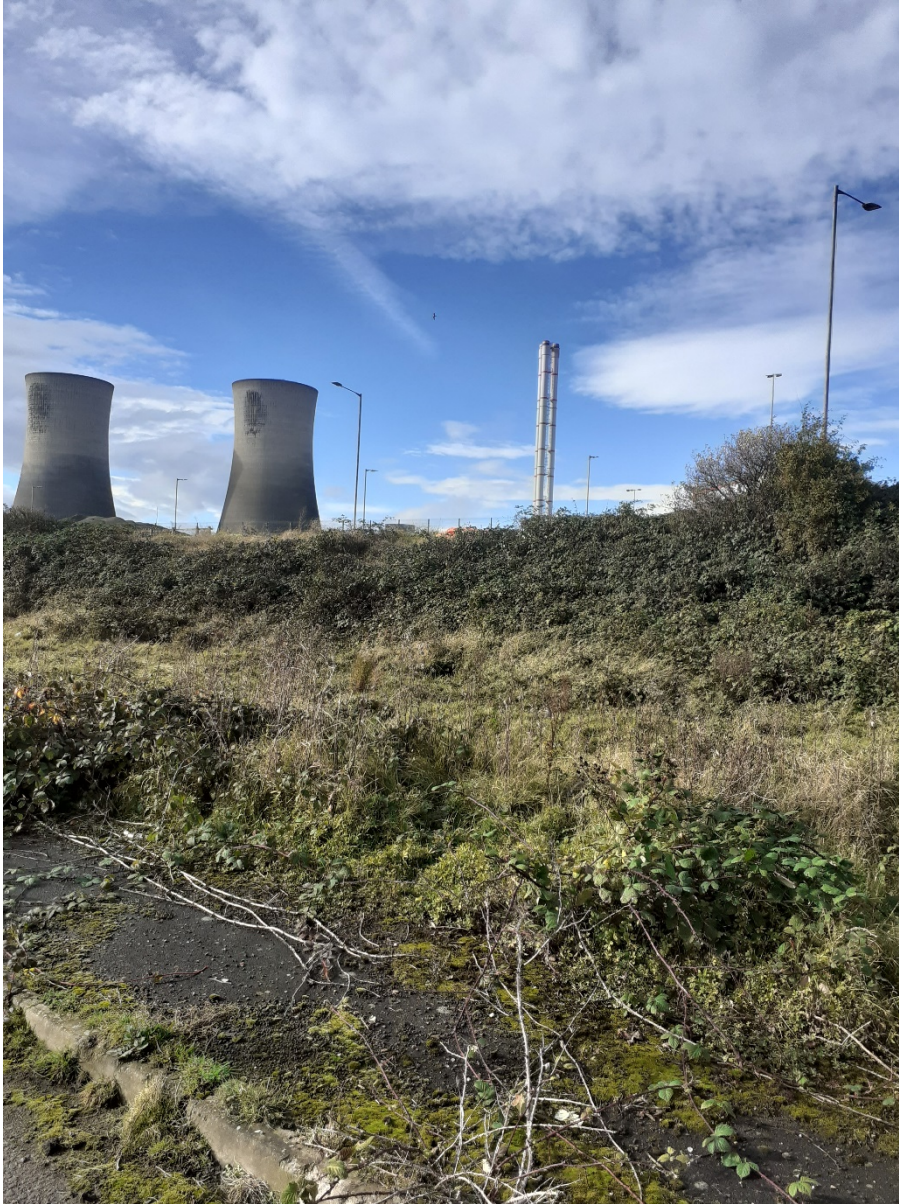
| Retaining structures | A retaining wall was noted along the northern boundary supporting the adjacent A1046 (Haverton Hill Road) above the site. | |

PLATE 3 – GENERAL STATE OF VEGETATION IN THE NORTH, NOTE VEGETATION COVERING RETAINING WALL

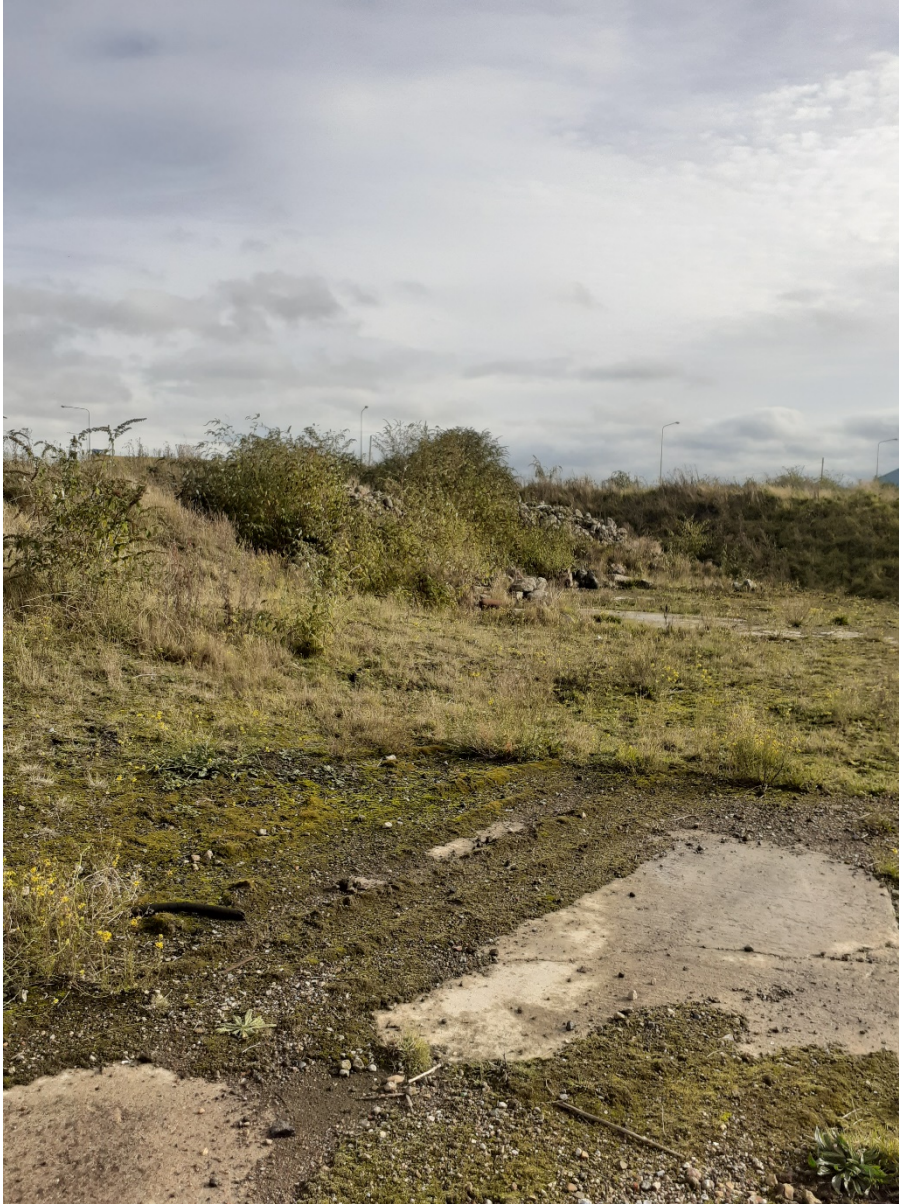
The site was noted to be predominantly level with a steep slope on the northern site boundary and 2no. platforms in the southern/central site area. 2no. stockpiles were noted within the south-eastern and south-western site areas with a large bund present along the western site boundary.

PLATE 4 – SLOPE TO THE SOUTHERN PLATFORM, NOTE STOCKPILE

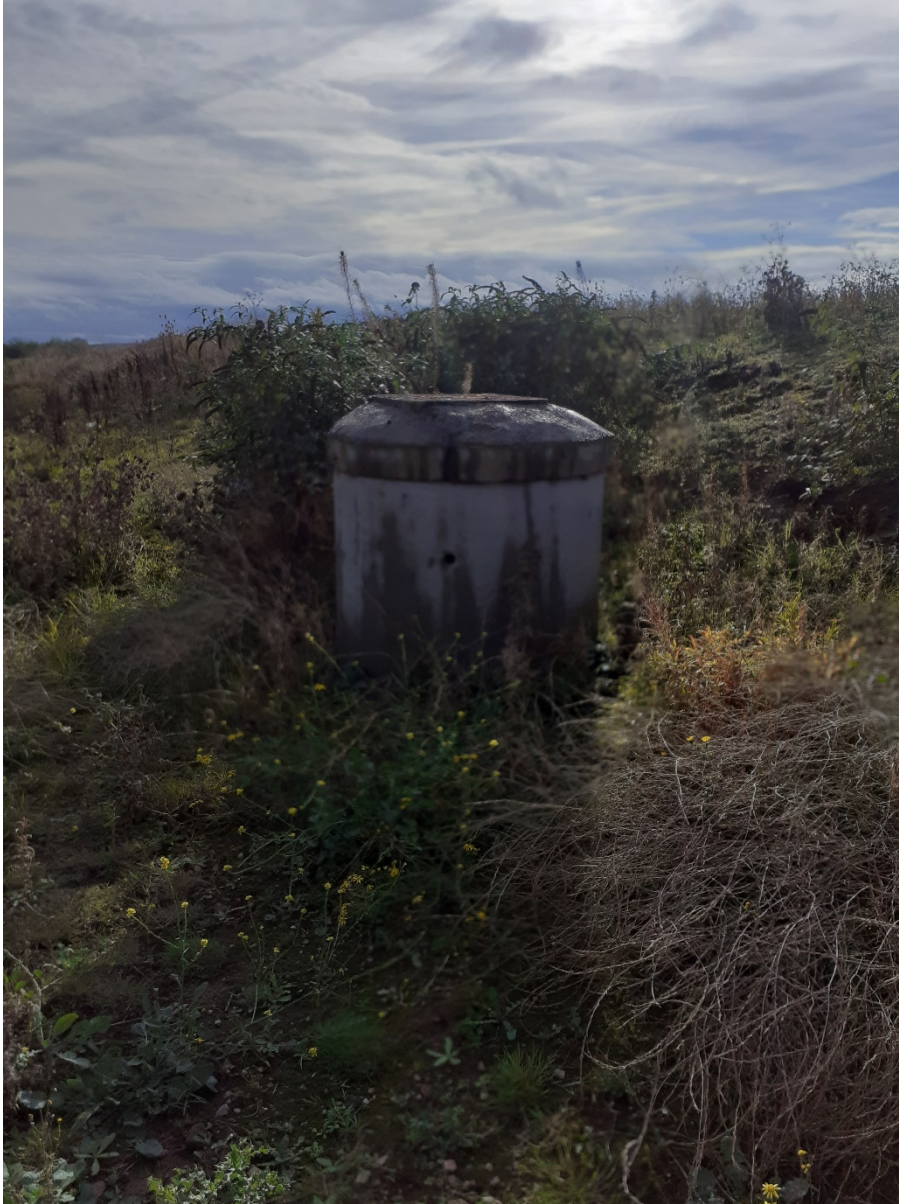
PLATE 5 – RASIED MANHOLE ALONG THE WESTERN BOUNDARY

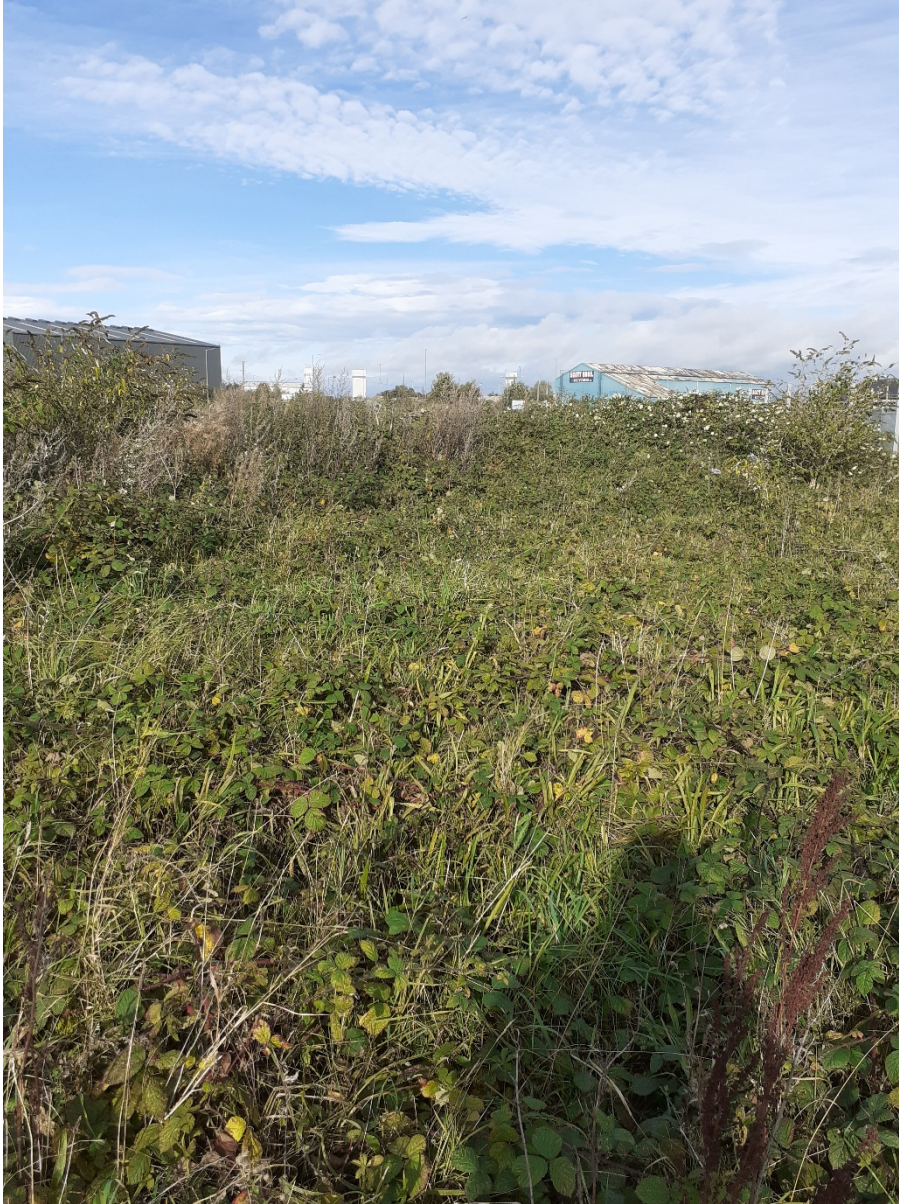
| Vegetation/ Ecology | Rough self-seeded scrub vegetation is present across the site with areas of dense overgrown bushes to the north east and central areas of the site. No evidence of invasive species were identified during the site walkover, however it is recommended confirmation of this is sought from a qualified specialist. | |

PLATE 6 – GENERAL STATE OF VEGETATION IN THE SOUTHERN SECTION

Additionally, it is recommended that an ecological survey is completed to confirm the absence of any invasive species such as Japanese Knotweed which may result in significant remedial works being required to be undertaken.

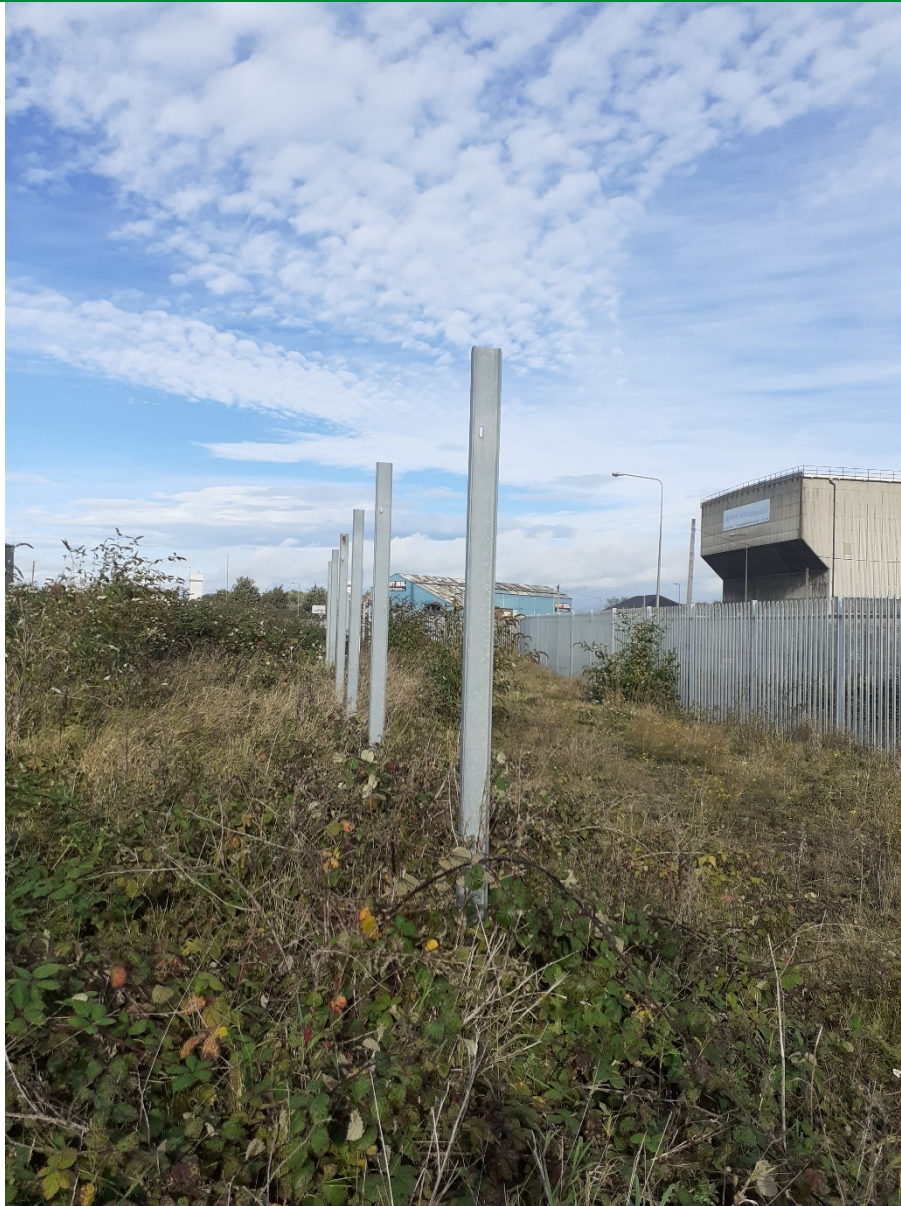
PLATE 7 – FENCE ALONG EASTERN BOUNDARY, NOTE PARTIALLY BUILT FENCE

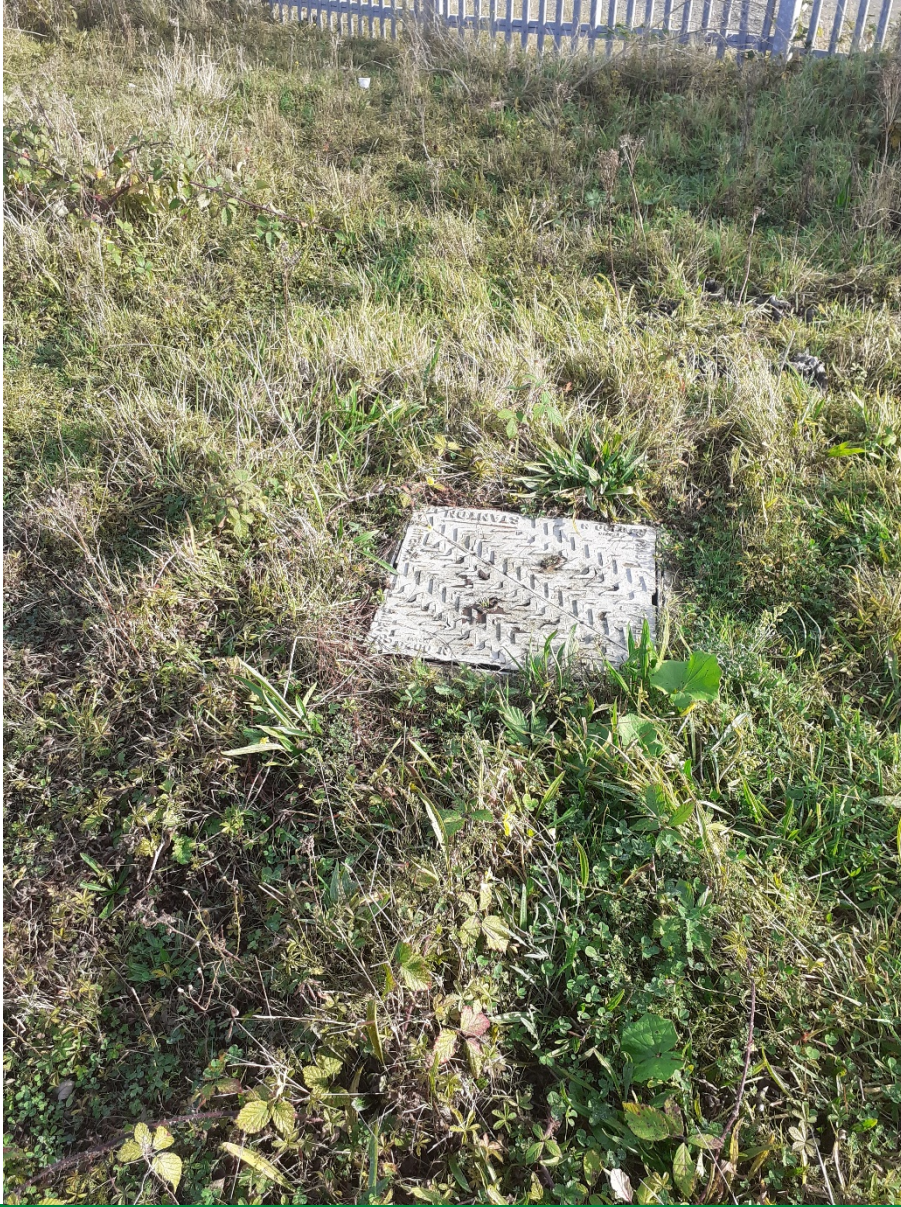
PLATE 8 – MANHOLE ALONG EASTERN BOUNDARY

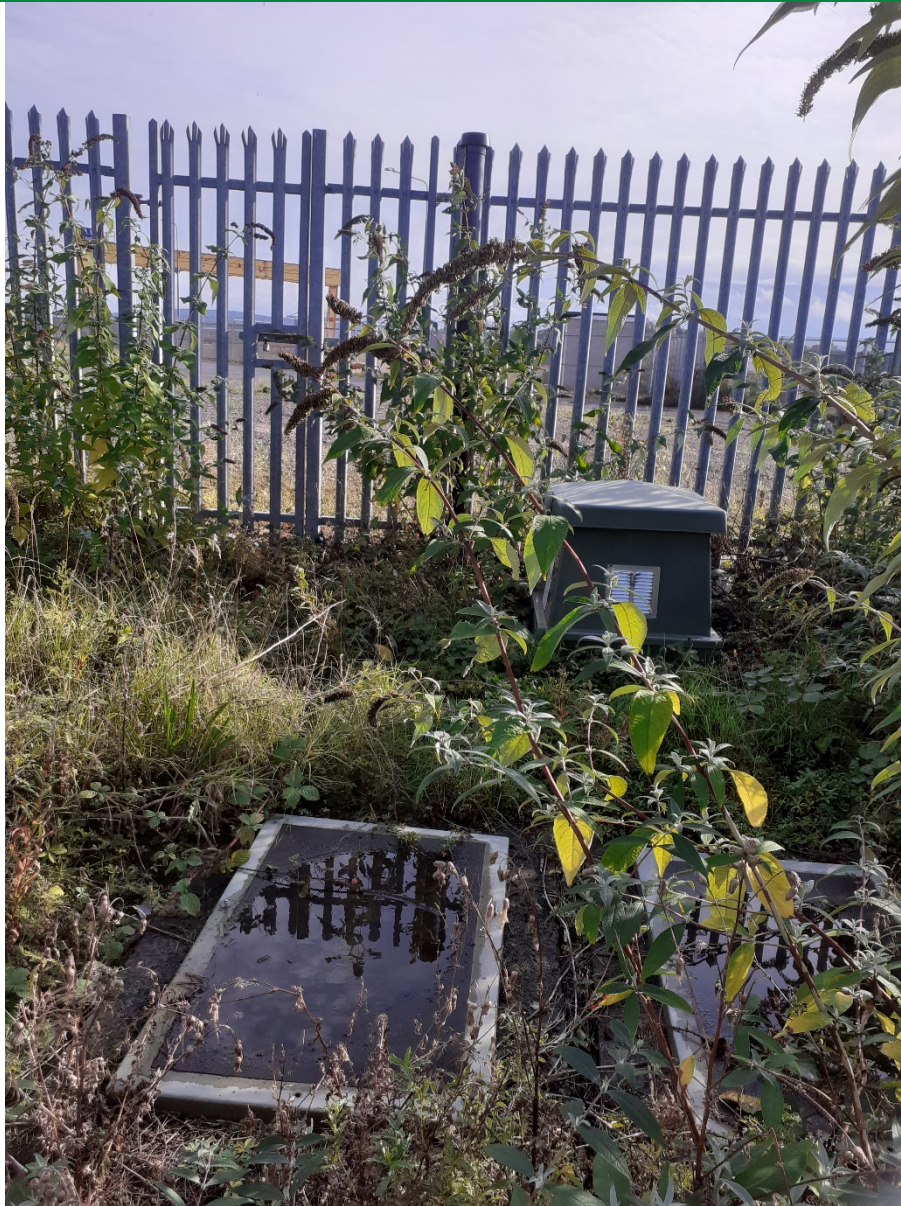
| Structures | <p>1No. partially buried feature understood to comprise a 'Switch Pump' for the adjacent shipbuilding yard was noted on the southern site boundary. No further structures were present within the site boundary.</p> <p>However, it is considered that the foundations of former structures may be present in the subsurface. The presence of dense scrub vegetation significantly inhibited the observation of these features.</p> |

PLATE 9 – FENCED OFF SERVICE – ANECTDOTAL EVIDENCE SUGGESTS THAT THIS IS A SWITCH PUMP ASSOCIATED WITH NEIGHBOURING SHIP YARD
