**STRUCTURAL APPRAISAL REPORT,
Timber Framed Office Building at
132 Cock Bank Whittlesey Peterborough Cambridgeshire**

Property:-	Office Building:- 132 Cock Bank Whittlesey Peterborough Cambridgeshire PE7 2HN	Instructed:- Oct 2021 Surveyed:- Nov 2021
Client:-	Mr R Dempsey 122 Duncombe's Road Turves Peterborough Cambridgeshire PE7 2DS	Survey & Report by:- John Ellington BSc. CEng M.I.Struct E,
Reference:-	ES7301A/21/pae	Report Issued:- Nov 2021

Ref:- ES7301A/21

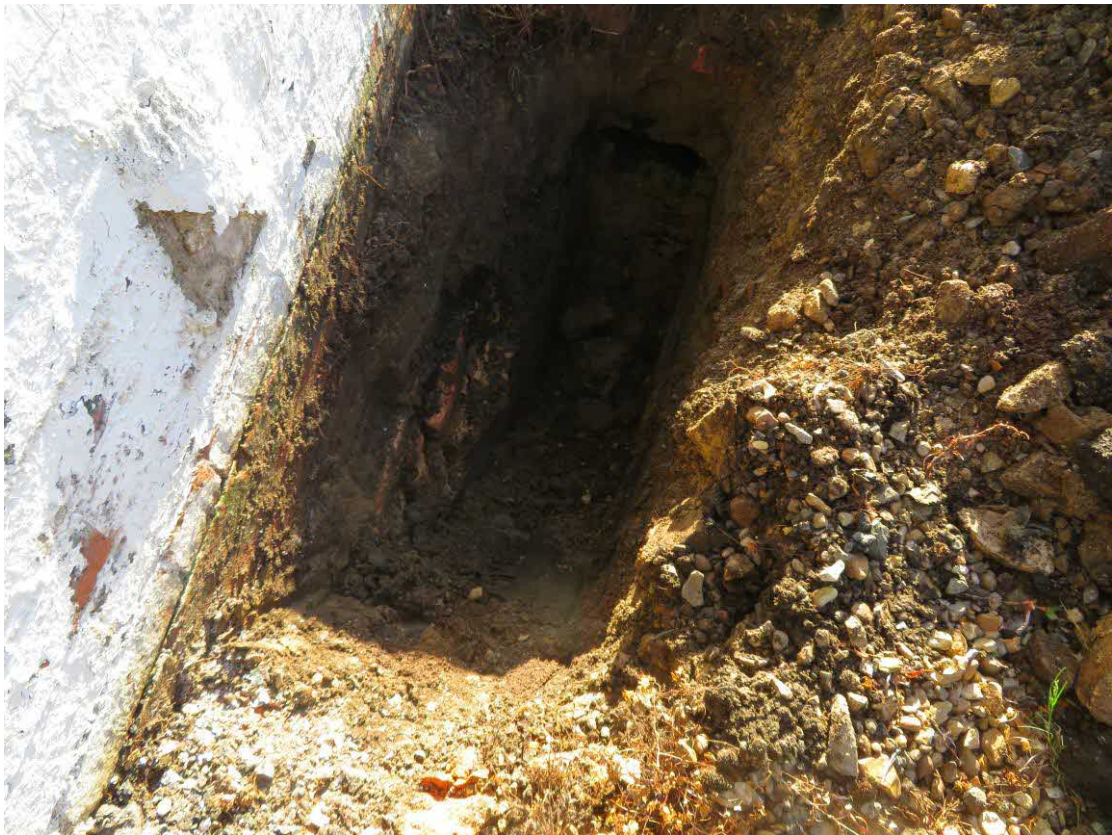
- 4.3 The foundations exposed in the trial hole consisted of a three tiered brick corbel formed on a firm grey/brown clay thought to be the Oxford clay formation due to its colour at a depth of approximately 900mm below existing ground level.

PHOTO No. 6 – TRIAL HOLE EXPOSING CORBELLED FOUNDATIONS

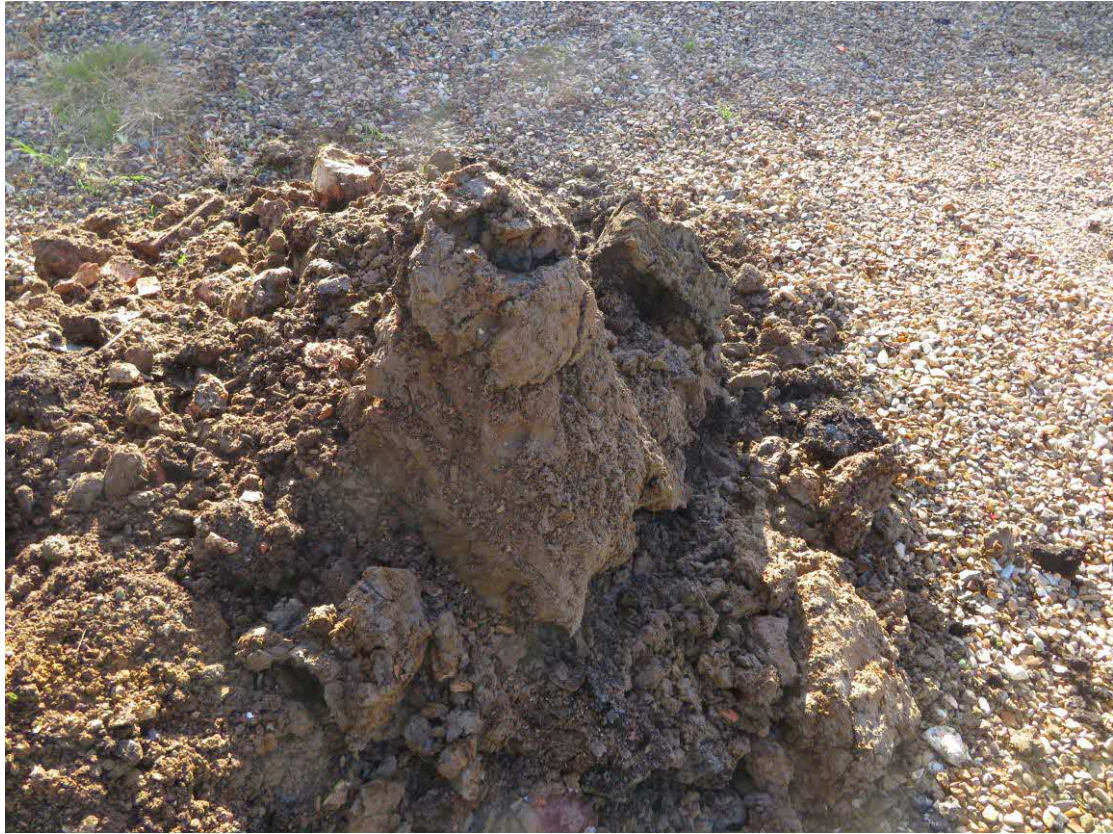
**PHOTO No. 7 – SPOIL FROM TRIAL HOLE SHOWING FIRM
BLUEY GREY/ BROWN SILTY CLAY FROM FOUNDATION
FORMATION LEVEL**
