Ellfield House Hanthorpe Road Stainfield
Bourne Lincolnshire PE10 0RR

Tel: 01778 571483 Fax: 01778 571626
email: john@ellfield.com

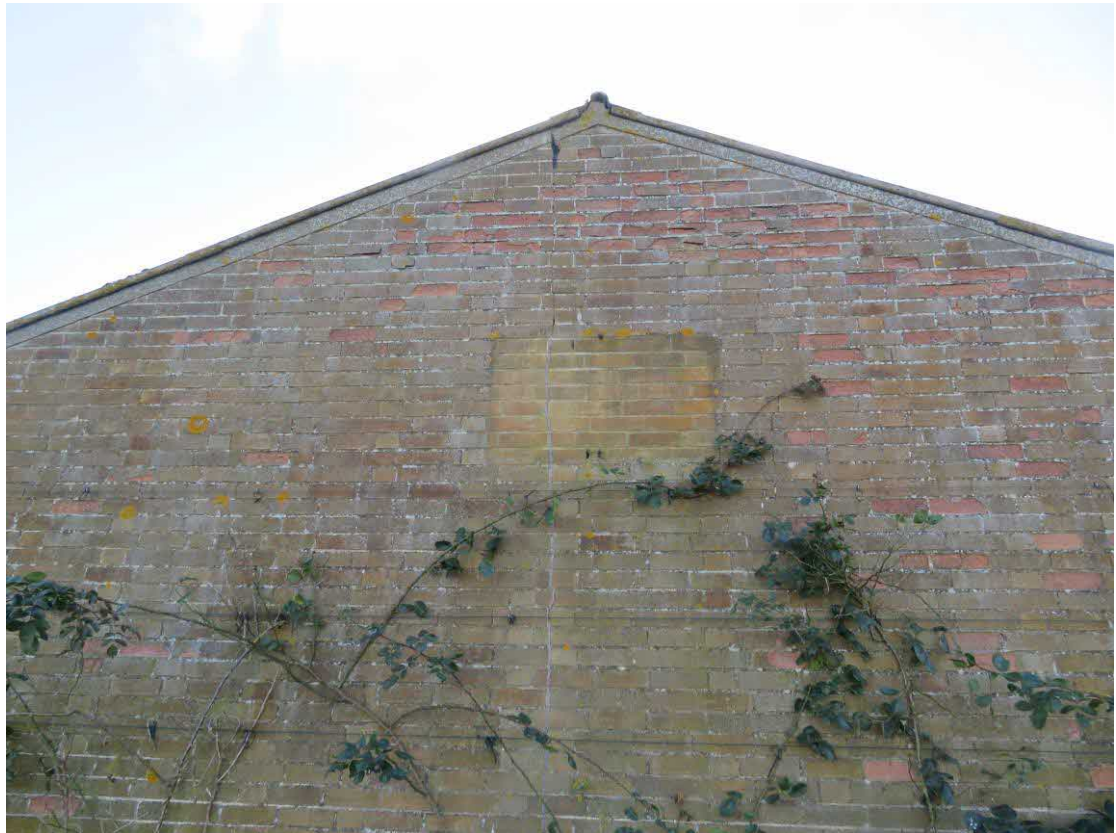
PHOTO No. 4 – VERTICAL CRACK IN NORTH GABLE

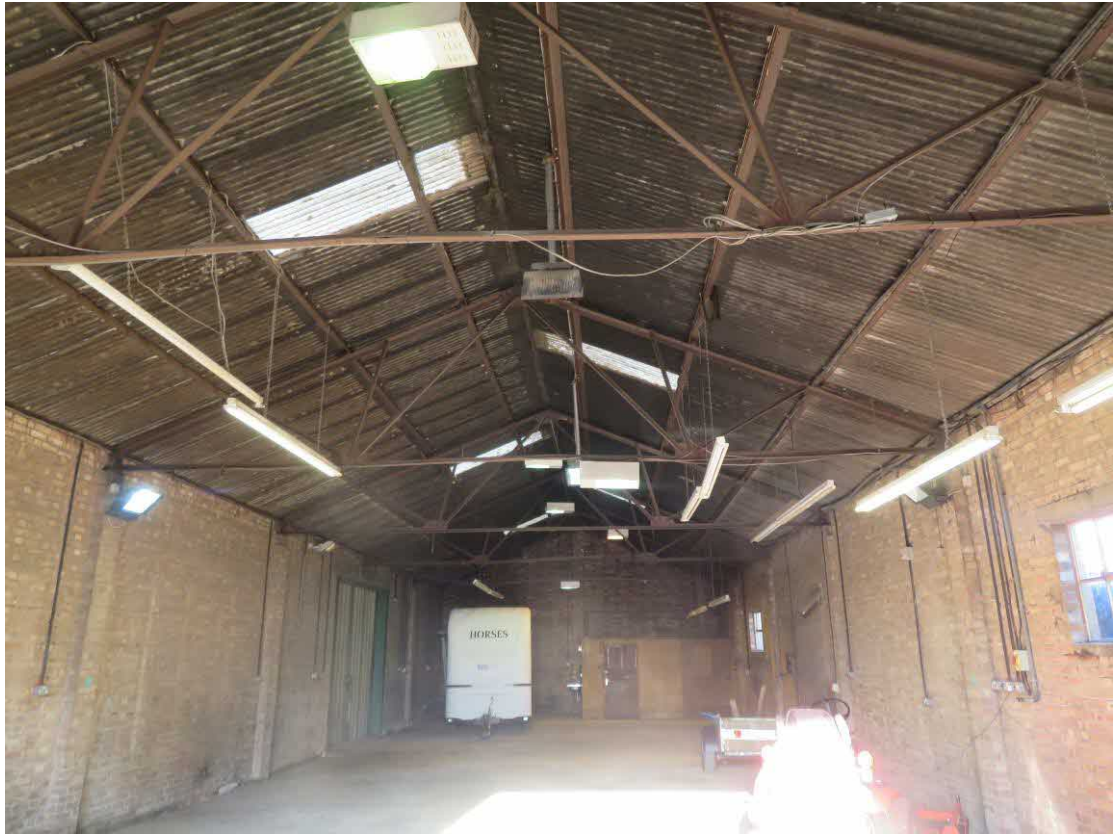
**PHOTO No. 5 – INTERNAL ROOF TRUSS ARRANGEMENT
WITH SUPPORTING PIERS**

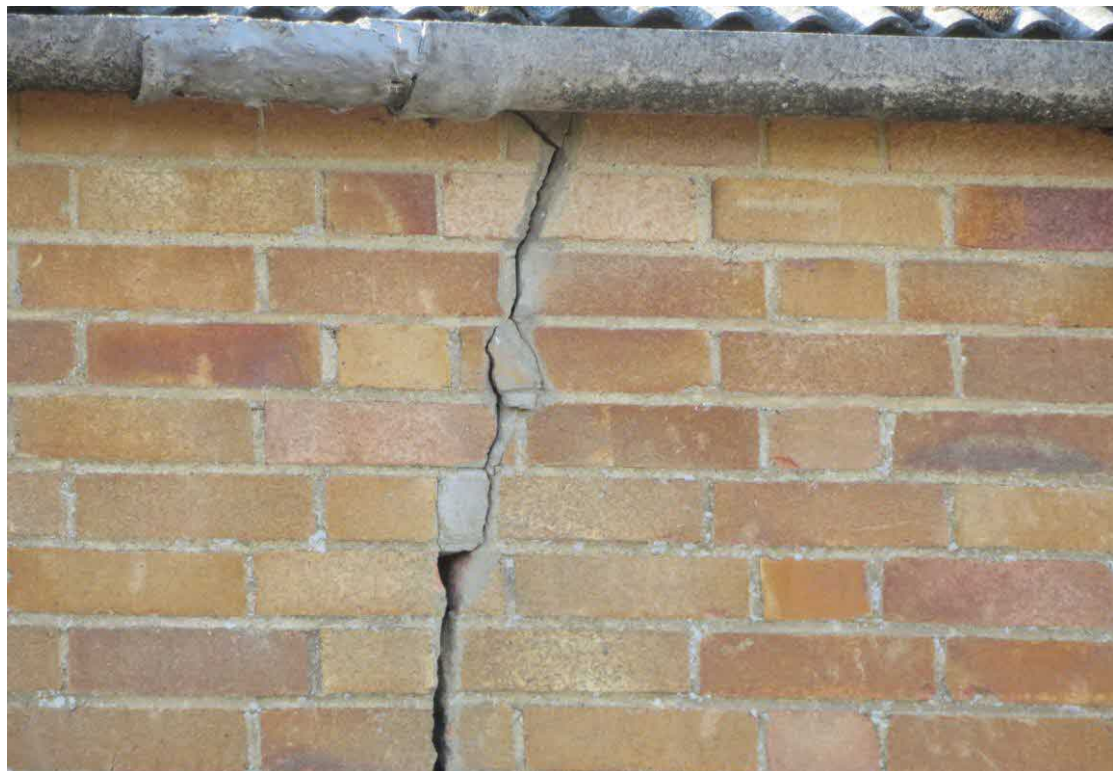
PHOTO No. 6 – VERTICAL CRACK ON EAST ELEVATION

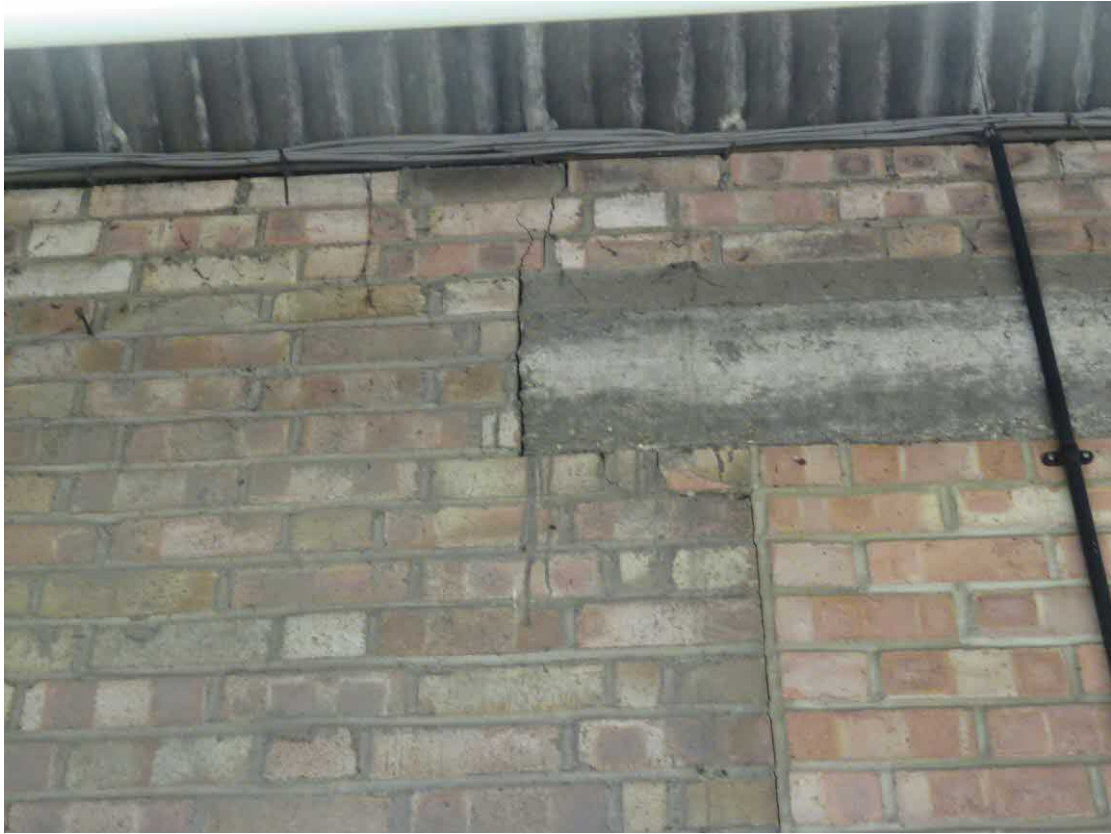
PHOTO No. 7 – VERTICAL CRACK AT FILLED IN DOOR OPENING

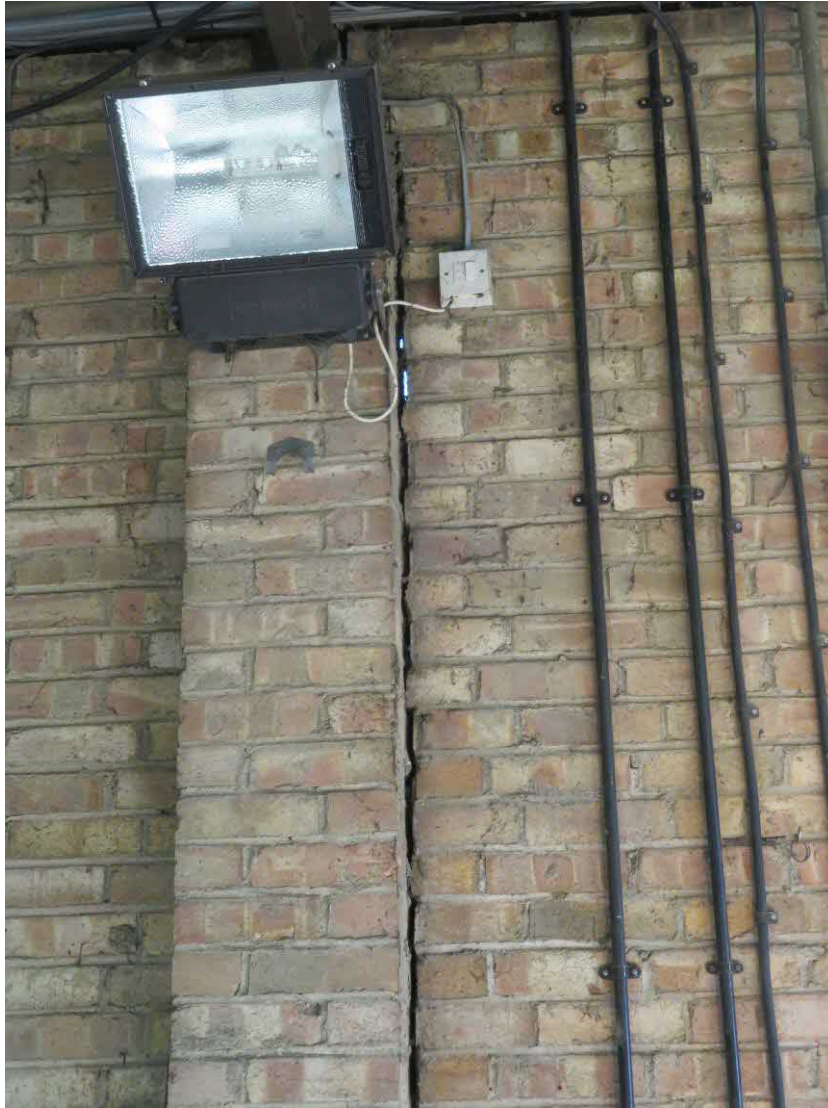
**PHOTO No. 8 – VERTICAL CRACK ADJACENT TO PIER
REFLECTING CRACK ON EAST ELEVATION**

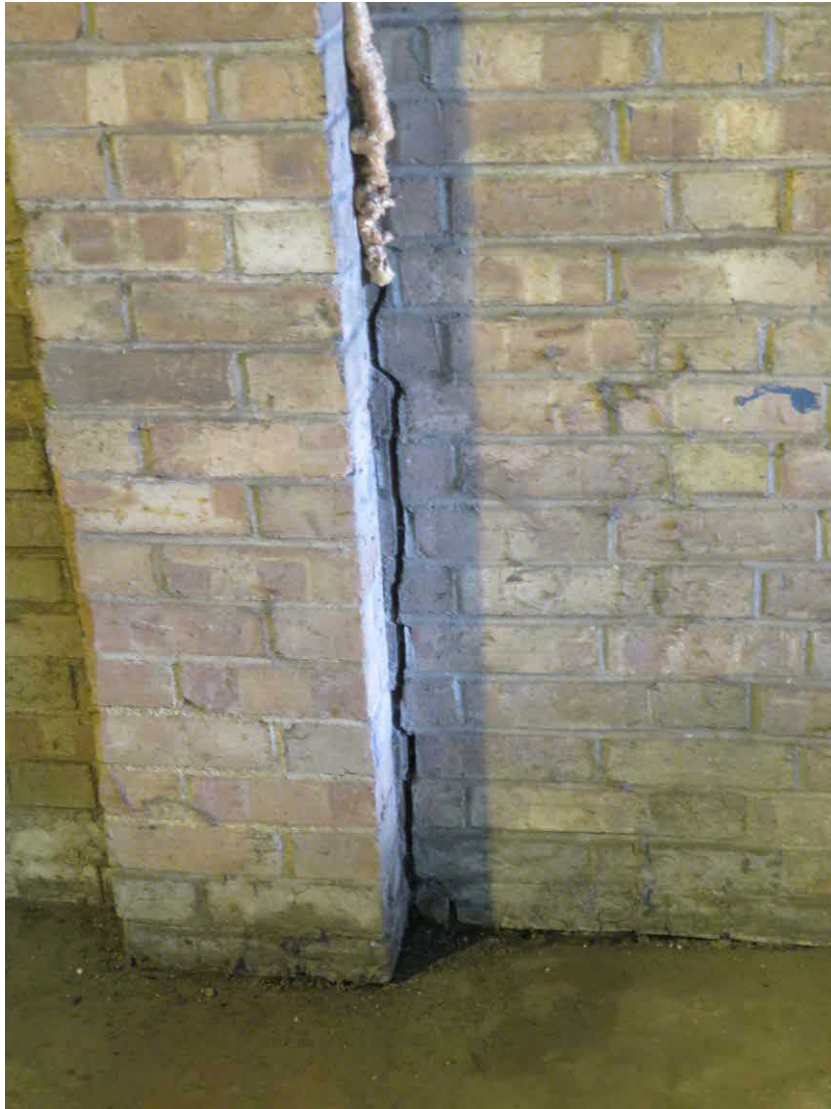
**PHOTO No. 9 – VERTICAL CRACK ADJACENT TO PIER
FILLED WITH FOAM FILLER**

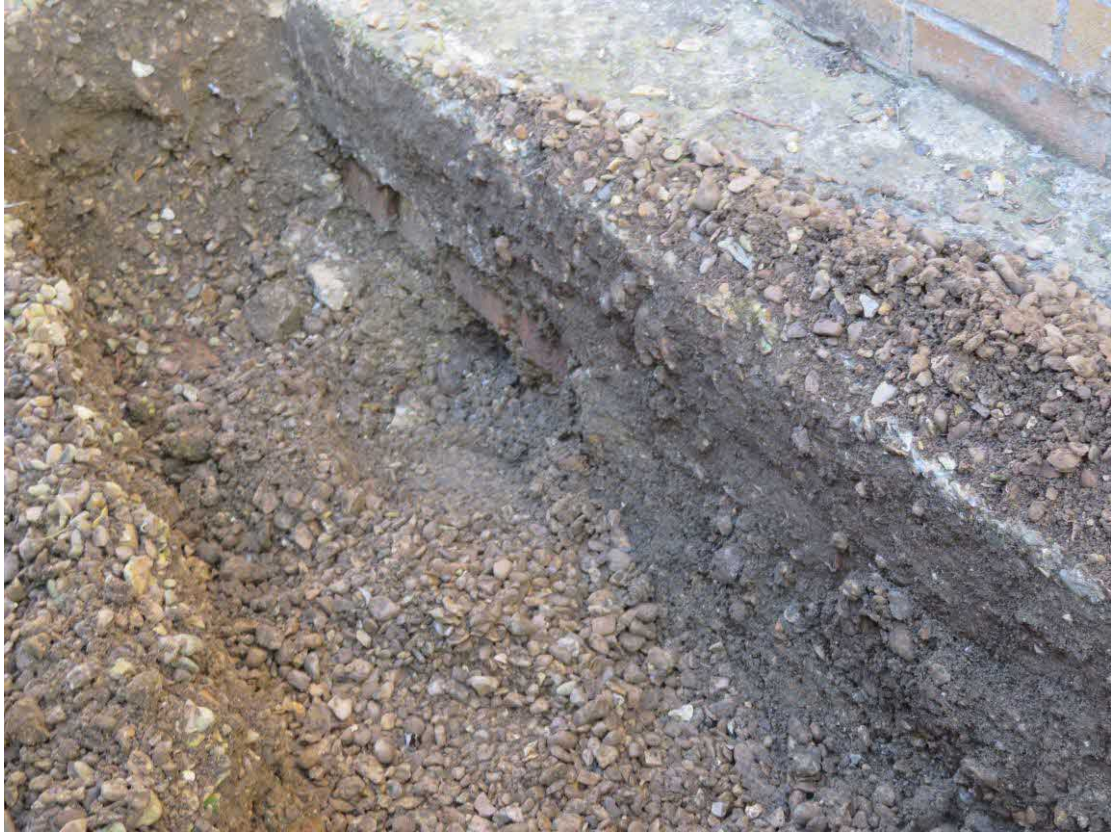
PHOTO No. 10 – TRIAL HOLE EXPOSING CONCRETE RAFT SLAB AND SUB-BASE
