Report on
Conversion of Grain Store
At
Bonhams Farm
London Road, Holybourne
Alton GU34 4JA
For
Redbrown Limited

DATE: 29th April 2022

JOB REFERENCE NUMBER: RMW/14823/22

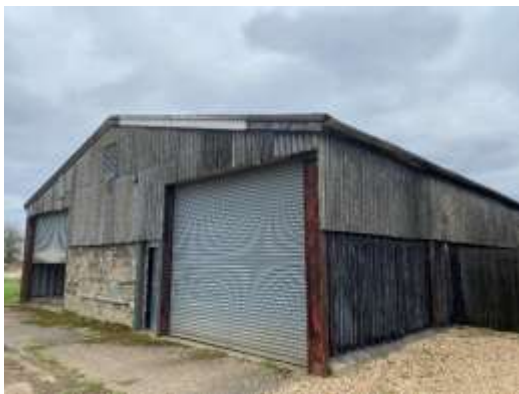
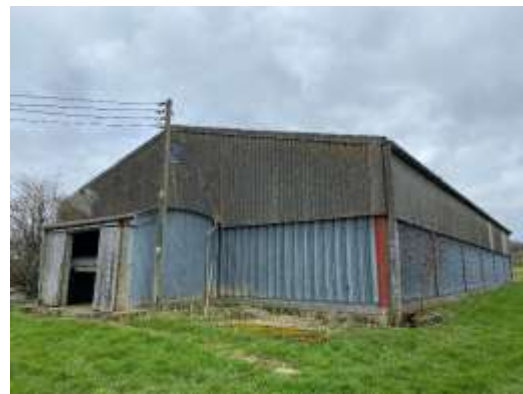
The barn comprises of a steel portal frames with the main stanchions measuring 306mm by 165mm with an overall span of approximately 15.1 metres and the building length of 27.5 metres. The height to the eaves measures 4.2 metres and the height to the ridge is 6.1 metres, all measured from the solid concrete floor.

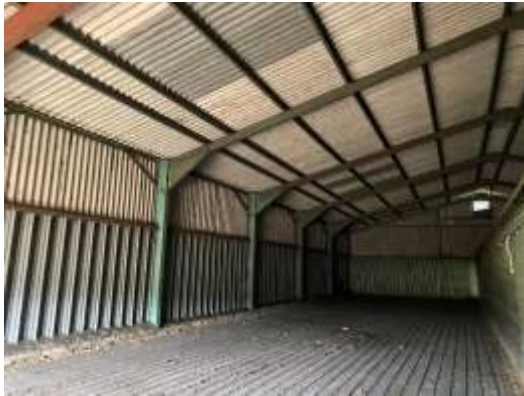
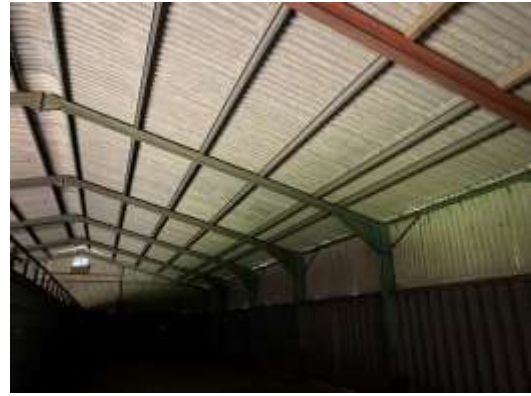
There are 7 portal frames each set at approximately 4.72 metre centres, but the forward frame may be an additional section to the build as there are double portal frames. The portal frames support horizontal steel beams which in turn support corrugated units that withstand the horizontal thrust of the grain storage.

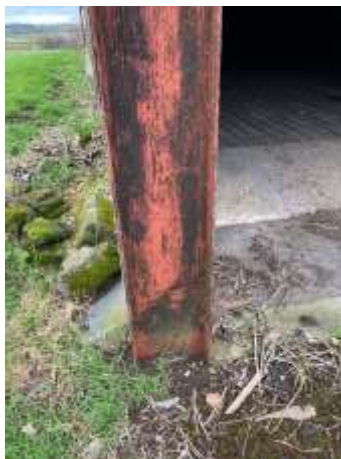
An inspection of the steel columns and portal frames revealed no structural issues regarding corrosion or other defects that would otherwise compromise the condition of the building.

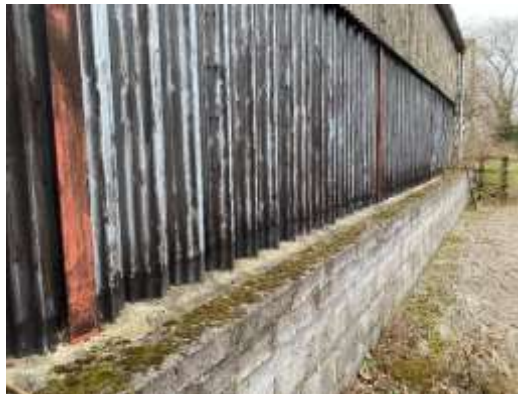
Along the right-hand flank there is a retaining wall in the courtyard to the main oak framed barn where the perimeter plinth supporting the lateral steels can be observed. There is no failure or damage to the retaining wall or the main concrete foundation and plinth.
