STRUCTURAL APPRAISAL

**Outbuildings
The Chequers Inn
Braintree Road
Felsted
Dunmow
Essex CM6 3DL**

Hawthorn Leisure

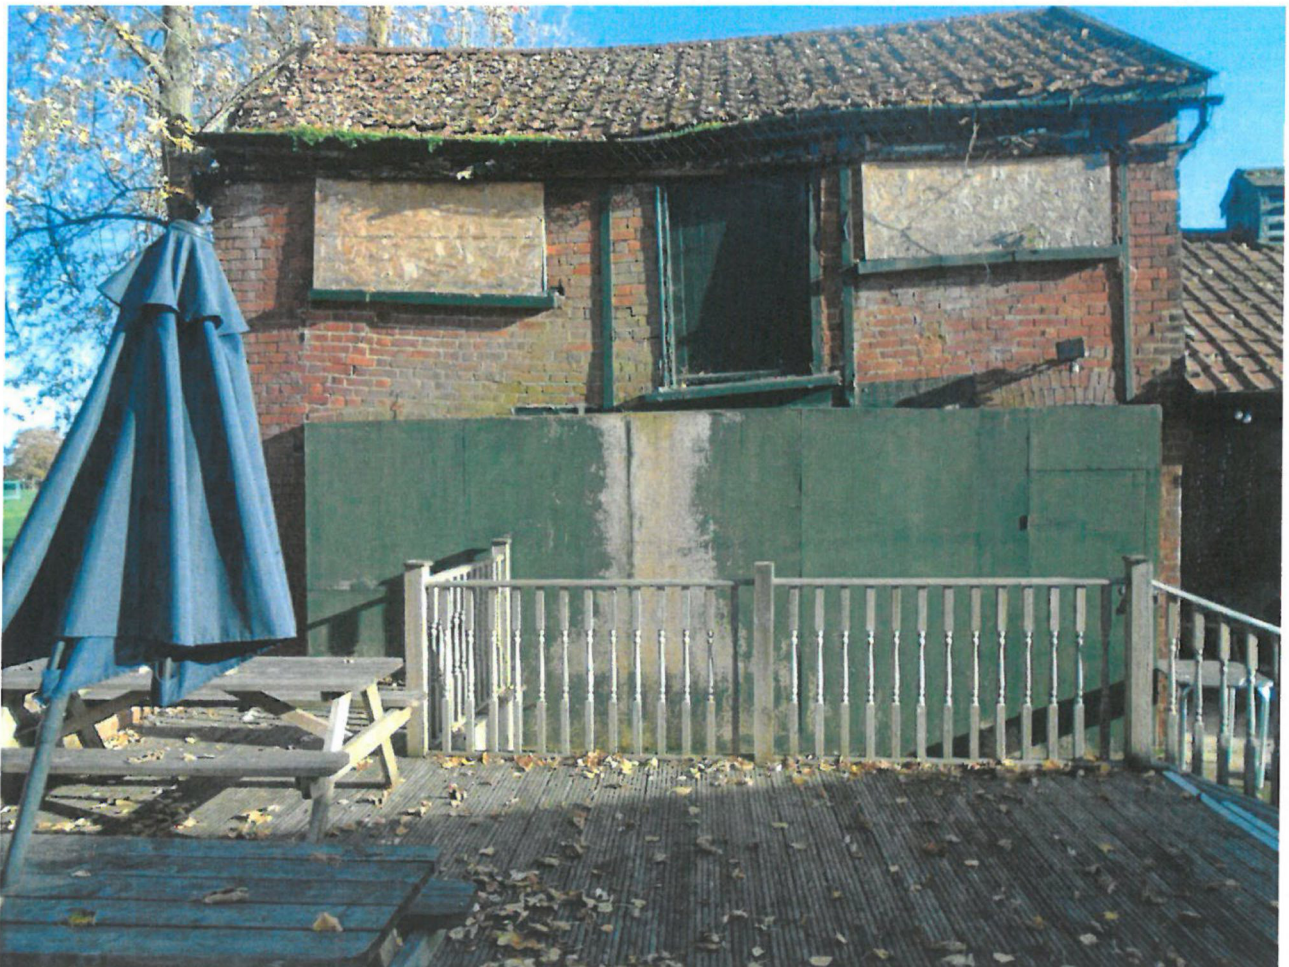
The stables building is in a poor state of repair and nearing collapse. The front wall at first floor level is severely deformed, as the supporting timber beam over the front entrance is decayed. The internal floor and roof have both collapsed with the brickwork severely cracked, bowing outwards and deflected downwards. As a consequence, the internal timber floor, which spans front to rear, which was supported on the beam, has also collapsed.

With regard to the stables building, we consider this to be a dangerous structure. Access into the building should be prevented and the external façade fenced off. We consider that the stables building should be demolished.

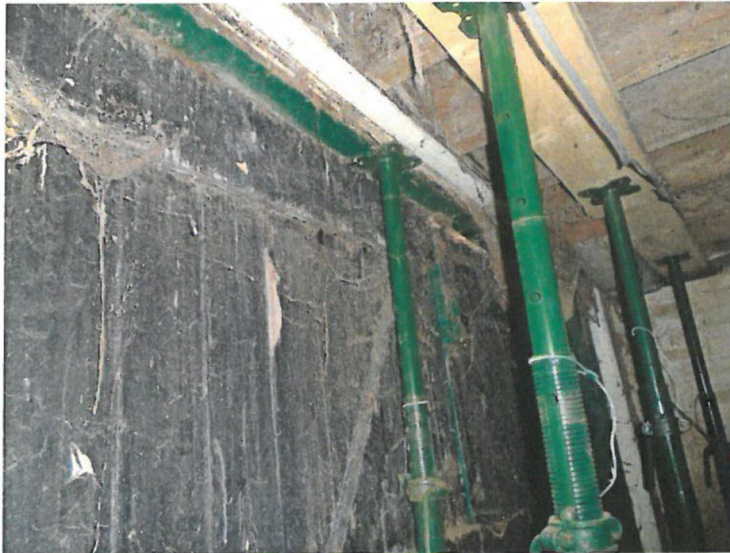
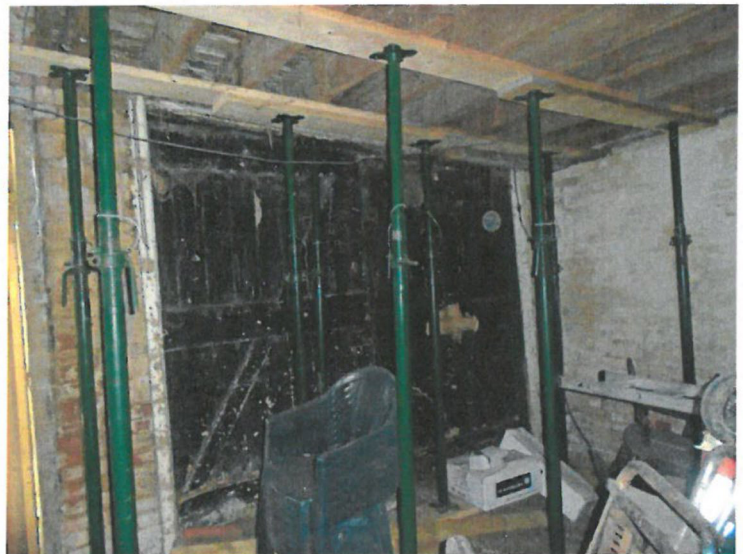
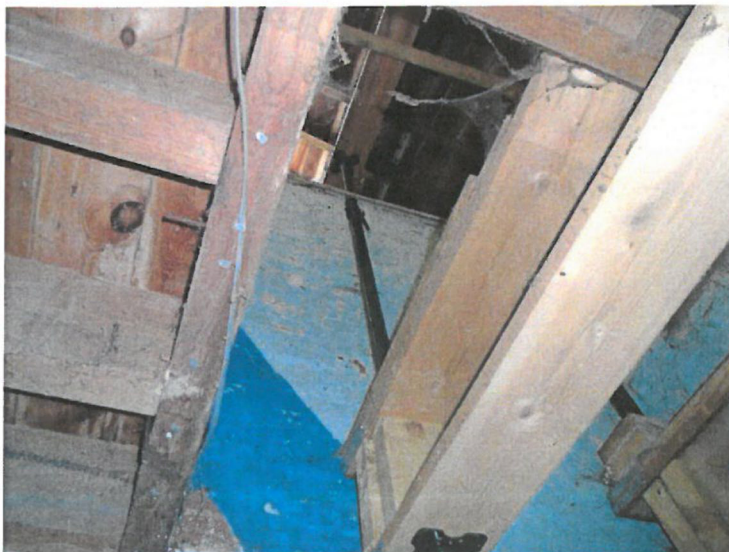
In order to make the building safe the roof of the building is back propped down on to the first floor, and the first floor then propped down to ground level. The decayed beam across the front opening has also been propped.

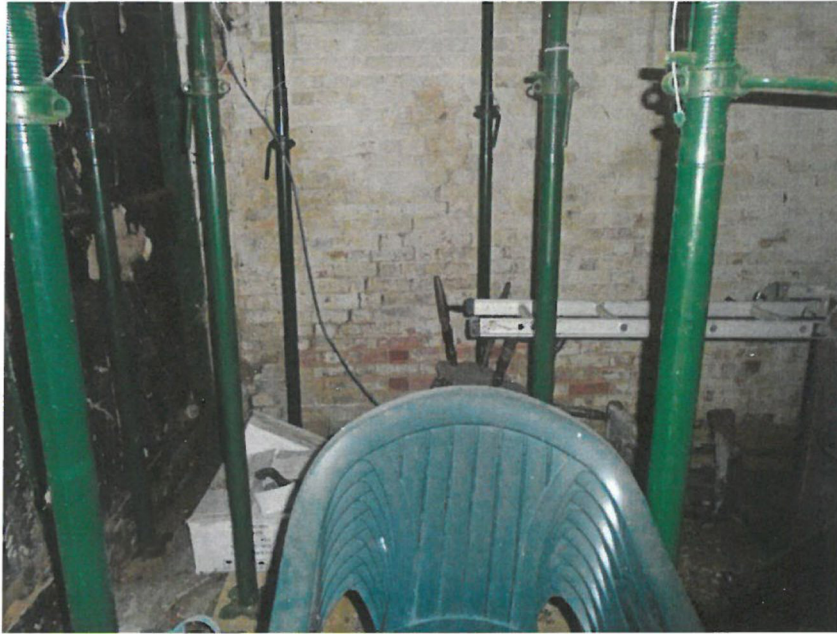
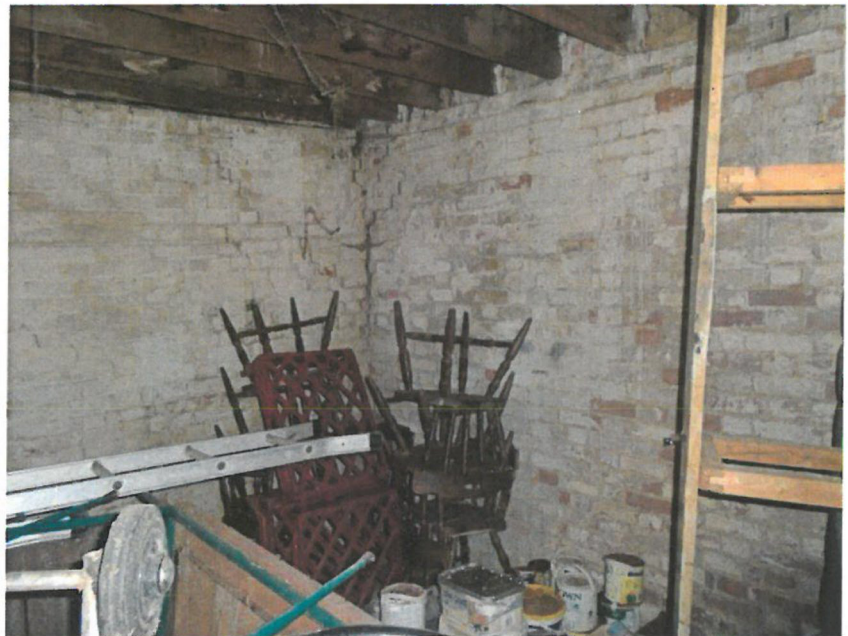
There is stepped cracking of the masonry walls internally to the rear and left hand flank walls.

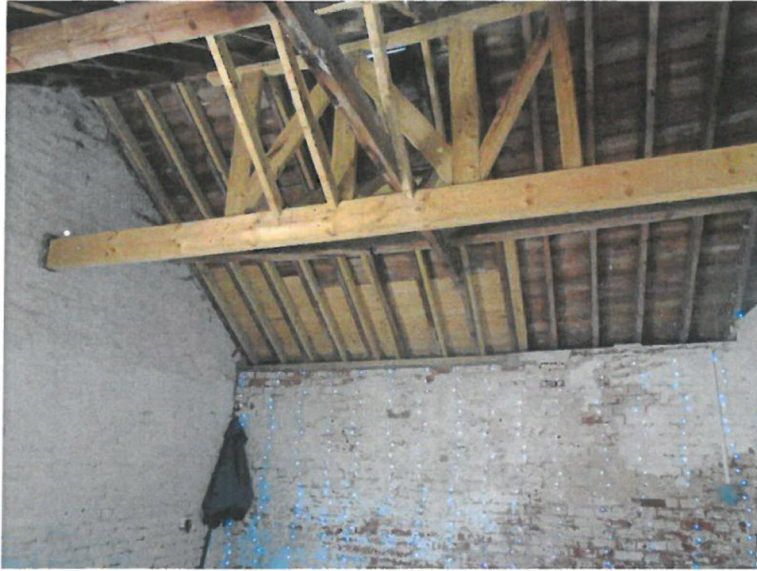
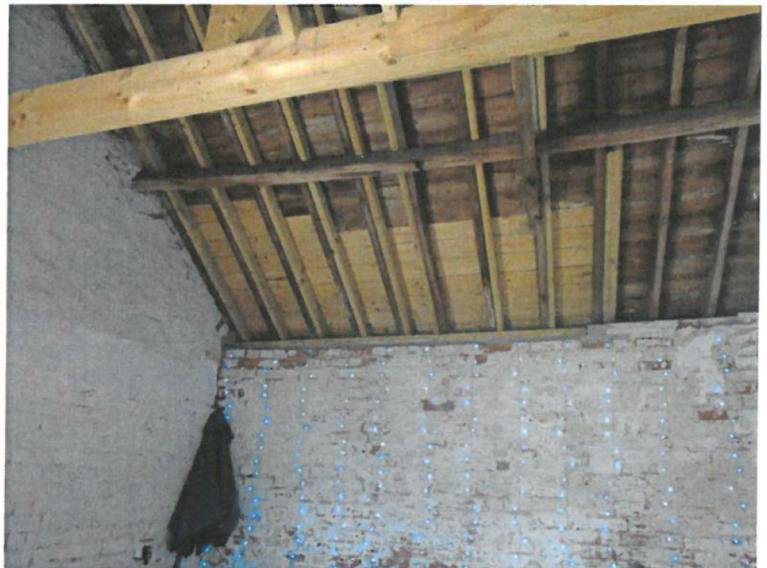
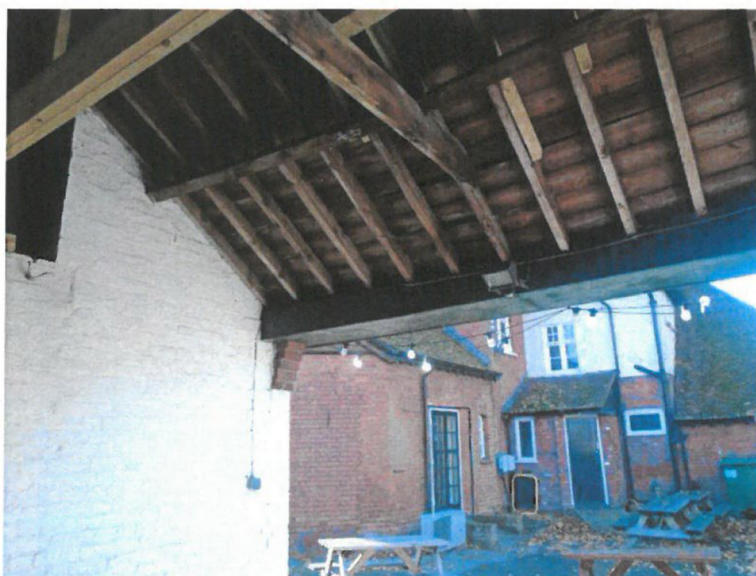
The roof pitches of the cart lodge have deflected as has the front beam over the opening. A study of the roof structure reveals that the original roof to consist of common rafters, purlins and collars. The purlins have deflected significantly

The roof structure has been strengthened with additional rafters placed alongside the originals to the rear pitch, replacement timber boarding, some strengthening of the front pitch rafters and two fabricated timber trusses / beams propping the ridge

With regard to the cart lodge, this shares a wall with the stables building. The roof requires replacement which will only leave a relatively small element of the building remaining. We consider that the cart lodge should also therefore be demolished.

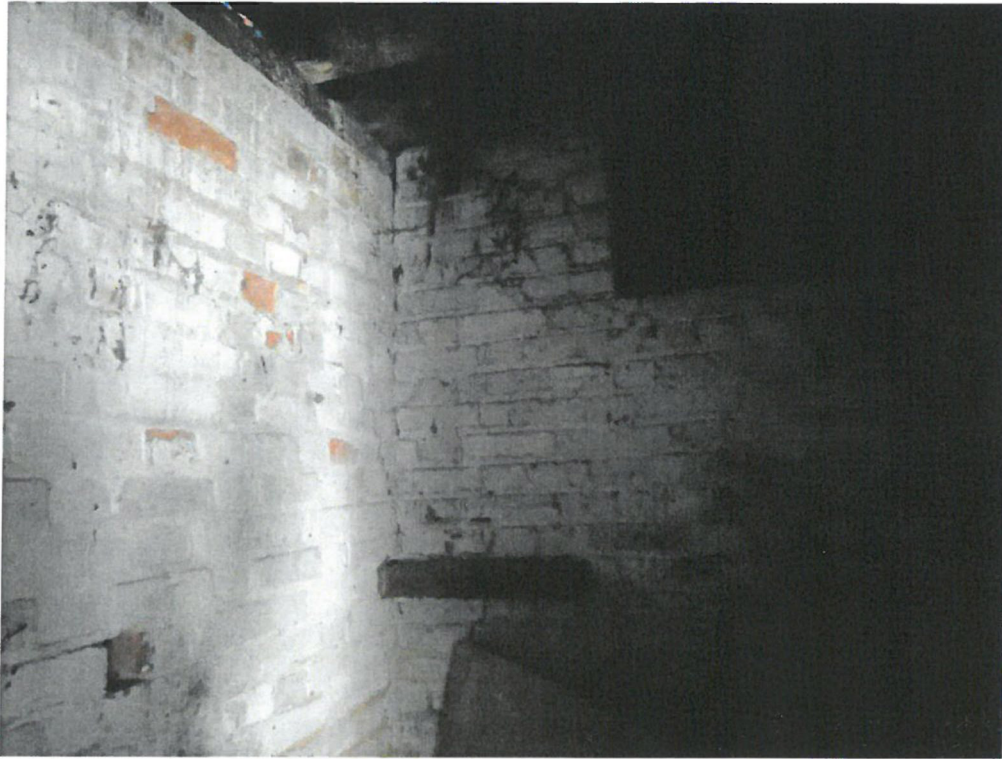
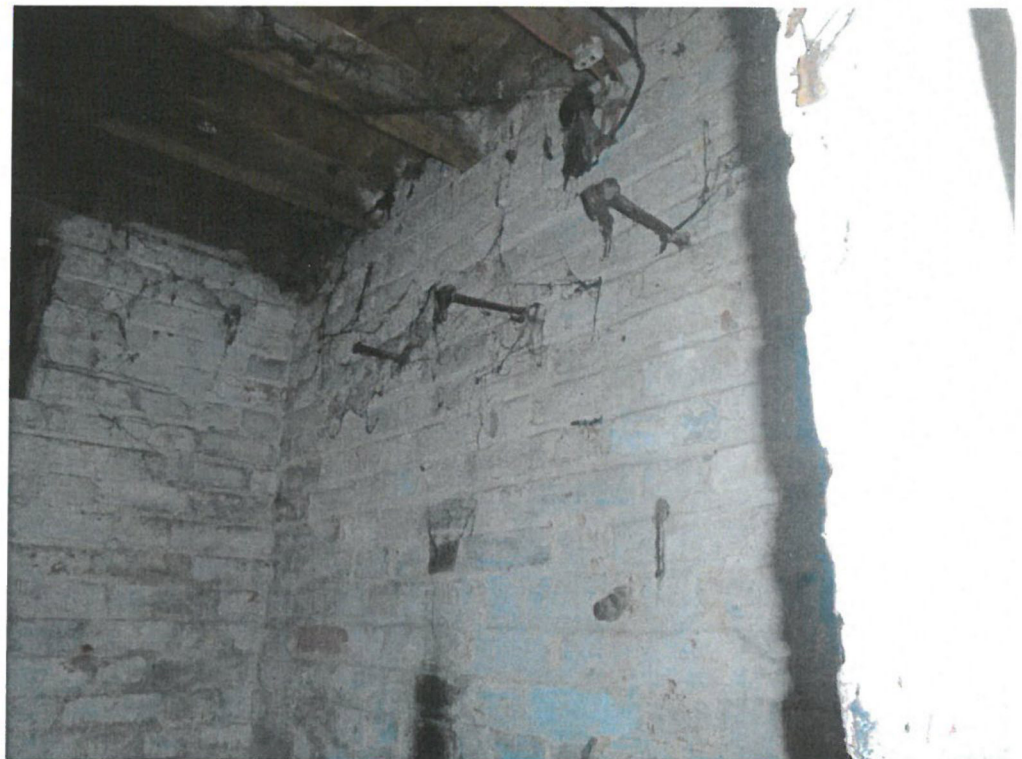
Within the cart lodge were small storerooms formed with brickwork single skin walls

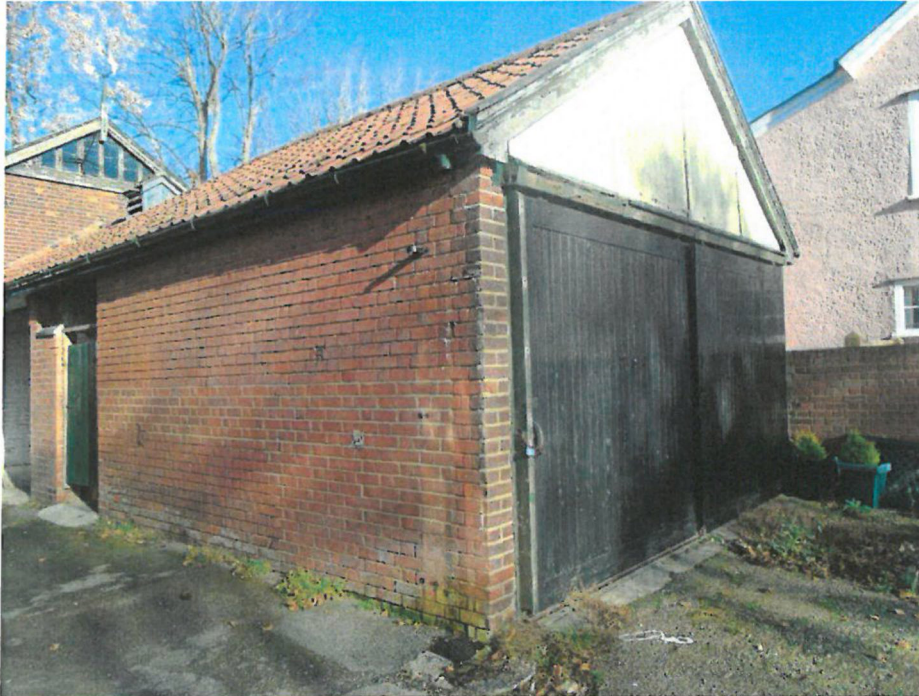
The garage is at the right hand end of the outbuildings. The garage is of brickwork masonry construction with a roof pitched front to rear clad in interlocking tiles

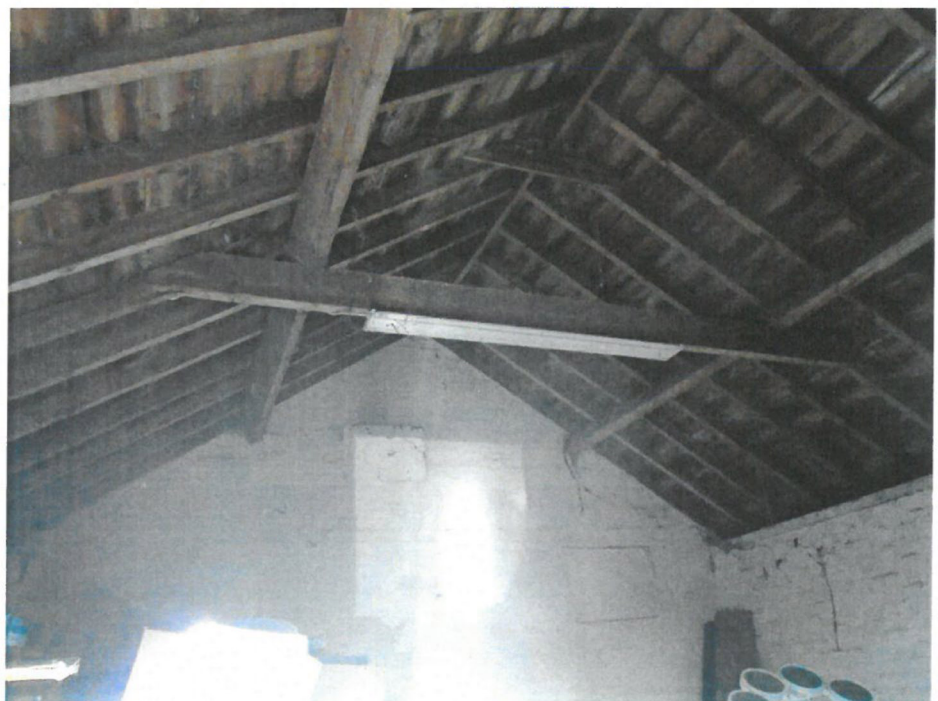
The roof of the garage was formed from close boarding below the roof tiles, common rafters supported by purlins and collars

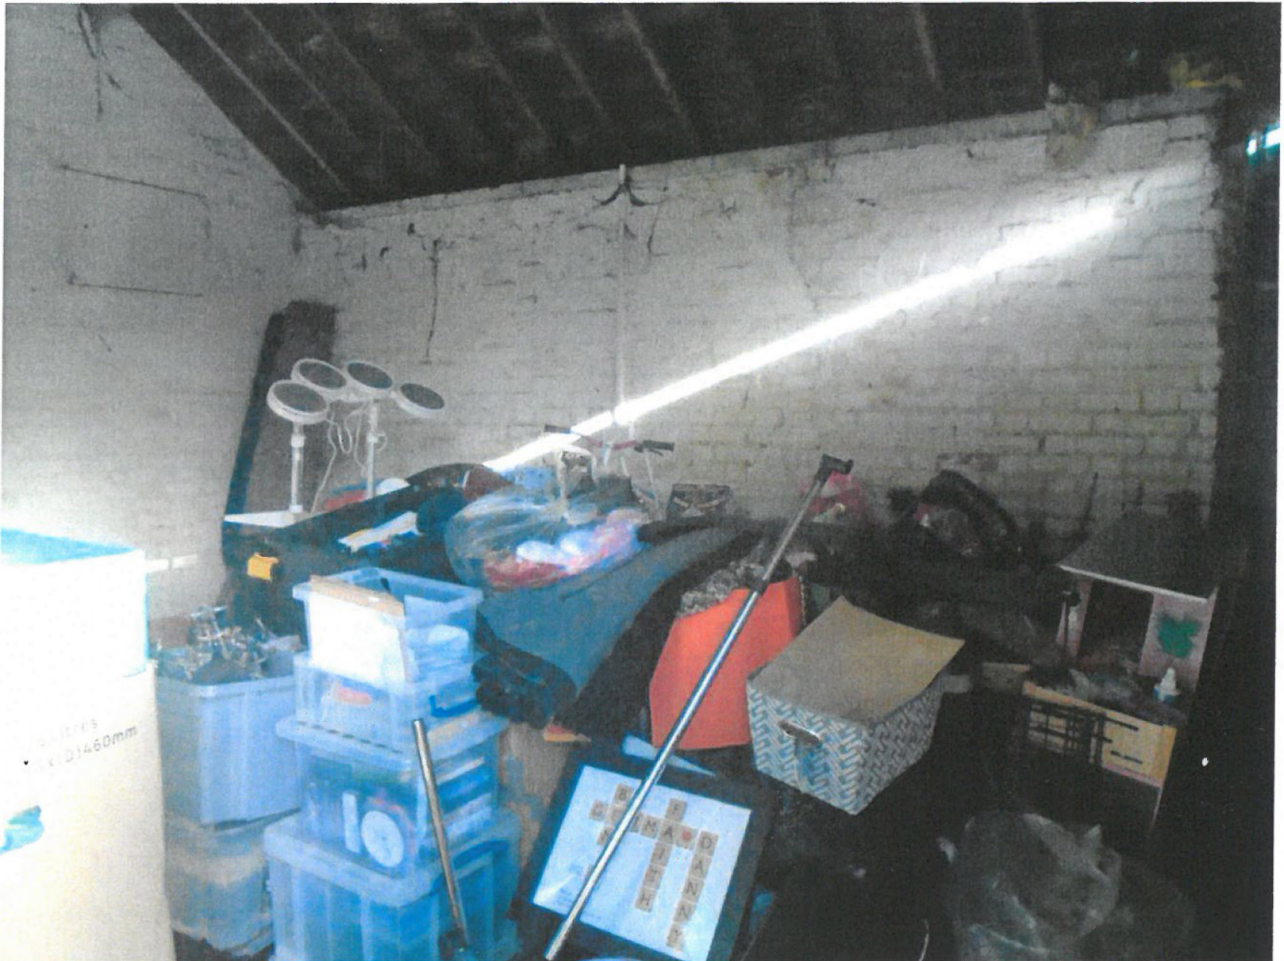
Internally, the garage was full of stored items

The garage, whilst in a poor condition overall did not exhibit significant symptoms of structural distress.

The garage building could be refurbished if required.
