LDN Architects

Mains of Crommey - Planning Submission

March 2022

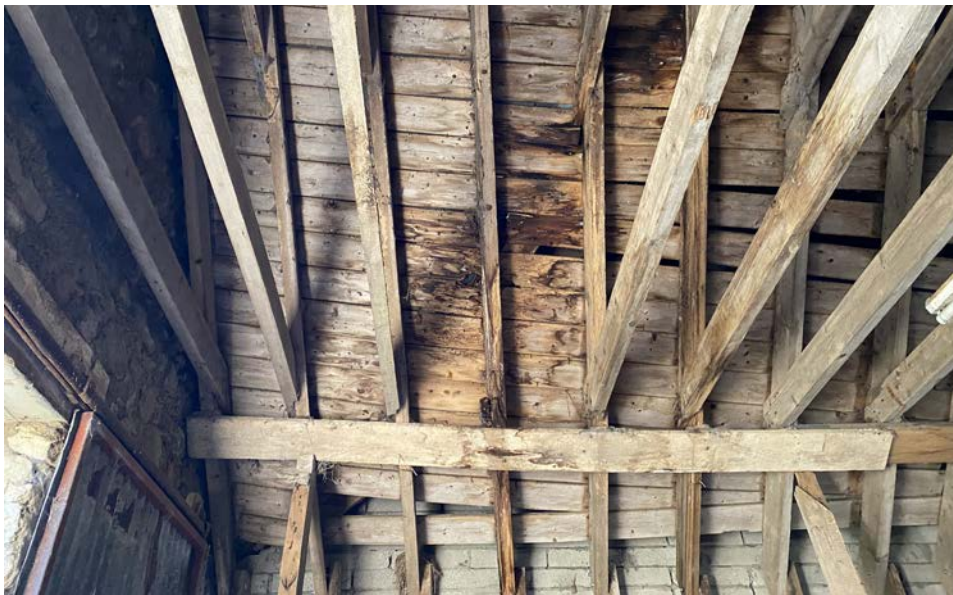
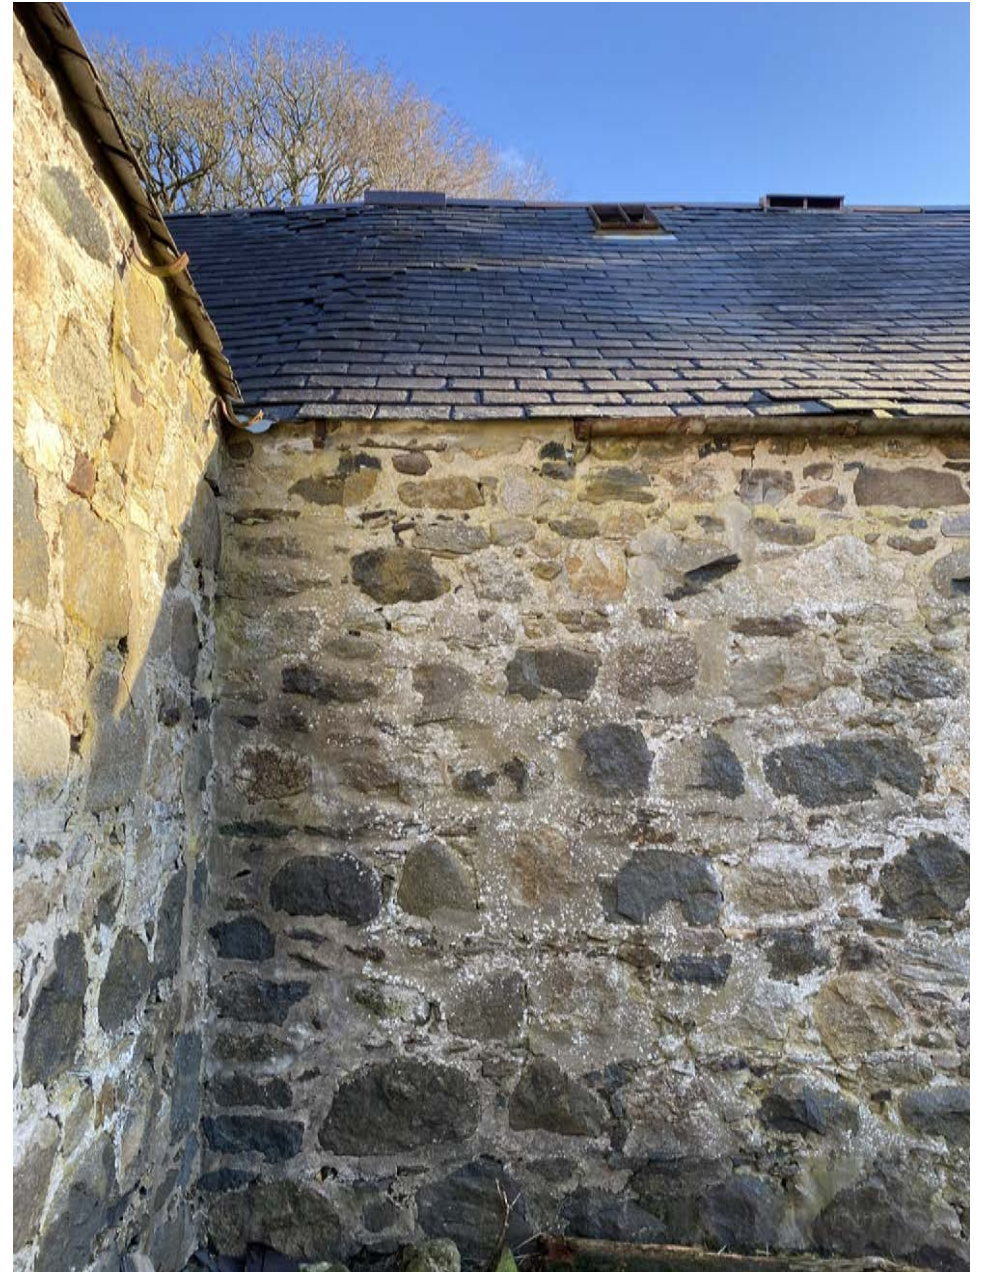
The roof of the steading range, to be retained, is racking to the east with heavy undulation through the ridge. This has resulted in disruption to the slates (Welsh) and caused cast iron rooflights to fall into the building. This movement has also resulted in heavy water ingress which is exacerbating the decay (areas of rot with some ties fallen in). The roof requires stabilisation as soon as practicable to prevent collapse.

There is undulation across the ridge of the Cottage which is demonstrative of movement within this structure too. The ridge has failed in places. Where it remains the bed (to the mixed clay ridge) has failed. The movement and undulation has caused disruption to the slates (Welsh) allowing water ingress. The four pane cast iron rooflight has sunk in reflection of the movement. The two pane rooflight has a broken pane.

The chimneys are unremarkable. There are hungry joints in the copes allowing water ingress. Cracking was recorded in the gable stack. Cement repairs have been carried out to both chimneys and the pots are capped.

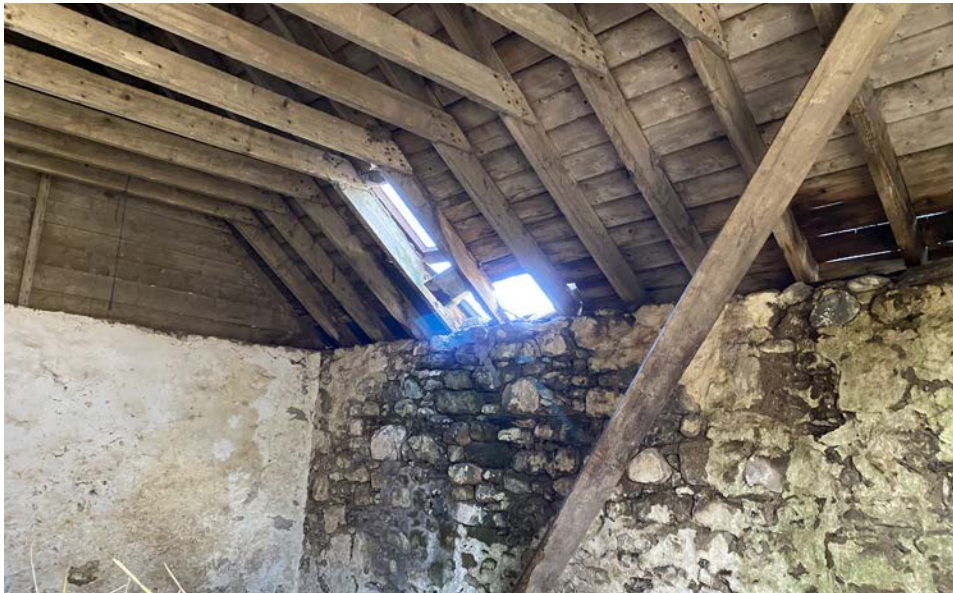
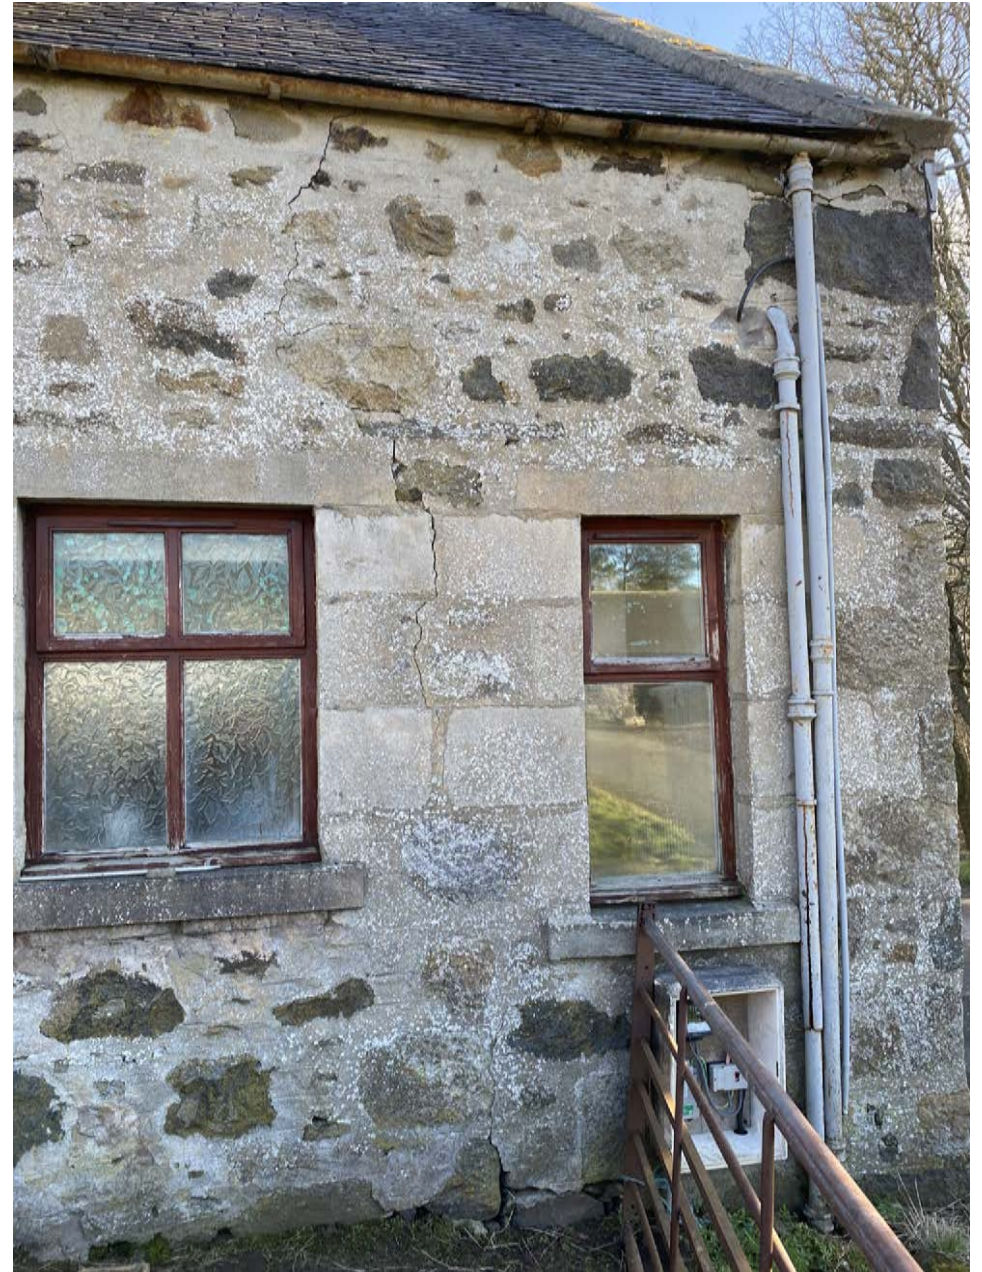
There is a mix of sizes of cast iron rainwater goods which affects performance and most sections are in poor condition with areas of heavy vegetation. There are also a number of missing sections which is exacerbating the decay to the fabric.

These are of modern form with a single ply membrane to the the flat roof covering. The timber fascias and windows have generally deteriorated.

The skews on the gable of the steading range have been replaced in cast concrete and this has heavily deteriorated.

The stone skews remain on the cottage gable but there is some deterioration to the cement mortar fillets.

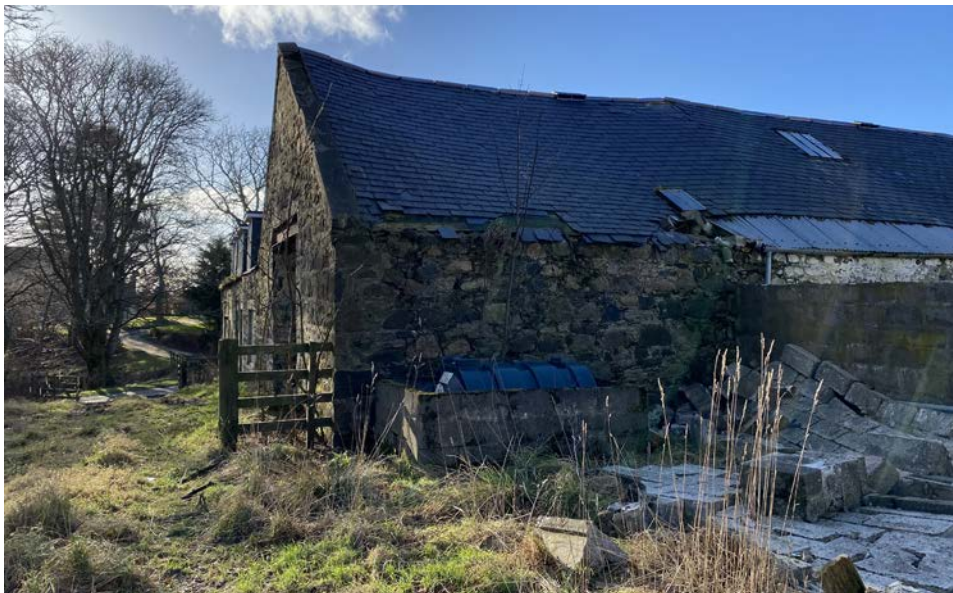
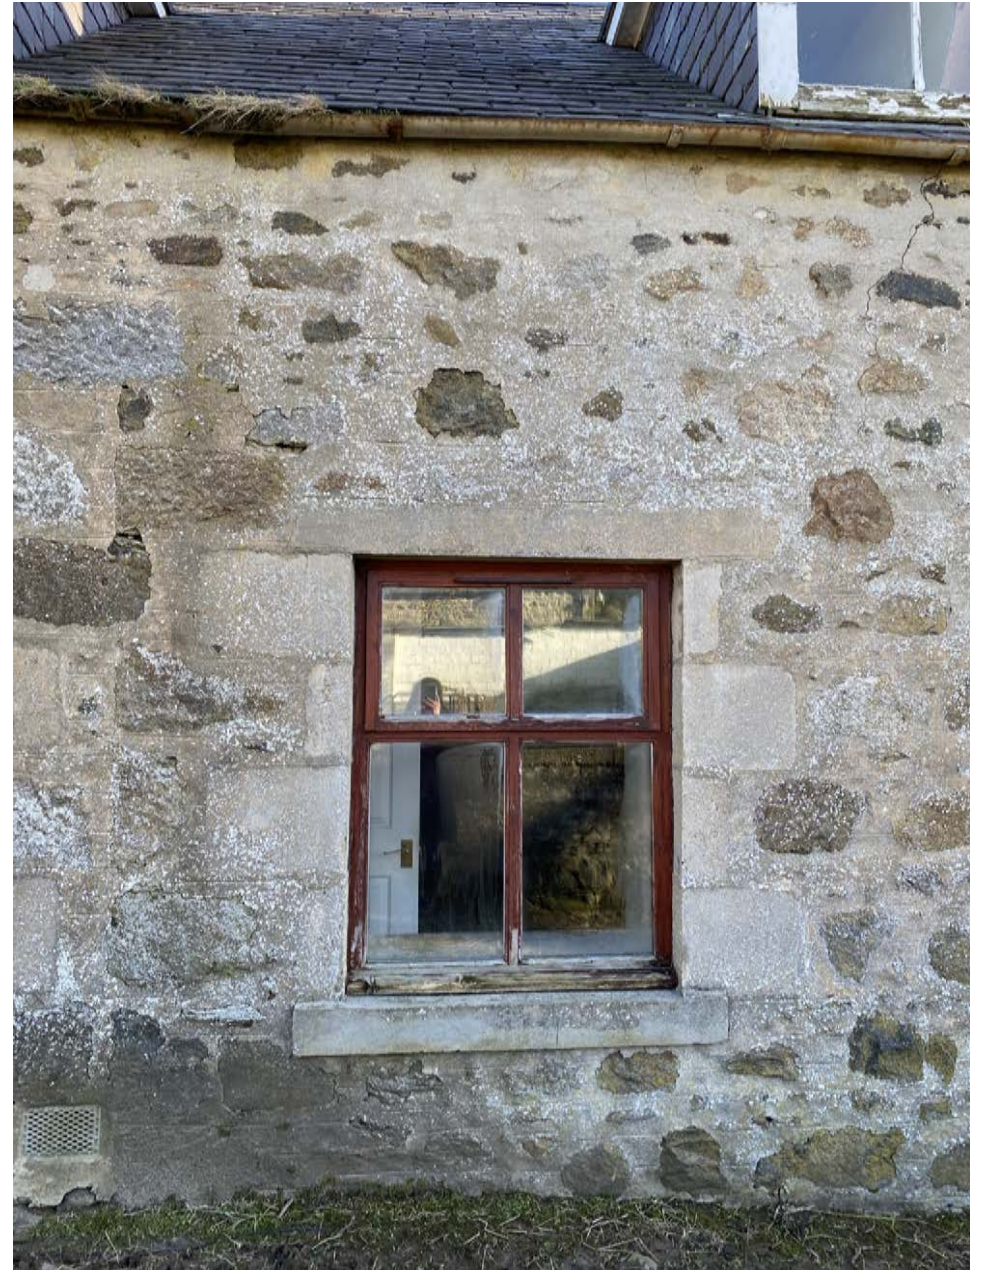
The walls are a mix of heavy 'stuck' cement pointing, numerous periods of cement repairs and some areas of original lime. In places the cement is heavily coated in biological growths which is an indication as to the level of moisture that is being retained within the walls.

There is extensive cracking running down through each of the elevations - an indication of movement and the level of deterioration (due to the high level of retained moisture within the fabric, a result of the level of deterioration).

All of the openings have cast concrete dressings with the exception of the large window adjacent to the east gable which has exposed concrete blockwork.

Other than the dormer windows, all of the external joinery is modern and in varying levels of deteriorated condition.

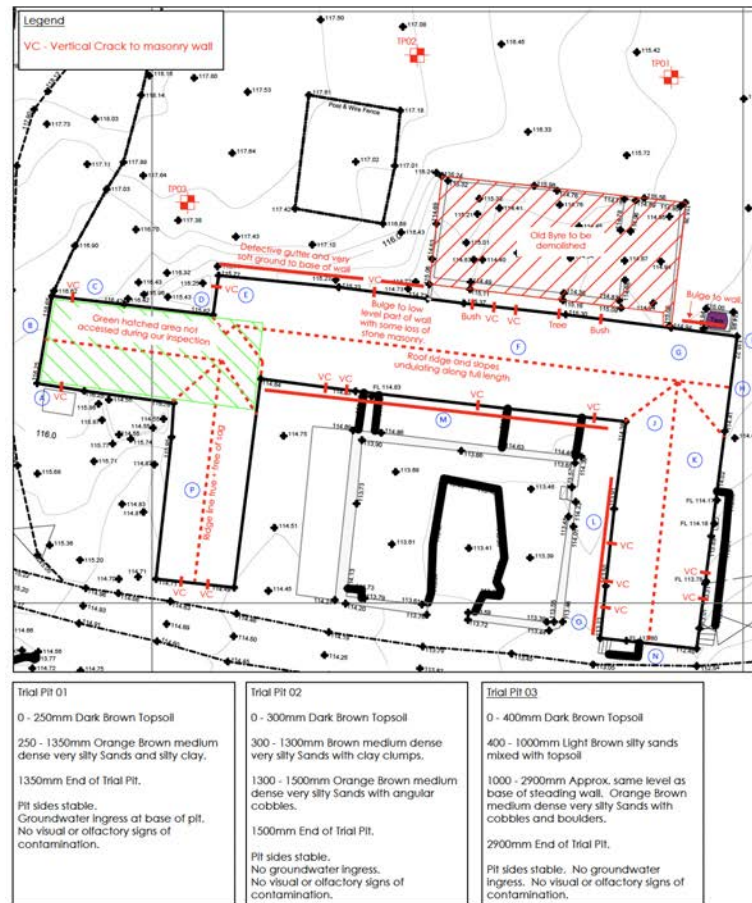
Structural Inspection Notes - Noted as (A) on plan.

- A - Washout of mortar to wall, lack of guttering to roof likely cause. Overhaul of rainwater goods to be carried out to ensure walls do not become saturated.

- B - Gable heavily pointed in cement, small voids noted to high level. Masonry repairs and picking & pointing in time required.
- C - Outward lean of gable noted, causing some vertical cracking to each side wall. Tying of gable wall back into roof structure and intermediate floors would suitably restrain gable.

- D - Very damp/ soft ground at base of masonry wall. Wall Overhaul of rainwater goods to be carried out to alleviate this issue and removal of ground away from masonry walls will improve this situation. New drainage system to new rainwater downpipes.

- E - Widespread cracking to wall. Masonry repairs and picking & pointing in time required. Area appears quite serious so caution to be exercised when working in this area.

- F - Pointing Roof ridge and slopes undulates along full length of steading range. Sagging in between trusses, generally caused by defective rooflights and prolonged water ingress. Roof replacement required to steading range.

- G - Roof in very poor condition in this area. Roof replacement to be considered.
- H - Lintel Gable wall in very poor condition with widespread cracking and an outward lean evident. Potential duntaking and rebuilding of this gable required.

- I - Detachment at corner of masonry wall. Masonry around corner could be strapped or rebuilding of corner to be considered.
- J - Roof in very poor condition around valley and over storage area. Roof replacement to be considered.

- K - General comment to entire farmhouse - Widespread cement repairs to masonry walls. Masonry repairs and picking & pointing in time required.
- L - Wall bulges inwards and outwards along full length - possible lack of tying from first floor and roof structure - rotten timber ends likely cause. Reinstatement of tying required and possible rebuilding of external wall. May require large sections of duntaking to enable the remedial works to be carried out.

- M - Wall bulges inwards and outwards along full length - possible lack of tying from cross wall which have Ribband joints defective/ sagging roof structure. Reinstatement of tying required and possible rebuilding of external wall. May require large sections of duntaking to enable the remedial works to be carried out.

- N - Wall appears to lean outwards at the head and there is widespread cracking to the masonry and chimney stack. Gable will require to be tied back into main structure with steel straps. Investigations into the ground conditions and foundation of the building will be required also. Depending on the findings, underpinning may be required.

- O - Gutters and downpipes discharge onto ground. This may be affecting the masonry walls and foundation with the softening of the subsoil. Full overhaul of rainwater goods required with new drainage system to convey the flows away from the building.

- P - Steading range general in fair to poor condition. Cross walls appear to have Ribband joints with some lack of tying to external side walls. Downstand beams supports first floor which is in a fair condition with minimal bounce. Some loose masonry and loss of mortar pointing. General overhaul of masonry required and tying of walls together with steel straps. Some cracks stitching required to south gable where vertical cracks are present.

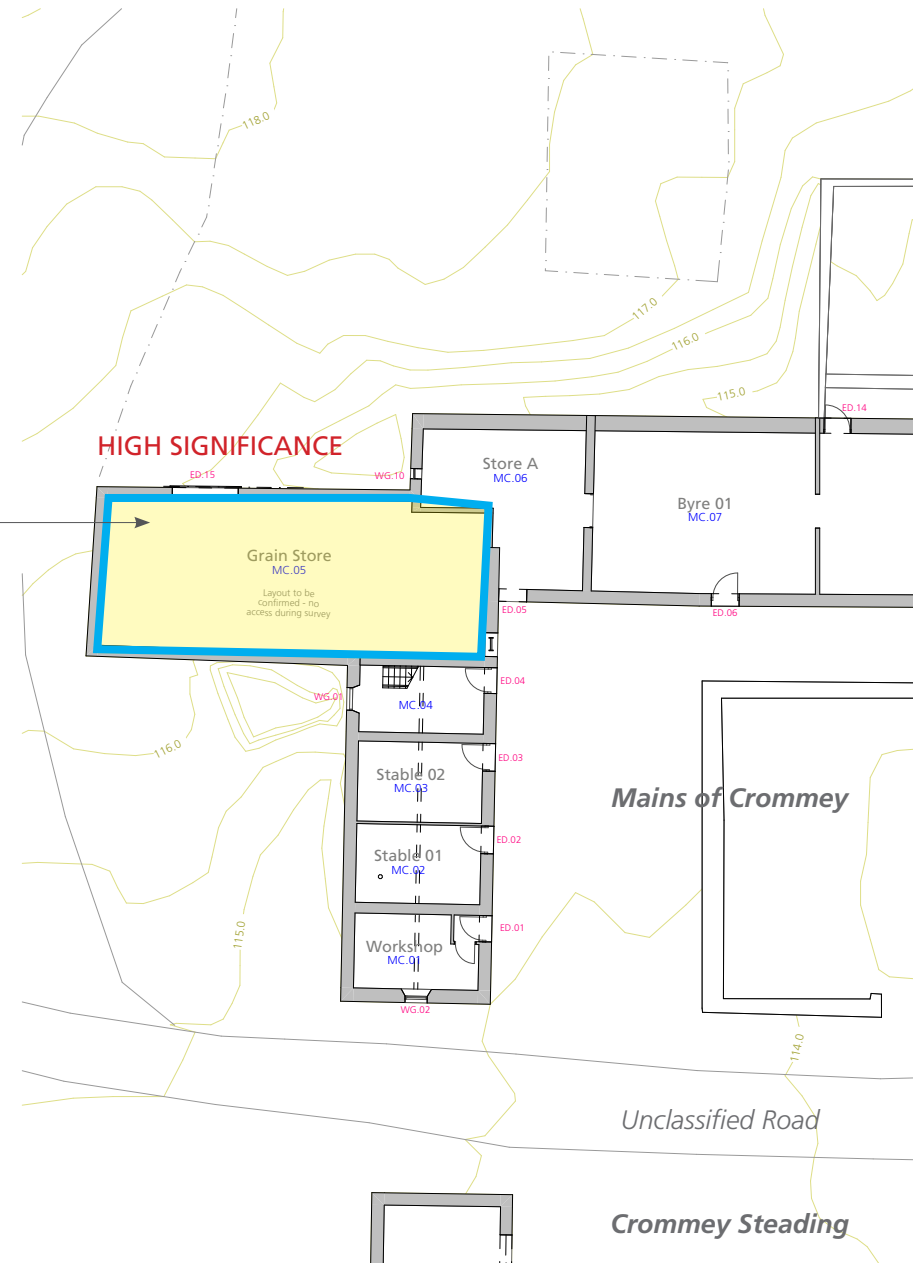
Drawing Title:
EXISTING
Ground Floor Plan

Grain store interventions - blockwork walls, redundant machinery and roof penetration to be carefully removed to enable safe access to inspect the condition of the traditional building fabric / structure

← Extent of proposed demolition
