Tree Condition Assessment with Pruning Specifications

No. 28 The Avenue, Radlett, Herts WD7 7DW

CLIENT:	Mr R Binns
CLIENT REF:	RB/TARH
AAAL REF:	SAL/KMA/11125
AAAL CONSULTANT:	Shane A Lanigan
REPORT DATE:	11th May 2022

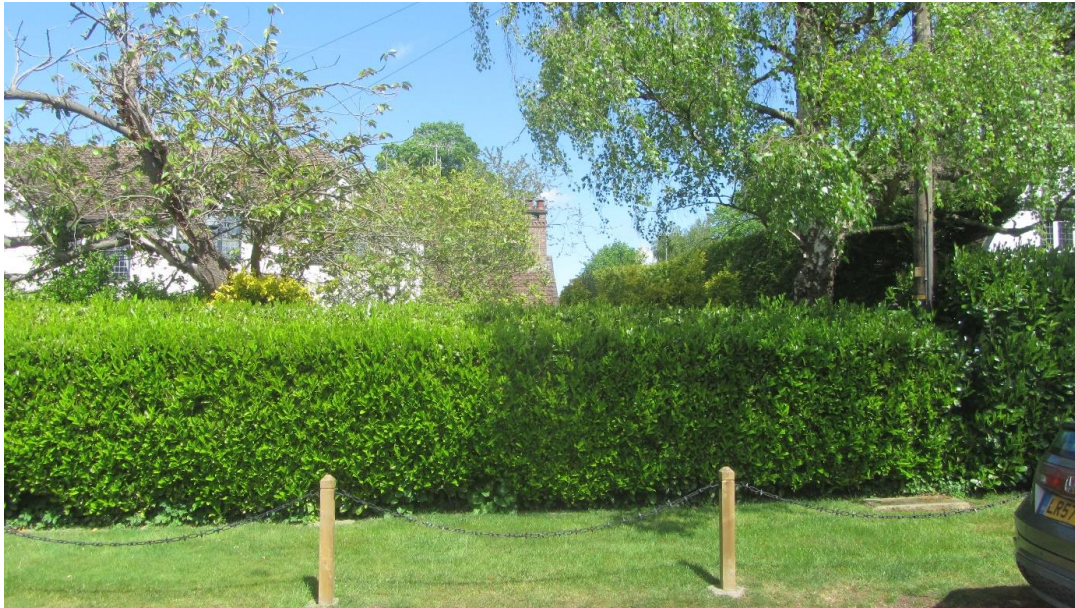
- 3.2 Tree 12 (saucer magnolia) is a much smaller tree which was also once severely pruned. It has regrown back strongly with multiple ascending branches and some aberrant growth within the crown (see photographs 1 & 6, Appendix 1 at the back of this report).

PHOTOGRAPH NO. 1 – T12 – MAGNOLIA – VIEWED FROM THE ROADWAY

- 6.1 T12 – Magnolia – reduce crown by 1.5m on height and 1m on overall spread, lift crown to 1.8m above ground level – hand saws should be used in this operation.
- 6.2 T13 – Oak – reduce lateral crown spread by around 3.5m on the northern side and 2.5m on all other areas, a height reduction of 2-2.5m would help to balance the crown and create an acceptable aesthetic appearance, lift crown to 6m above ground level by pruning off small diameter – around 10-20 mm epicormic branches.
- 6.3 T14 – Oak - reduce lateral crown spread by around 2.5m on all areas and height by 2-2.5m, lift crown to 6m above ground level by pruning off small diameter – around 10-20 mm - epicormic branches.

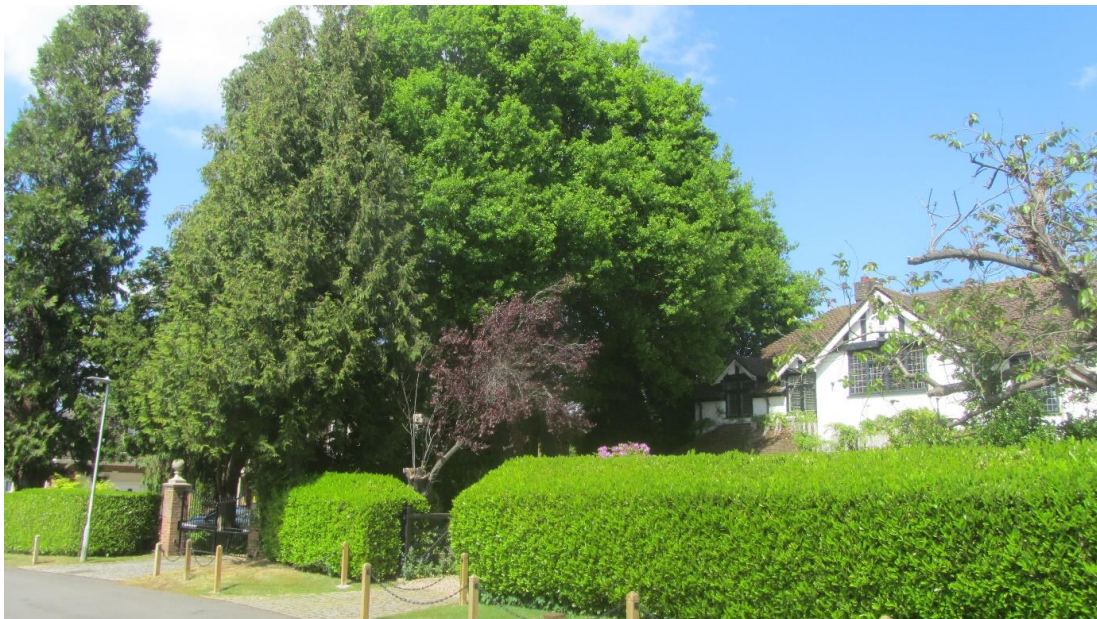
- 3.1 I inspected the trees from ground level around about 270° of their circumference. Before beginning my individual inspections, I made an overall assessment of the trees, particularly the two oaks, in the context of their surroundings. I saw that the two oaks dominate their surroundings (see photographs 2, 3, 4 & 5, Appendix 1 at the back of this report) and encroach significantly into the curtilage of No. 30. In response to the early very extensive pruning works both trees have regrown strongly, now having more individual second-order branches than before and so carrying commensurately more foliage and consequently casting appreciably more shade than they previously did (see photographs 5, 9, 10 & 11, Appendix 1 at the back of this report). The most recent pruning performed around nine years ago likely addressed the surfeit of foliage to a certain extent but now, unavoidably, the regrowth from this operation is both dense and extensive (see photographs 2, 3, 4 & 5, Appendix 1 at the back of this report). Thus, the leaf area index and overall extent of the tree crowns are now both significantly greater than they were in the trees' 'maiden' forms.

**PHOTOGRAPH NO. 2 – T13 & T14 – OAKS – VIEWED FROM SOUTHWEST
SHOWING THEIR DENSE CROWNS AND OVERBEARING BULK**

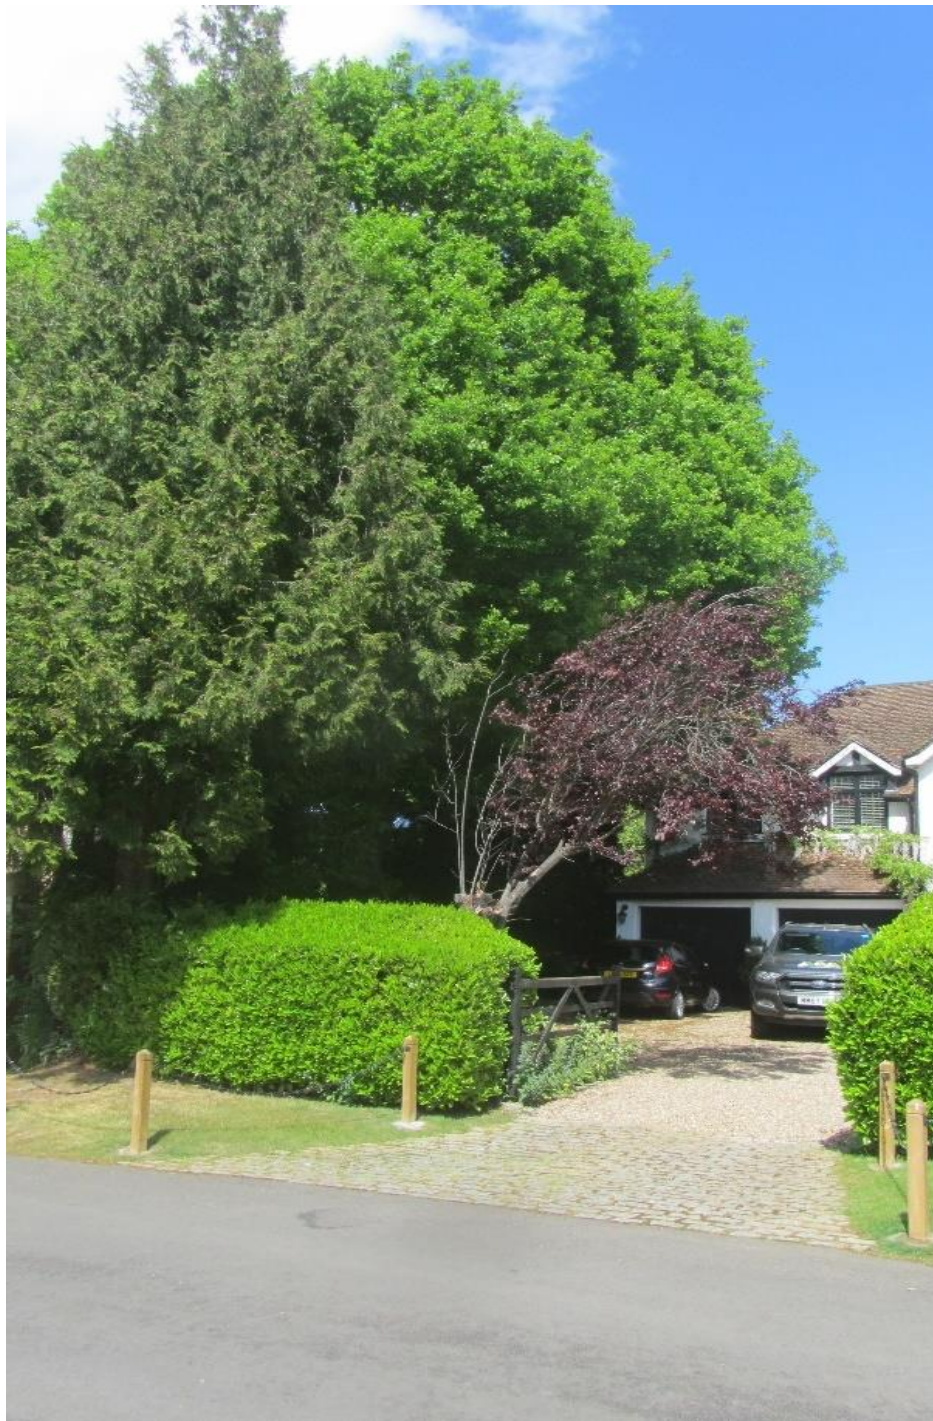
PHOTOGRAPH NO. 3 – T13 & T14 SHOWING CROWNS GROWING OVER THE DRIVEWAY AND DWELLING HOUSE OF NO. 28 THE AVENUE

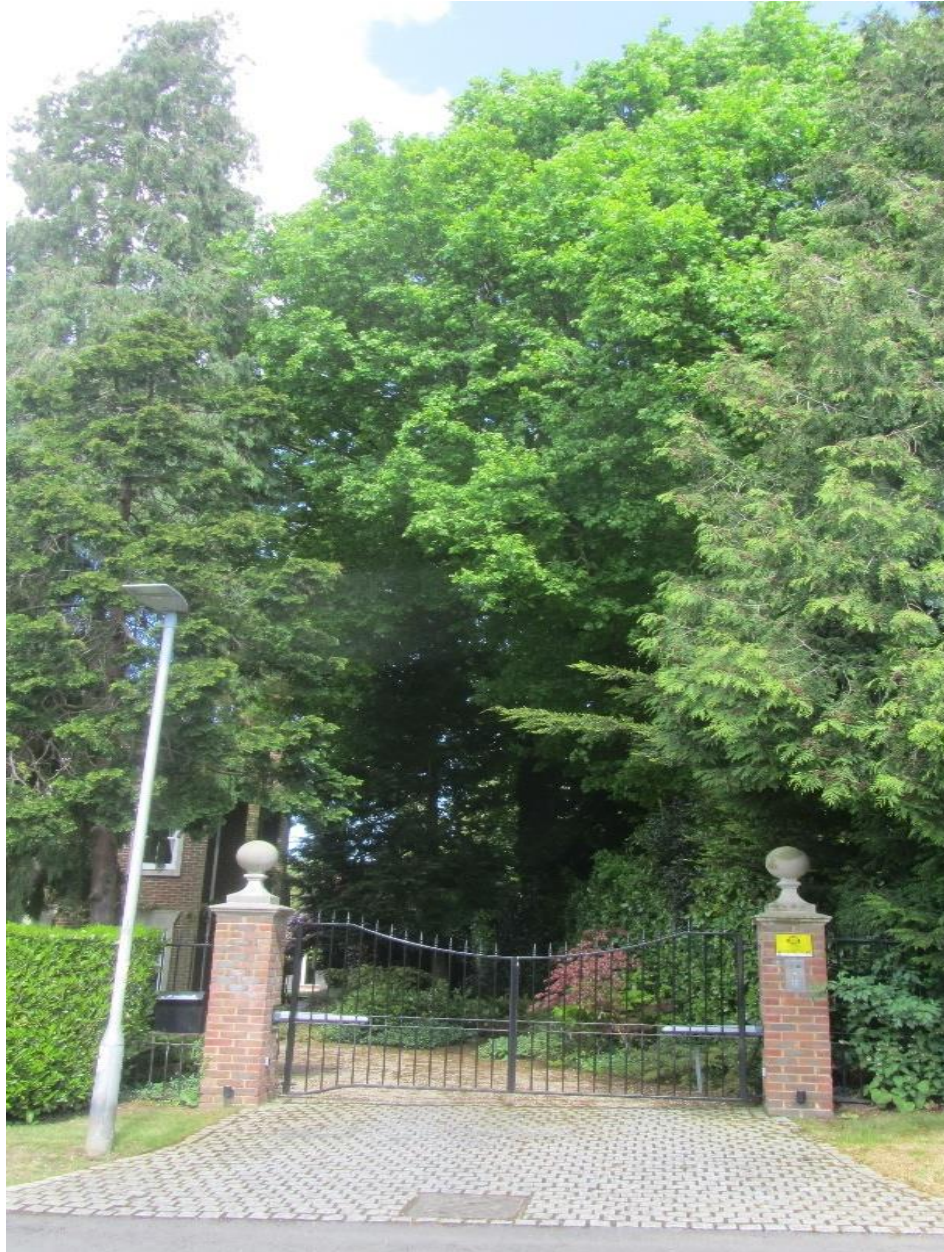
Comment:	Tree 13 has recovered well from its most recent and quite significant crown reduction. It is now 23.8 m high with a significant spread in all four cardinal compass directions, particularly so to the north and west which means that it has encroached significantly into the curtilage of No. 30. The compass orientation is such that it casts significant shade over the southern elevation and garden/driveway of No. 30. Ambient light is largely excluded from areas below the tree within the garden of No. 28.

PHOTOGRAPH NO. 4 – T13 & T14 SHOWING CROWNS GROWING OVER THE DRIVEWAY AND DWELLING HOUSE OF NO. 30 THE AVENUE

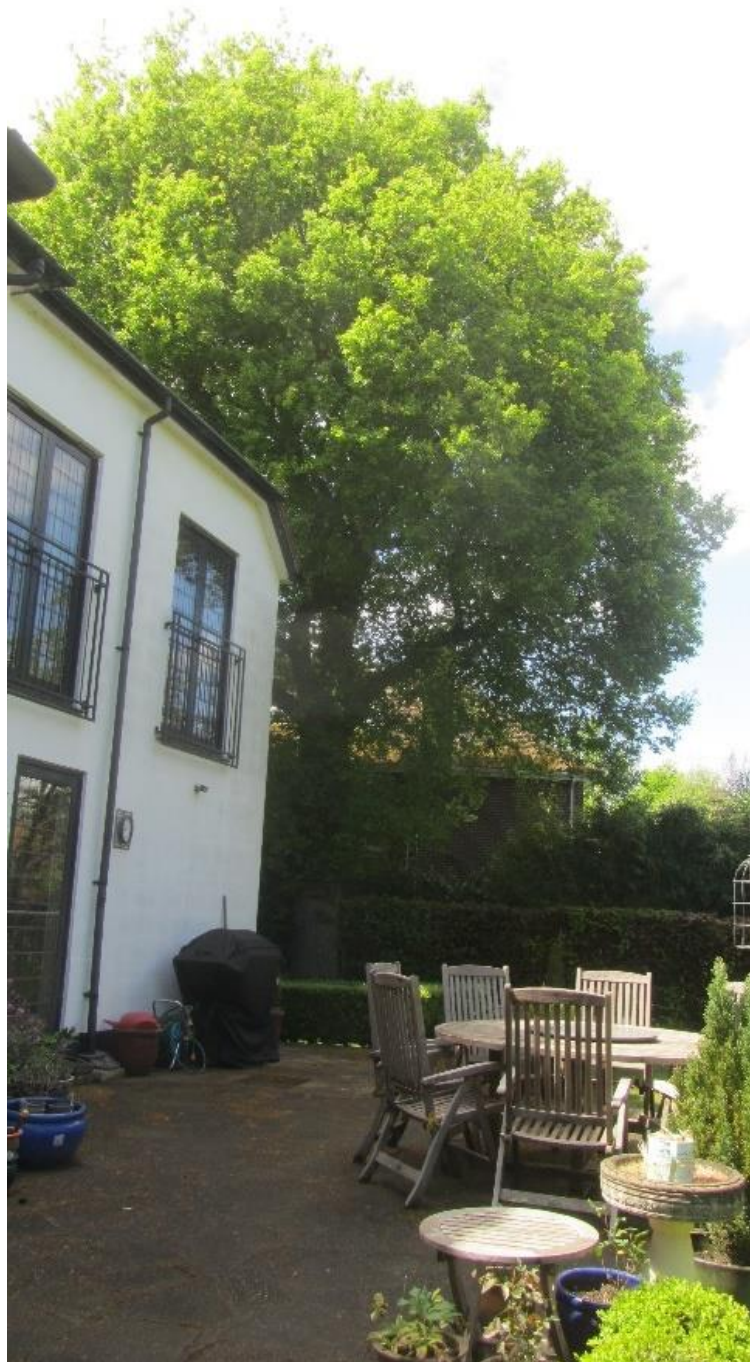
Comment:	This second oak has also been significantly reduced in height and spread though not to the same extent as T13. Lower lateral branches were once truncated at about 5-6 m from the tree trunk, higher lateral branches have been cut back a little less, presumably to retain a basic structural form. As with the former oak, shading of the southern elevation of the neighbouring property and encroachment into its curtilage is significant. Some mid-level lateral branches are in direct contact with the westernmost chimney.

PHOTOGRAPH NO. 5 – EASTERN SIDE OF THE TREE CROWN OF T14

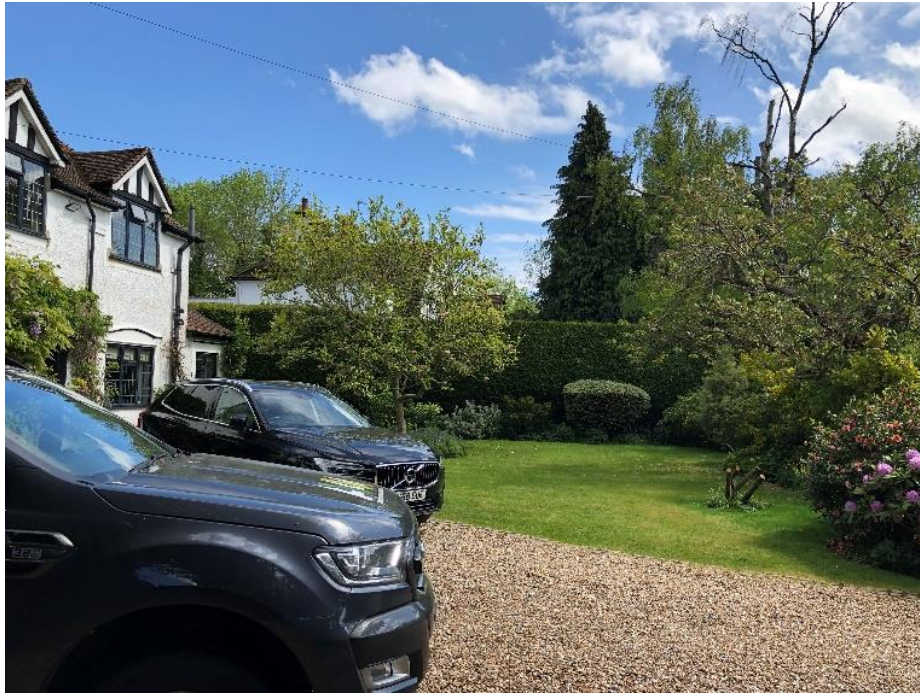
PHOTOGRAPH NO. 6 – T12 – MAGNOLIA VIEWED FROM THE NORTHWEST

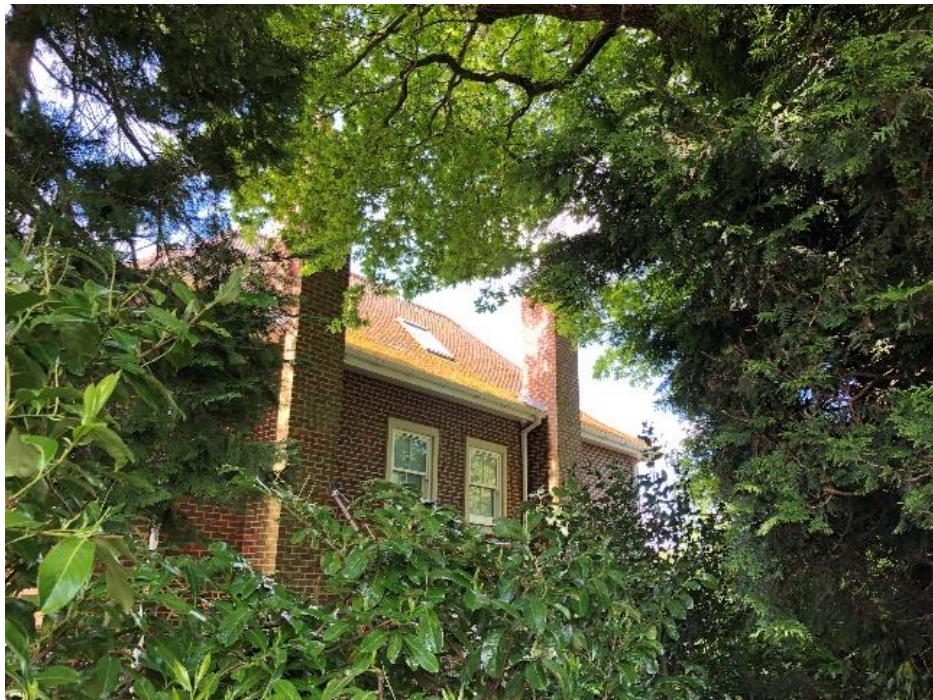
PHOTOGRAPH NO. 7 – LATERAL BRANCHES OF T13 & T14 ENCROACHING INTO THE CURTILAGE OF NO. 30 THE AVENUE

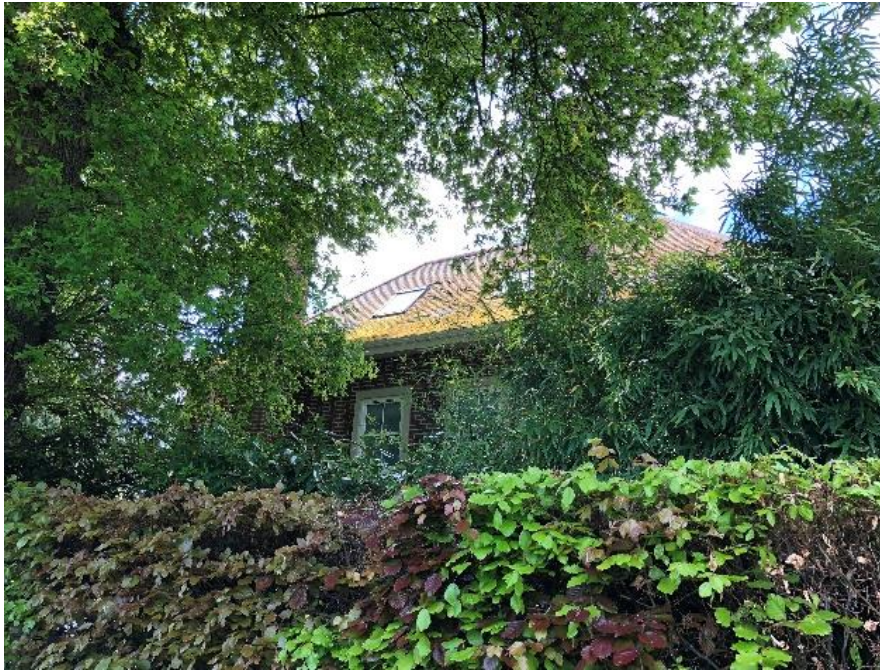
PHOTOGRAPH NO. 8 – LATERAL BRANCHES OF T13 & T14 ENCROACHING INTO THE CURTILAGE OF NO. 30 THE AVENUE

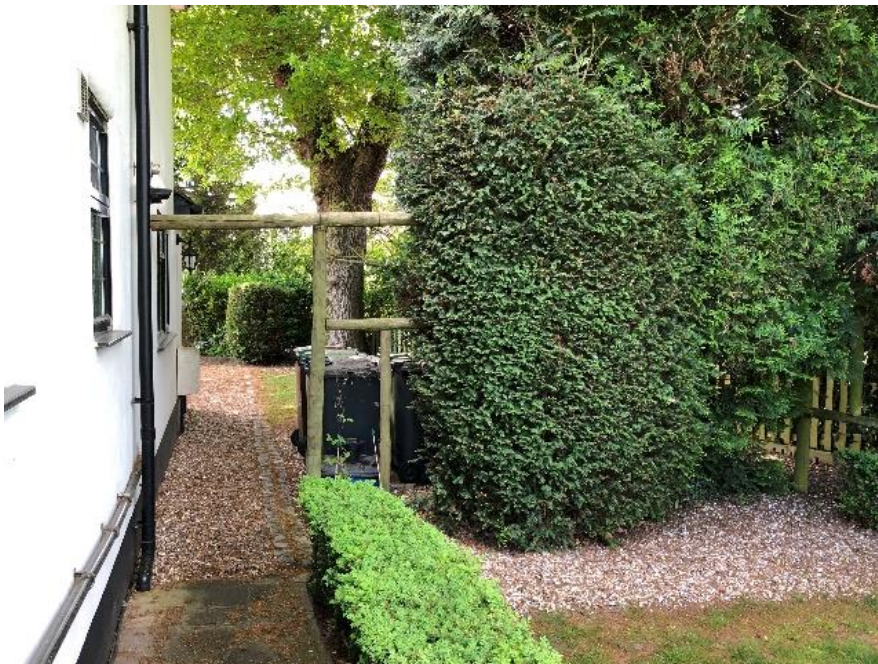
PHOTOGRAPH NO.9 – SHADED GARDEN AREA WITHIN THE CURTILAGE OF NO. 28 THE AVENUE

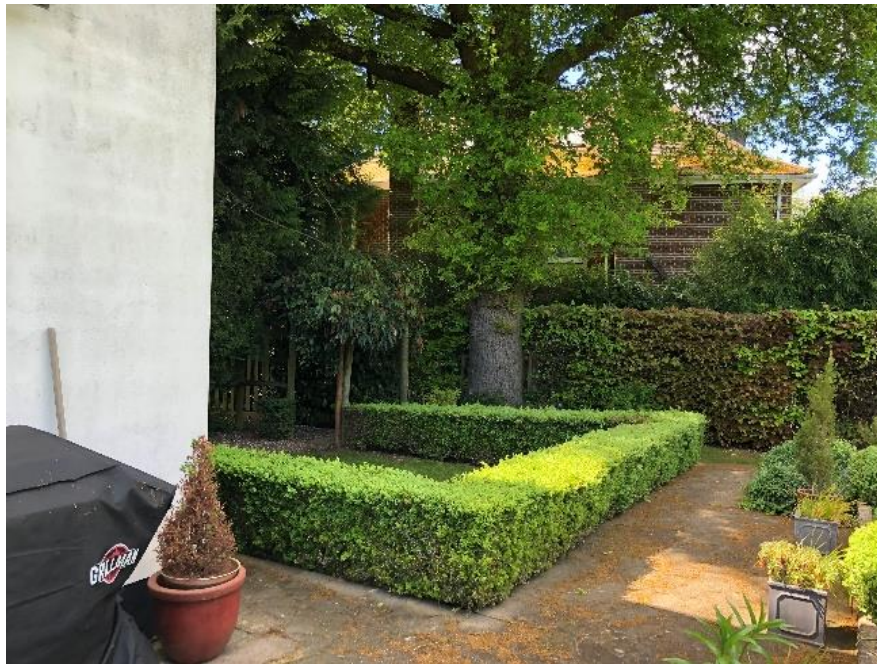
PHOTOGRAPH NO.10 – SHADED GARDEN AREA WITHIN THE CURTILAGE OF NO. 28 THE AVENUE

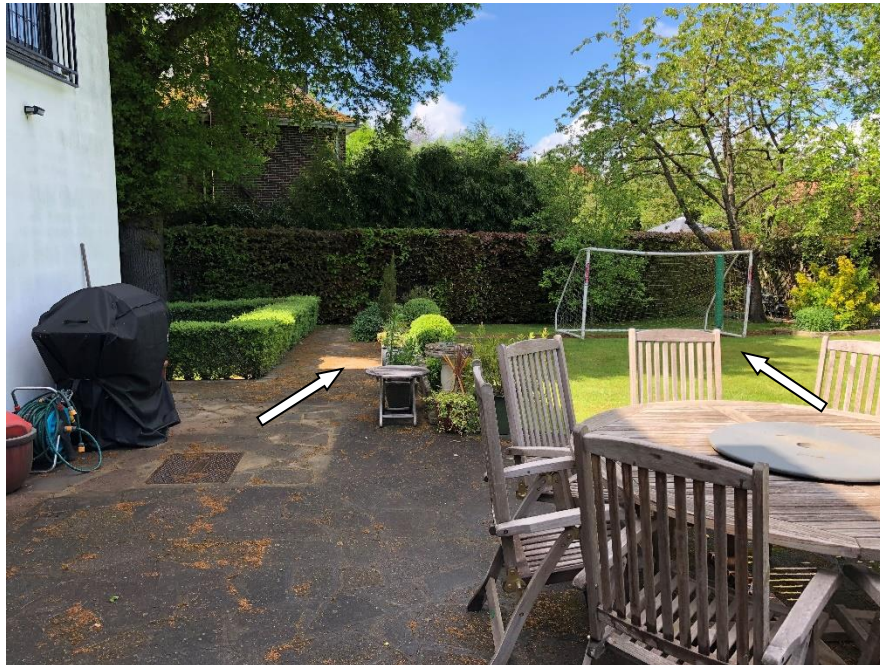
PHOTOGRAPH NO.11 – SHADE CAST BY T14 OVER NORTHEASTERN GARDEN AREA OF NO. 28 THE AVENUE (ARROWED)
