Project number:  
12392

Date:  
18/06/2018

**UNDERGROUND  
SURVEYS LTD**

**Client:** **Aram Mohammed**  
**Contact Name:**  
**Department:**  
**Road:** **206 Toll End Road**  
**Town:** **Tipton DY4 0HF**  
**County:**  
**Telephone:**  
**Fax:**  
**Mobile:**  
**E-mail:**

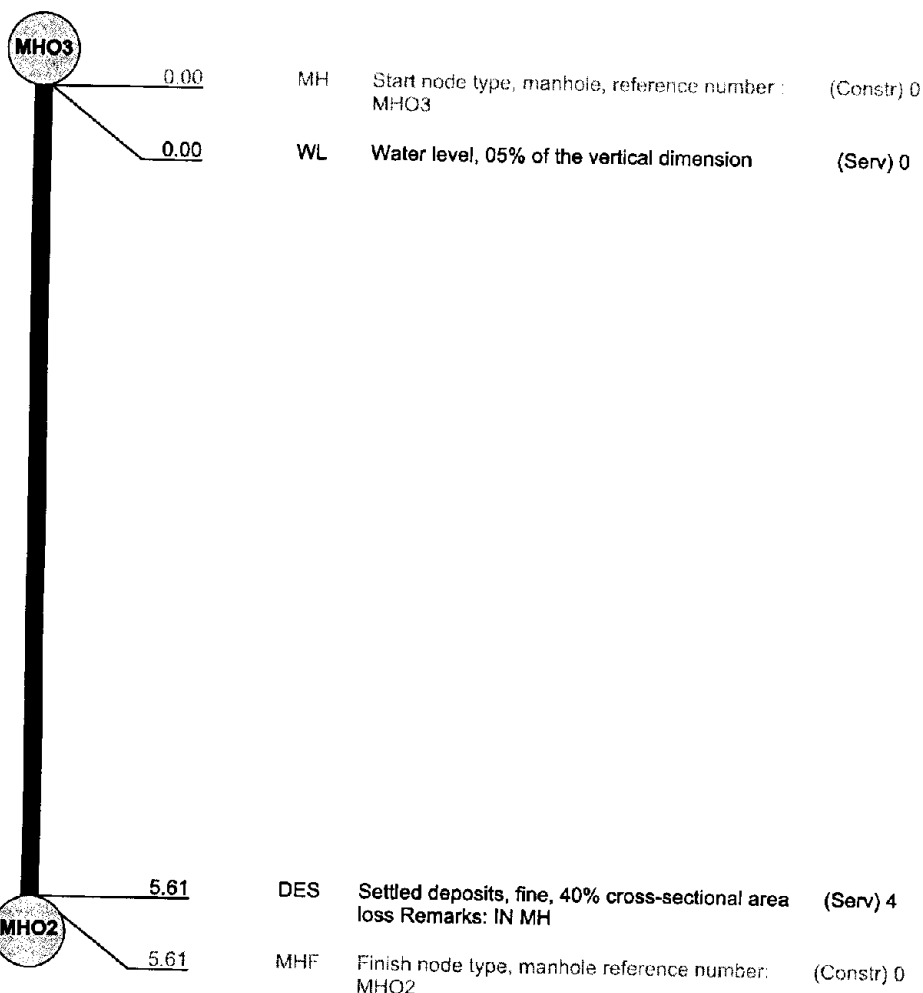
## Inspection report

Place :	TIPTON	Location details:	U/S MH :	MHO2
Road :	TOL END ROAD	Catchment:	U/S Depth :	
Location	Property with buildings	Pipe Shape :	D/S MH :	MHO3
Inspection	MHO3 (U/S) MHO2	Pipe Length	D/S Depth :	
Use:	Surface water	Pipe Width :		
Year laid :	z	Pipe Diameter :	150 mm	
Purpose :	Other (state in remarks)	Pipe material :	Vitrified clay	
Total length :	5.61 m	Lining :		
Comment :	BULDOVER PRE SURVEY

STR no def	STR peak	STR mean	STR total	STR grade	SER no def	SER peak	SER mean	SER total	SER grade
0	0	0	0	1	1	5	0.89	5	4

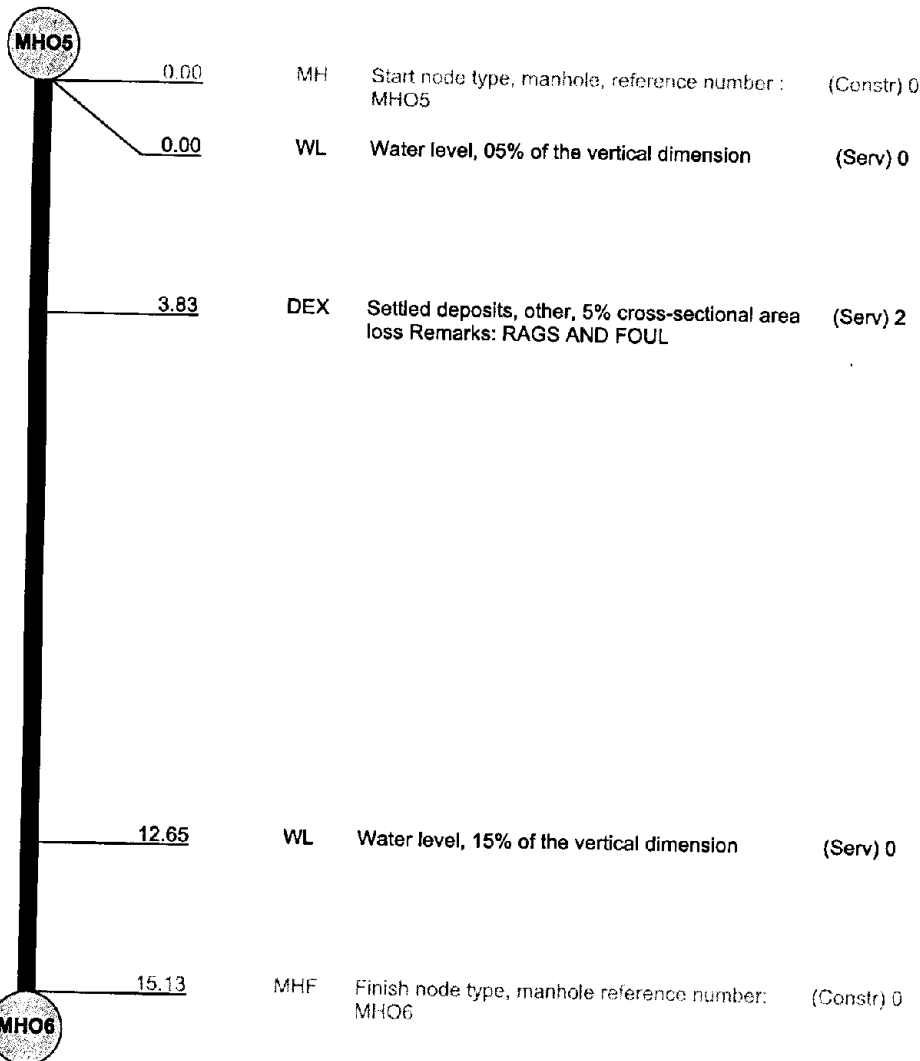
## Inspection report

Comment :	BUILD OVER PRE SURVEY
-----------	-----------------------

Structural Defects					Constructional Features				
Service Defects					Miscellaneous Features				
STR no def	STR peak	STR mean	STR total	STR grade	SER no def	SER peak	SER mean	SER total	SER grade
0	0	0	0	1	1	1	0.07	1	2

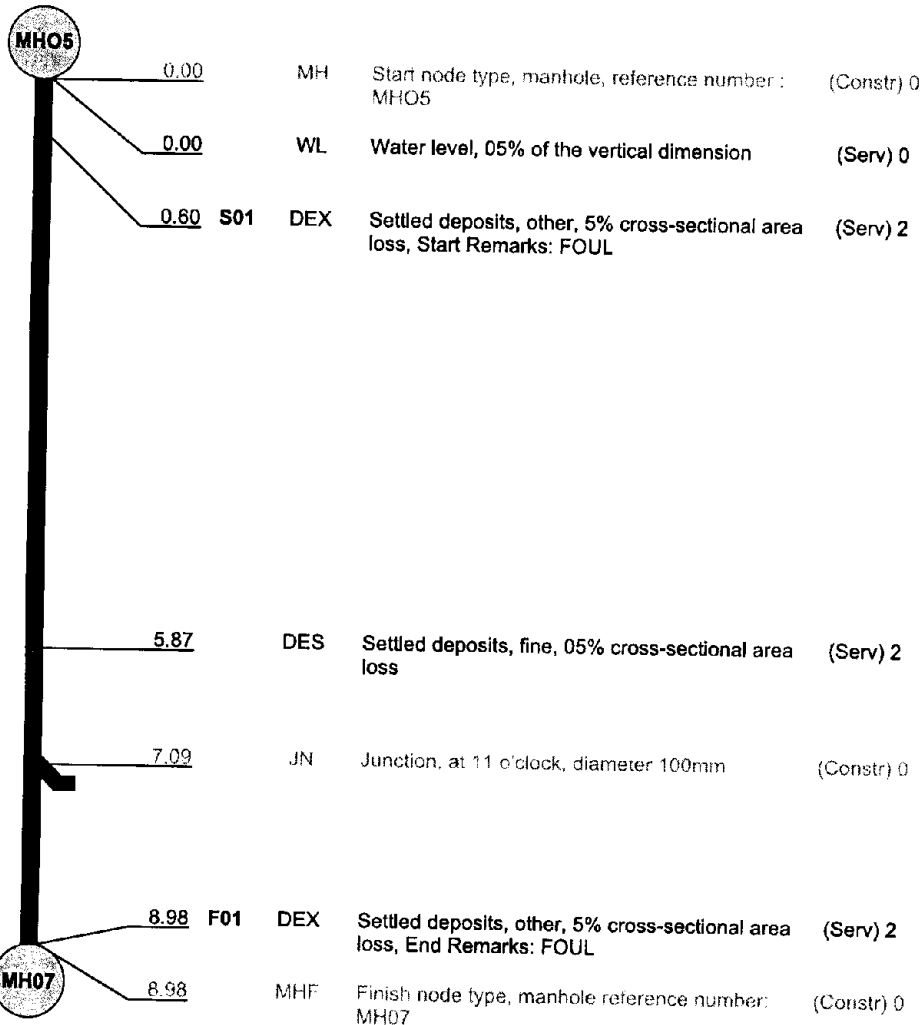
## Inspection report

Comment :	BUILD OVER PRE SURVEY
-----------	-----------------------

Structural Defects					Constructional Features				
Service Defects					Miscellaneous Features				
STR no def	STR peak	STR mean	STR total	STR grade	SER no def	SER peak	SER mean	SER total	SER grade
0	0	0	0	1	2	2	1.04	9.3	3
