# Inspection Report

Property address	8 Drummond Place
Membership No	412 785
Date of inspection	22/02/2022
Date of report	22/02/2022
Report prepared by	T Simmons

### 6.1 ROF1 Main roof

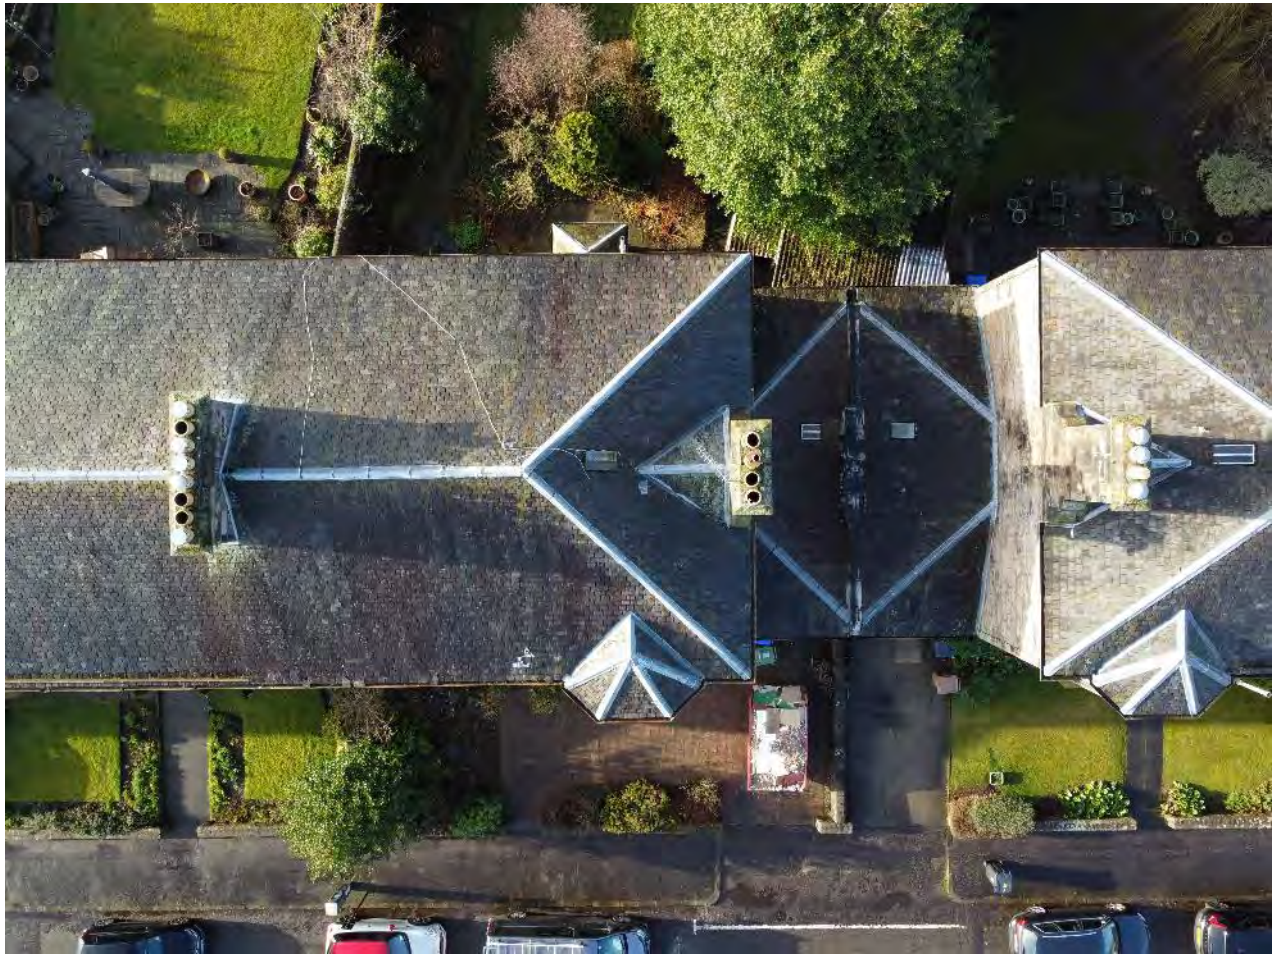
Ref	Element	Condition, defects present & recommended repair priority
6.1.1	<b>ROF 1 Pitched Surface</b>	<p>The pitched surfaces of the roof (ROF1 R1 – R5) are covered in Scot’s slate laid in diminishing courses.</p> <p><b>The condition of the Pitched Surfaces appears to be poor and these components are likely to require repair.</b></p> <ul style="list-style-type: none"> <li>• Slates have cracked and sections of slate are loose or have fallen away. Cracked slates reduce cover and can make the roof vulnerable to water ingress. IMG: 3, 6, 7, 13, 17</li> <li>• A number of slates upon the roof have fallen or slipped indicating that nail sickness may be an issue. Nail sickness or failure of the slate fixings can reduce cover and lead to water ingress. Falling slates also present a hazard to building users. IMG: 3, 6, 7, 13, 18</li> </ul> <p><i>Recommended Action</i>  <i>Replace cracked slates with units to match existing type and style. A comprehensive overhaul of the roof is required including the complete removal, redressing and reaffixing of the slate. Supplement existing slate with units of a matching type.</i></p>

6.1.2	<b>ROF 1 Ridges</b>	<p>The ridges of roof (ROF1) are protected with zinc flashings held down with galvanised fixing straps.</p> <p><b>The condition of the Ridges varies and this component may require some maintenance or repair to avoid further deterioration.</b></p> <ul style="list-style-type: none"> <li>• The galvanised fixing straps holding the zinc ridge have corroded. Corroded fixing straps will ultimately fail resulting in a loose ridge flashing. IMG: 4, 5</li> <li>• Sections of ridge have been lifted and are distorted. There is a large gap between the flashing and the roof covering. If ridges are not fitted correctly they may provide insufficient cover and potentially allow water ingress. IMG: 4, 5</li> </ul> <p><i>Recommended Action</i>  <i>Monitor fixing straps, if failure appears likely replace galvanised straps with new replacements ensuring that there is a strong connection between the fixing and the substrate.</i>  <i>Replace distorted sections of ridge with aligned sections of a matching profile.</i></p>	2

6.1.3	<b>ROF 1 Flashings &amp; Watergates</b>	<p>The flashings and watergates between the roof and chimneys are in lead.</p> <p><b>The condition of the Flashings &amp; Watergates varies and these components may require some maintenance or repair to avoid further deterioration.</b></p> <ul style="list-style-type: none"> <li>• The mastic or mortar within the raggles has cracked or failed. Cracked or missing mastic and pointing can leave joints vulnerable to water ingress which may lead to internal dampness and accelerated decay. IMG: 20, 23</li> </ul> <p><i>Recommended Action</i>  <i>Rake out any cracked or failed mastic/pointing and replace with a Polysulphide mastic or lime based mortar for raggles more than 18 mm.</i></p>	2

6.1.4	<b>ROF 1 Valleys</b>	<p>The valleys are formed of profiled zinc.</p> <p><b>The condition of the Valleys varies and these components may require some maintenance or repair to avoid further deterioration.</b></p> <ul style="list-style-type: none"> <li>• The zinc valley is detailed in a way that is likely to allow water ingress. Water ingress can cause internal decay. IMG: 15</li> <li>• There is an accumulation of debris within the valleys. Debris impedes the flow of water and can result in overspill during high rainfall events. IMG: 10</li> </ul> <p><i>Recommended Action</i>  <i>Alter the detailing of the zinc valley to protect against water ingress.</i>  <i>Clear valleys of debris and undertake a regular programme of maintenance ensure they remain clear.</i></p>	2

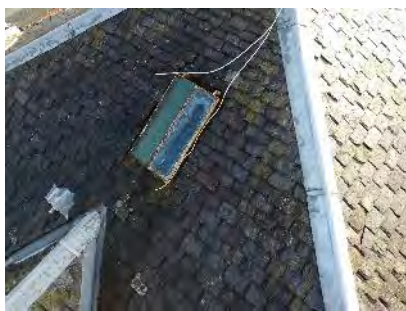
- The surface of the cast Iron has corroded. Corroded cast iron will ultimately fail leading to potential leakage. IMG: 11
- Sections of the glazing putty have cracked and fallen away from the glass. Missing sections of glazing putty may result in water ingress and could leave the glazing poorly supported within the frame which is potentially a serious hazard to building users. IMG: 11
- The glazing within the roof light is cracked. Cracked glazing panes make the roof light vulnerable to water ingress and may result in internal dampness and associated fabric decay. IMG: 11

*Remove rust from the cast iron rooflight and repaint to protect against future corrosion.*

*Remove any loose glazing putty and replace using a traditional glazing putty based on whiting and boiled linseed oil.*

*Remove cracked glazing within the roof light and replace with a piece of glass specified to match the dimensions and manufacturing process of the original. Use a traditional glazing putty based on whiting and boiled linseed oil to hold the glass within the frame.*

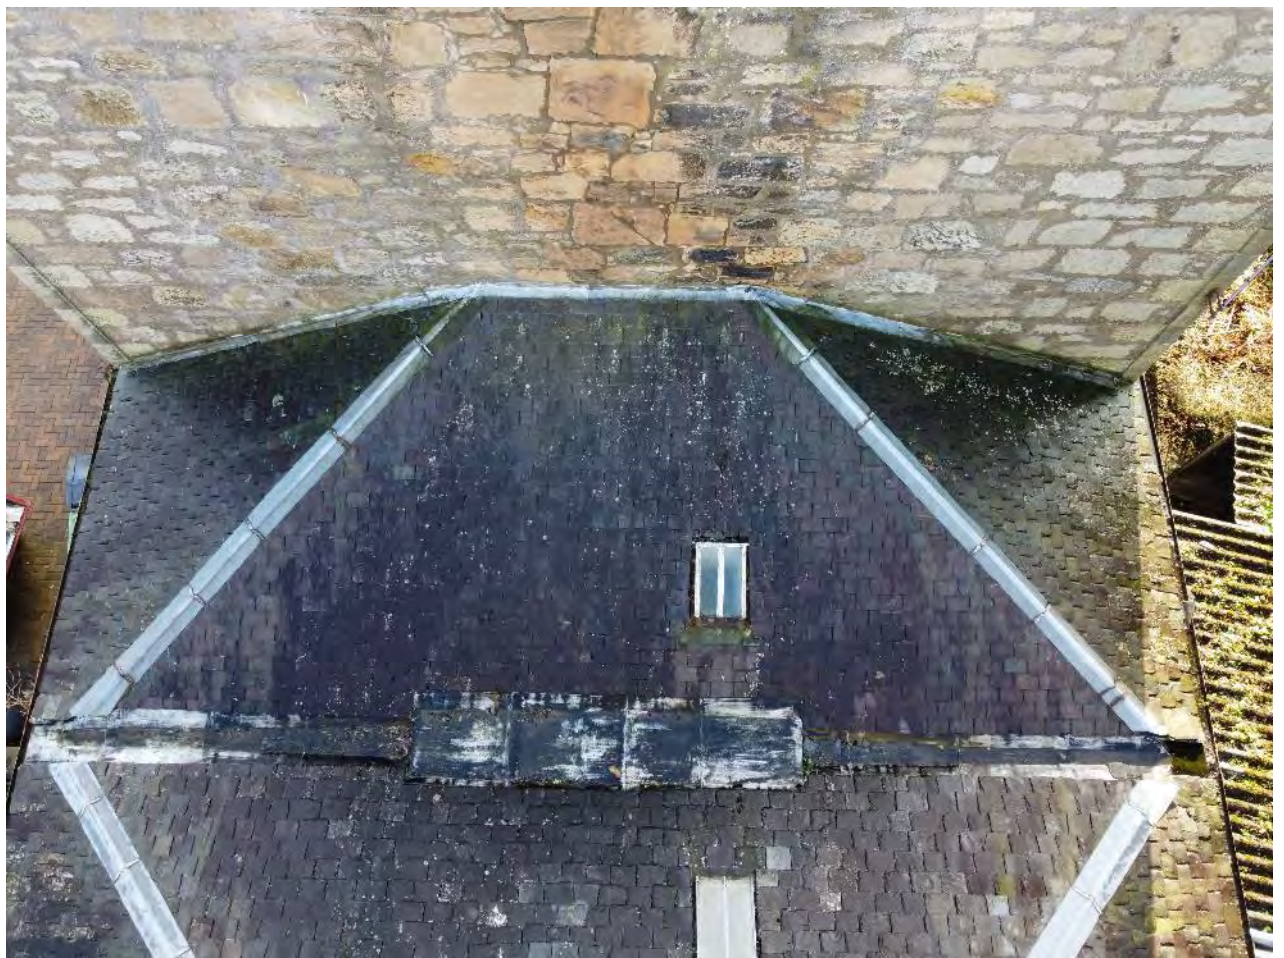
6.2.1	<b>ROF 2 Pitched Surface</b>	<p>The pitched surface is covered in Scot's slate laid in diminishing rows.</p> <p><b>The condition of the Pitched Surfaces appears to be poor and these components are likely to require repair.</b></p> <ul style="list-style-type: none"> <li>• Slates have cracked and sections of slate are loose or have fallen away. Cracked slates reduce cover and can make the roof vulnerable to water ingress. IMG: 36</li> <li>• Slates have been displaced and do not lie flat upon the surface of the roof. Displaced slates reduce cover and can make the roof more vulnerable to water ingress. IMG: 36</li> <li>• Slates have fallen from their positions upon the roof. Missing slates reduce cover and can make the roof vulnerable to water ingress. IMG: 36</li> </ul> <p><i>Recommended Action</i>  <i>Replace cracked slates with units to match existing type and style. Reposition displaced slates and ensure fixings are secure. Replace fixings and/or slates if fixing or fixing hole is not fit for purpose. Replace missing slates with units to match existing type and style.</i></p>	2

6.2.2	<b>ROF 2 Ridges</b>	<p>The ridges of the roof (ROF2) are protected with zinc flashings held down with galvanised fixing straps.</p> <p><b>The condition of the Ridges varies and this component may require some maintenance or repair to avoid further deterioration.</b></p> <ul style="list-style-type: none"> <li>• The galvanised fixing straps holding the zinc ridge have corroded. Corroded fixing straps will ultimately fail resulting in a loose ridge flashing. IMG: 36</li> </ul> <p><i>Recommended Action</i>  <i>Monitor fixing straps, if failure appears likely replace galvanised straps with new replacements ensuring that there is a strong connection between the fixing and the substrate.</i></p>	2

6.2.3	<b>ROF 2 Flashings &amp; Watergates</b>	<p>The flashing between the pitched surfaces (R6 – 8) and wall (FAC2) is in lead.</p> <p><b>The condition of the Flashings &amp; Watergates appears to be poor and these components are likely to require repair.</b></p> <ul style="list-style-type: none"> <li>• The mastic or mortar within the raggles has cracked or failed. Cracked or missing mastic and pointing can leave joints vulnerable to water ingress which may lead to internal dampness and accelerated decay. IMG: 36, 37</li> </ul> <p><i>Recommended Action</i>  <i>Rake out any cracked or failed mastic/pointing and replace with a Polysulphide mastic or lime based mortar for raggles more than 18 mm.</i></p>	2

<p><b>The condition of the Rainwater Drainage varies and this component may require some maintenance or repair to avoid further deterioration.</b></p> <ul style="list-style-type: none"> <li>• The Lead rainwater goods have been repaired with flashing tape. Flashing tape is a temporary repair medium and has a limited lifespan, failure of the repair could mean leakage and associated decay. IMG: 37, 39</li> <li>• There is a build up of sludge and debris within the gutter. Sludge and debris restricts flow and can lead to overspill during high rainfall events. IMG: 37, 39</li> </ul> <p><i>Recommended Action</i>  Remove flashing tape and replace the damaged section of lead in a code and profile dressed to meet Lead Sheet Training Academy Spec.  Clear the gutter of debris and undertake a regular programme of yearly maintenance to ensure they remain clear.</p>

6.2.5	<b>ROF 2 Roof Lights</b>	<p>The roof light (RL2) is an original cast iron unit.</p> <p><b>The condition of the Roof Light varies and this component may require some maintenance or repair to avoid further deterioration.</b></p> <ul style="list-style-type: none"> <li>• The surface of the cast Iron has corroded. Corroded cast iron will ultimately fail leading to potential leakage. IMG: 36</li> <li>• The roof light has been repaired with flashing tape. Flashing tape is a temporary repair medium and has a limited lifespan, failure of the repair could mean leakage and associated decay. IMG: 36</li> </ul> <p><i>Recommended Action</i>  Remove rust from the cast iron rooflight and repaint to protect against future corrosion.  remove the flashing tape and make good the underlying condition of the roof light.</p>	2

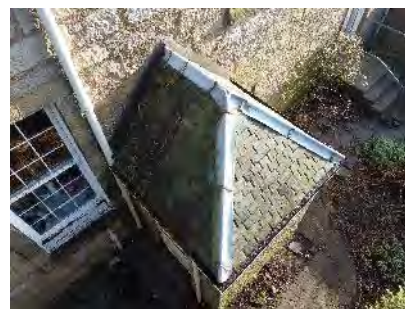
43

Ref	Element	Condition, defects present & recommended repair priority
6.3.1	<b>ROF 3 Pitched Surface</b>	<p>The pitched surfaces (ROF3) are covered in Scot's slate.</p> <p><b>The condition of the Pitched Surfaces appears to be good and these components only requires monitoring for future maintenance requirements.</b></p> <ul style="list-style-type: none"> <li>The slated covering upon the pitched roof is in good condition. No repair is required. IMG: 43, 44</li> </ul>

<p><i>Recommended Action</i>  <i>Monitor the pitched roof for any future maintenance requirements.</i></p>	
6.3.2	<b>ROF 3 Ridges</b>	<p>The ridges of roof (ROF3) are protected with zinc flashings held down with galvanised fixing straps.</p> <p><b>The condition of the Ridges varies and these components may require some maintenance or repair to avoid further deterioration.</b></p> <ul style="list-style-type: none"> <li>The galvanised fixing straps holding the zinc ridge have corroded. Corroded fixing straps will ultimately fail resulting in a loose ridge flashing. IMG: 42</li> </ul> <p><i>Recommended Action</i>  <i>Monitor fixing straps, if failure appears likely replace galvanised straps with new replacements ensuring that there is a strong connection between the fixing and the substrate.</i></p>	2

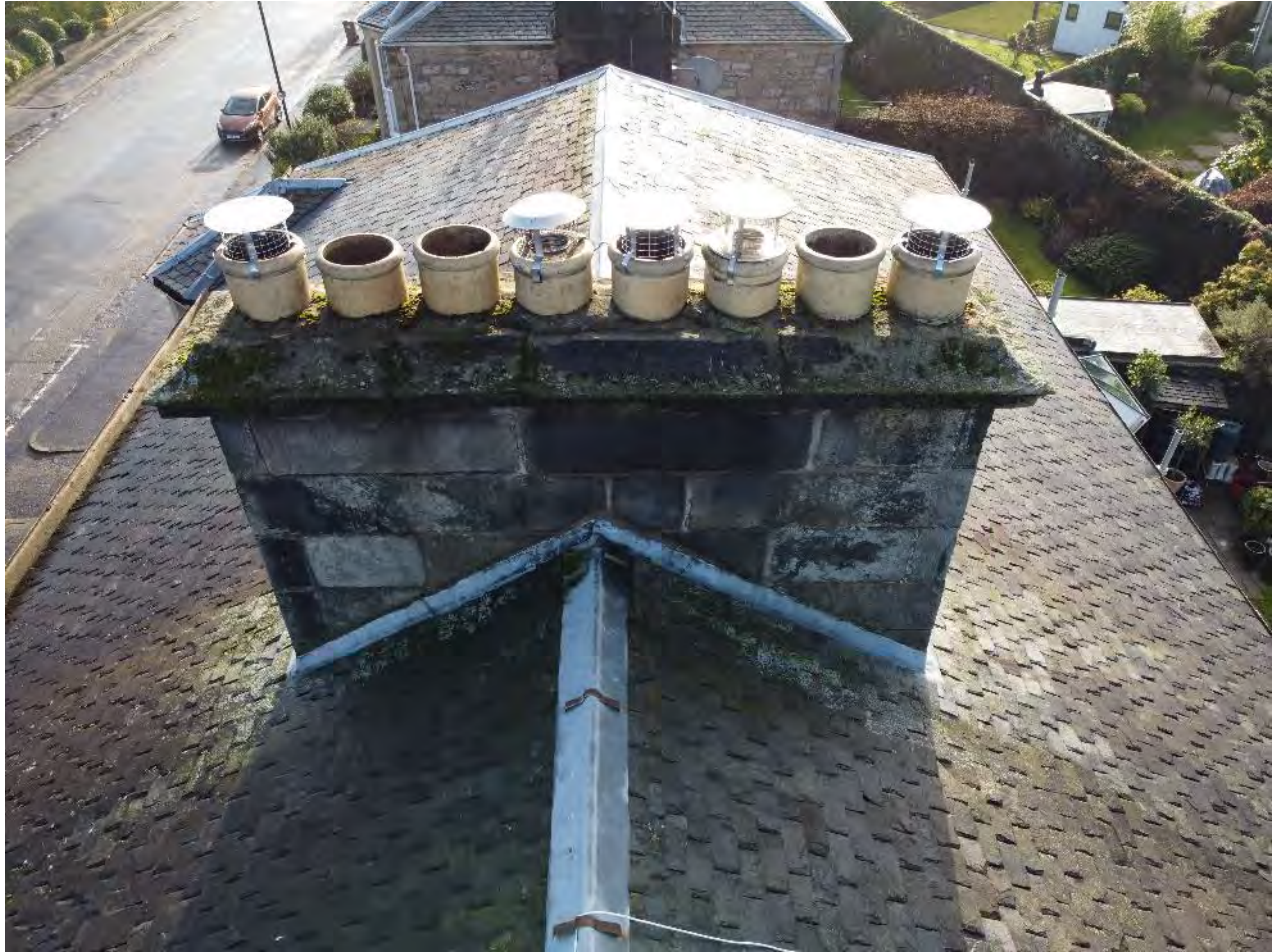
Ref	Element	Condition, defects present & recommended repair priority	
6.4.1	<b>CHM 1 Chimney Pots</b>	<p>The Chimney (CHM1) has 8 flues all of which are topped with a chimney pots. 5 of the flues are protected with a metal cowl.</p> <p><b>The condition of the Chimney Pots varies and these components may require some maintenance or repair to avoid further deterioration.</b></p> <ul style="list-style-type: none"> <li>• Lack of cowl or cap upon chimney pot or flues. Uncapped pots and flues may result in bird infestation and/or water ingress which can cause internal decay of the stack. IMG: 25</li> <li>• The mortar haunch around the base of the chimney pots has cracked. A cracked haunch can make the cope and flue vulnerable to water ingress and may result in a loose pot upon the cope. IMG: 24, 25</li> </ul> <p><i>Recommended Action</i>                      Fit a cap or cowl to the top of the chimney pot.                      Remove the cracked mortar haunch and replace with a lime mortar, use of a modified lime may provide better performance above the level of the cope.</p>	2

6.4.2	<b>CHM 1 Chimney Stack</b>	<p>The chimney stack (CHM1) is constructed of ashlar sandstone units with a moulded protruding cope.</p>	2

<p><b>The condition of the Chimney Stack varies and this component may require some maintenance or repair to avoid further deterioration.</b></p> <ul style="list-style-type: none"> <li>• Vegetation is growing upon the masonry of the chimney stack. Vegetation retains moisture which can accelerate decay. IMG: 23</li> <li>• Joints appear to have been repointed in an impermeable mortar. Impermeable pointing limits vapour transfer and can cause accelerated decay in adjacent masonry units. IMG: 23</li> <li>• The mortar within the joint has cracked and there are gaps between the pointing. Cracked mortar can make joints vulnerable to water ingress potentially leading to internal dampness and accelerated decay. IMG: 20</li> </ul> <p><i>Recommended Action</i>  Remove vegetation and treat with an appropriate herbicide to avoid future regrowth.  Monitor adjacent units for evidence of decay, if stone decay is occurring rake out impermeable mortar and repoint using a lime mortar.  Rake out cracked pointing from between masonry units within chimney stack and repoint using a lime mortar.</p>

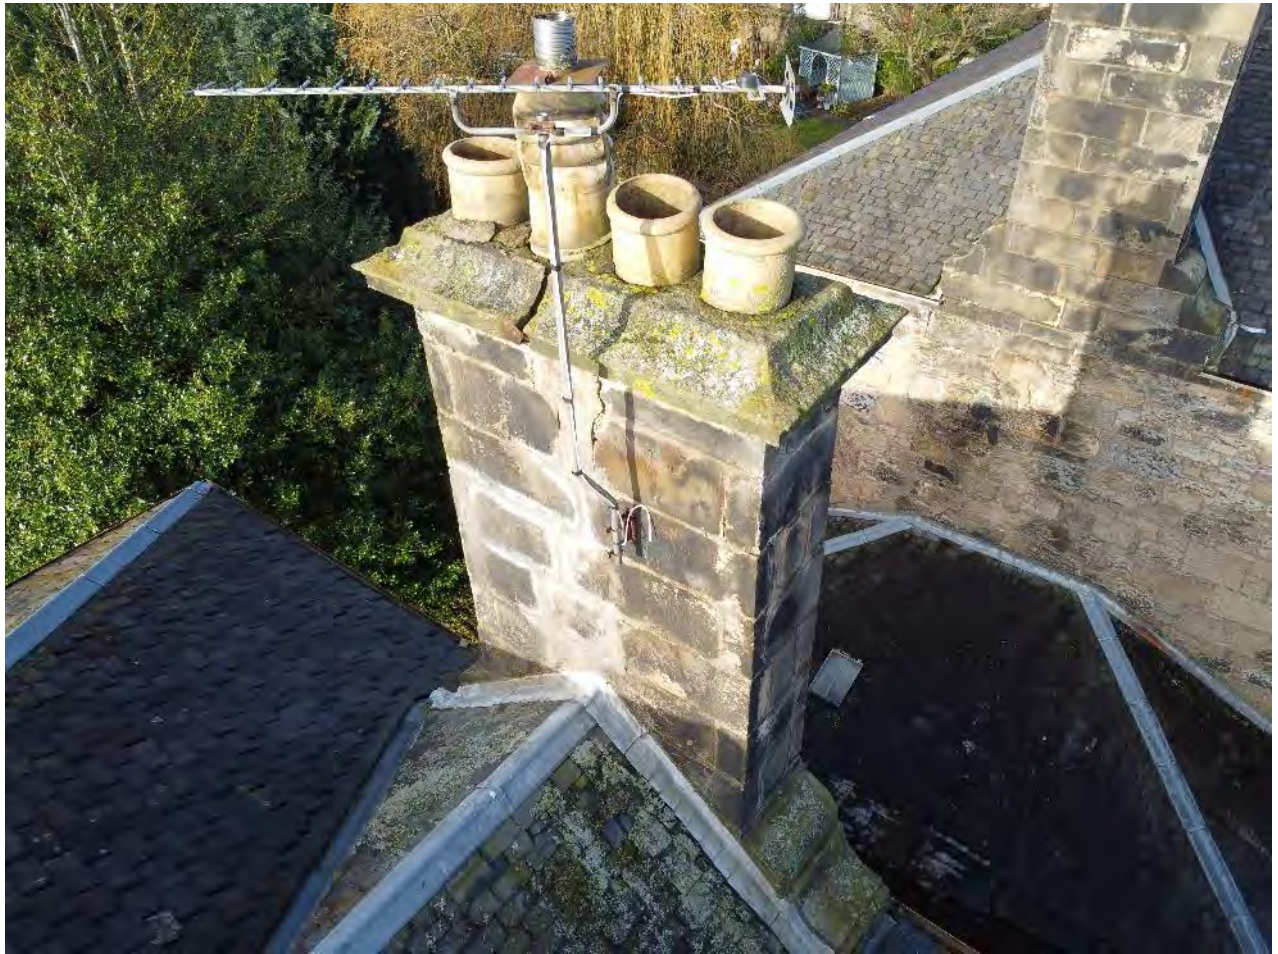
Ref	Element	Condition, defects present & recommended repair priority	
6.5.1	<b>CHM 2 Chimney Pots</b>	<p>The Chimney (CHM2) has 4 flues all of which are topped with a chimney pot. 1 of the flues is protected with a metal cowl.</p> <p><b>The condition of the Chimney Pots varies and these components may require some maintenance or repair to avoid further deterioration.</b></p> <ul style="list-style-type: none"> <li>• Lack of cowl or cap upon chimney pot or flue. Uncapped pots and flues may result in bird infestation and/or water ingress which can cause internal decay of the stack. IMG: 26</li> <li>• The mortar haunch around the base of the chimney pots has cracked. A cracked haunch can make the cope and flue vulnerable to water ingress and may result in a loose pot upon the cope. IMG: 26, 34</li> </ul> <p><i>Recommended Action</i>  <i>Fit a cap or cowl to the top of the chimney pot.</i>  <i>Remove the cracked mortar haunch and replace with a lime mortar, use of a modified lime may provide better performance above the level of the cope.</i></p>	2

6.5.2	<b>CHM 2 Chimney Stack</b>	<p>The chimney stack (CHM2) is constructed of ashlar sandstone units with a moulded protruding cope.</p>	2

<p><b>The condition of the Chimney Stack appears to be poor and this component is likely to require repair.</b></p> <ul style="list-style-type: none"> <li>• The mortar has failed and sections of the pointing are missing resulting in open joints. Open joints are vulnerable to water ingress which can lead to saturation of the masonry and accelerated decay. IMG: 26, 35</li> <li>• An aerial, satellite or other fixture has been attached to the chimney stack. Fixtures mounted upon the stack are subject to wind loading, vibrations from which can cause displacement and cracking of masonry. IMG: 27</li> <li>• Masonry units within the stack are misaligned and have shifted significantly from their original position indicating historic or progressive movement. Movement within a chimney stack can result from internal deterioration and may indicate structural instability. Progressive movement may result in deterioration that is a serious hazard to building users. IMG: 34, 133</li> <li>• Joints appear to have been repointed in an impermeable mortar. Impermeable pointing limits vapour transfer and can cause accelerated decay in adjacent masonry units. IMG: 35</li> </ul> <p><i>Recommended Action</i>  <i>Rake out and clean open joints. Repoint using a lime mortar that has been well packed into the joint.</i>  <i>Remove the fixture from the stack and make good any damage from the fixings using a lime mortar.</i>  <i>Seek advice on the appropriate method to stabilise the movement of the stack from a structural engineer with conservation experience.</i>  <i>Monitor adjacent units for evidence of decay, if stone decay is occurring rake out impermeable mortar and repoint using a lime mortar.</i></p>

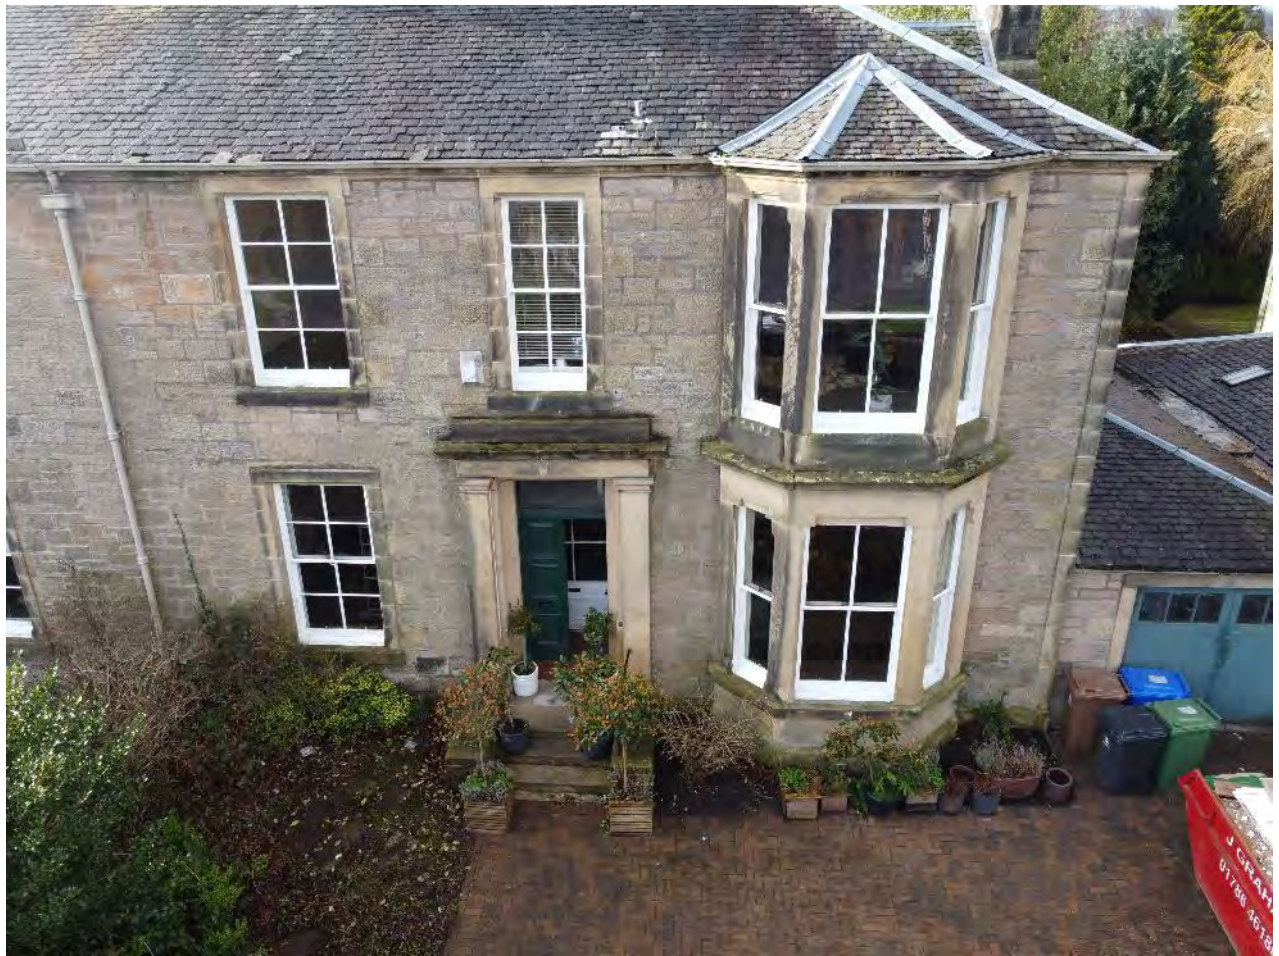
Ref	Element	Condition, defects present & recommended repair priority	
6.6.1	<b>FAC 1 Doors</b>	<p>The front door and garage doors appear to be the original timber units.</p> <p><b>The condition of the Doors appears to be good and these components only requires monitoring for future maintenance requirements.</b></p> <ul style="list-style-type: none"> <li>The Doors are in good condition. No repair is required. IMG: 91, 126</li> </ul> <p><i>Recommended Action</i> <i>Monitor the doors for any future maintenance requirements.</i></p>	3

6.6.2	<b>FAC 1 Rainwater Drainage</b>	<p>The roofs (R172) drain to an ogee profile cast iron gutter. The roof (R8) drains to a half round cast-iron gutter. all gutters drain to cast iron downpipes (RWP1 &amp; RWP2) respectively.</p> <p><b>The condition of the Rainwater Drainage varies and these components may require some maintenance or repair to avoid further deterioration.</b></p> <ul style="list-style-type: none"> <li>The interior of the gutter has corroded. Corroded cast iron will ultimately fail leading to leakage from the gutter. IMG: 73, 74</li> <li>There is a build-up of sludge and debris within the gutter. Sludge and debris restricts flow and can lead to overspill during high rainfall events. IMG: 73, 74, 69</li> </ul>	2

<ul style="list-style-type: none"> <li>Vegetation is growing from the gutter. Vegetation can block gutters and the root structure can cause displacement potentially leading to overspill and leakage. IMG: 68, 69</li> </ul> <p><i>Recommended Action</i>  Remove rust from the interior of the gutter and repaint to protect against future corrosion.  Clear the gutter of debris and undertake a regular programme of yearly maintenance to ensure they remain clear.  Remove vegetation from the gutter and undertake a regular programme of yearly maintenance to ensure they remain clear.</p>

6.6.3	<b>FAC 1 Wall</b>	<p>The wall (FAC1) is constructed of squared blonde rubble sandstone with a tooled surface finish laid in rough courses. The façade includes a double height bay window and pilastered portico over door. Window and door surrounds are finished with raised ashlar margins.</p> <p><b>The condition of the Wall varies and this component may require some maintenance or repair to avoid further deterioration.</b></p> <ul style="list-style-type: none"> <li>The mortar has failed and sections of the pointing are missing resulting in open joints. Open joints are vulnerable to water ingress which can lead to saturation of the masonry and accelerated decay. IMG: 75, 81, 83</li> <li>Vegetation is growing upon the masonry of the wall. Vegetation retains moisture which can accelerate decay. IMG: 83</li> <li>Joints appear to have been repointed in an impermeable mortar. Impermeable pointing limits vapour transfer and can cause accelerated decay in adjacent masonry units. IMG: 68</li> </ul> <p><i>Recommended Action</i>  Rake out and clean open joints. Repoint using a lime mortar that has been well packed into the joint.  Remove vegetation from stone and treat with an appropriate herbicide to avoid future regrowth.  Monitor units adjacent to impermeable pointing for evidence of decay, if stone decay is occurring rake out impermeable mortar and repoint using a lime mortar.</p>	2

6.6.4	<b>FAC 1 Windows</b>	<p>The windows appear to be the original timber sash and case units in two over two and four over four configurations.</p> <p><b>The condition of the Windows varies and these components may require some maintenance or repair to avoid further deterioration.</b></p> <ul style="list-style-type: none"> <li>Paintwork upon the window frame has cracked. Cracked paint is vulnerable to water ingress and traps moisture beside timber creating an ideal environment for the outbreak of rot. IMG: 85</li> <li>The sash cords have become detached from the weights within the casement. The sash is not counterweighted by the sash weights and is unlikely to hold its position within the casement when raised. IMG: 111</li> </ul> <p><i>Recommended Action</i>  Remove areas of cracked paint to provide a sound substrate. Repaint to</p>	2

<i>protect against future water ingress using a linseed based paint system. Replace Sash cord with a rope that is rated to carry sufficient weight to counteract the sash unit.</i>

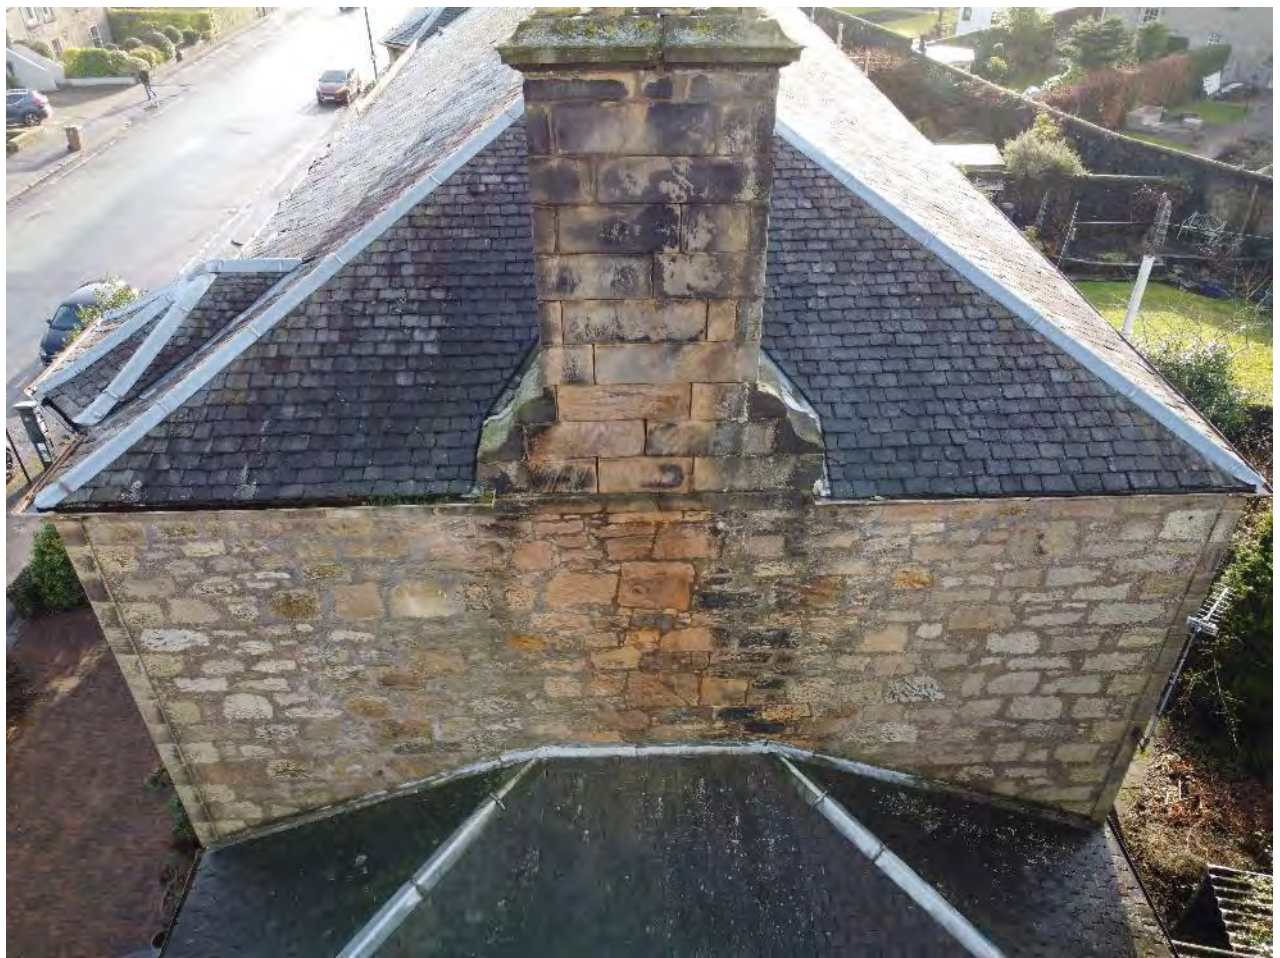
Ref	Element	Condition, defects present & recommended repair priority	
6.7.1	<b>FAC 2 Rainwater Drainage</b>	<p>The roof (R4) drains to a ogee profile cast iron gutter to north of chimney (CHM2) and a half round cast iron gutter to south. Both gutters flow to downpipes that drain from facades FAC1 &amp; FAC2 respectively.</p> <p><b>The condition of the Rainwater Drainage varies and these components may require some maintenance or repair to avoid further deterioration.</b></p> <ul style="list-style-type: none"> <li>The interior of the gutter has corroded. Corroded cast iron will ultimately fail leading to leakage from the gutter. IMG: 72</li> </ul>	2

<ul style="list-style-type: none"> <li>• There is a build up of sludge and debris within the gutter. Sludge and debris restricts flow and can lead to overspill during high rainfall events. IMG: 72</li> <li>• Vegetation is growing from the gutter. Vegetation can block gutters and the root structure can cause displacement potentially leading to overspill and leakage. IMG: 72</li> </ul> <p><i>Recommended Action</i>  Remove rust from the interior of the gutter and repaint to protect against future corrosion.  Clear the gutter of debris and undertake a regular programme of yearly maintenance to ensure they remain clear.  Remove vegetation from the gutter and undertake a regular programme of yearly maintenance to ensure they remain clear.</p>

6.7.2	<b>FAC 2 Wall</b>	<p>The wall is constructed of squared rubble laid in rough courses.</p> <p><b>The condition of the Wall varies and this component may require some maintenance or repair to avoid further deterioration.</b></p> <ul style="list-style-type: none"> <li>• The surface of the stone is friable and has decayed. Friable stone is highly absorbent and can drive further cycles of accelerated decay. Decaying stone can leave ledges at joints which are vulnerable to water ingress. IMG: 66</li> <li>• Joints appear to have been repointed in an impermeable mortar. Impermeable pointing limits vapour transfer and can cause accelerated decay in adjacent masonry units. IMG: 66</li> <li>• The mortar within the joints has cracked and there are gaps between the pointing. Cracked mortar can make joints vulnerable to water ingress potentially leading to internal dampness and accelerated decay. IMG: 66</li> <li>• An aerial, satellite or other fixture has been attached to the wall. Fixtures mounted upon the wall are subject to wind loading, vibrations from which can cause displacement and cracking of masonry. IMG: 63</li> </ul> <p><i>Recommended Action</i>  Monitor friable stone rate of decay and if/when masonry unit is compromised making building vulnerable to water ingress undertake an indent repair or full replacement of the unit. Ensure the replacement is well bedded in a lime mortar and that all cavities are well filled, use of a lime grout may be required.  Monitor units adjacent to impermeable pointing for evidence of decay, if stone decay is occurring rake out impermeable mortar and repoint using a lime mortar.  Rake out cracked pointing from between masonry units in wall and repoint using a lime mortar.  Remove the fixture from the wall and make good any damage from the fixings using a lime mortar.</p>	2

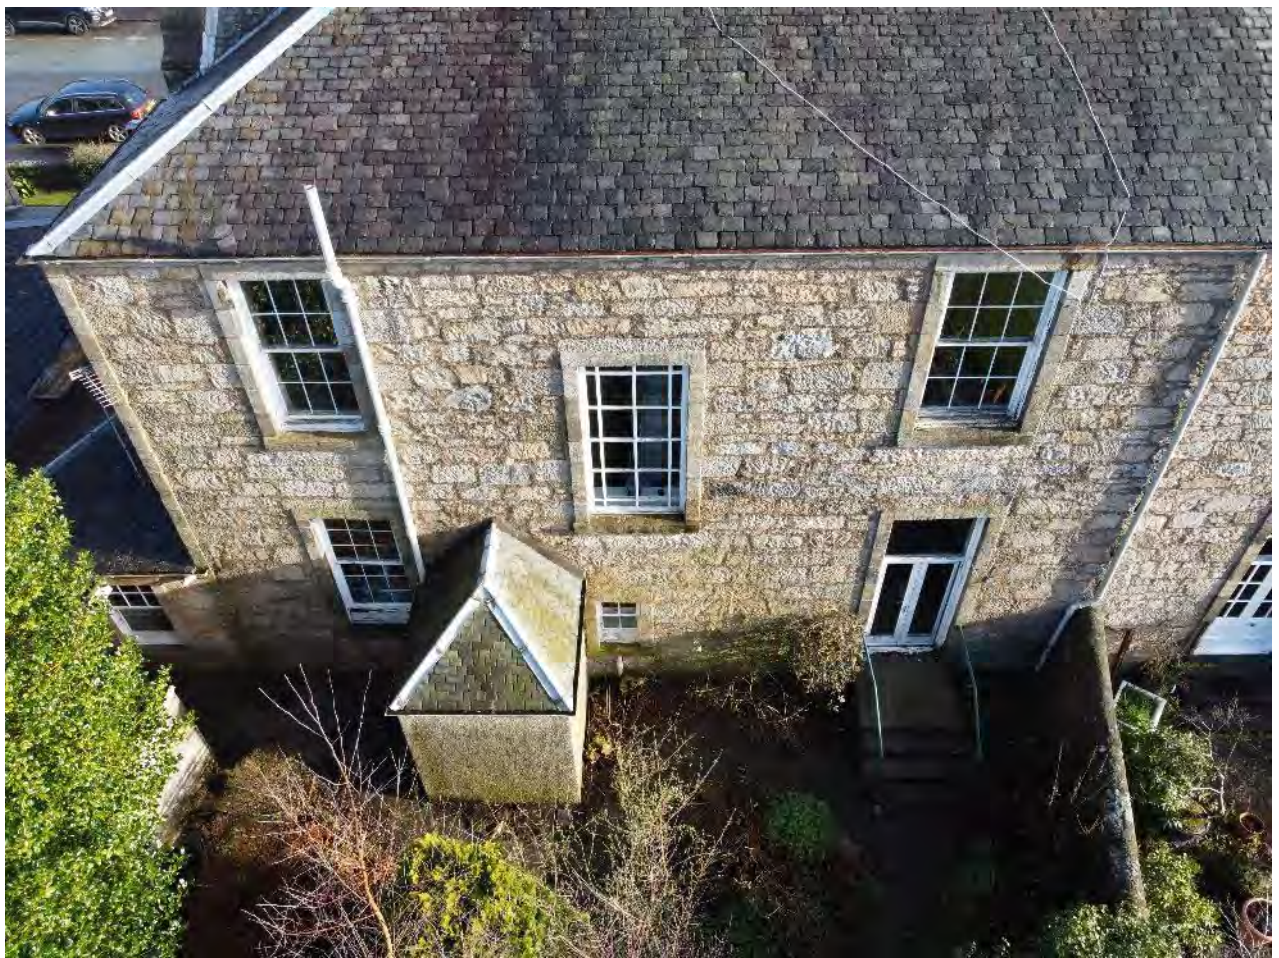
Ref	Element	Condition, defects present & recommended repair priority	
6.8.1	<b>FAC 3 Doors</b>	<p>The door is a replacement timber unit with glazed panels.</p> <p><b>The condition of the Door appears to be poor and this component is likely to require repair.</b></p> <ul style="list-style-type: none"> <li>The timber is rotten. Rotten timber can undermine the structural integrity of the door potentially resulting in failure of the unit. Rotten timber also retains moisture which can perpetuate and accelerate further cycles of decay. IMG: 52, 53</li> </ul>	2

6.8.2	<b>FAC 3 Rainwater Drainage</b>	<p>The roof (R3) drains to a half round cast-iron gutter. The gutter flows to a cast iron downpipe (RWP3).</p> <p><b>The condition of the Rainwater Drainage varies and these components may require some maintenance or repair to avoid further deterioration.</b></p> <ul style="list-style-type: none"> <li>The interior of the gutter has corroded. Corroded cast iron will ultimately fail leading to leakage from the gutter. IMG: 46</li> </ul> <p><i>Recommended Action</i> Remove rust from the interior of the gutter and repaint to protect against future corrosion.</p>	2

6.8.3	<b>FAC 3 Wall</b>	<p>The wall (FAC3) is constructed of squared blonde rubble sandstone with a tooled surface finish laid in rough courses. Window and door surrounds are finished with raised ashlar margins.</p> <p><b>The condition of the Wall varies and this component may require some maintenance or repair to avoid further deterioration.</b></p> <ul style="list-style-type: none"> <li>The mortar within the joints has cracked and there are gaps between the pointing. Cracked mortar can make joints vulnerable to water ingress potentially leading to internal dampness and accelerated decay. IMG: 56, 61</li> <li>Ferrous metal within the wall has oxidised and the expansion has caused damage to the stone. Ferrous metal can expand significantly when oxidised causing cracking and displacement of stone. Cracked and displaced stone may be vulnerable to water ingress which can exacerbate oxidisation and lead to internal dampness. IMG: 105</li> </ul> <p><i>Recommended Action</i> Rake out cracked pointing from between masonry units in wall and repoint using a lime mortar. Remove ferrous metal from wall and if required replace with stainless steel fixing. Make good any damage caused using a lime mortar and petrographically matched stone.</p>	2

6.8.4	<b>FAC 3 Windows</b>	<p>The windows are replacement timber sash and case units with double glazed units containing false astragals between the glazing.</p> <p><b>The condition of the Windows appears to be poor and these components are likely to require replacement. The component has limited significance and an appropriate replacement may represent a material enhancement of the property.</b></p> <ul style="list-style-type: none"> <li>The timber is rotten. Rotten timber can undermine the structural integrity of the window potentially resulting in failure of the unit. Rotten timber also retains moisture which can perpetuate and accelerate further cycles of decay. IMG: 100</li> </ul>	2

<ul style="list-style-type: none"> <li>• Areas of paint have failed and are missing from the timber Exposed timber is vulnerable to saturation which can lead to the outbreak of rot. IMG: 48, 49, 50</li> <li>• The burnt sand mastic between the window and masonry check has cracked. Cracked burnt sand mastic may be vulnerable to water ingress which may cause rot within the casement and/or internal dampness. IMG: 51</li> </ul> <p><i>Recommended Action</i>  Remove areas of rotten timber and piece in sections in a matching species and profile. Use a lightly foaming up glue and ideally use mechanical fixings from the internal side or cover well with a water tight filler.  Rub down area of exposed timber to provide a sound substrate. Repaint to protect against future water ingress using a linseed-based paint system.  Rake out the failed areas of sand mastic and clean the joint. Replace burnt sand mastic with a two-part site mixed traditional sand mastic comprising boiled linseed oil and burnt sand, avoid the use of resin hardeners that reduce vapour permeability of the joint.</p>

6.8.5	<b>FAC 3 Grill</b>	<p>The grill to the solum is cast iron.</p> <p><b>The condition of the Grill varies and this component may require some maintenance or repair to avoid further deterioration.</b></p> <ul style="list-style-type: none"> <li>• There is corrosion on the surface of the vent. Corroded cast iron components will ultimately fail which can expose vents to infestation and water ingress. IMG: 101</li> </ul> <p><i>Recommended Action</i>  Remove rust from the vent and repaint to protect against future corrosion.</p>	2

<p><i>Recommended Action</i> Remove areas of rotten timber and piece in sections in a matching species and profile. Use a lightly foaming pu glue and ideally use mechanical fixings from the internal side or cover well with a water tight filler.</p>

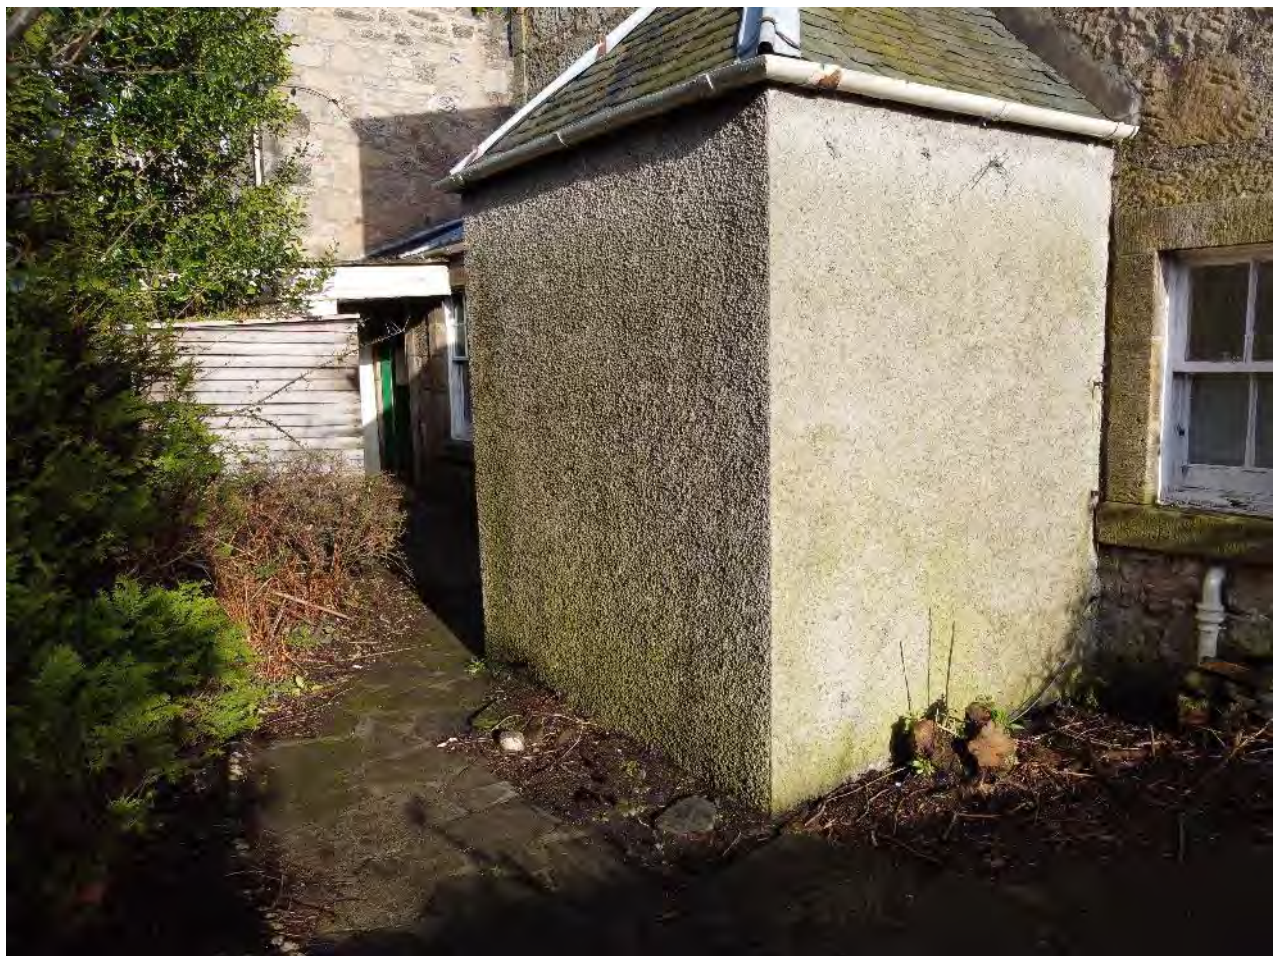
6.9.1	<b>FAC 4 Doors</b>	<p>The door appears to be a replacement timber unit with an upper glazed panel.</p> <p><b>The condition of the Doors is poor and this component requires repair.</b></p> <ul style="list-style-type: none"> <li>The timber is rotten. Rotten timber can undermine the structural integrity of the door potentially resulting in failure of the unit. Rotten timber also retains moisture which can perpetuate and accelerate further cycles of decay. IMG: 62</li> </ul> <p><i>Recommended Action</i> Remove areas of rotten timber and piece in sections in a matching species and profile. Use a lightly foaming pu glue and ideally use mechanical fixings from the internal side or cover well with a water tight filler.</p>	2

6.9.2	<b>FAC 4 Rainwater Drainage</b>	<p>The roof (ROF3) drains to a half round cast iron gutter. The gutter drains to a cast iron downpipe (RWP4).</p> <p><b>The condition of the Rainwater Drainage varies and these components may require some maintenance or repair to avoid further deterioration.</b></p> <ul style="list-style-type: none"> <li>The interior of the gutter has corroded. Corroded cast iron will ultimately fail leading to leakage from the gutter. IMG: 43, 44</li> <li>There is a build-up of sludge and debris within the gutter. Sludge and debris restricts flow and can lead to overflow during high rainfall events. IMG: 43, 44</li> <li>There is corrosion at the joints between sections of gutter. Corrosion at the joints often indicates a failure of the mastic sealant between sections of the gutter. IMG: 59</li> </ul> <p><i>Recommended Action</i> Remove rust from the interior of the gutter and repaint to protect against future corrosion. Clear the gutter of debris and undertake a regular programme of yearly maintenance to ensure they remain clear. Dismantle section of gutter and remove rust, repaint to protect against future corrosion and reassemble using either a low modulus silicone mastic or traditional putty sealant to seal the union between the gutter sections.</p>	2

6.9.3	<b>FAC 4 Wall</b>	<p>The wall is covered in a cement render/harl.</p> <p><b>The condition of the Wall appears to be good and this component only requires monitoring for future maintenance requirements.</b></p> <ul style="list-style-type: none"> <li>A Ferrous metal fixture is imbedded within the render/harl and has potential to cause damage to the stone. Ferrous metal can expand significantly when oxidised causing cracking and displacement of render/harl. Cracked and displaced render may be vulnerable to water ingress which can exacerbate oxidation and lead to internal dampness. IMG: 59</li> </ul> <p><i>Recommended Action</i> Monitor ferrous metal and remove from wall if oxidation occurs. Replace with a stainless-steel fixing and make good any damage caused to the render/harl.</p>	3
