JACKDAWS CASTLE

HIGHCLERE CASTLE

Scope of Works and Heritage Impact Assessment

Job No: 2178
4th May 2021

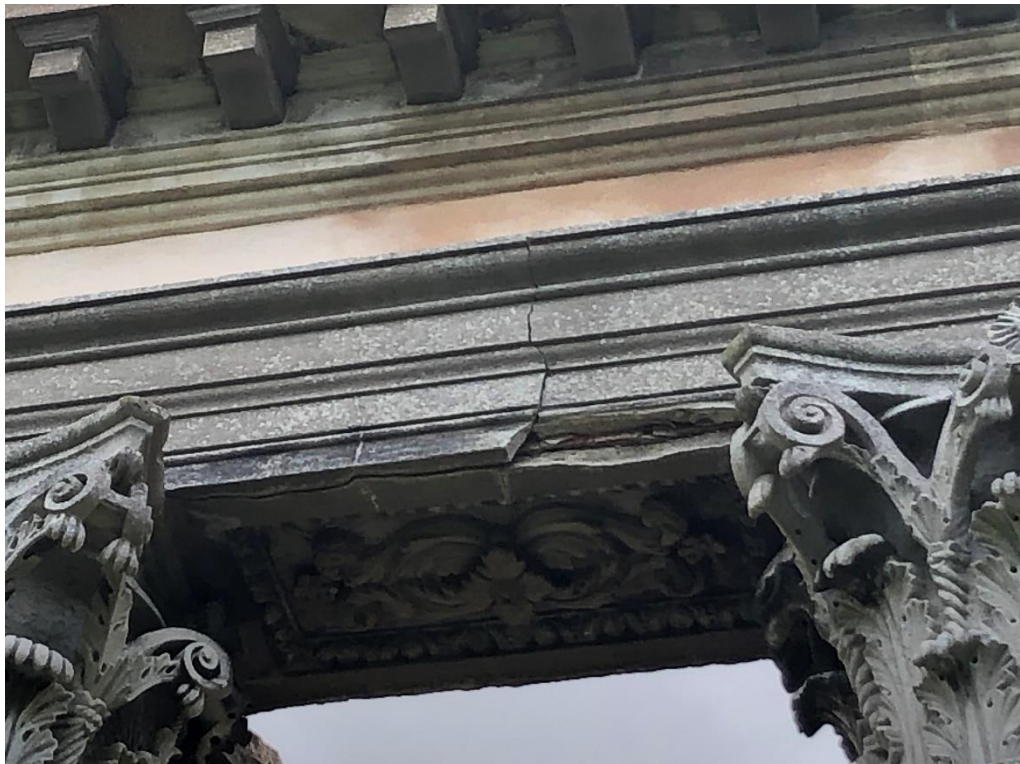
The section of render has been stored at the base of the structure below where it has fallen. This is the banded frieze directly above the colonnade to the western elevation (facing the castle). Cracking is noted to the remaining sections both to the underside between the columns and through the height of the rendered panel. The brickwork to the masonry wall beneath is evident, the render is approximately 30mm thick at its thinnest.

Fallen section of render, note cracking. Sound render above

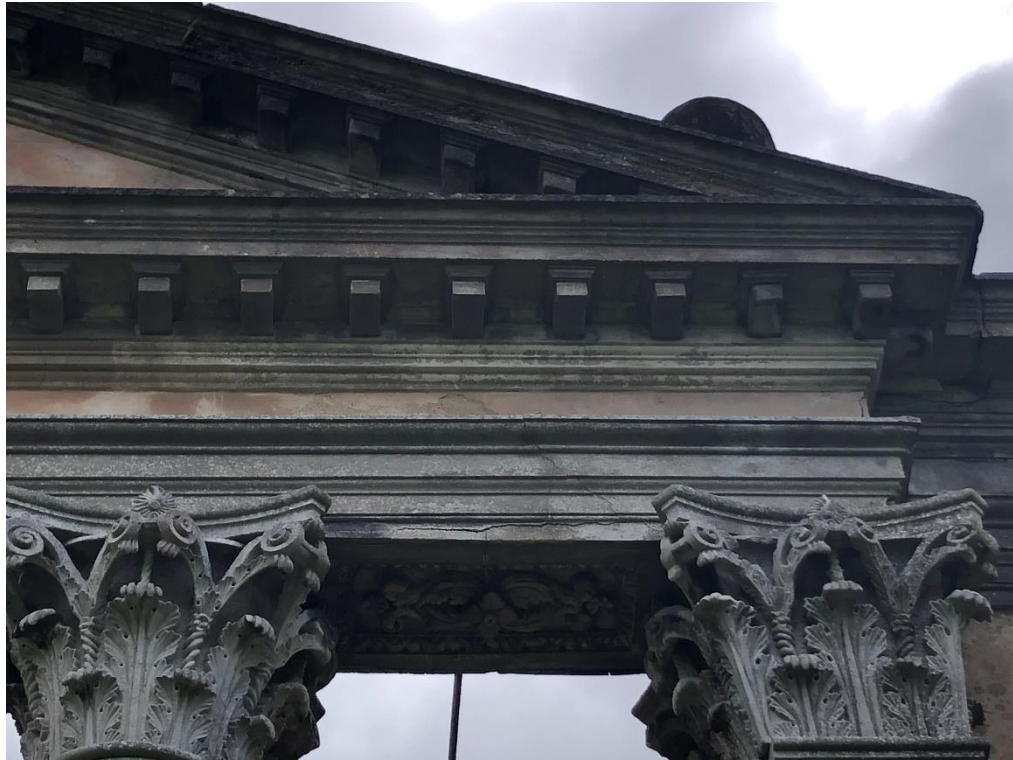
Adjacent cracking to render

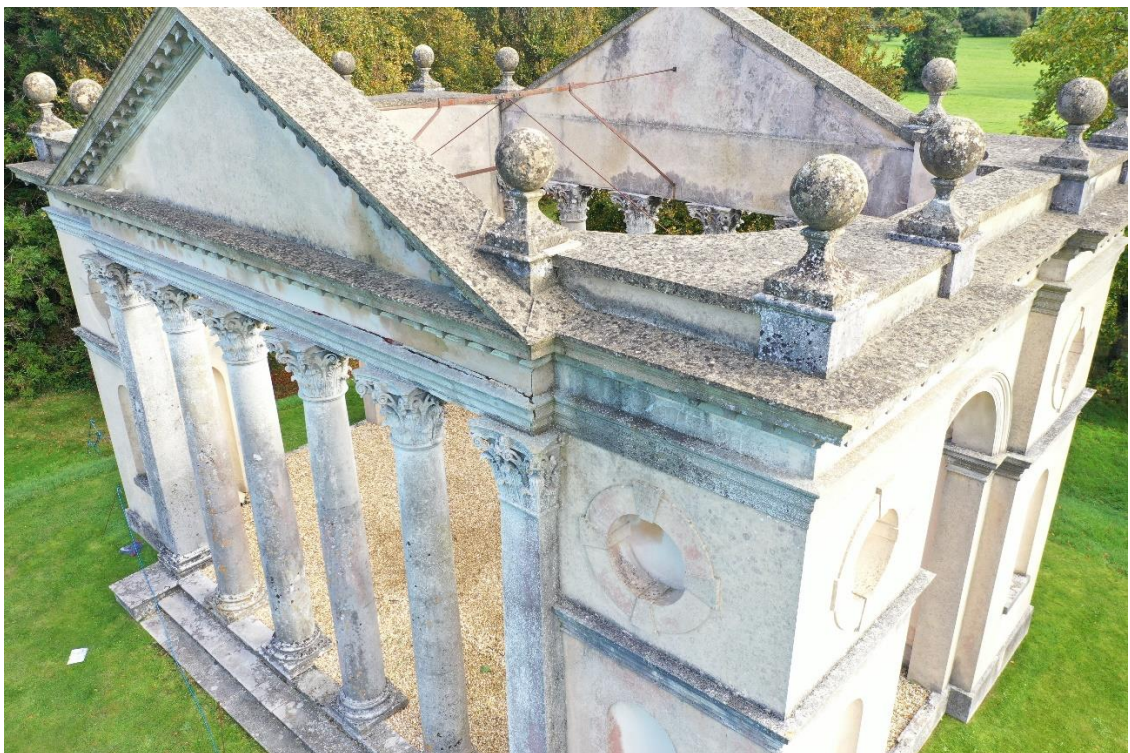
A drone was used to obtain a high level view of the string course from above. Tower scaffold was also provided to enable inspection at level. This found a sizeable crack and outwards displacement of the string course of up to 40mm.

Outwards movement is most pronounced at the south-west corner where cracking continues through the height of the south return. This is visible in the attached Drone photos.

Full length crack above string course from south-west corner

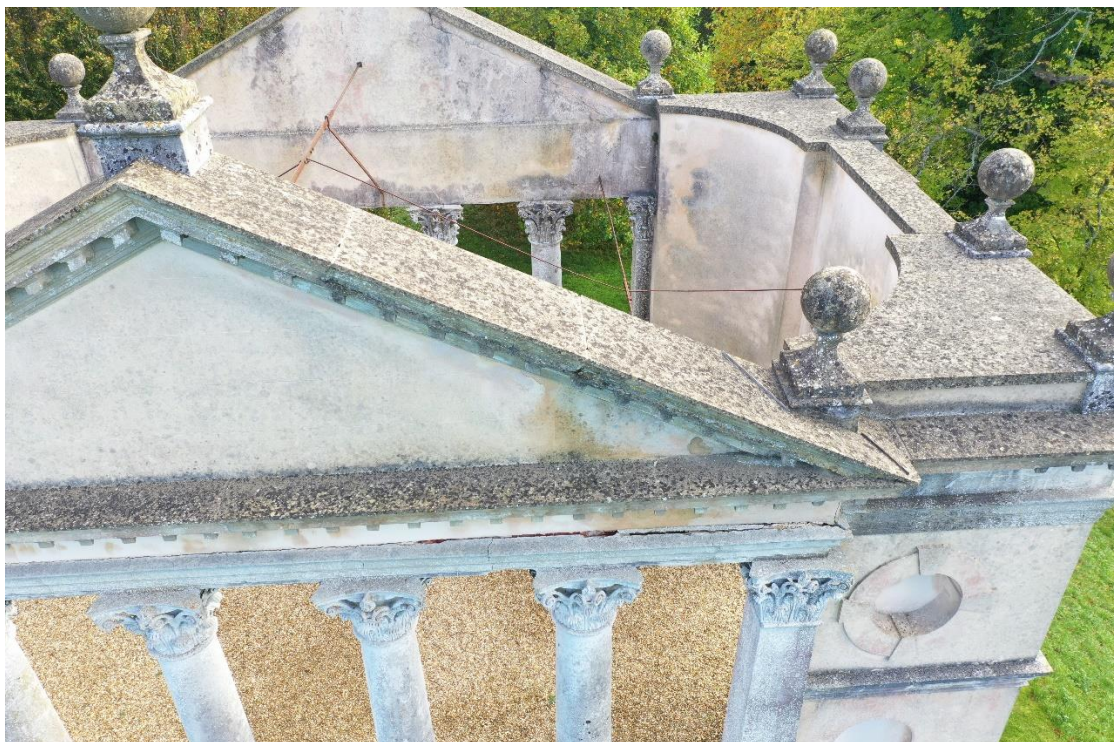
The most severe movement has resulted in two vertical cracks towards the south-west corner both showing signs of differential, outwards deflection.

The issue appears to be due to localised cracking at a weak point in two different renders. The flat frieze is a different mix of lime render fitted above the roman cement render of the weathering and string. These can be differentiated visually due to differences in colour. Water has ingressed through this cracking. The movement is due to expansion as the water freezes within this void.

Significant crack to SW corner and destabilised string course

The existing render should be retained insitu and stabilised using stainless steel coach screw and washer mechanical fixings. These should be staggered across the string course and countersunk. The roman cement render will be filled using a matching mortar mix and the appearance unified. All cracking should be repointed in a matching mortar. Following repointing and tying of the render the void should be grouted to fill.
