27 April 2022
 Ref: P2542 /0422 /01

Further to your instruction I have carried out an inspection of the tree situated in your property immediately adjacent to Deene Road about which there is some concern. My inspection was completed on the afternoon of 28th March 2022 and photographs of the tree in question are provided below along with other boundary trees adjacent to the road and a plan showing the position of these.

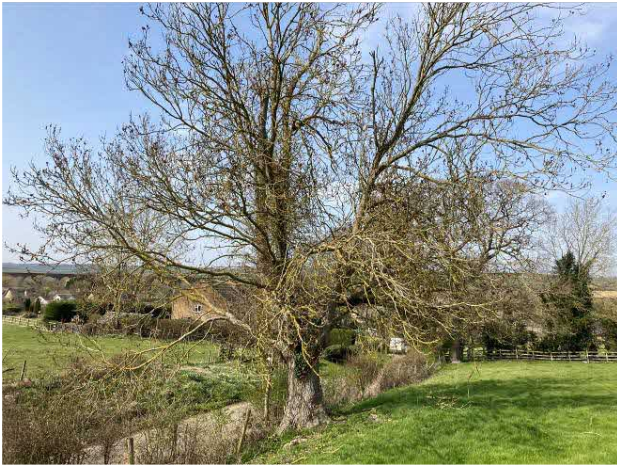
Tree T1

Tree No	Species	Ht (m)	Stem Diam mm@ 1.5m	Canopy Spread (m)	Height of Crown Clearance	Age Class	Est yrs	Structural condition	BS 5837 Category	RPA Radius (m)
T1	Ash <i>Fraxinus excelsior</i>	9	860	N-6 S-6 E-7 W-6	3	OM	<10	This tree is in very poor structural condition. The leader has been lost and the irregular crown remaining is in severe decline with significant dead wood throughout. The crown overhangs the adjacent road WHICH IS A cause for concern. The trunk leans slightly towards the road and there is a very large and extensive cavity present in the trunk, open at the top allowing water ingress with water seepage from the top and also lower in the trunk close to ground level. Removal of this tree is recommended	U	10.3

Ash T1 – This tree is in severe decline. The trunk damage which extends from a large open cavity, down through the trunk to an open cavity on the site, suggests that this is a wound from a lightning strike which removed the main leader of the tree at some time in the past. The tree is regenerating but the future structural stability of the tree is compromised by the extensive decay within the trunk and the presence of water seeping through this. There is significant dead wood present in the canopy and some large fallen branches are present around the base of the tree. Since this tree extends its crown across the adjacent road it is recommended that **it should be felled and removed**. A replacement tree can be planted elsewhere within the plot of land in mitigation.

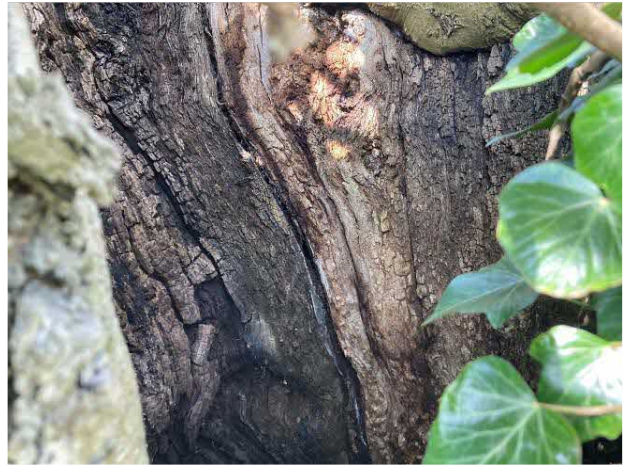
T1 - Large cavity and decay in trunk

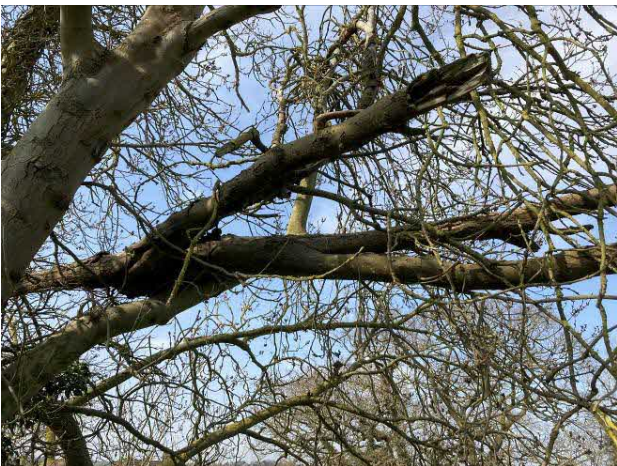
T1 - Significant dead wood in canopy over road

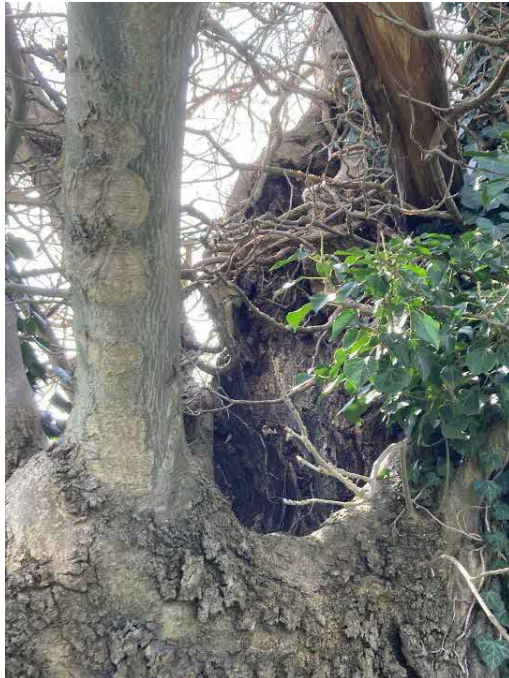
T1 - Large open cavity at top of main trunk.

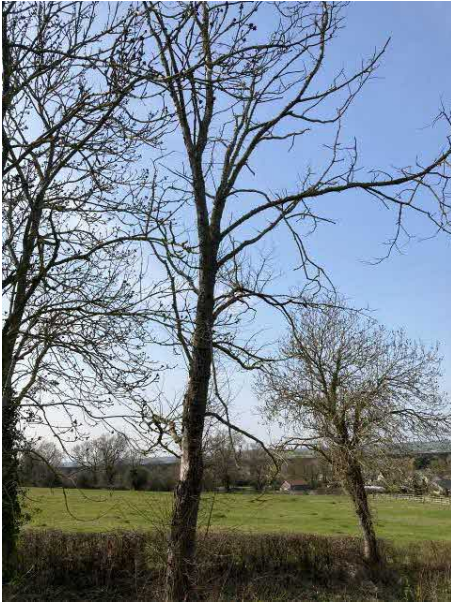
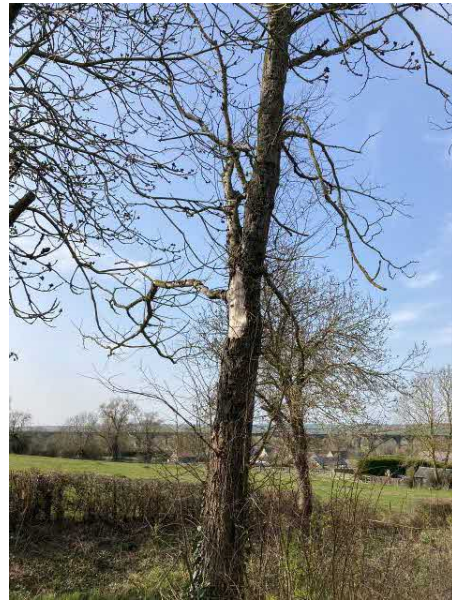
Tree No	Species	Ht (m)	Stem Diam mm@ 1.5m	Canopy Spread (m)	Height of Crown Clearance	Age Class	Est yrs	Structural condition	BS 5837 Category	RPA Radius (m)
T2	Ash <i>Fraxinus excelsior</i>	11	305	N/A	4	OM	0	This tree is dead and lies on the property boundary immediately next to the road. There is one significant dead branch extending directly across the road. Removal of this tree is recommended	U	3.6
T3	Ash <i>Fraxinus excelsior</i>	9	195 180 150	N-2 S-4 E-5 W-5	4	Y	20	This is a regenerating coppice situate don the road bank along the edge of the property boundary. Minor ivy growth on the trunk. No structural concerns identified within this tree from the ground level inspection.	B2	3.6
T4	Oak x 3 <i>Quercus petraea</i>	18 / 20	760	Varies up to 8m	4	M	40	Three mature oak trees in close proximity creating a single large merging canopy which extends across the road. Highly visible and appears in good condition. No structural faults visible from ground level but clearly in severe decline.	A2	9.1

T2 – Dead tree

Ash T2 – This tree is already dead and is shedding branches. It lies adjacent to the road and therefore **removal is recommended**.

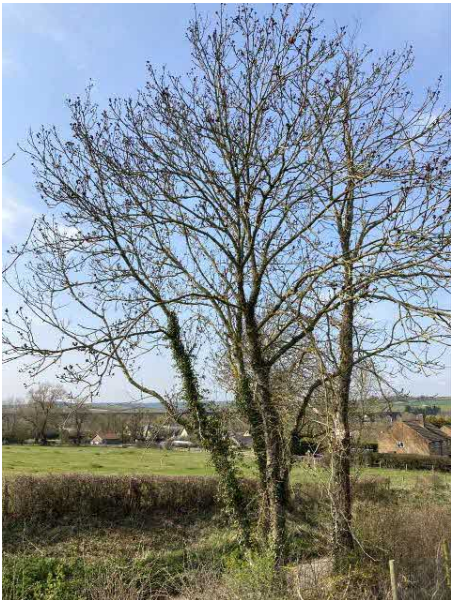
Ash T3 – there are no structural faults noted within this coppice regeneration and with the removal of T2 there will be space for the tree to continue to mature in this position.

T3 adjacent to T2

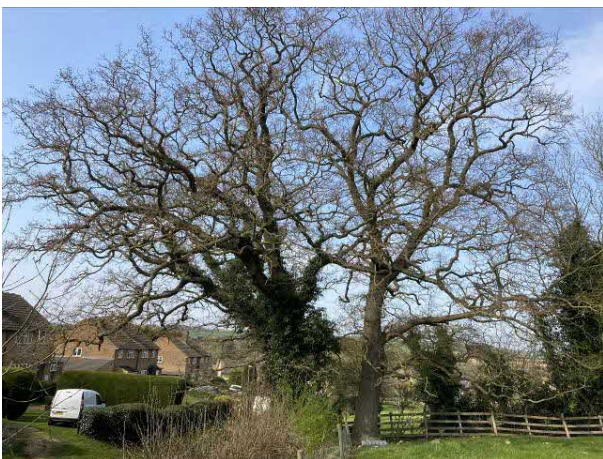
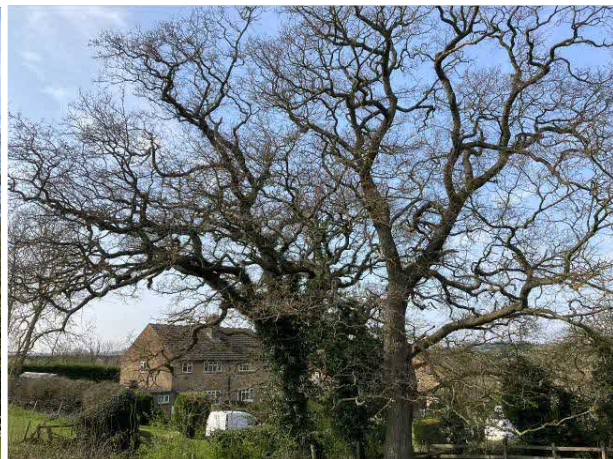
Oak Group G4 – these three Oak form a large merging crown on the southern edge of the village. There is ivy growth that should be removed, and the trees should be monitored as the canopies extend across the road and an adjacent garden. However, these appear to be of good quality and there are no obvious structural faults noted. These trees have high landscape value and should be retained.

Merging canopy G4
