Description of proposed works (Overview)

DATE 8th December 2021
REPORT REPORT NUMBER 5/34629
PLAN ADDRESS 3 Abbey Hill

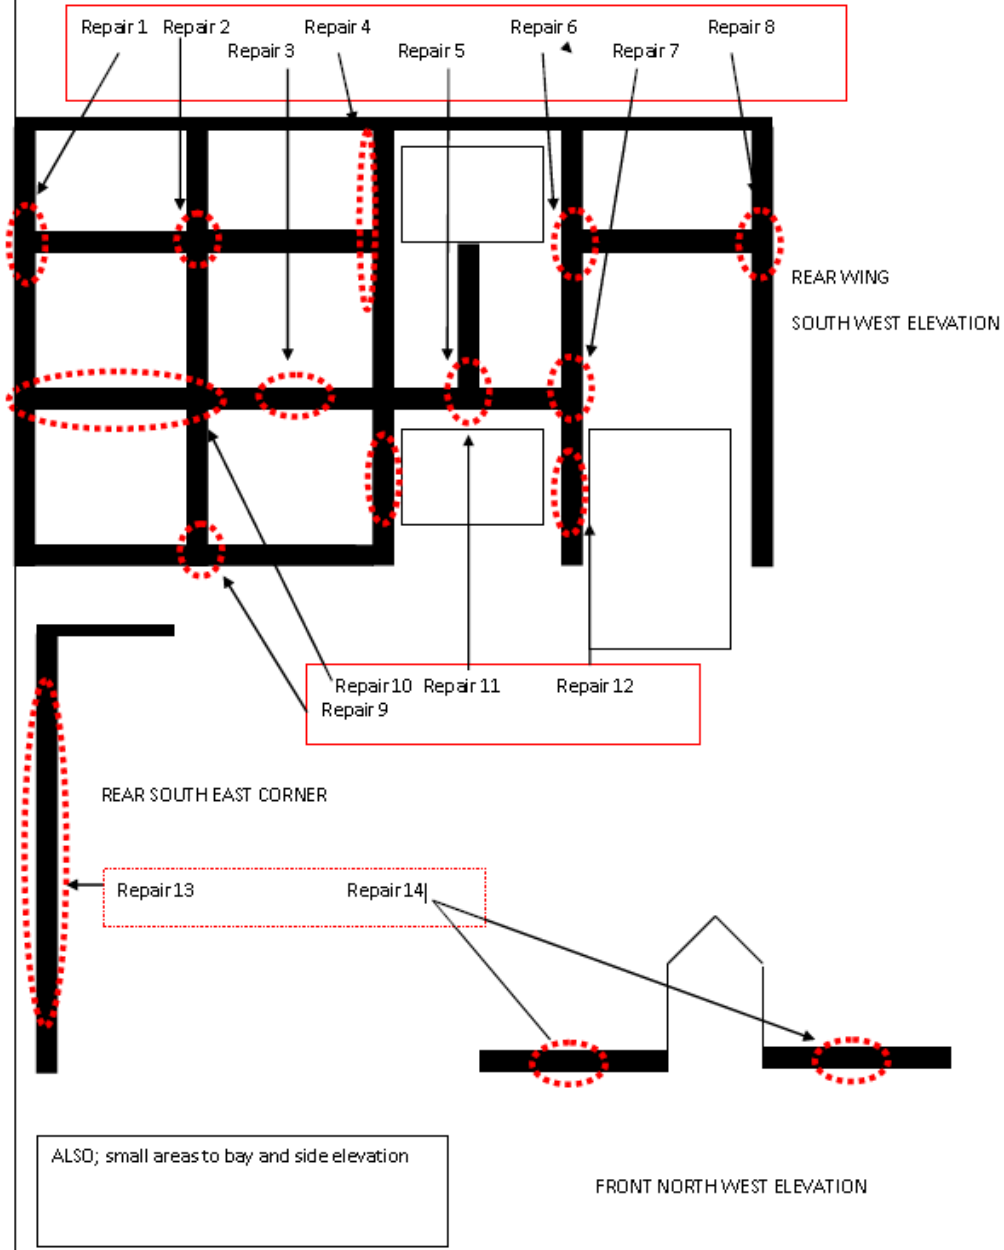
Figure 1 – Repair Location diagram

Specific external repairs and locations are given below and in Figures 1&2. Typical repair types are given, by way of illustration only, in Example timber repair diagrams 1 and 2 (attached separately)

Repair Nos. 1,2,5,6,7,8 9,10.

- Cut out decayed timber to joints.
- Cut back frame members to sound.
- Consolidate friable surfaces.
- Fix new timber sections with fiberglass rods connectors to joints.
- Fill edges of frame / masonry panel if required.

Repair Nos. 3,4,10,11,12,14.

- Cut out decayed timber back to sound.
- Consolidate friable surfaces.
- Fit new timber sections.

Repair 13

- Remove timber panel / cover.
- Examine and allow to fit new vertical timber.

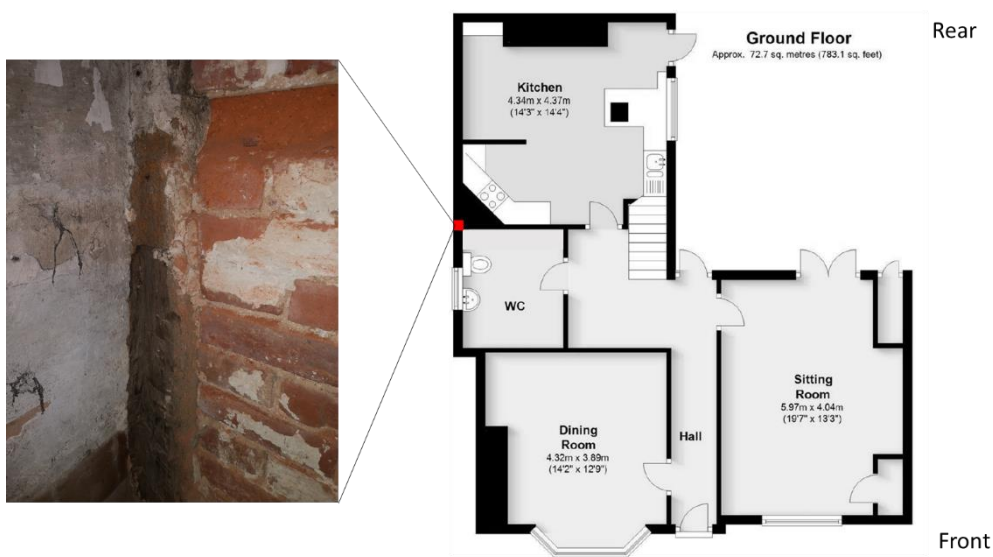
Figure 3 – Ground floor plan showing location of internal timber repair

Ground floor at location shown in figure 3.

- Attached new timber section to form joint with vertical and cut back decay to vertical and fix new section as necessary
