Arboricultural Report

Proposed Development at 49 Front Street Middleton on the Wolds East Riding of Yorkshire YO25 6AU

April 2022 (Rev 1)

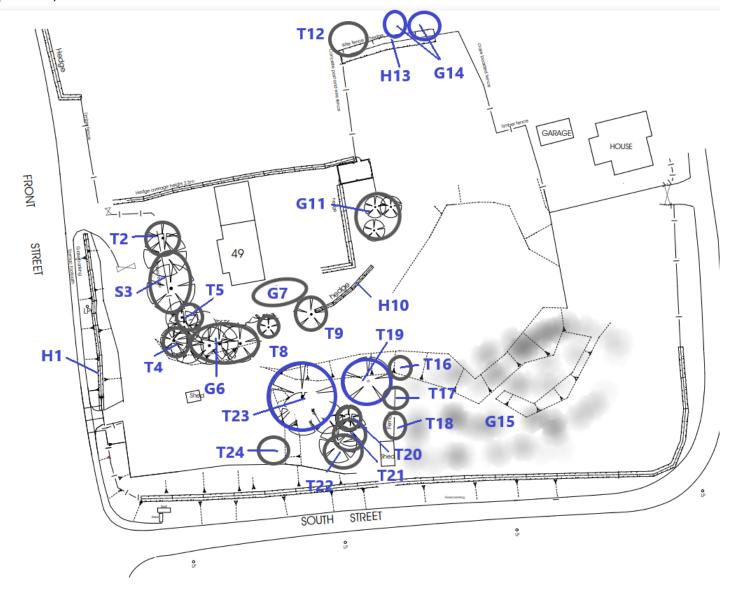
2.2 Tree Survey (Plan 2A)

Tree no	Species	Height	Stem Dia RPA	Branch Spread	Crown Height	Age Glass	Physiological Condition	Structural Condition	Preliminary Management Recommendations	Useful life Expectancy	Category Grading
H1	Hawthorn hedge	1m	100e 1.2m	0.5m-	-	M	Fair	Fair	Remove a short section for access drive for plot 2	40+	C2
T2	Purple plum	8m	300e 3.6m	3m	2m	М	Good	Good	No action	20	C2
S3	Shrubs (Laurel)	4m	200e 2.4m	2m	-	M	Good	Good	No action	20+	C2
Т4	Cherry	9m	400e 4.8m	4m	3m	М	Good	Good	No action	20+	C2
Т5	Scots pine	12m	300e 3.6m	3m	5m	M	Fair	Fair	No action	20+	C2
G6	Scots pine 3 trees	16m	430 5.1m	3m	3m	М	Good	Good	Crown Lift to 5m over access road.	40+	B2

Tree no	Species	Height	Stem Dia RPA	Branch Spread	Crown Height	Age Glass	Physiological Condition	Structural Condition	Preliminary Management Recommendations	Useful life Expectancy	Category Grading
G7	Cypress Multi stemmed	17m	400e 4.8m	4m	1m	М	Good	Good	No action	40+	C2
Т8	Laburnum	4m	200m 2.4m	2m	2m	М	Good	Good	No action	20+	C2
Т9	Laburnum Multi stemmed	6m	300m 3.6m	3m	2m	М	Good	Good	Crown lift to 5m over access road.	20+	C2
H10	Hedge Lonicera	1m	100e 1.2m	0.5m	-	М	Good	Good	No action	20+	C2
G11	Fruit trees	7m	300e 3.6m	3m	1m	M	Fair	Fair	No action	20	C2
T12	Leyland Cypress	12m	400e 4.8m	3m	-	М	Good	Good	No action Tree on adjacent land	40	C2
G13	Hawthorn Hedge	5m	200e 2.4m	2m	-	М	Good	Good	No action	40+	C2

Tree no	Species	Height	Stem Dia RPA	Branch Spread	Crown Height	Age Glass	Physiological Condition	Structural Condition	Preliminary Management Recommendations	Useful life Expectancy	Category Grading
G14	Sycamores 2 trees Multi stemmed	16m	500e 6.0m	5m	3m	М	Good	Good	No action Trees on adjacent land Located at a lower level than the site.	40+	B2
G15	Scrub	4m	-	-	-	M	-	-	Remove areas for plot 2 Mainly bramble scrub with odd small elderberry and hawthorn	-	U
T16	Cherry	9m	180 2.1m	2m	2m	MA	Good	Good	No action	20+	C2
T17	Horse Chestnut	6m	240 2.9m	2m	1m	MA	Good	Good	Remove for development	40+	C2
T18	Horse chestnut	6m	170 2.0m	2m	1m	MA	Good	Good	Remove for development	40+	C2
T19	Horse Chestnut	20m	720 8.6m	7m	1m	M	Good	Good	No action	40+	B2
T20	Scots pine	16m	360 4.3m	4m	4m	М	Fair	Fair	No action	40+	C2

Species	Height	Stem Dia RPA	Branch Spread	Crown Height	Age Glass	Physiological Condition	Structural Condition	Preliminary Management Recommendations	Useful life Expectancy	Category Grading
Norway spruce	17m	470 5.6m	5m	2m	M	Good	Good	No action	40+	C2
Cherry	9m	170 2.0m	2m	2m	MA	Good	Good	No action	20+	C2
Horse Chestnut	22m	840 10.1m	7m	1m	М	Good	Good	No action	40+	B2
Apple	6m	400 4.8m	3m	1m	M	Fair	Poor	Extensive decay in the trunk Remove due to condition	-	U
	Norway spruce Cherry Horse Chestnut	Norway spruce 17m Cherry 9m Horse Chestnut 22m	Norway spruce 17m 470 5.6m Cherry 9m 170 2.0m Horse 22m 840 10.1m Apple 6m 400	Norway spruce 17m 470 5m 5.6m Cherry 9m 170 2m 2.0m Horse Chestnut 22m 840 7m 10.1m Apple 6m 400 3m	Norway spruce 17m 470 5m 2m Cherry 9m 170 2m 2m 2.0m 2.0m 1m 1m Apple 6m 400 3m 1m	Norway spruce 17m 470 5m 2m M Cherry 9m 170 2m 2m MA Horse Chestnut 22m 840 7m 1m M Apple 6m 400 3m 1m M	Dia RPASpread RPAHeight GlassConditionNorway spruce17m4705m2mMGoodCherry9m1702m2mMAGood2.0m2m1mMGoodHorse Chestnut22m8407m1mMGoodApple6m4003m1mMFair	Norway spruce17m 5.6m470 5.6m5m 2m2m MMGood GoodGoodCherry9m170 2.0m2m2mMAGoodGoodHorse Chestnut22m3m1mMGoodGoodApple6m4003m1mMFairPoor	Norway spruce17m470 5.6m5m 5.6m2mMGoodGoodGoodNo actionCherry9m170 2.0m2m2mMAGoodGoodNo actionHorse Chestnut22m840 10.1m7m1mMGoodGoodNo actionApple6m4003m1mMFairPoorExtensive decay in the trunk Remove due to condition	Norway spruce17m470 5.6m5m 2m2mMGoodGoodGoodNo action40+Cherry9m170 2.0m2m2mMAGoodGoodNo action20+Horse Chestnut22m840 10.1m7m1mMGoodGoodNo action40+Apple6m4003m1mMFairPoorExtensive decay in the trunk Remove due to condition-

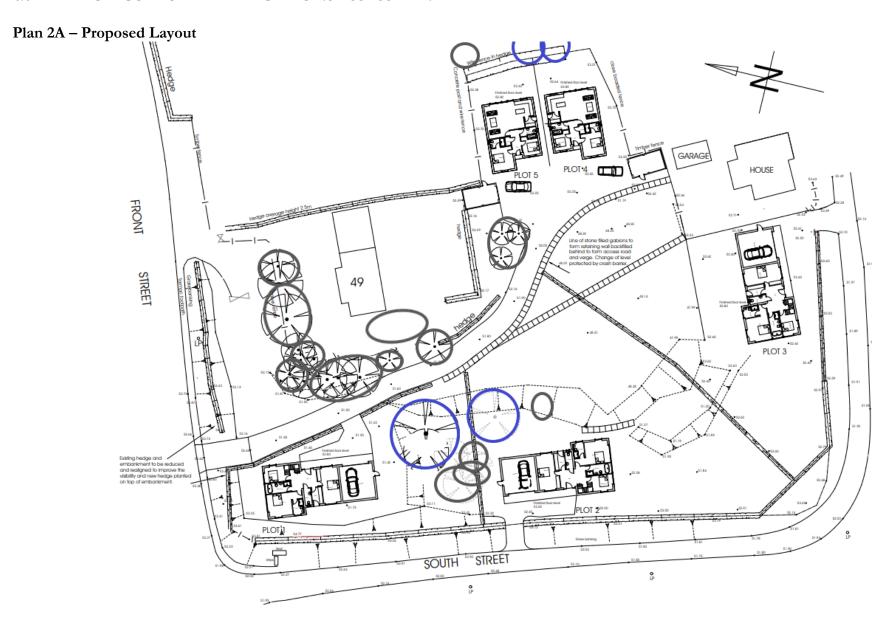
The proposed development retains virtually all the trees on the site, the exceptions being T24 due to its poor condition and two small young trees T17 and T18. Low scrub, (G15) which is mainly bramble is also proposed to be removed for plot 2. The group of pine trees (G6) and the laburnum (T9) would require minor pruning to lift the crowns over the access drive.

• Tree T17, T18 and T24 to be removed. Minor crown lifting to G6 and T9. Short section of hedge(H1) to be removed for access to plot 2.

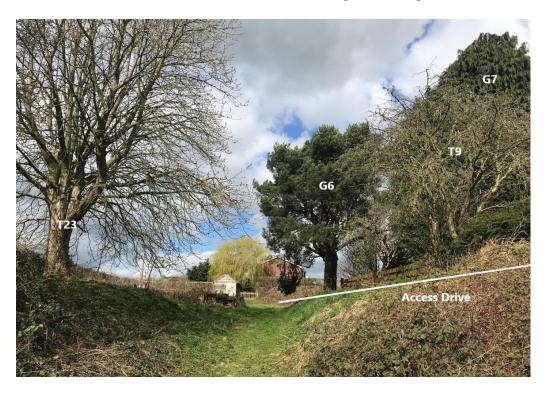
The access road would pass close to the Pines (G6), Laburnum (T8) and Chestnut (T23). However, no excavation work for the access road would be required as the existing ground level is below the base level of the trees. The proposal is to raise the road so that the finish level is at the similar level to the ground level of the trees (See photograph below). Given the locations, size of the trees and extent of the driveway it is considered that the construction of the drive would have no significant impact on the trees.

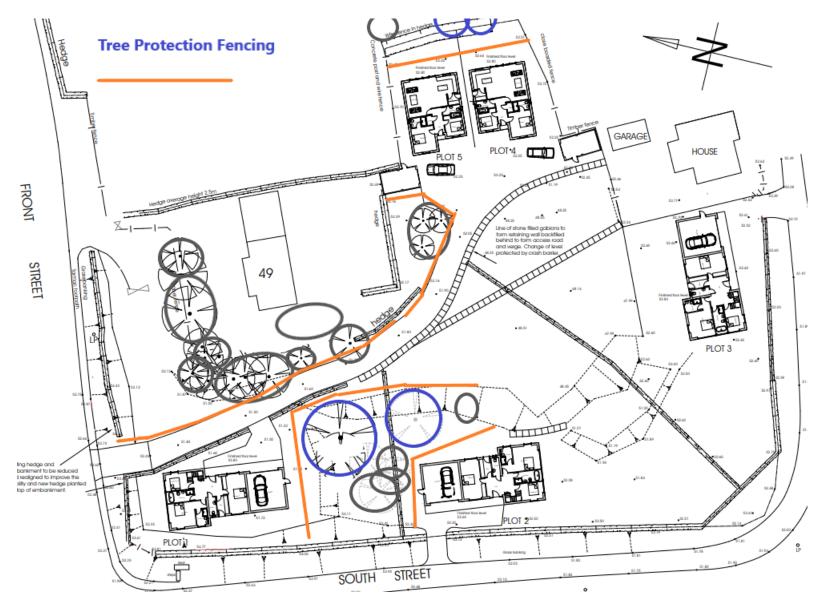
Appendix A - Tree Protection Plan (Plan 3A)

During construction tree protection fencing would be required to offer protection to the existing trees and hedges. Details have been shown on the Tree Protection Plan (3A) – appendix A with fencing details in Appendix B.

• Tree Protection Fencing and to be erected as indicated on the Tree Protection Plan (plan 3A) and as detailed in Appendix A. Notices to be erected on the fencing at 5m intervals stating 'Tree Protection Fencing - Do not remove'.
