28 April 2022
CG22/0043

RE: VEHICLE STRIKE, THE OLD SHIP INN, 2 VALLEY ROAD, CLACTON ON SEA, ESSEX CO15 4AR.

Introduction.

APPENDIX A

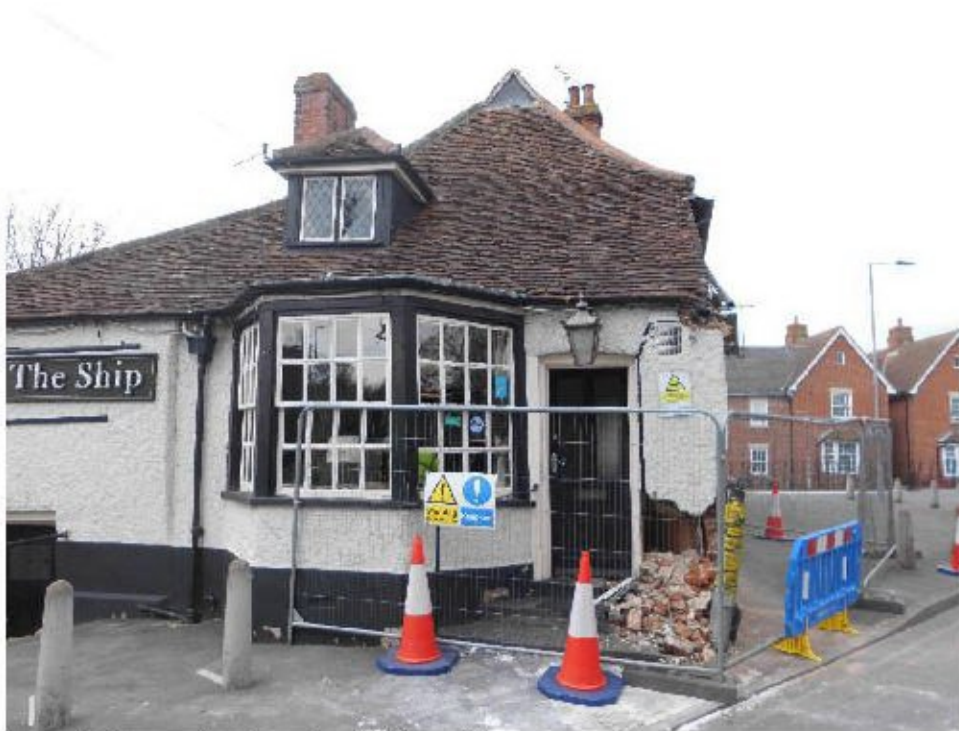
- The external wall panel at the point of impact has been destroyed between ground level and eaves level (Item 1), causing the timber lintel over the entrance door to lose its bearing.

Impact damage to external wall. (Item 1).

- Install props as indicated on enclosed sketches TW01 & TW02. Pack below ground floor joists at mid span as shown on Sketch TW01.
- Remove external render and internal finishes and carefully take down external wall brickwork for extents shown on Photographs 1 & 2 in Appendix C of this report. If any purlins or beams not identified in this report are found to be bearing on this wall, stop work and identify JP Chick & Partners immediately.

- Rebuild brickwork to reinstate the external wall. New brickwork is to be bonded into the existing. Brick units and bond are to match the existing arrangement. Any lintel and/or beam bearings must be rebuilt into the brickwork taking care to tightly pack any voids between the timber and brickwork with steel shims or well rammed dry pack. Any lintels damaged by the impact are to be identified to JP Chick & Partners for new lintel design.

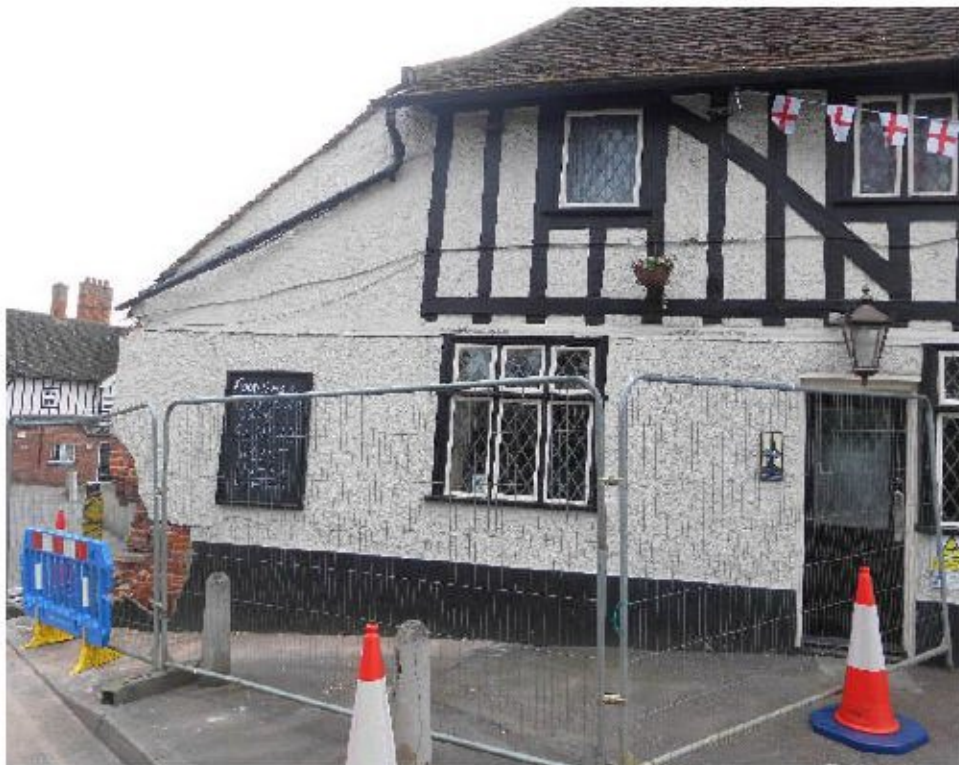
- A horizontal crack in the brickwork continues around the front elevation (north) external wall approximately 1m above ground level (Item 2).
- 1st floor joists notched into the Oak beam over the bay window have been displaced and lost around 10mm of bearing (Item 3).
- An Oak beam supporting the 1st floor appeared excessively deflected. The plywood cladding around the beam was removed and the beam was found to have split through its full depth (Item 5). This beam also appears to have been subject to an historic woodworm infestation and has rotted. We do not consider that the split was caused by the vehicle impact, as historic dust and debris was found inside the split timber. This defect needs to be addressed and rectified as part of the remedial work, prior to this area being reopened to the public.
- A portion of the plasterboard ceiling appeared to be sagging excessively (Item 4).

Impact damage to external wall. (Item 1 & 2).

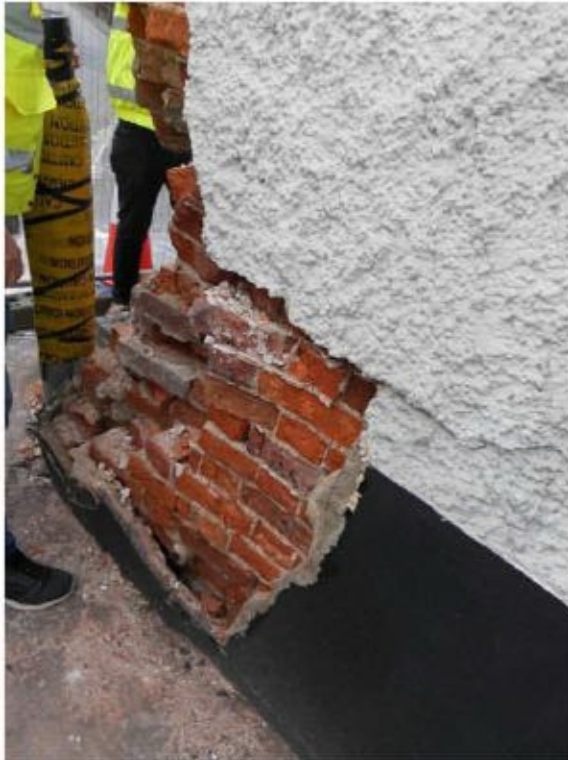
Impact damage to external wall. (Item 1 & 2).

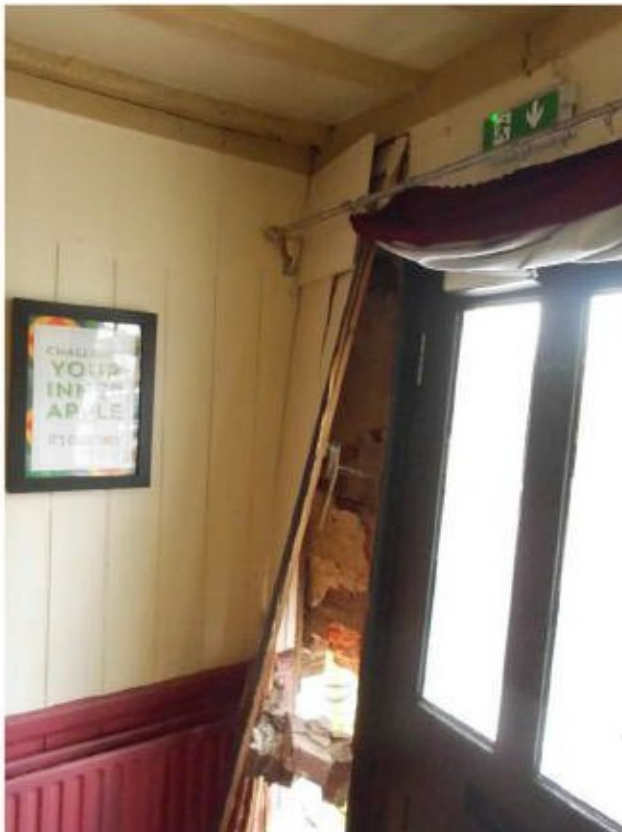
Impact damage to external wall, internal view. (Item 1).

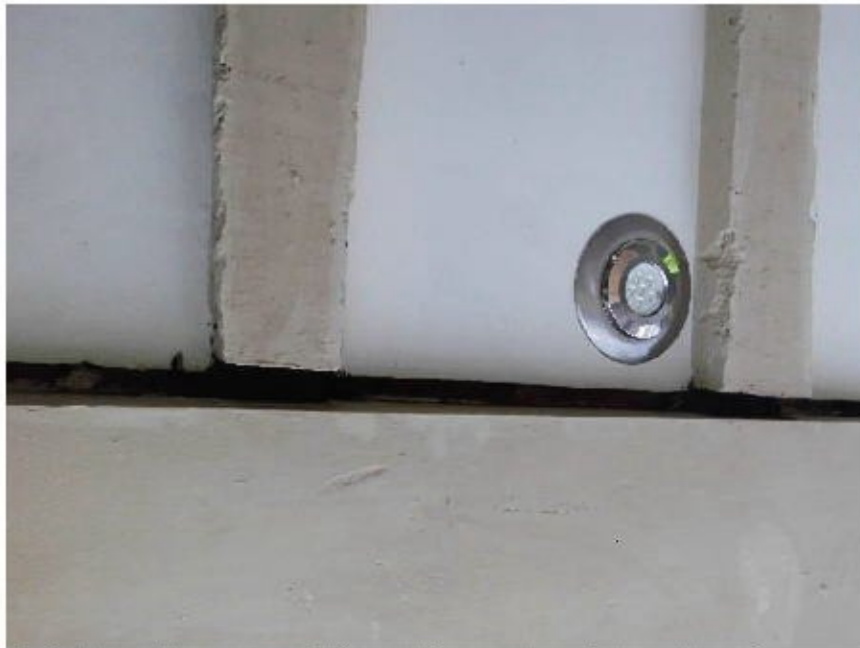
Partial loss of bearing to 1st floor joists over bay window. (Item 3).

- Pack voids between 1st floor joists and beam over the bay window with glued timber shims.
- Take down sagging ceiling finishes (Item 4). Inspect the exposed 1st floor joists and report any defects or excessive deflection in the joists themselves to JP Chick & Partners. If joists are in good condition replace the ceiling finishes with new plasterboard.

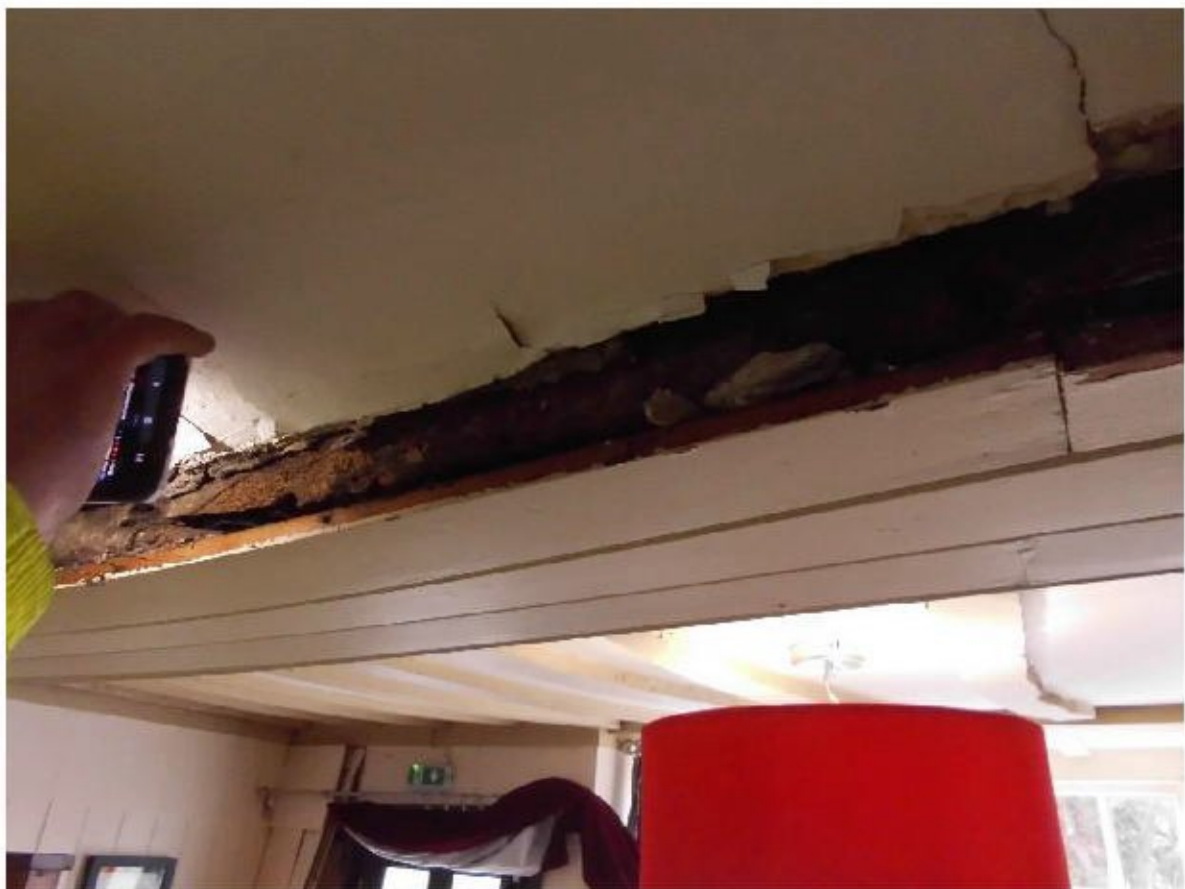
Excessively deflected Oak beam. Historic woodworm. Rot. Split beam. (Item 5).

- Replace or repair the split Oak beam (Item 5) as shown on the enclosed sketch RW02, subject to approval by English Heritage.
We have provided two options for consideration.
 - A) Complete removal and replacement of the original beam with a new Oak section. We consider this the least intrusive option, as no shortening of the existing 1st floor joists will be necessary. The propping arrangement will need to be reconfigured to allow removal of the existing Oak beam. See Sketch RW02 in Appendix C.
 - B) The most desirable and unintrusive option would be to repair the existing oak beam, however given its current condition, we do not believe this is likely to be possible. A historic timber repair specialist could be commissioned to inspect the beam and advise whether it could be repaired. Contact JP Chick & Partners if required and we will advise a suitable specialist.

We did look into the option of augmenting the existing, failed oak beam with steelwork either side, however this proved impractical due to the existing arrangement of the building and the disruption it would cause.

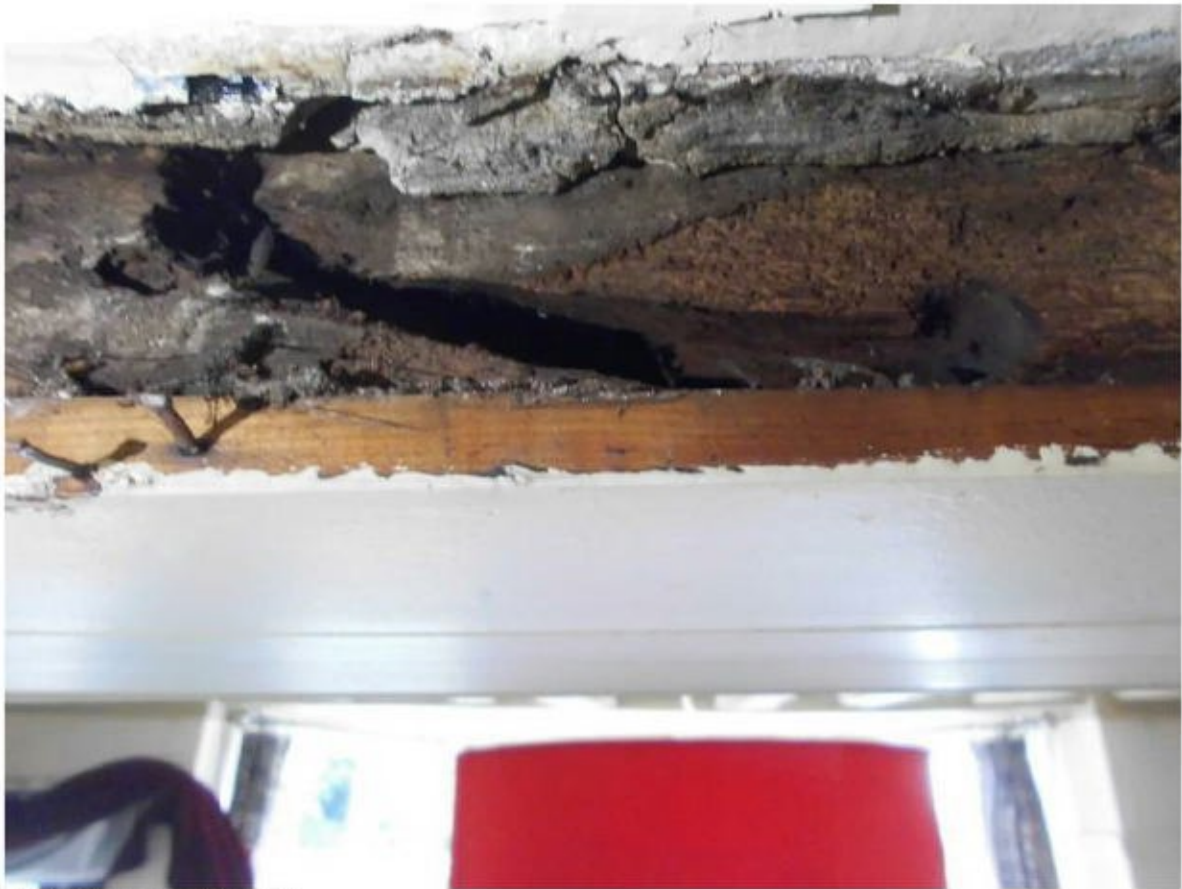
Split Oak beam. (Item 5).

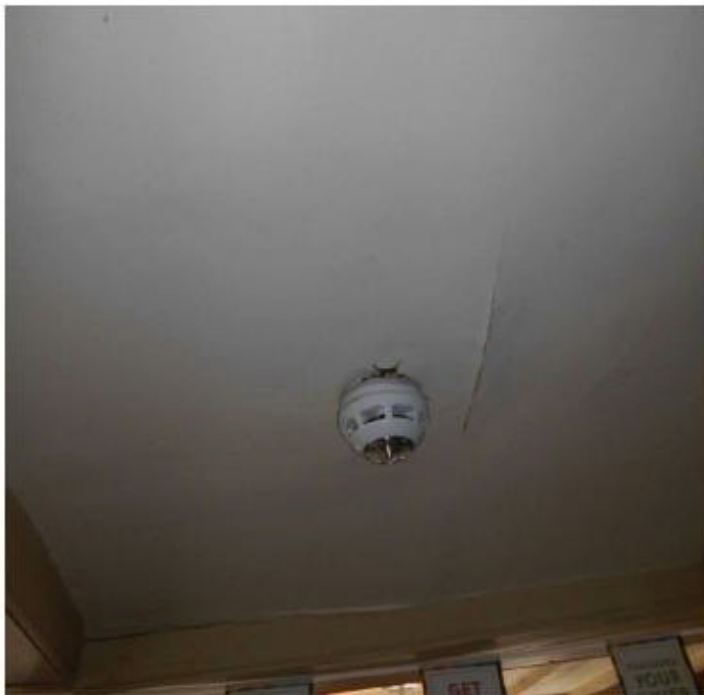
Sagging ceiling finishes. (Item 4).
